Report on Texada “goop” used on Denman Island

Nick Doe P.(Eng), Hon. Research Assoc. Earth Sciences, Malaspina U-C.

June 7, 2008

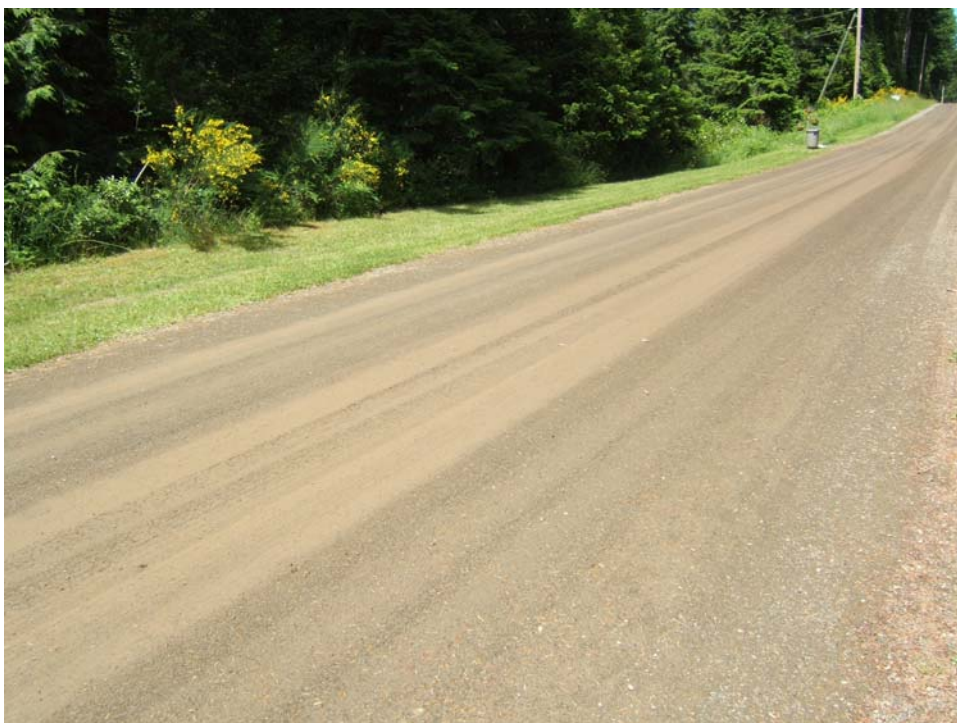
Many stretches of unpaved road on Denman were free of potholes (including dried-up ones) and were slime-free at the time of the visit. They were also not dusty. All roads were in, as good as, or better shape than Gabriola's.

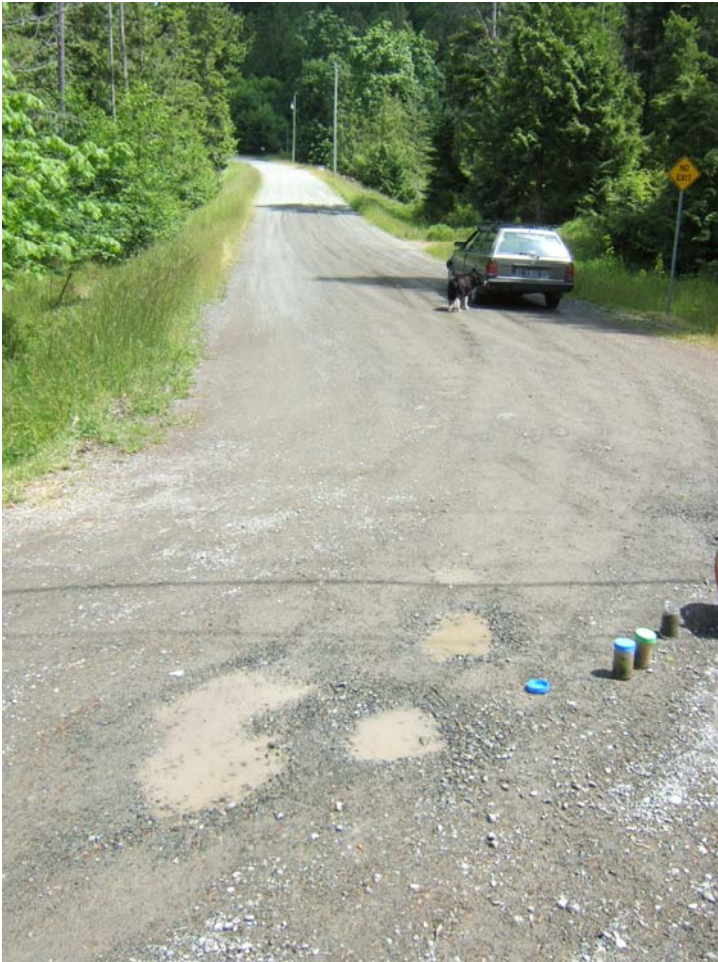
Where potholes existed, they were either at the bottom of inclines or near the junction with another road.

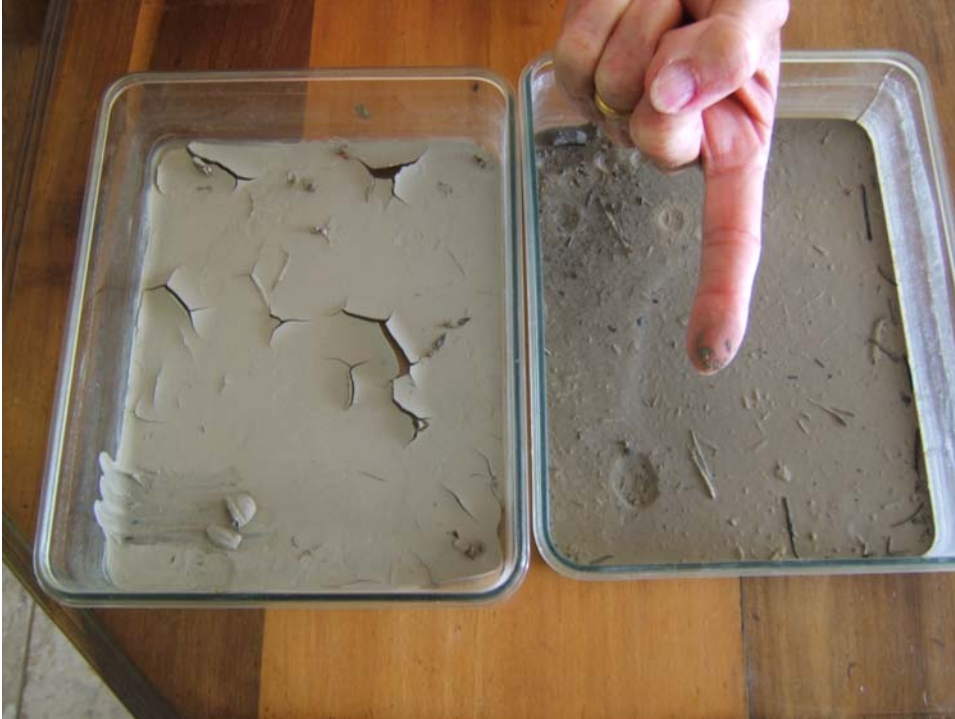
Left: clay from Denman Island goop. *Right:* clay from Gabriola Island goop.

The clay from Denman (*left*) dries out quickly and leaves tension gashes as a result of shrinkage. In contrast, the Gabriola clay (*right*) dries more slowly and is still sticky after a week of extra drying. The surface remains intact even after prolonged drying.

The difference lies in the chemistry of the two. Unlike Denman clay, the Gabriola clay contains calcium carbonate which acts as a cement. Super-saturated solutions of calcium carbonate in the interstices of the clay expand slightly when they crystalize. This crystallization pressure locks the grains together, lowers the permeability of the concreted clay, and creates compression stress on the surface. The Denman clay remains as dried and caked mud and although the clay is relatively impermeable, it is brittle, fairly readily reverts to mud when water is added, and tension gashes allow trapped water to escape.

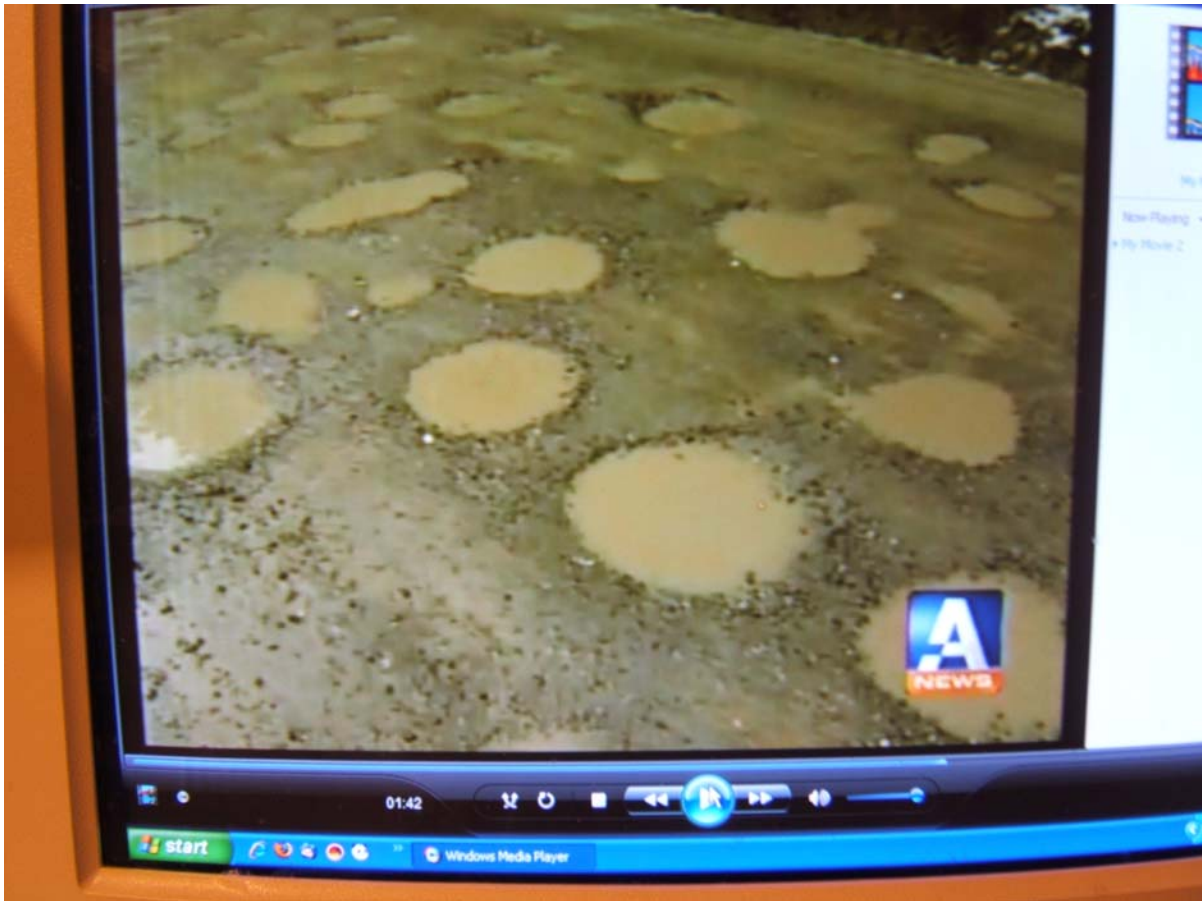
Potholes like these on Gabriola are forming a quasi-hexagonal patterns with spacing determined by the “zone of influence” of the individual holes.

The radius of the zones is probably a measure of how far away from the hole clay-laden water has to be before it fails to return to the hole after being splashed out by a vehicle. Note the coarser material accumulating around the perimeters of the holes. This is gradually being replaced by mud in the holes.

There must be a completely water-tight seal beneath the surface for this condition to persist. Evaporation is the only way the water can escape. The seal is likely being formed by carbonate loaded clay forming a sub-surface layer of claystone or concreted mudrock.

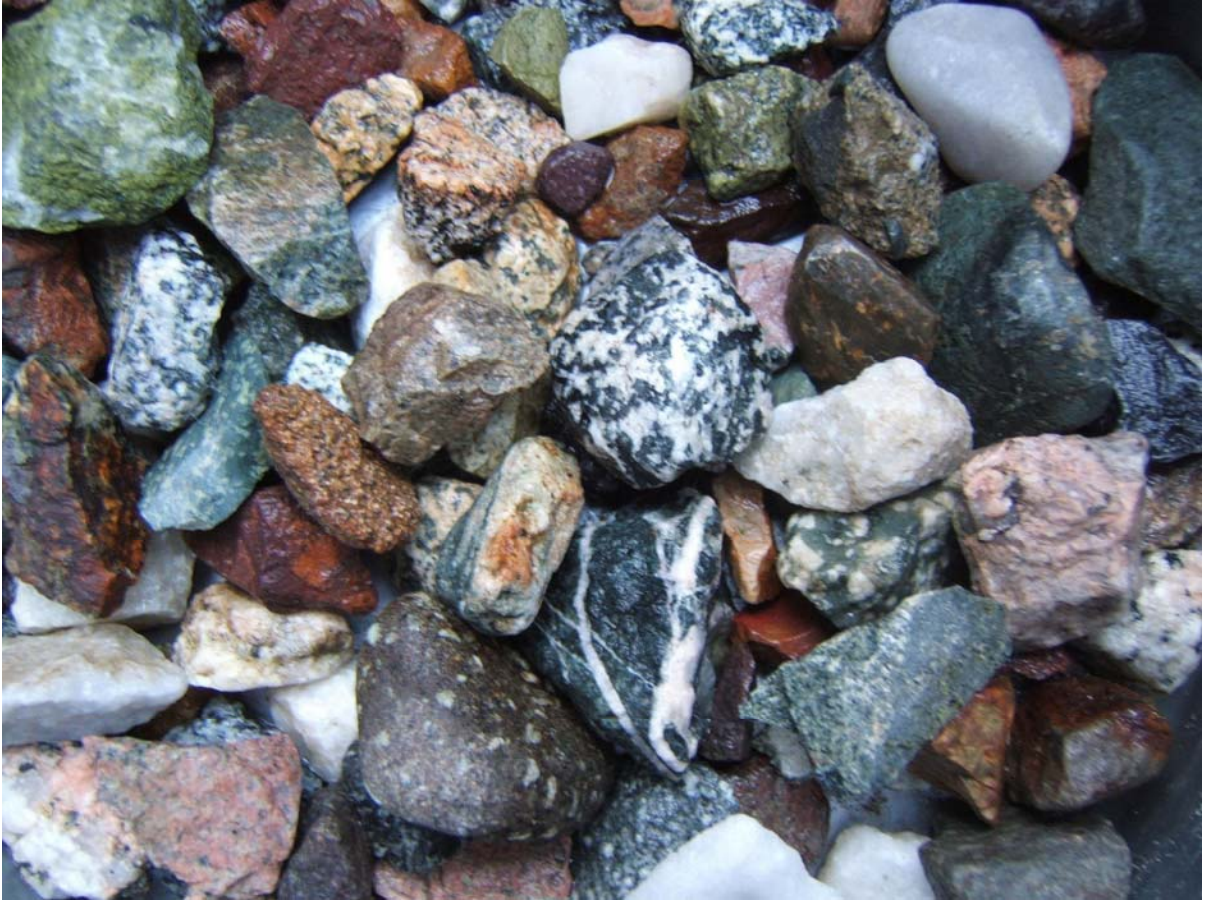
Selected grains of gravel in Texada aggregate from mixed sources. The abundance in the picture in no way represents the abundance in the bulk material; nevertheless, a good indication of how varied Texada geology is, and how samples can vary widely in their properties.
