Coats Marsh Weir Replacement Elevation Study Final Report

April 12, 2023 Final Report, Rev. 0

NHC Reference 3007584

Regional District of Nanaimo 6300 Hammond Bay Road Nanaimo BC V9T 6N2

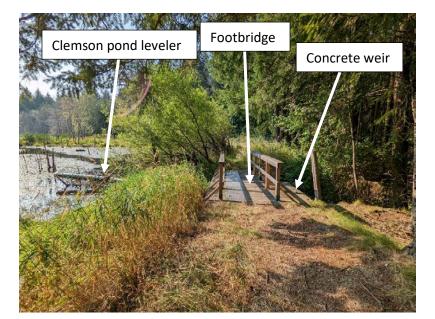
Photo 2.2 Coats Marsh Weir, viewed from the right abutment (NHC, Sep. 2022).

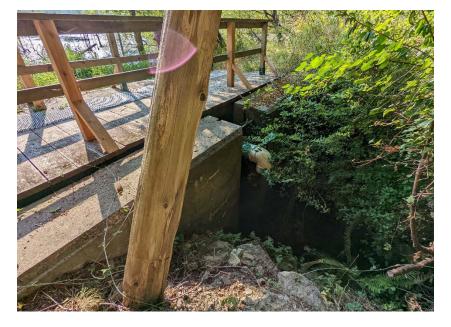
Photo 2.3 Coats Marsh Weir, viewed from the right channel bank (NHC, Sep. 2022).

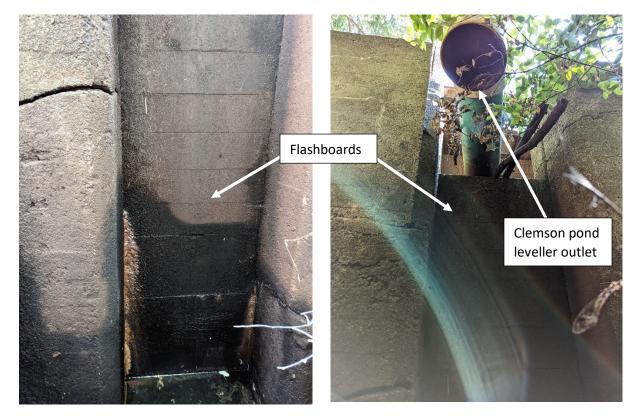
- There were several deficiencies identified with the existing weir and berm, including inadequate spillway width and freeboard; spillway obstructions; concrete cracking; abutment seepage; berm geometry issues (inadequate crest width and freeboard, and overly steep side slopes); poor berm foundation conditions, lack of fill compaction during the berm's construction, and evidence of seepage along the toe of the berm; and trees growing on the berm slopes.

Photo 2.4 Lower (left) and upper (right) portions of the weir outlet slot and flashboards, viewed from the downstream channel. Note cracks in the concrete at several locations (NHC, Sep. 2022).

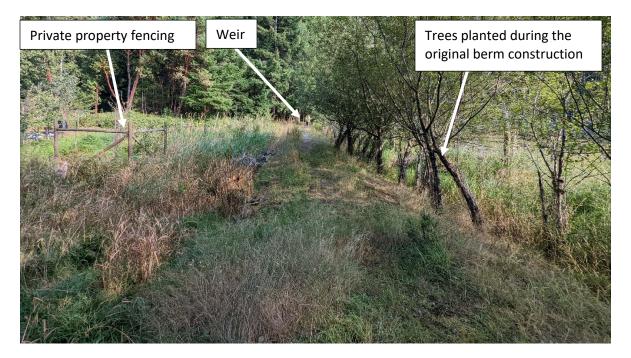
Photo 2.5 Typical condition of the berm, view looking north (NHC, Sep. 2022).

- RDN should remove trees from the existing berm by cutting as close to the ground as possible. Root wads should be left in place.
- Depending on their risk tolerance, RDN could consider removing the beaver dam this summer (2023) if beaver dam removal is a component of their preferred dam elevation scenario. Apart from environmental considerations, the main drawback to removing the beaver dam is that it couldn't be used as part of a cofferdam/site isolation system during construction of a future weir replacement or decommissioning.
- RDN could consider installing a temporary log boom upstream of the weir to mitigate spillway blockage in the event of beaver dam failure or other debris entrainment.

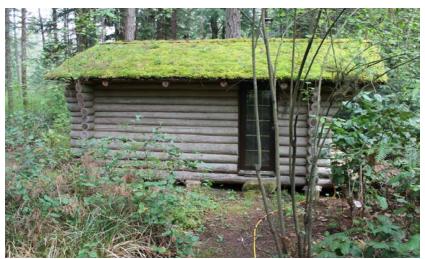
- NHC provided a dam consequence classification review in accordance with provincial guidelines, including an inventory of downstream assets and a qualitative assessment of potential consequences in the event of a dam breach. We recommend a preliminary classification of High Consequence for the existing weir due to potential for loss of life at a cabin located on private property at 1040 Coats Drive.

Photo 4.2 Condition of cabin at 1040 Coats Drive (SRM Projects, 2020).

- RDN should inform the DSO that the proposed classification for the existing dam is High Consequence.
- RDN should initiate discussions with the land owner at 1040 Coats Drive regarding options for reducing flood hazards to the existing downstream cabin.
- A provincial water licence application is required to authorize surface water storage. We understand that RDN submitted a water license application on November 24, 2022 (J. Vander Klok, pers. comm.).
- RDN must meet requirements under Part 2 and Part 3 of the Dam Safety Regulation. A High consequence dam requires weekly site surveillance. All Significant and High consequence dams

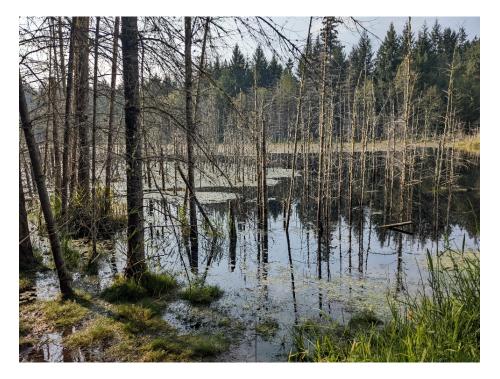
Photo B4 Coats Marsh above the beaver dam, note waterlogged trees, swamp conditions.

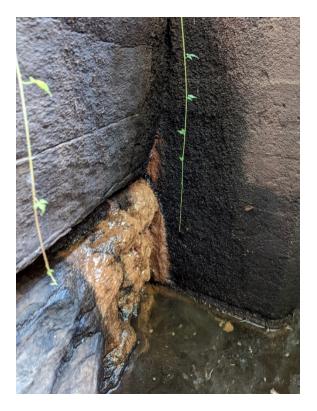
Photo B11 Leaks visible in the weir structure from downstream.

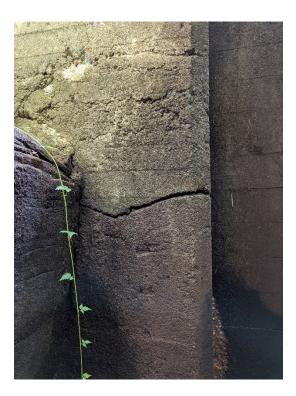
Photo B12 Concrete cracks in weir.

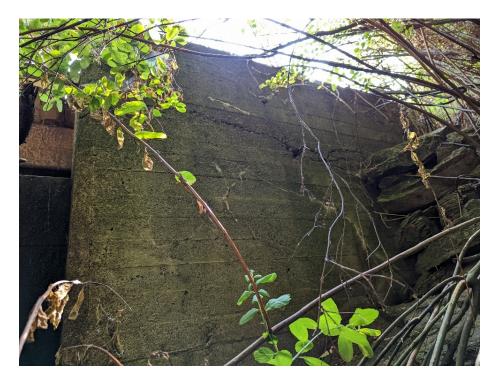
Photo B13 Concrete cracks in weir.

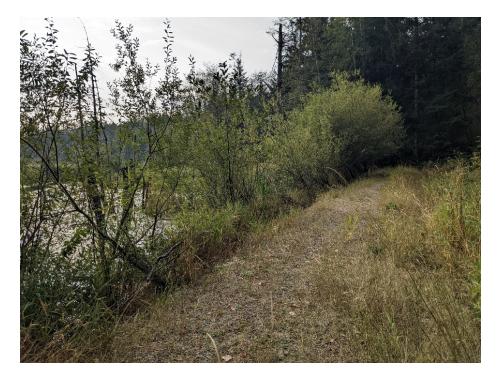
Photo B14 Vegetated berm.

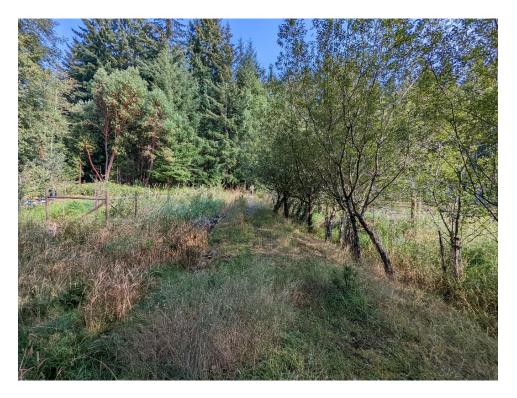
Photo B16 View of berm looking north. Weir pool is on the right and private property to the left. Leakage occurs through the berm, as evidenced by wetland vegetation.

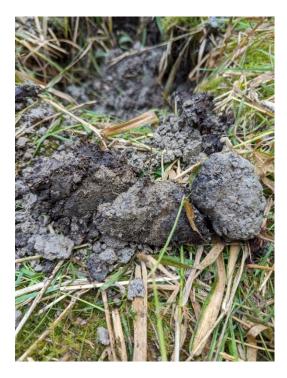
Photo B18 Excavated materials from test pit, representative of conditions for the foundation of the berm.

- Geotechnical drilling or test pit investigation will be required to confirm subgrade conditions. Additional survey may be warranted to map bedrock elevations.

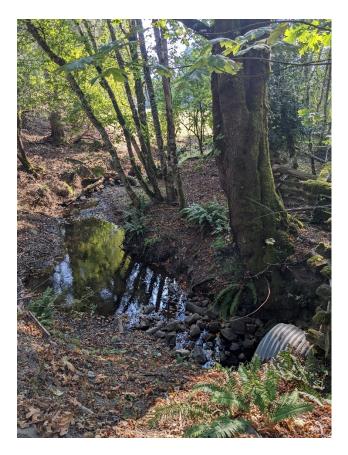
Photo B27 Outlet of South Road culvert crossing. Coats Marsh Creek flows another 200 m through private property before entering Hoggan Lake. Bedrock step feature acting as barrier to most fish passage is downstream of this location within private property.
