Coats Marsh Dam Preliminary Decommissioning Plan

Preliminary Plan, Rev. 0

NHC Reference 3008511

Regional District of Nanaimo

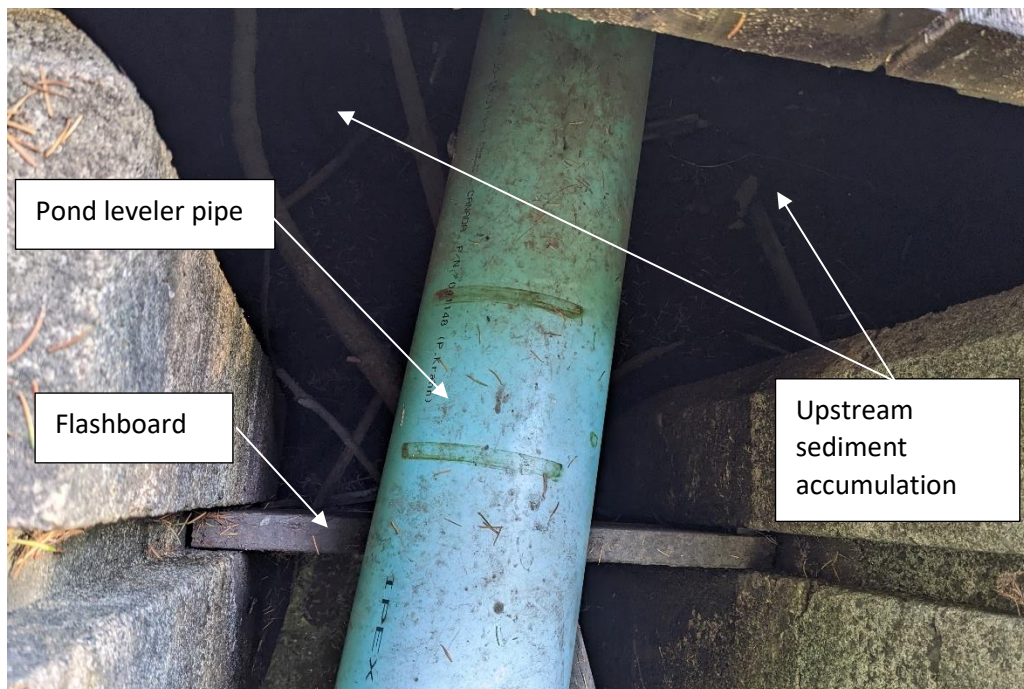
The existing weir structure is located in the blasted marsh outlet channel, with the channel bed and side walls consisting of fractured sandstone bedrock. The weir itself is constructed of concrete; however, it is not known whether the concrete is reinforced, and whether there are keyways or dowels present at the bedrock interface. Previous studies by NHC and SRM (2023; 2020) identified concerns with the long-term integrity of the structure, including concrete surface deterioration, cracking, and abutment seepage. The upstream face of the weir has not been viewed due to accumulated sediment and therefore its condition is not known.

Photo 3.1 Downward view of accumulated sediment upstream of the weir.

4. Dam decommissioning: the footbridge, concrete, and pipeworks will be removed and disposed of off site. Sediment and beaver dam debris will be removed from the upstream face of the weir to facilitate concrete demolition and construction of the grade control structure. Machine access into the marsh may require the use of swamp mats or other techniques due to soft bottom conditions. Concrete removal may involve saw cutting to the final design elevation, as well as hammer breaking or ripping with an excavator.

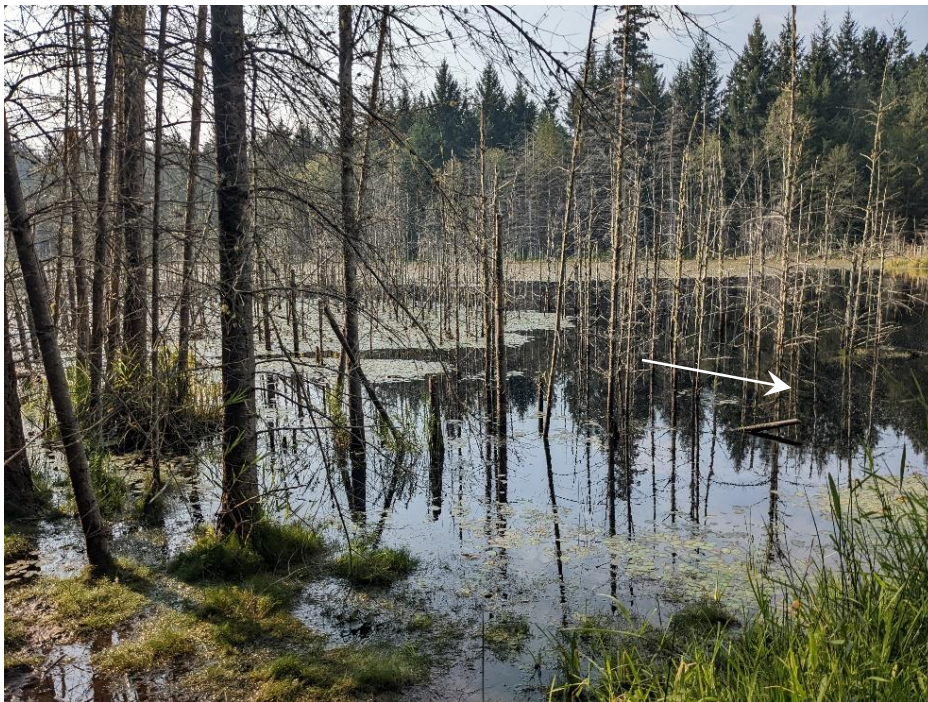
Photo B4 Coats Marsh above the beaver dam, note waterlogged trees, swampy conditions (14 Sept 2022).

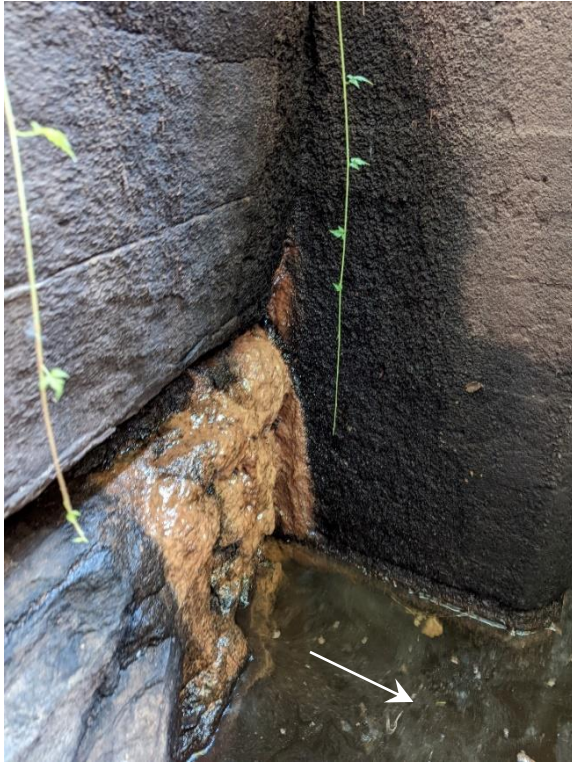
Photo B11 Leaks visible in the weir structure from downstream (14 Sept 2023).

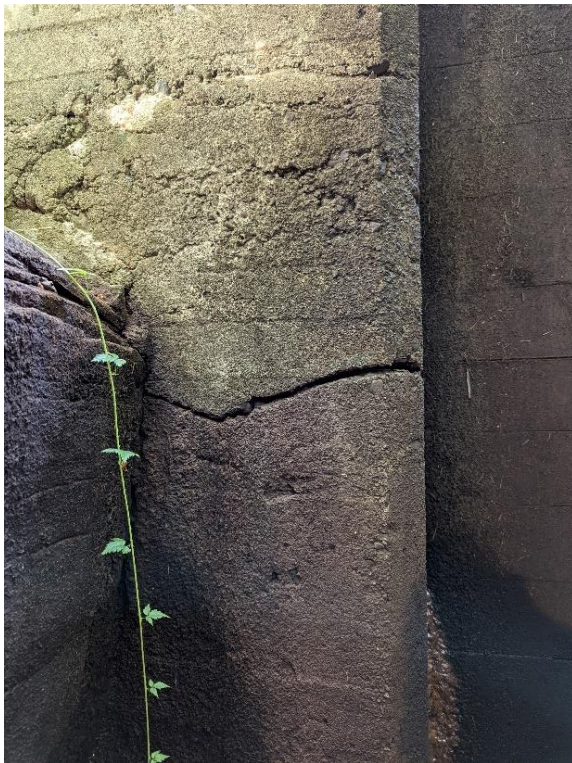
Photo B12 Concrete cracks in weir (14 Sept 2023).

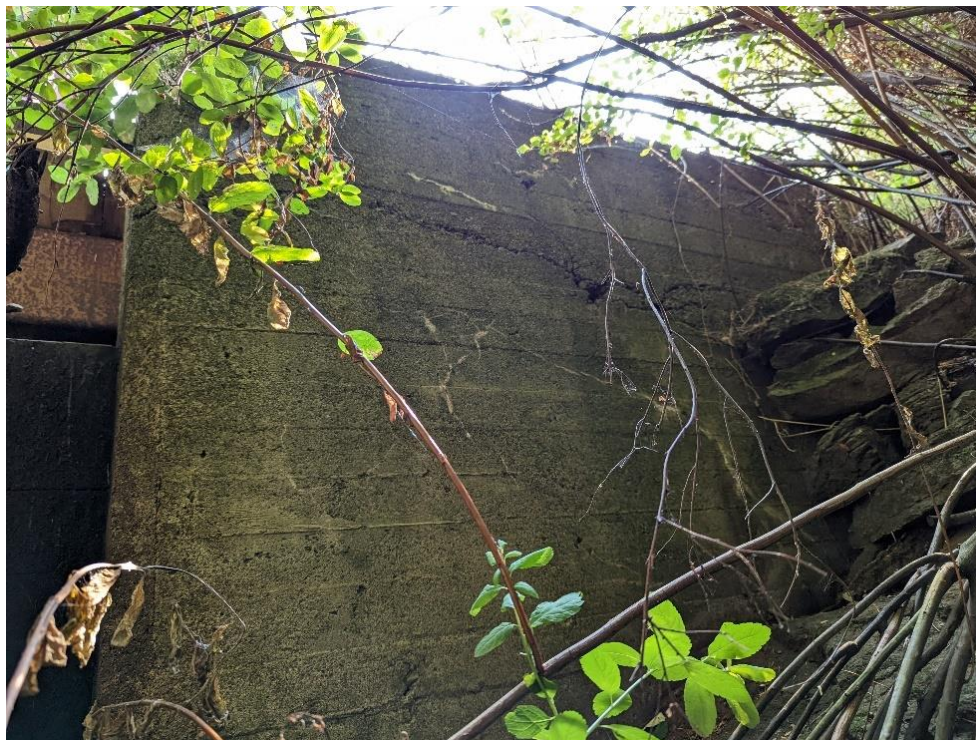
Photo B13 Concrete cracks in weir (14 Sept 2023).

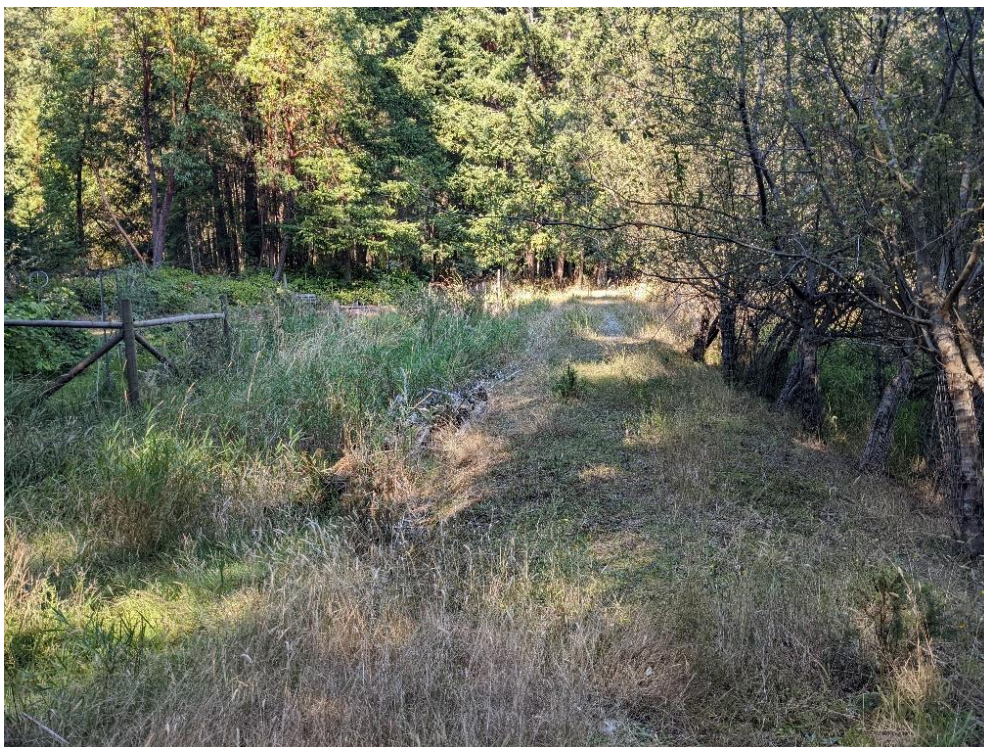
Photo B16 View of berm looking north. Weir pool is on the right and private property to the left. Leakage occurs through the berm, as evidenced by wetland vegetation (22 Sept 2023).

The decommissioning plan currently assumes that the existing berm will be fully removed down to natural subgrade. However, it is possible that stakeholder engagement, regulatory referrals, or First Nations engagement could be favorable to leaving the berm in place. We note that previous studies by NHC (2023) and SRM (2023; 2020) identified concerns with the berm's long-term stability, including non-standard crest width and slope geometry, a lack of foundation preparation during initial construction, inadequate freeboard, exposed geotextile, and trees growing directly into the embankment fill. These issues merit further discussion with the regulator if there is a change in project direction regarding removal or retention of the berm.

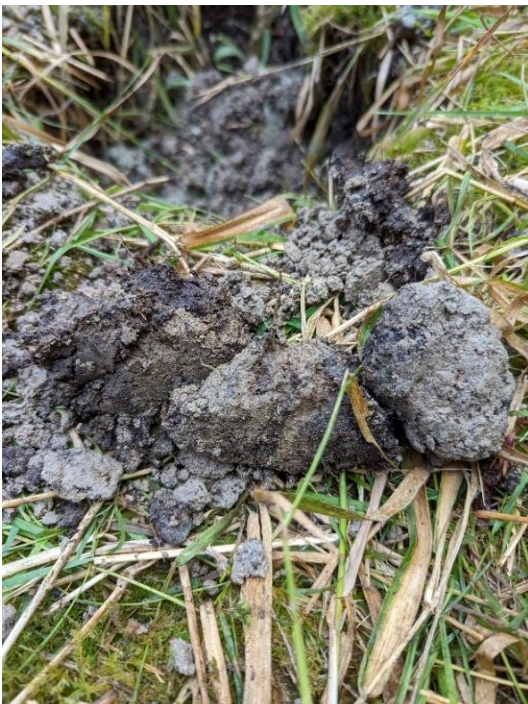
Photo B18 Excavated materials from test pit, representative of conditions for the foundation of the berm (14 Sept 2023).

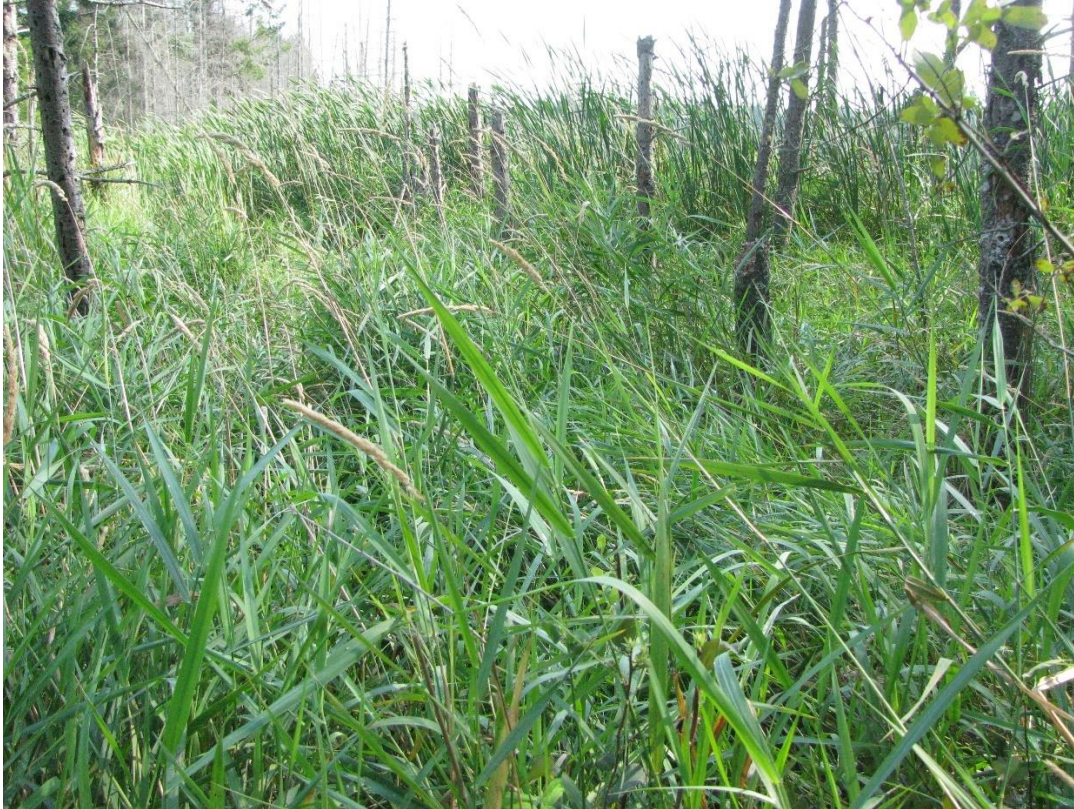
Photo 3-3. Marsh area that is currently dominated by invasive reed canarygrass.
