NHC Reference 3008511
January 10, 2024

Regional District of Nanaimo

**Re: Coats Marsh Weir Decommissioning
Beaver Dam Risk Assessment Final Report, Rev. 0**

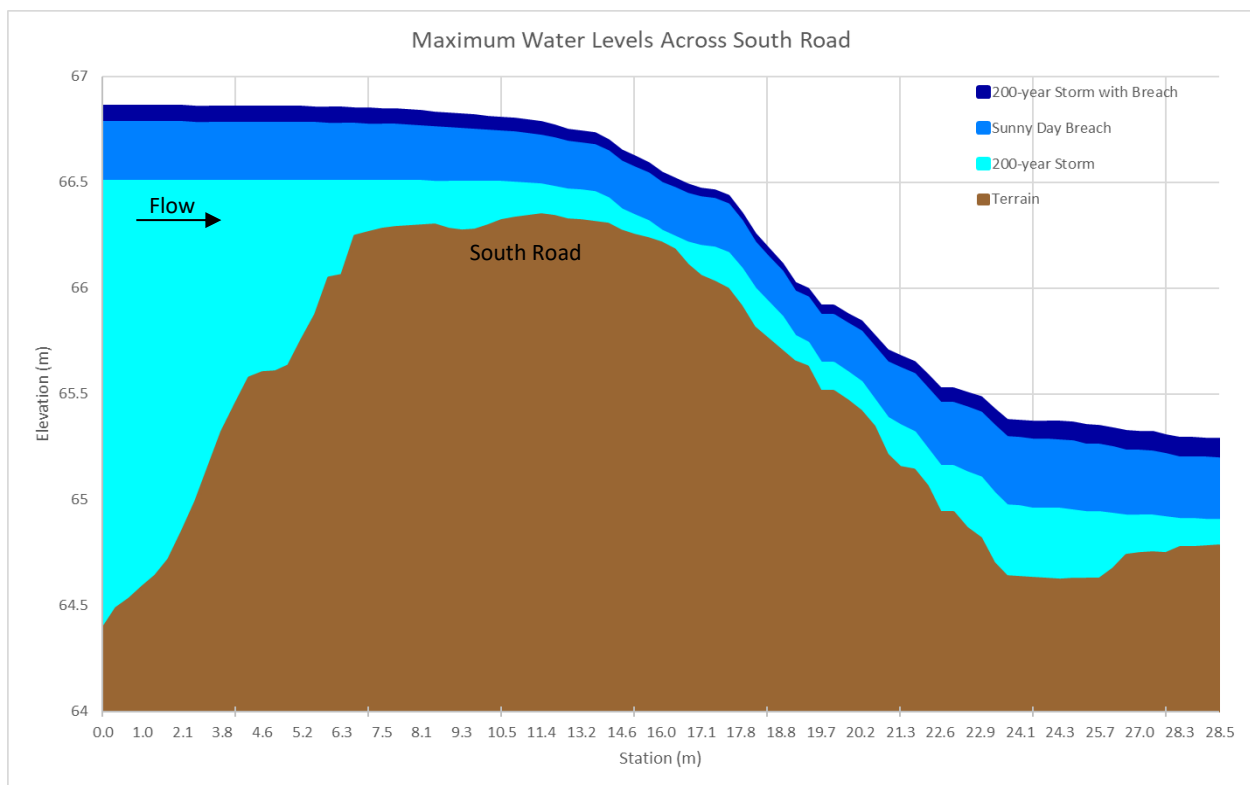
Figure 3.1 Maximum Water Levels Across South Road

The model results indicate overtopping of South Road for all the flow scenarios assessed. Table 3.2 summarizes the conditions modelled at South Road.

Figure 3.1 provides a cross section visualization of South Road with maximum water levels for each model scenario.

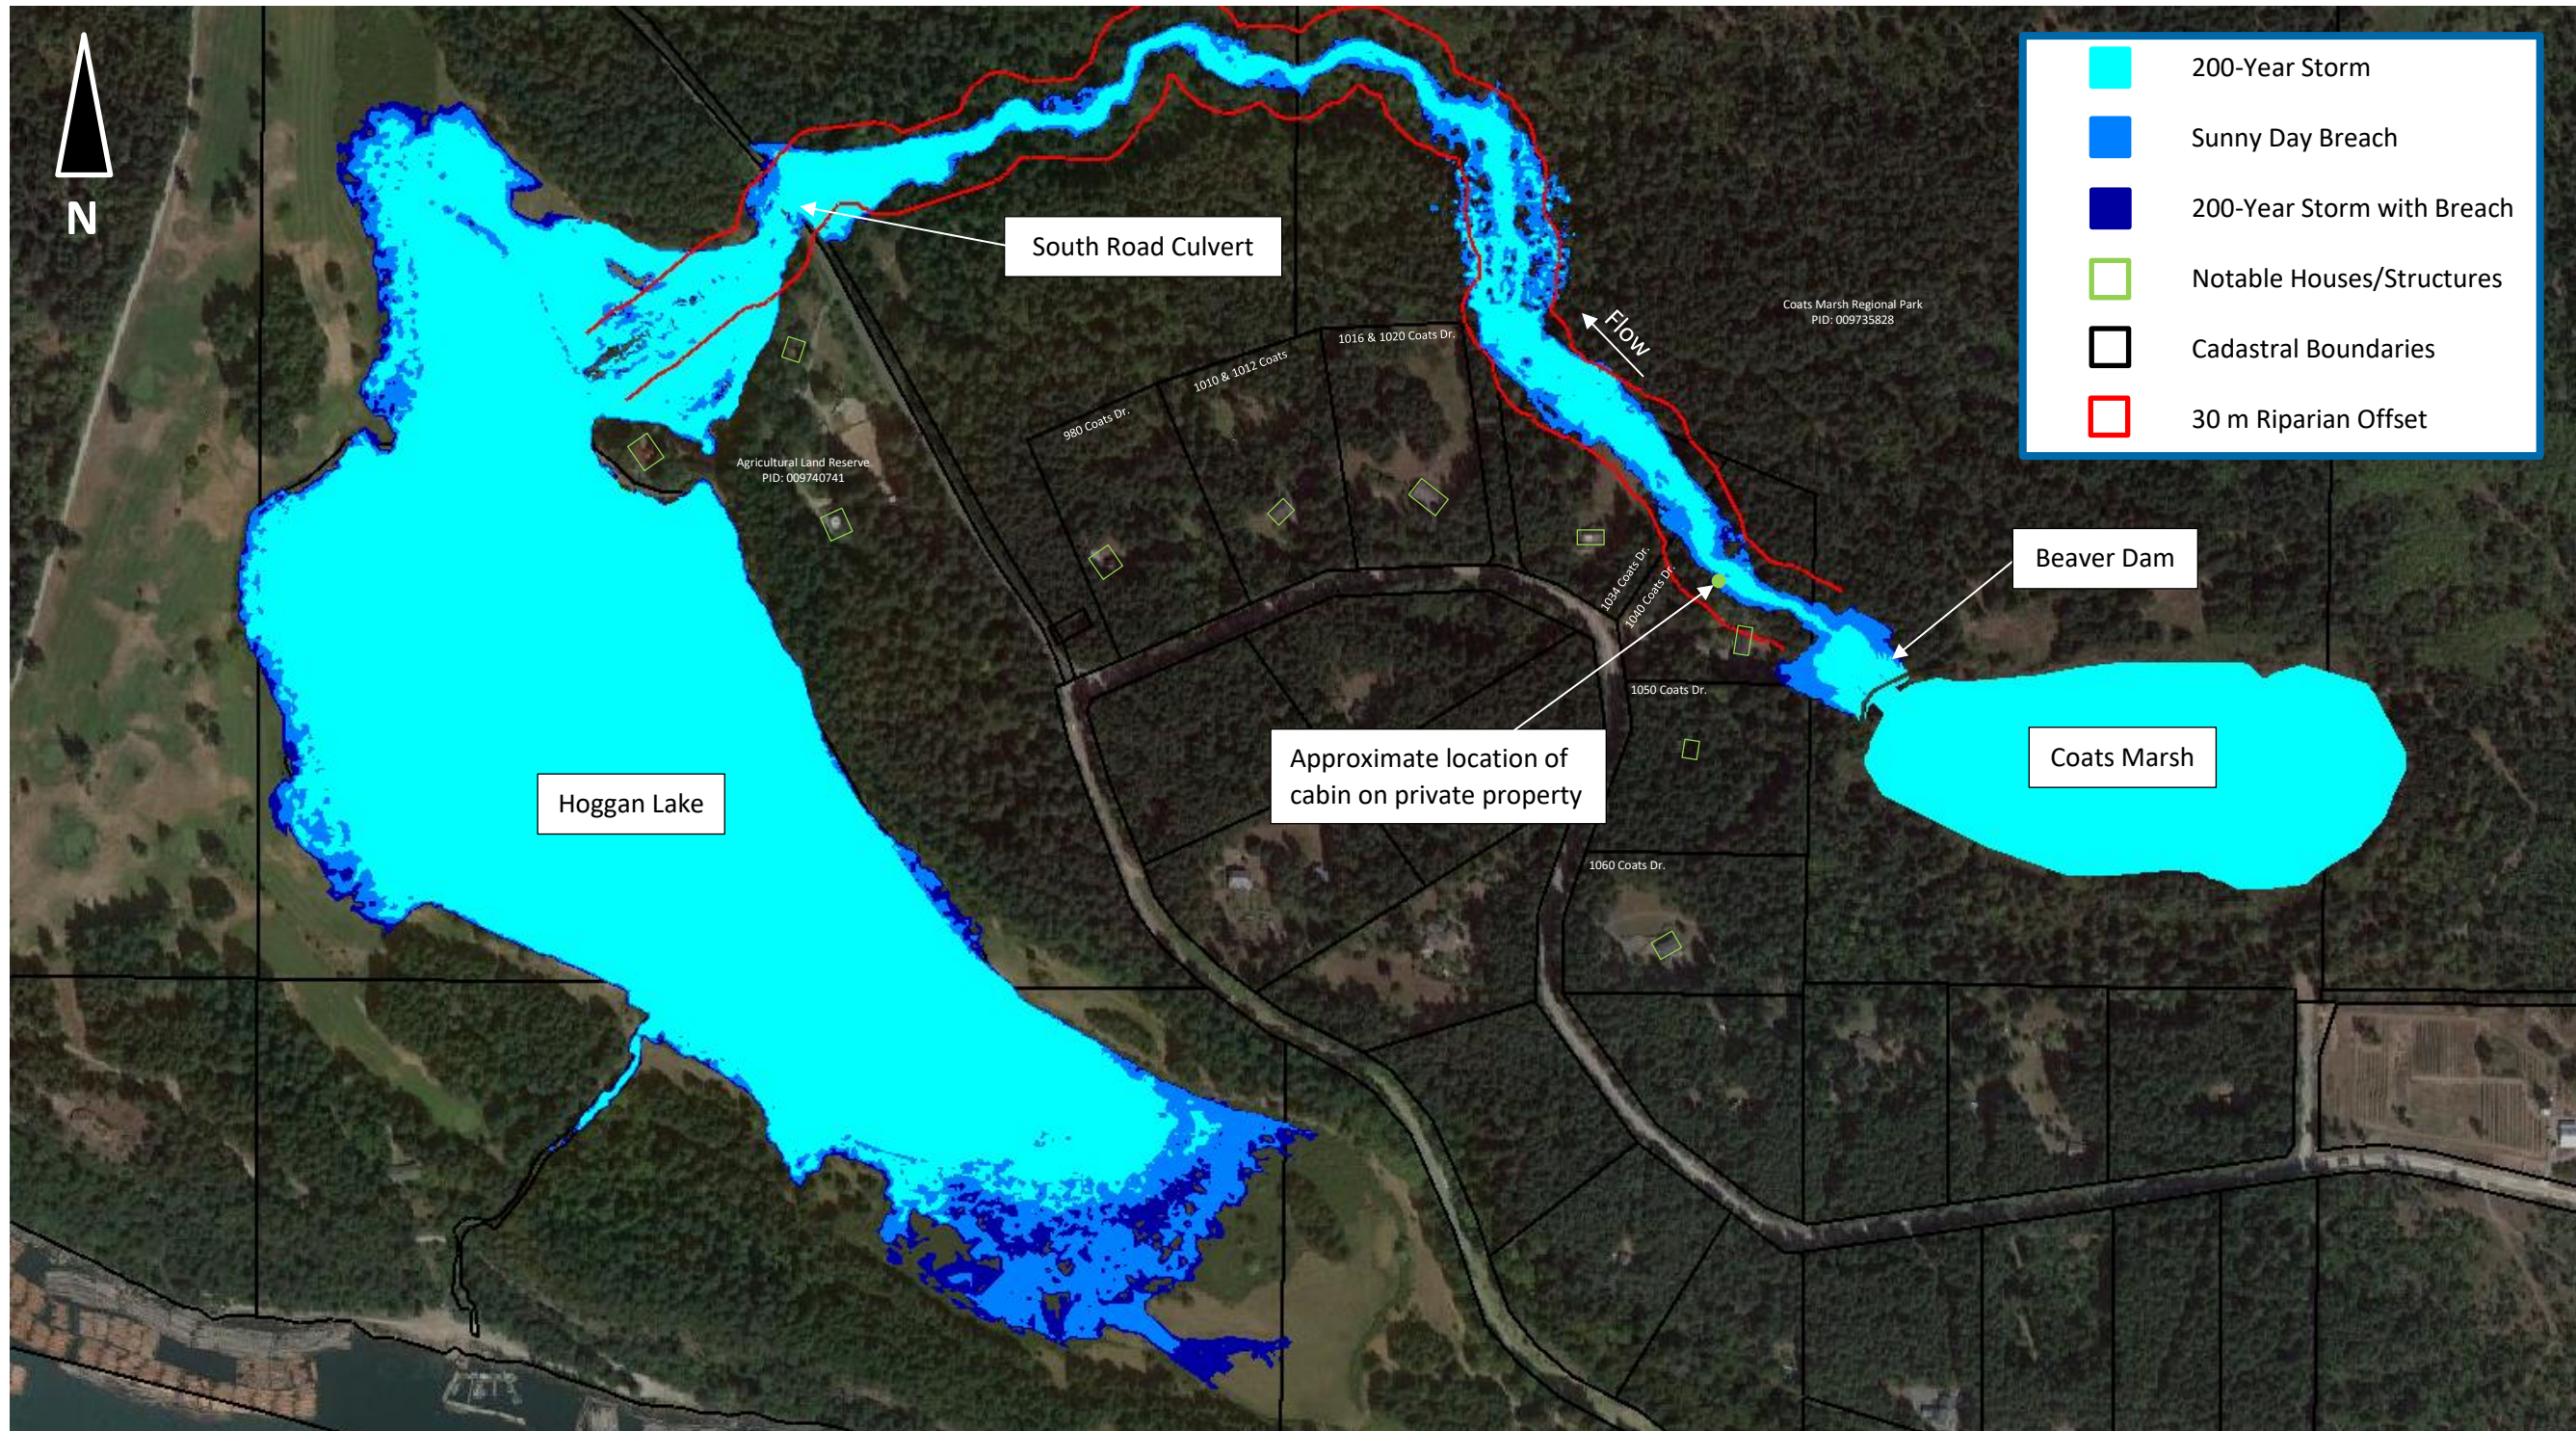
Coats Creek’s alignment intersects this property, flowing northwest. During flooding and breaches, flow overtops the creek banks and spills onto forested portions of the property. The primary residence on this property is not shown to be affected, however this property contains a log cabin that is inundated under all model scenarios. The severity of inundation is greatest during the flood-induced dam breach, when water depths are approximately 0.6 m around the cabin. Property owners have stated that this cabin is occasionally used as a guesthouse (NHC, 2023). It should also be noted that an unlicensed in-channel rock weir exists adjacent to the cabin and likely contributes to localized flooding.

C.2 Map of flood extents, with 200-year storm in cyan, sunny day breach in light blue, and 200-year storm with breach in dark blue³.

- We recommend removal of beaver dam debris from the marsh outlet if its height exceeds the elevation of the overflow channel. The overflow channel is intended to maintain the outlet's discharge capacity, mitigating flooding of private property at 1040 and 1050 Coats Drive during a breach.
