Comments on Golder Associates report on Texada “goop”

Nick Doe P.(Eng), Hon. Research Assoc. Earth Sciences, University of Vancouver Island.

June 6, 2009

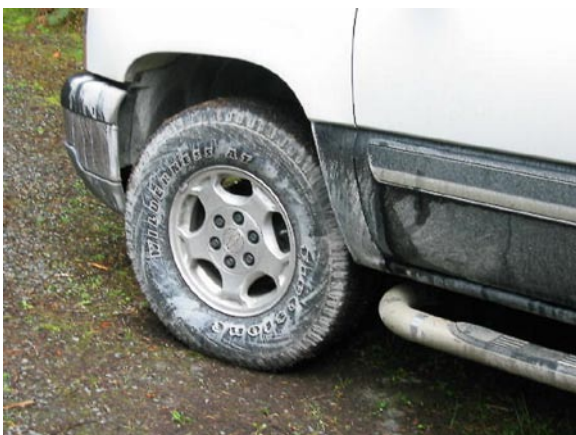
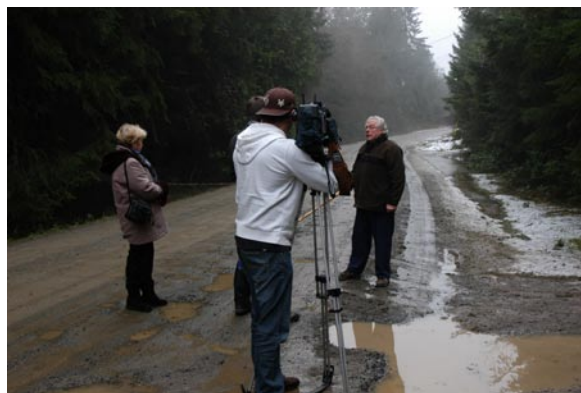
Photographs from <http://www.texadaslime.org> (*this site no longer exists*)

The only “physical” issue that is of concern in the Texada material is its clay content. This is difficult to determine consistently because the clay is so mobile. The relevant specification is Table 202-C, not Table 202-B. Table 202-C requires that the silt and clay component (less than 62.5 µm) be in the range 5–15%. Common observation is that this standard is not met, or that the standard is too lax. The clay component is clearly too high. Some results of measurements indicate compliance; others don’t. Clay adhering to surfaces as shown in the photograph cannot easily be removed with a garden hose. The clay is the major obstacle to good drainage.
