Comments on Golder Associates report on Texada “goop”

Nick Doe P.(Eng), Hon. Research Assoc. Earth Sciences, University of Vancouver Island.

June 6, 2009

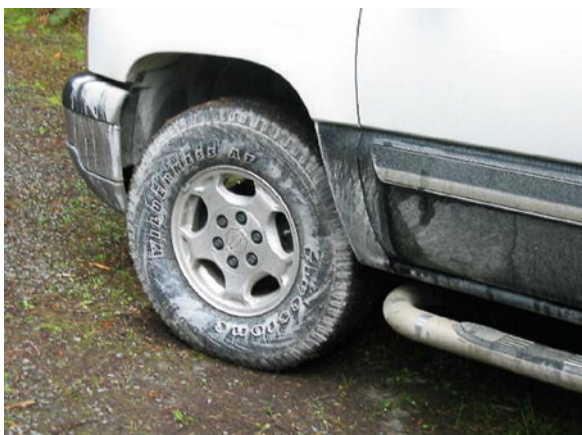
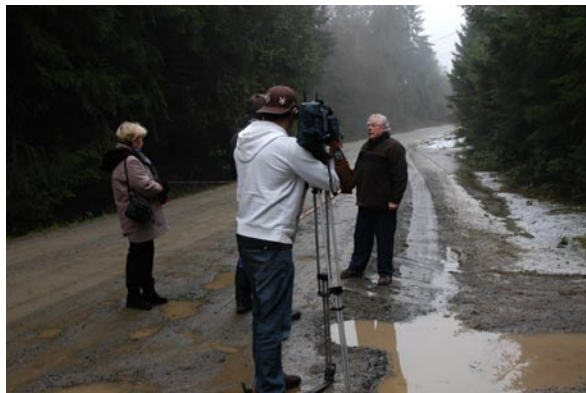
Photographs from <http://www.texadaslime.org>

The only “physical” issue that is of concern in the Texada material is its clay content. This is difficult to determine consistently because the clay is so mobile. The relevant specification is Table 202-C, not Table 202-B. Table 202-C requires that the silt and clay component (less than 62.5 µm) be in the range 5–15%. Common observation is that this standard is not met, or that the standard is too lax. The clay component is clearly too high. Some results of measurements indicate compliance; others don’t. Clay adhering to surfaces as shown in the photograph cannot easily be removed with a garden hose. The clay is the major obstacle to good drainage.
