Final report on Texada “goop” used on Gabriola Island.

Nick Doe P.Eng, Hon. Research Assoc. Earth Sciences, Malaspina U-C.

February 10, 2008; rev. February 11, 2008; rev. February 18, 2008

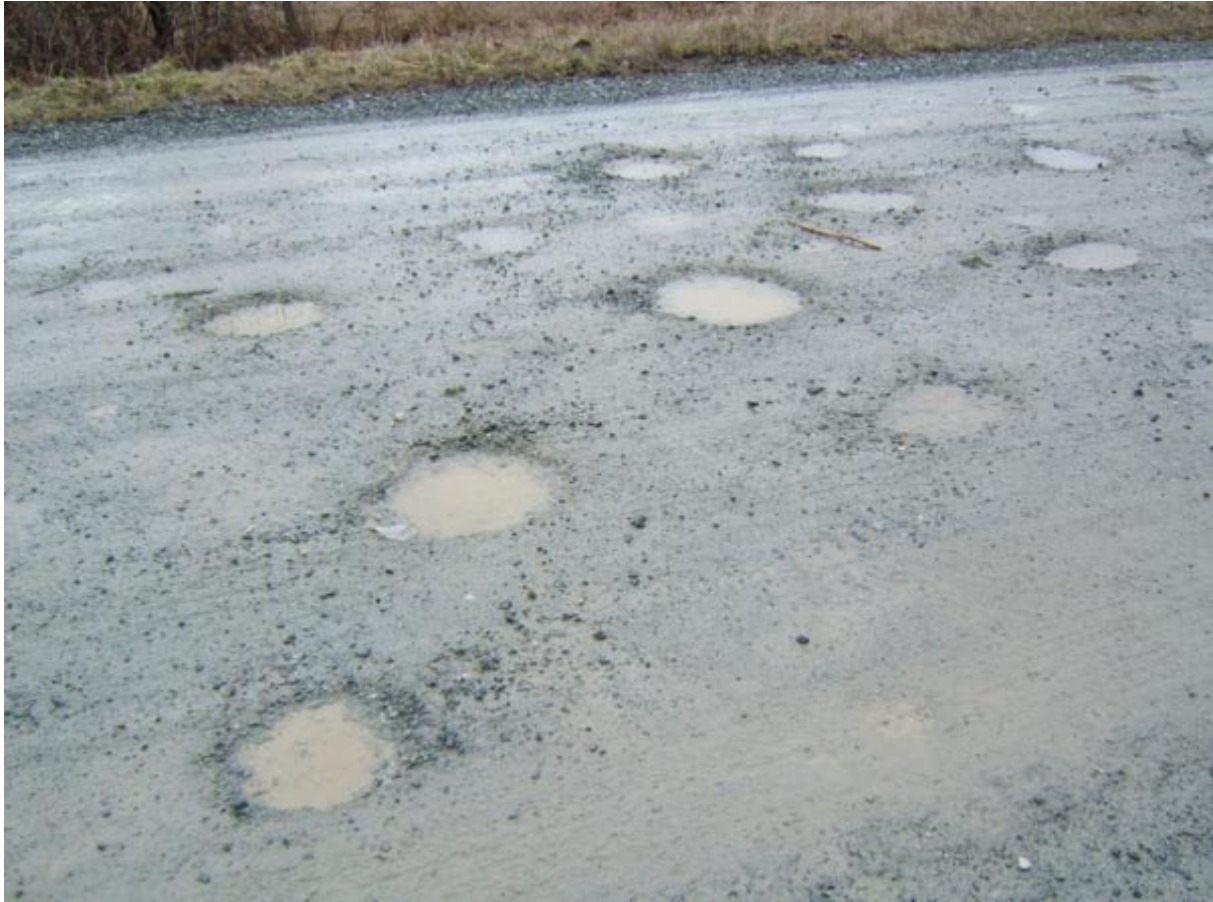
General view of the sampling site TEX-5 on Horseshoe Road, Gabriola (no, not a NASA planetary flyby photograph).

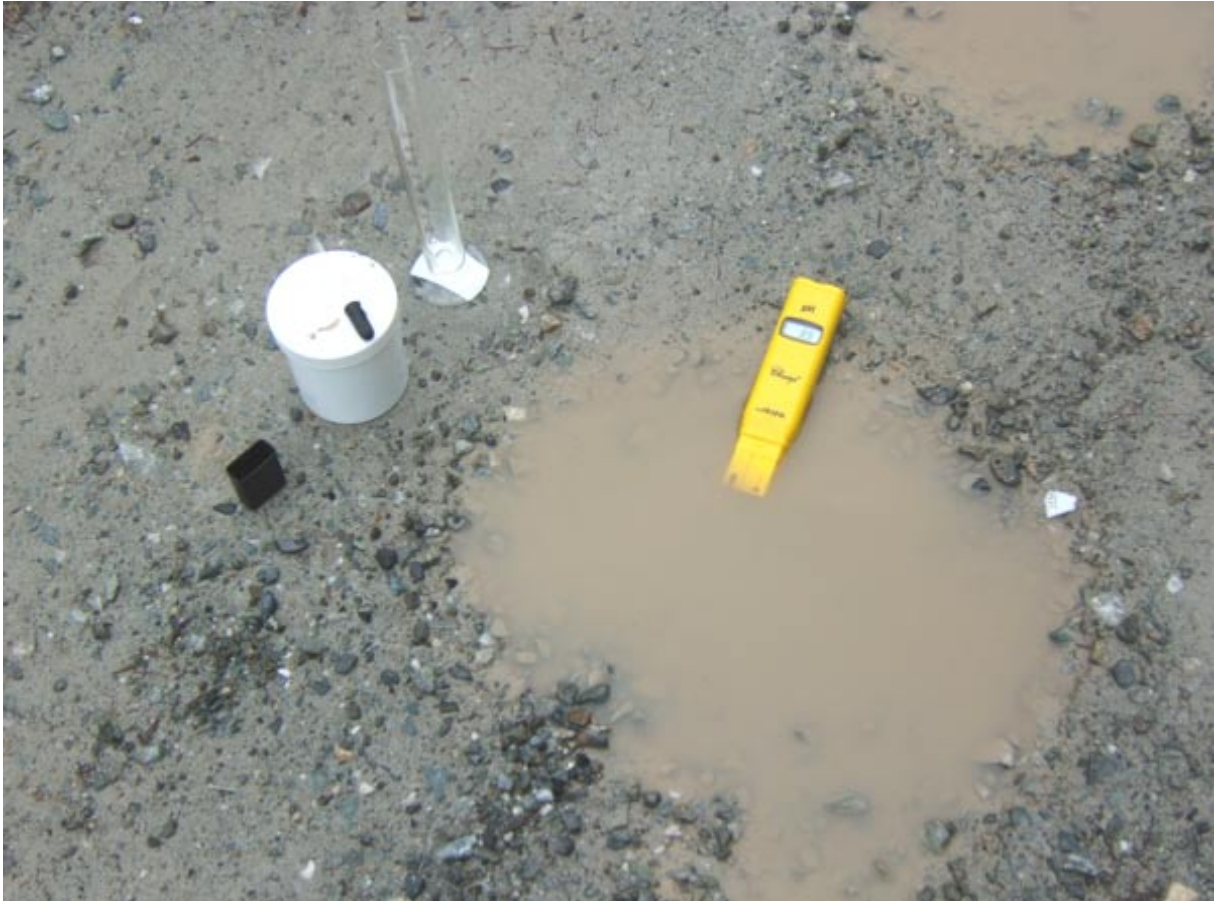
Taking sample TEX-5 on Horseshoe Road, Gabriola. The yellow instrument is the pH meter.

The brown colour indicates iron, but this is very common of course. The shales on Gabriola particularly contain a lot of it; very little iron is needed to provide colour; and iron is not a health hazard in groundwater. However, this particular sample did appear to be loaded with magnesium, probably from dust control treatment. The combination of calcite, magnesium chloride, and bentonite is a good candidate for being a major part of the “goop” problem.

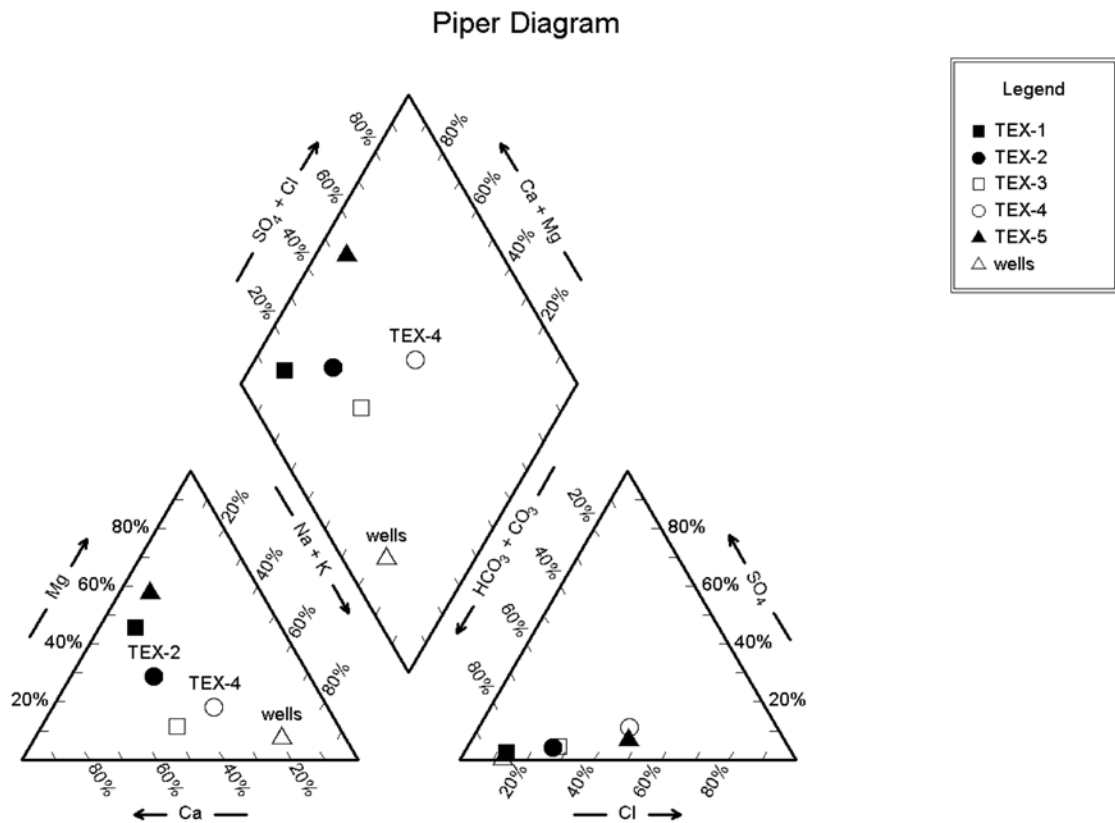
Piper diagram (all samples + well-water)

The pothole samples are TEX-1, -2, and -5 (filled symbols). TEX-3, -4, and “wells” (open symbols) are natural surface- or groundwater samples. All from Gabriola.

Note the unusually high content of magnesium in TEX-5 (the black triangle), implying application of MgCl₂.
