Coats Marsh Weir Assessment

Regional District of Nanaimo
1490 Springhill Road
Parksville, BC V9P 2T2
Liaison: Chris van Ossenbruggen,
Parks Operations Coordinator
Reference Number: NA

Scot Merriam, P.Eng.
Principal Engineer, SRM Projects

Date: June 1, 2020

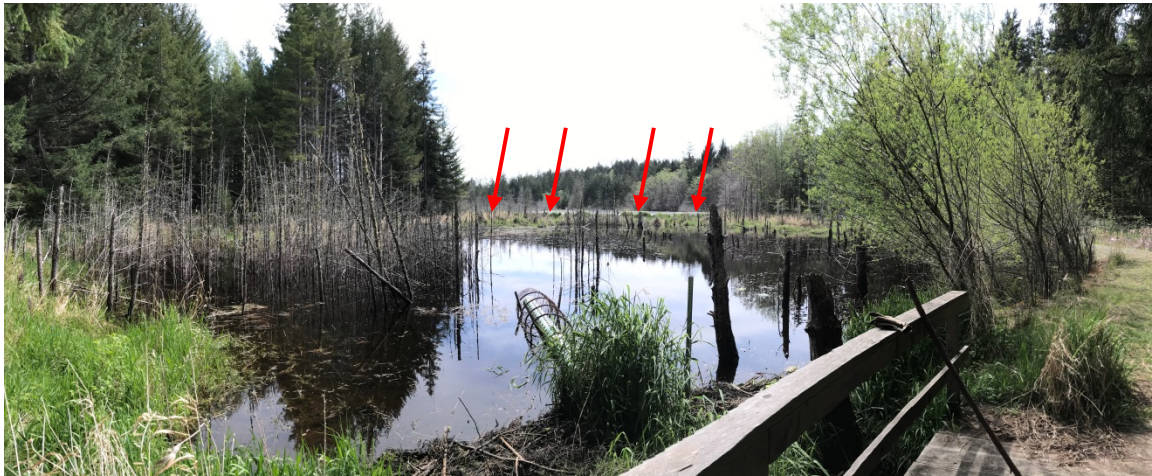
Figure 1-3: View of significant beaver dam (red arrows) at Coats Marsh

For the purposes of risk mitigation, the easiest risk to control is the risk of a release of water due to failure of the beaver dam. Lowering the greater pond (upstream of the beaver dam) level and installing an appropriately sized Clemson pond leveller across the beaver dam, to keep the greater pond level equal with the “design” weir spill level, is a straightforward solution. Note that lowering of the greater pond level would have to be done in a controlled way, through means such as a siphon(s) or pump(s), to avoid the potential for a sudden release of water from the beaver dam.

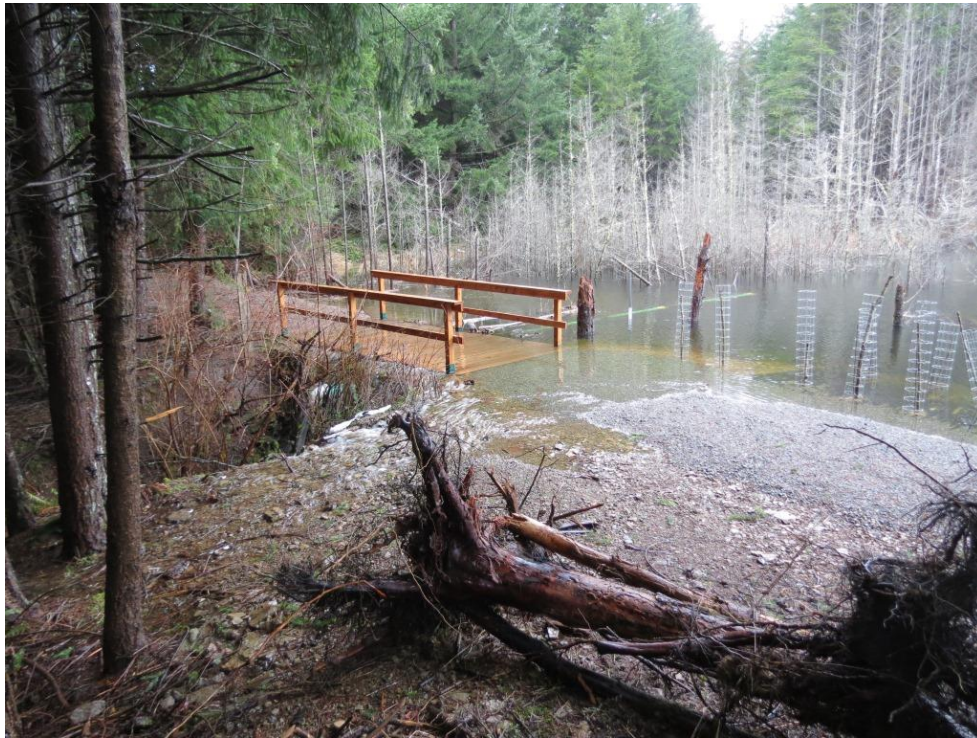
Figure 2-1: Overflow at Coats Marsh weir March 6, 2014

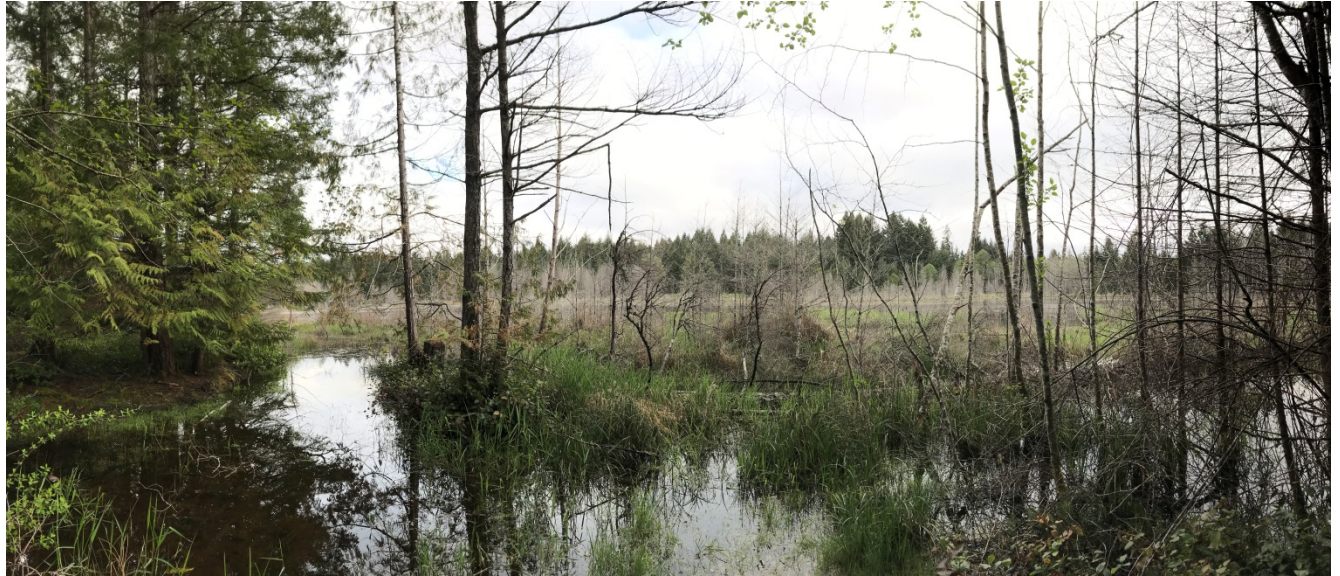
1. View of Coats Marsh looking north near end of Stanley Place – note high water level intruding into perimeter trees

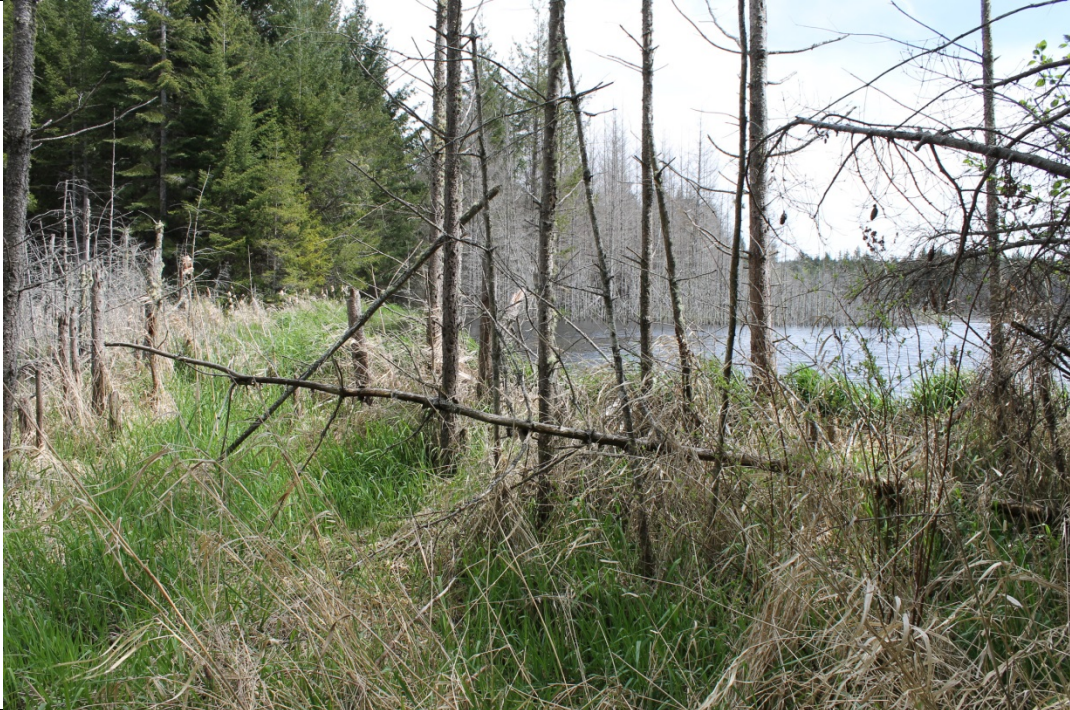
9. View of beaver dam looking NE; built against now dead and rotting trees

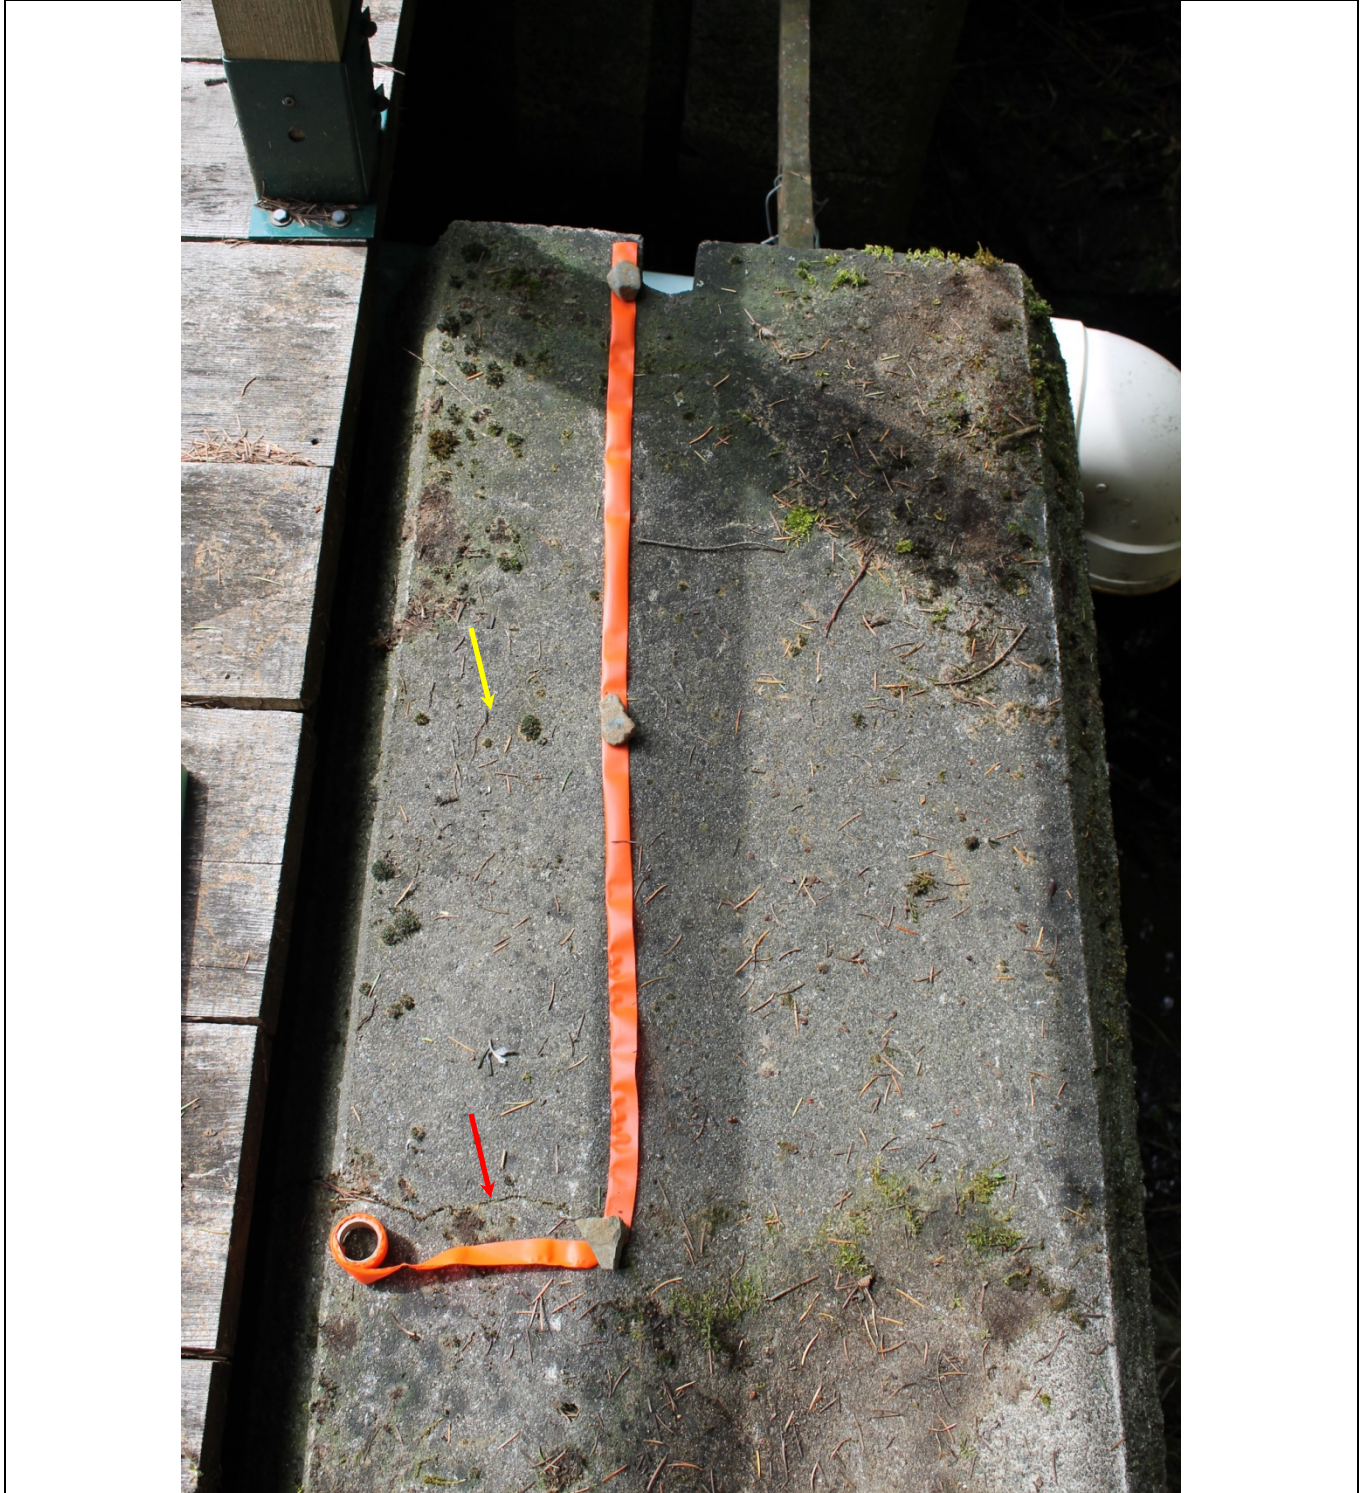
The crest concrete was visually and hammer test inspected. Cracking and two significant areas of spalling were identified. Please refer to the dam inspection report and photos for detail.

22. Area of spalled concrete at right crest of weir (taped area below yellow arrow) – note top crack (red arrow)

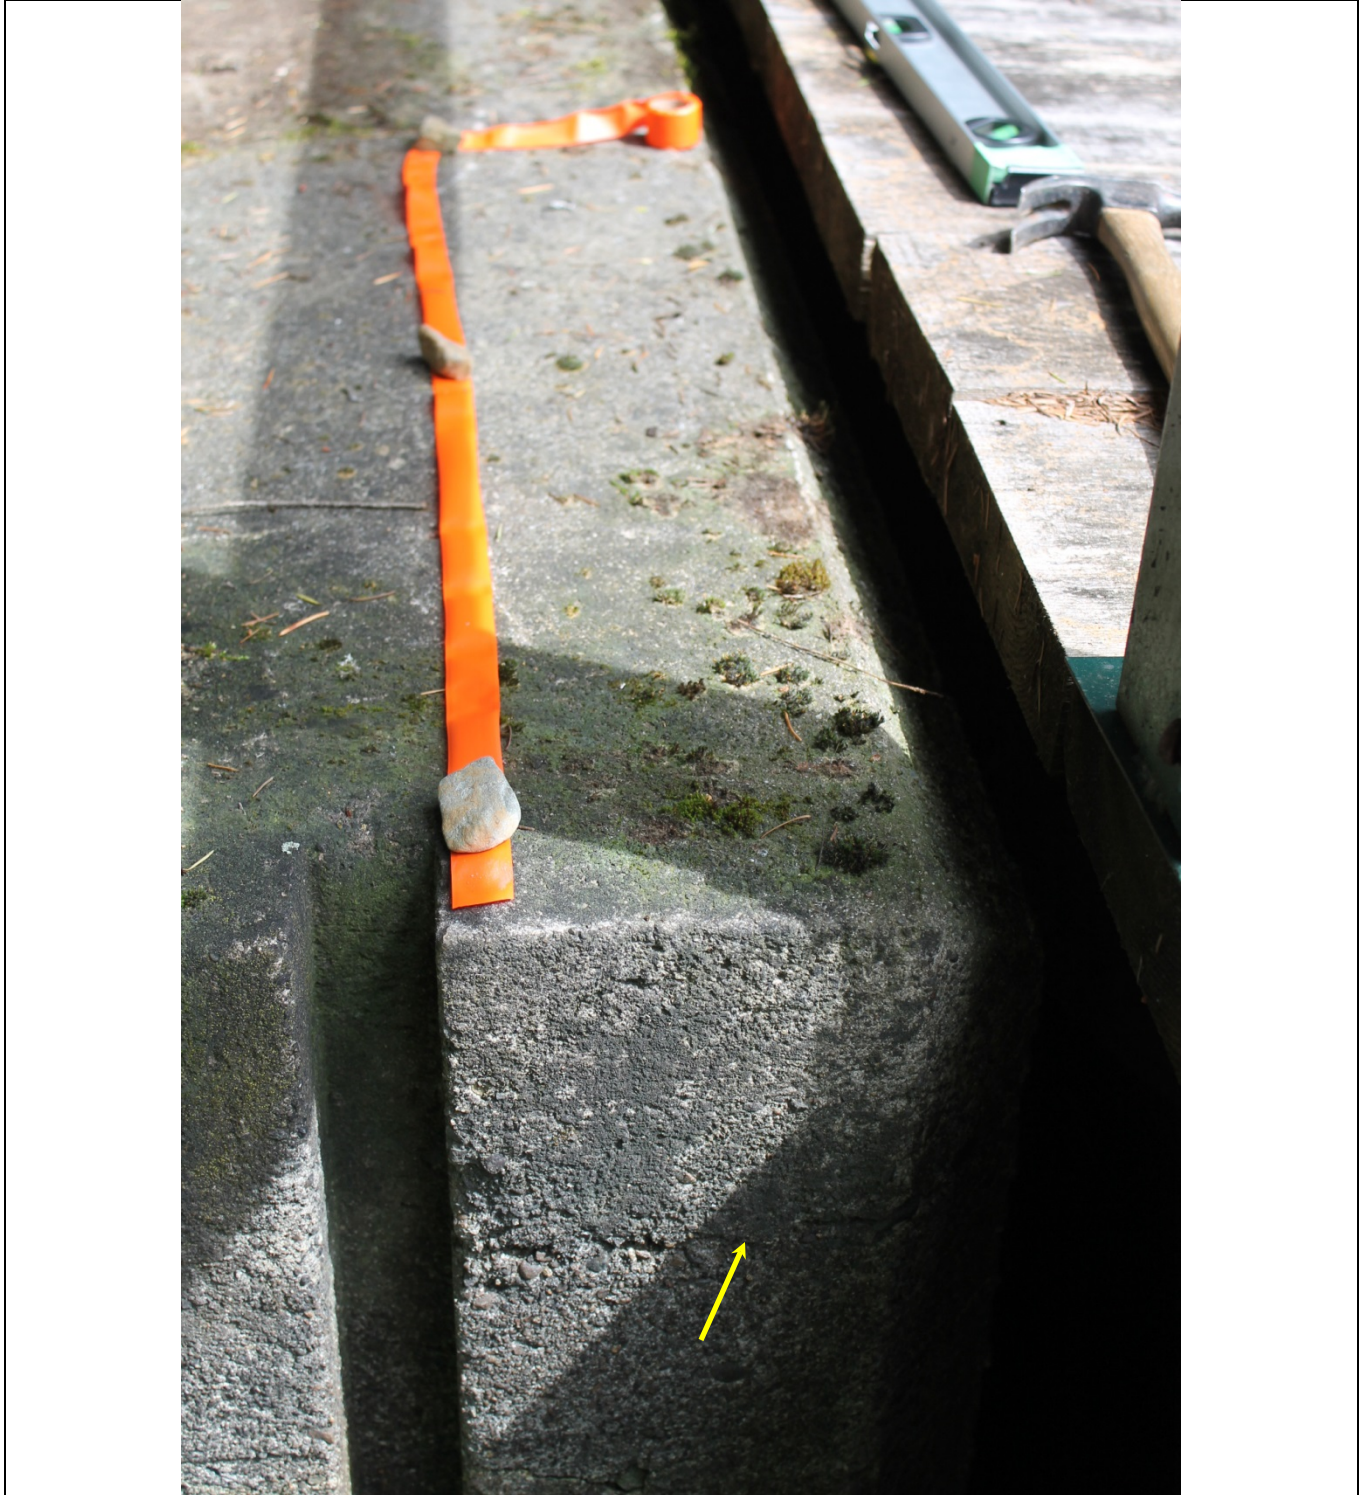
23. Opposite view of area of spalled concrete on right crest of weir – note deep spall crack (yellow arrow)

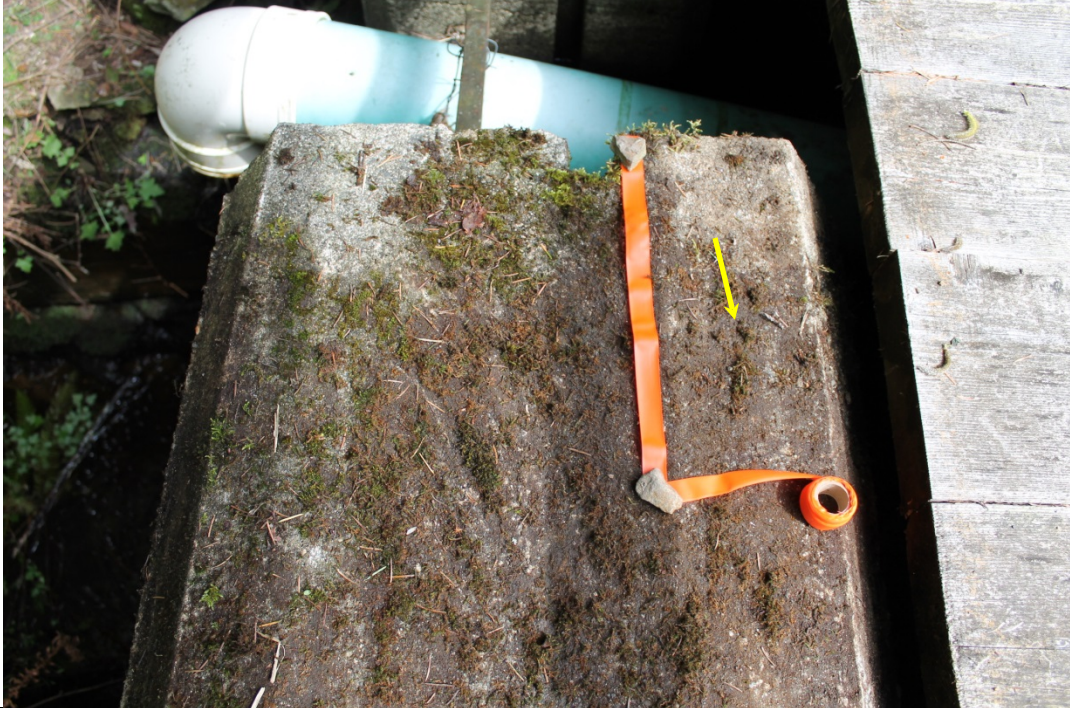
25. Area of spalled concrete at left crest of weir (taped area below yellow arrow)

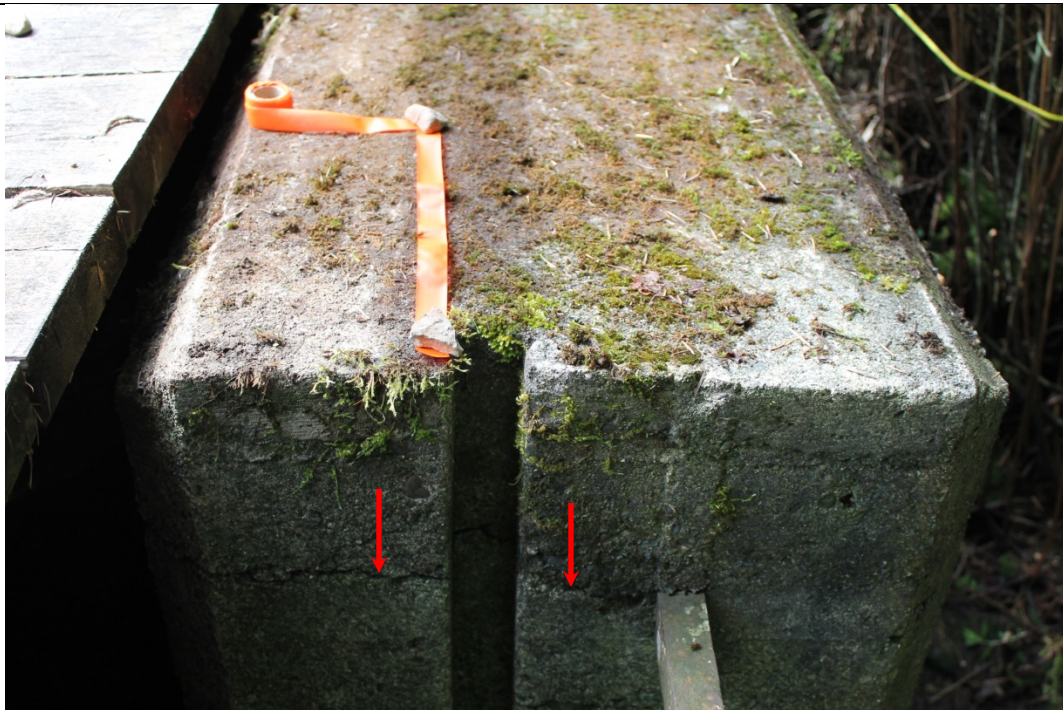
26. Opposite view of area of spalled concrete on right crest of weir – note deep spall crack (red arrows)

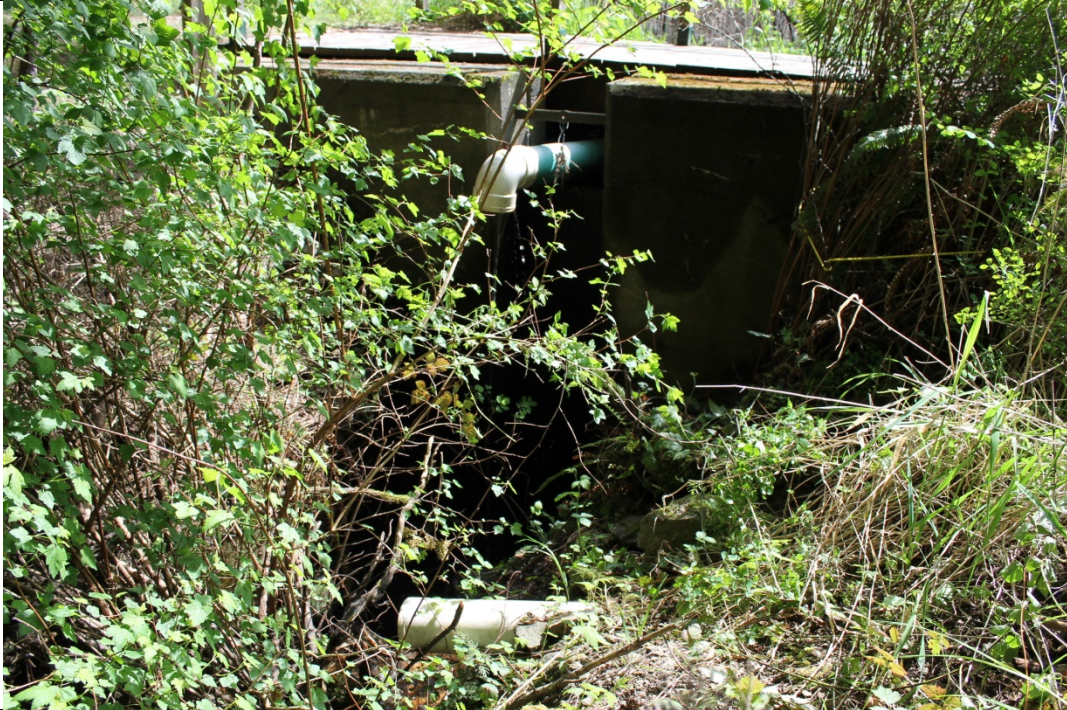
The weir structure is founded in a channel in sandstone bedrock. Based on the history of the structure, and the claim of neighbour Guy Mireau (1040 Coats Drive) that blasting holes have been observed in the surrounding bedrock, it is likely that the channel was excavated by blasting.

28. D/S view of concrete weir from right abutment – weir is located in a channel blasted into the sandstone bedrock

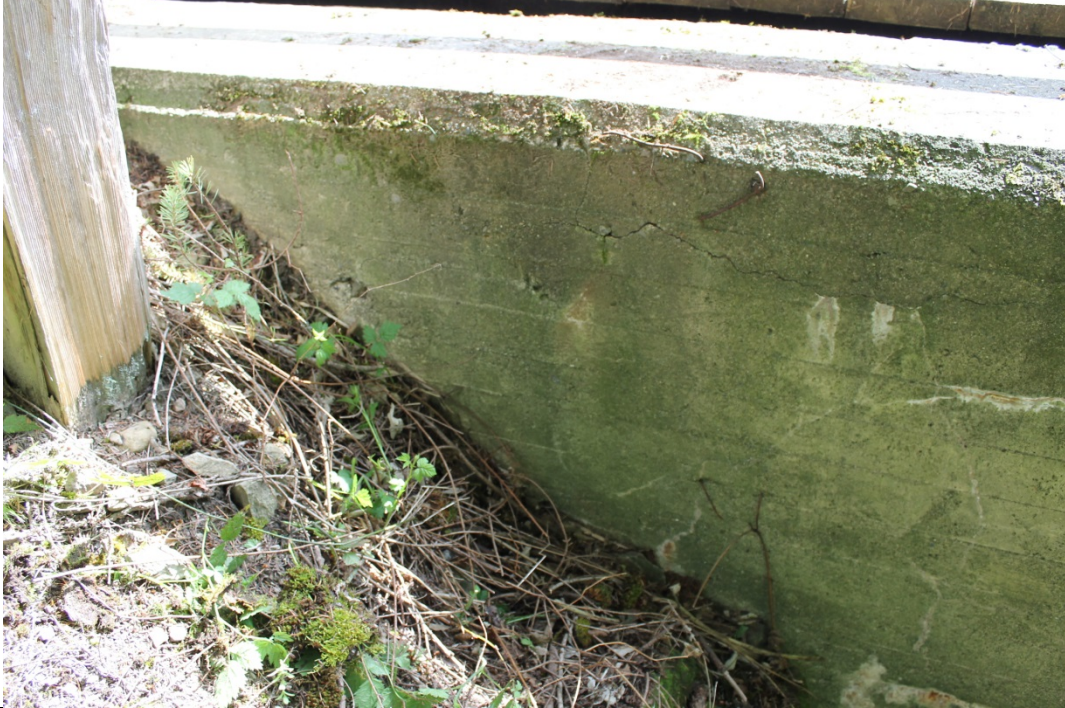
31. D/S face of concrete weir near right abutment – many cracks visible

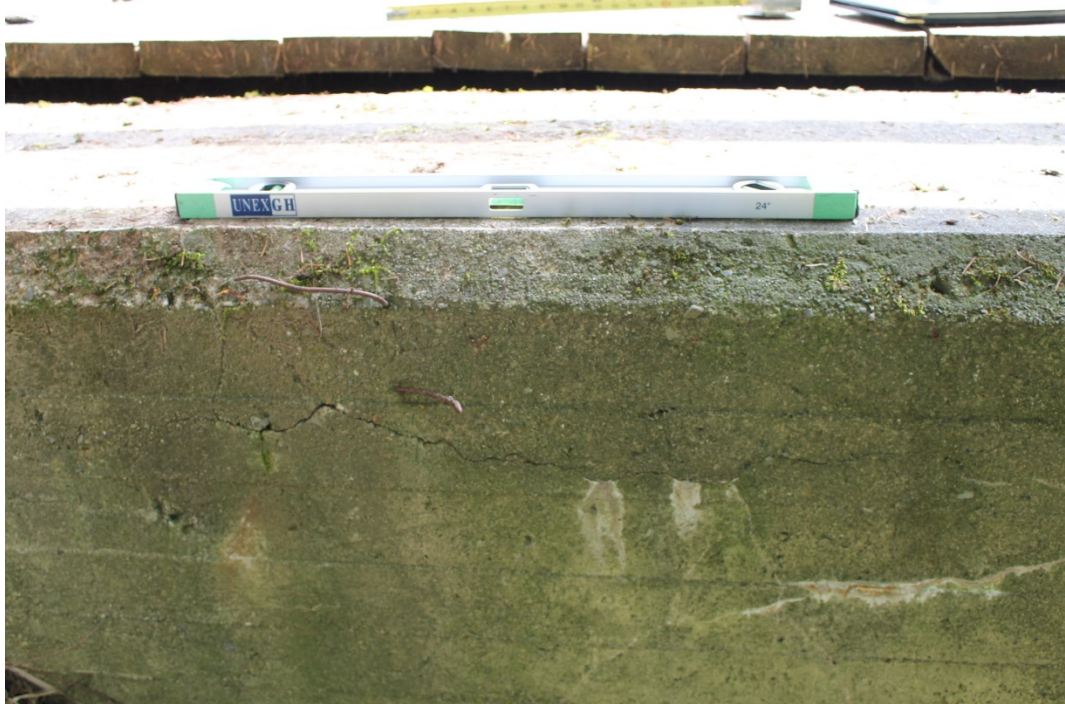
32. Close-up of photo 21 showing length of most obvious crack near top of concrete weir (24" long spirit level on crest)

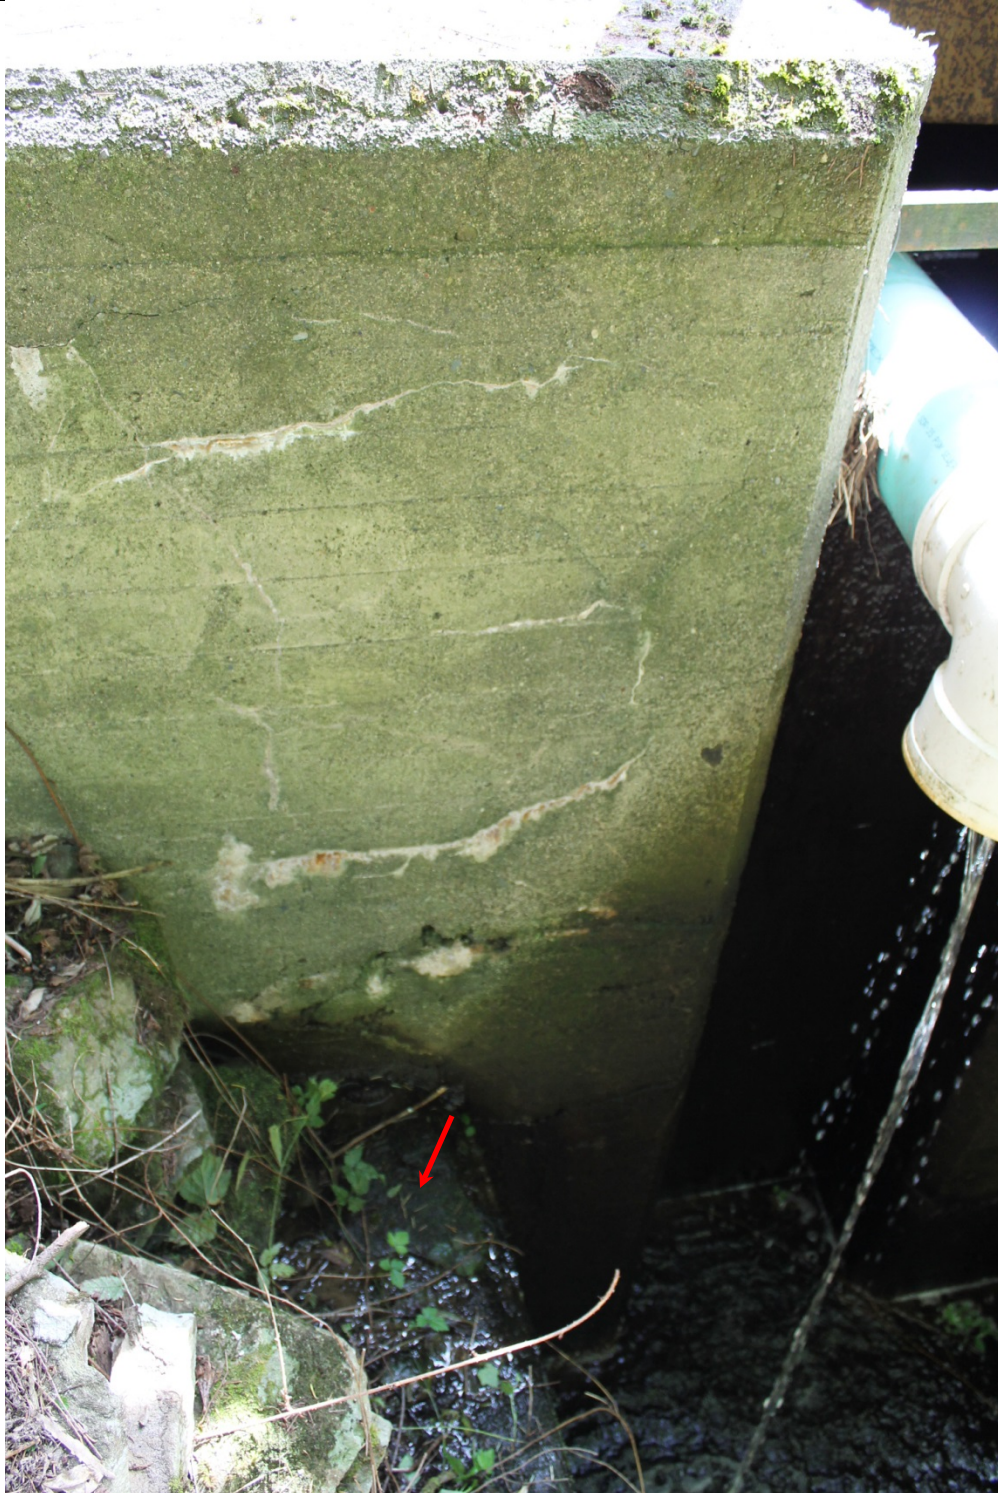
33. D/S right face of concrete weir beside spillway/stop-logs – many cracks and obvious seepage (red arrow) visible

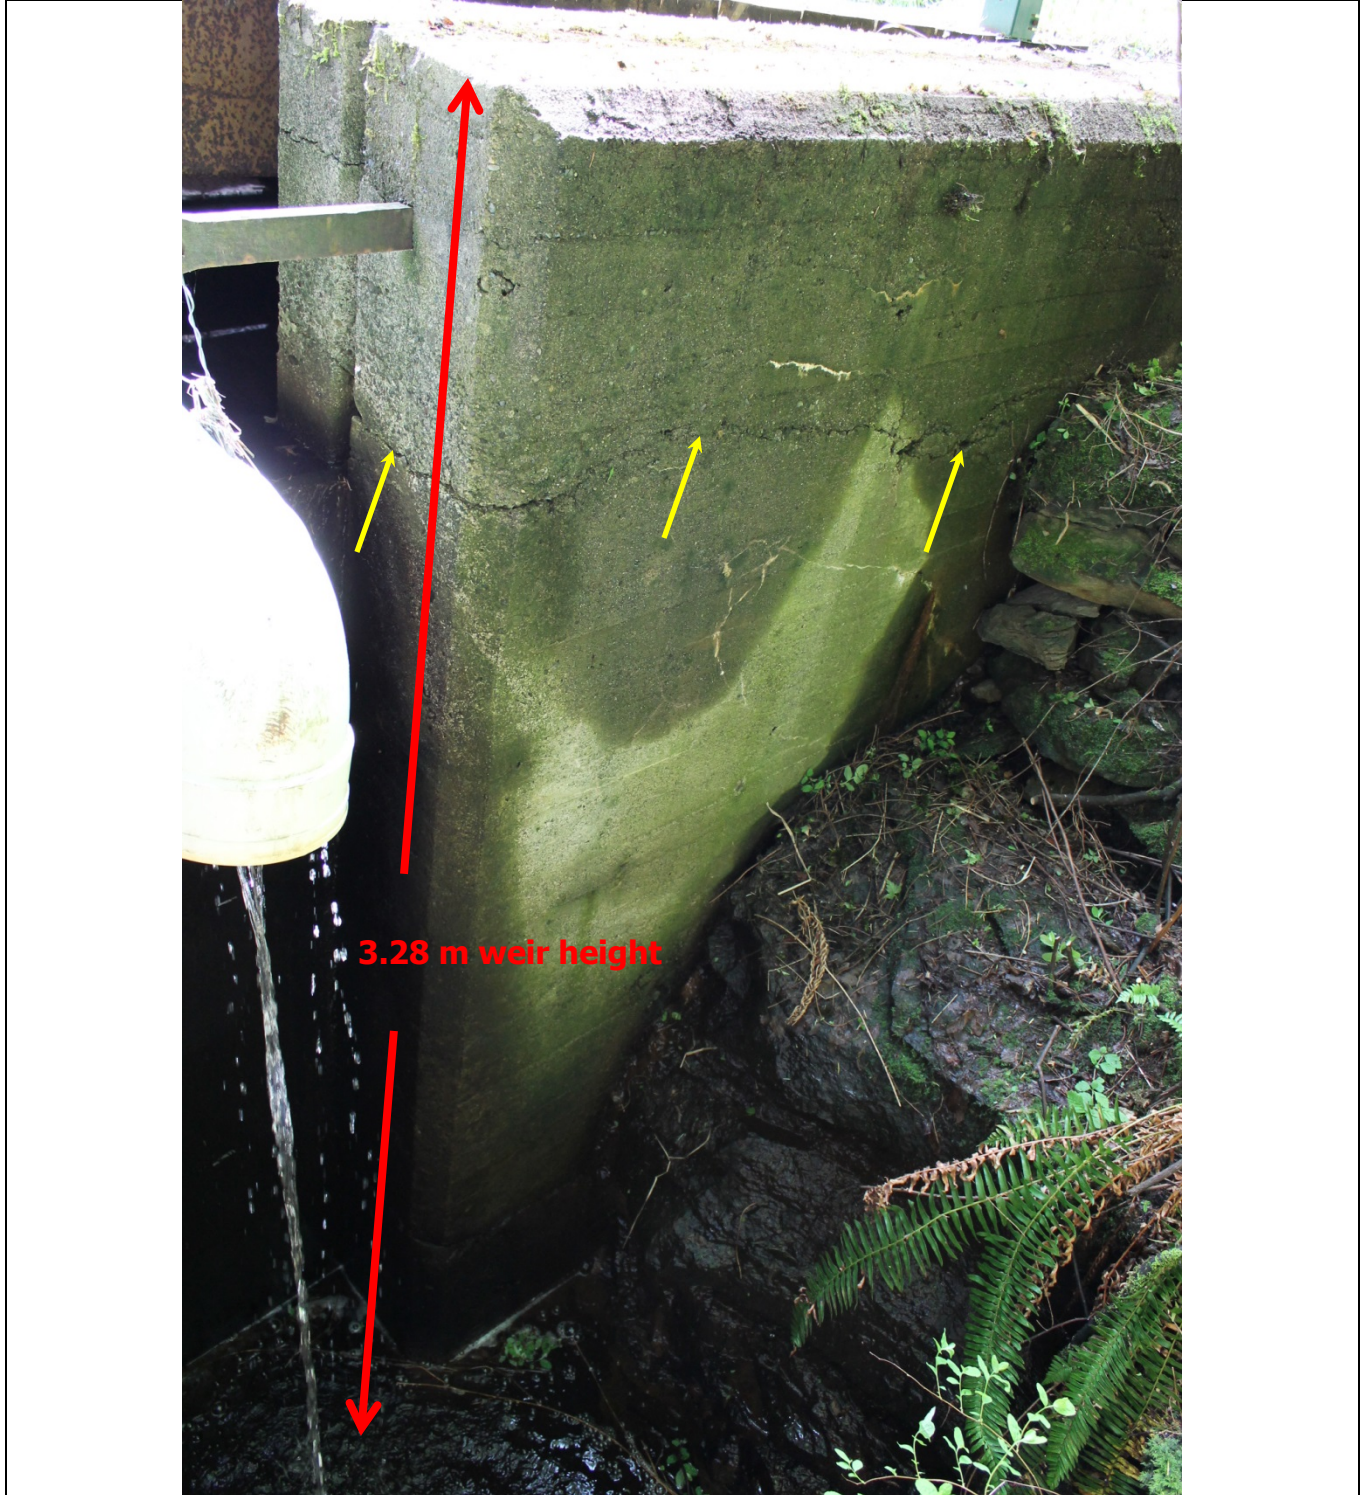
sudden release of water occur, a person could be engulfed and washed down the rocky channel). Many cracks and some spalled areas were observed. One "crack" in the left weir wall looks very much like a cold joint in the concrete and has a honeycomb appearance at one place. This fissure appears to go all the way through the weir wall to the upstream face. Some of the other fissures below the water line may also go all the way through the weir wall based on observed fissure width/prominence. Obvious water seepage was only observed at one location near the right abutment. Please refer to the dam inspection report and photos for detail.

34. D/S left face of concrete weir beside spillway/stop-logs – many cracks – one potential dry joint (yellow arrows)

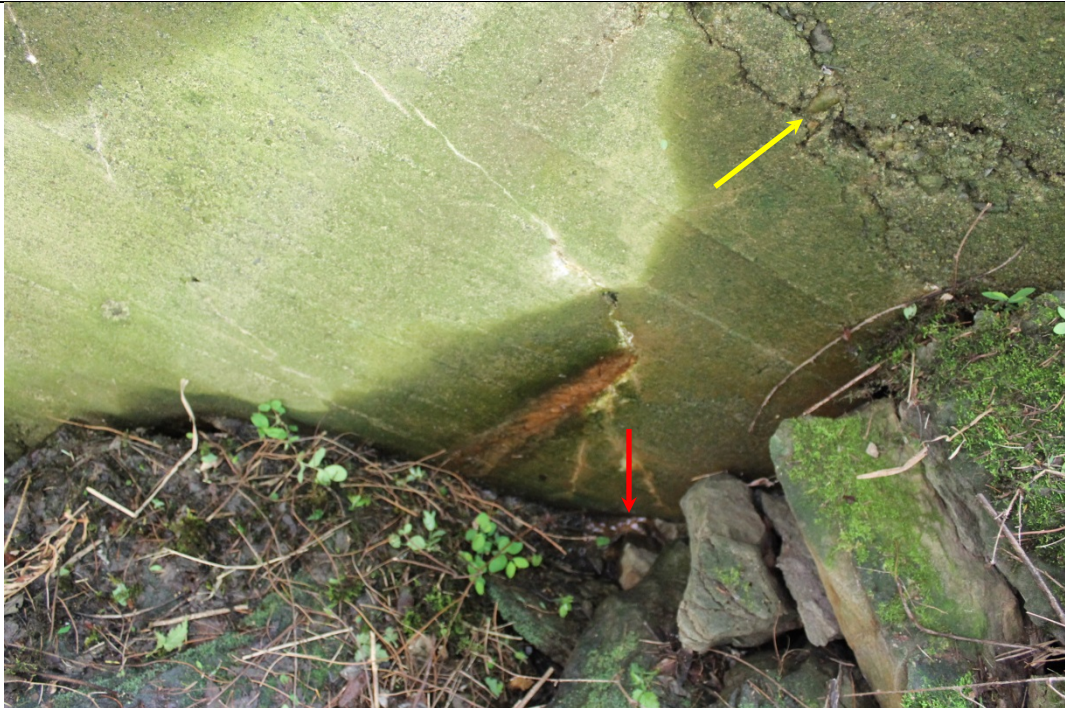
36. D/S face of concrete weir at left abutment & close-up of potential dry joint/honeycomb (yellow arrow) & minimal seepage (red arrow)

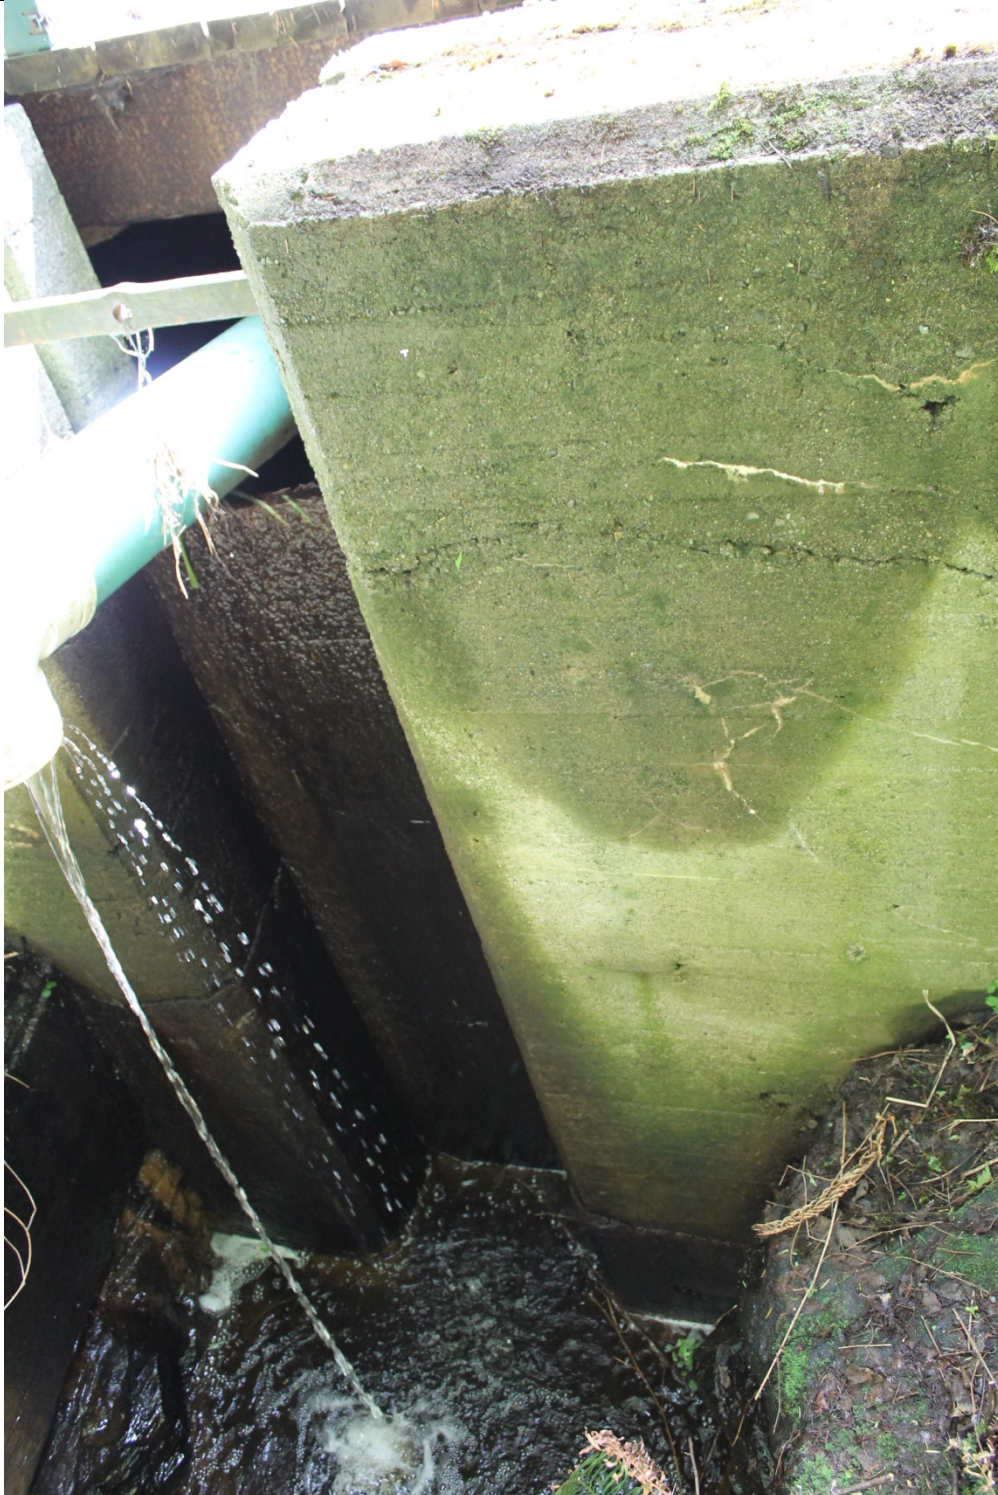
39. View of 41.3 mm thick X 723.9 mm long stop-logs. Stop-logs appear to be sound based on screwdriver probing
