Gabriola Streamkeepers—Water levels and quality

Observations at Coats Marsh, Gabriola Island

Summary of water-level measurements

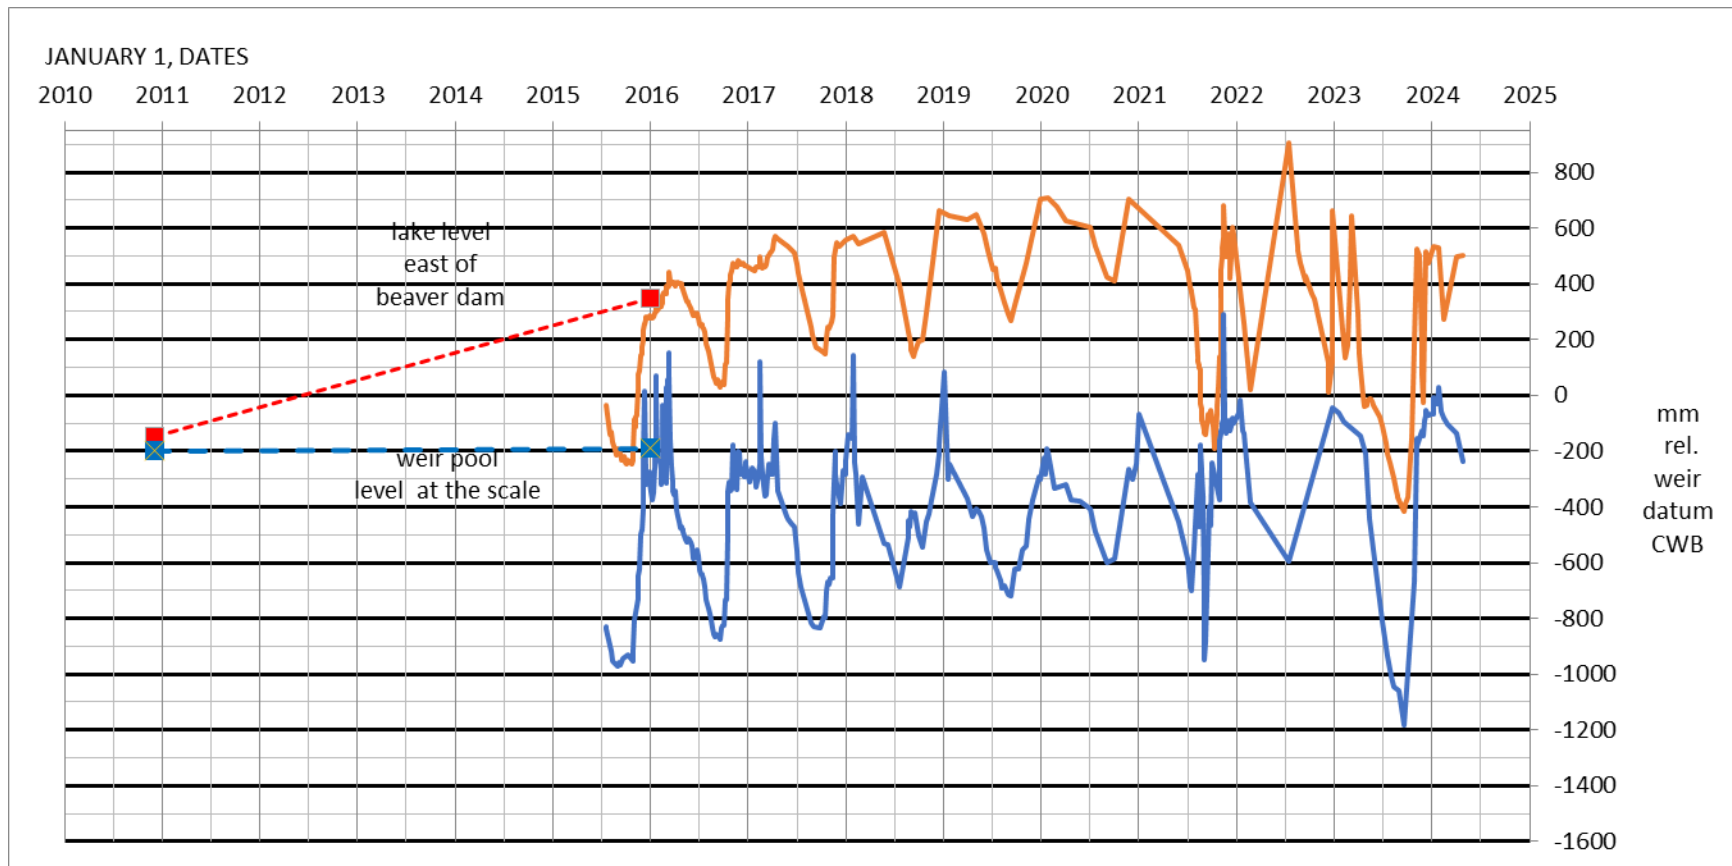
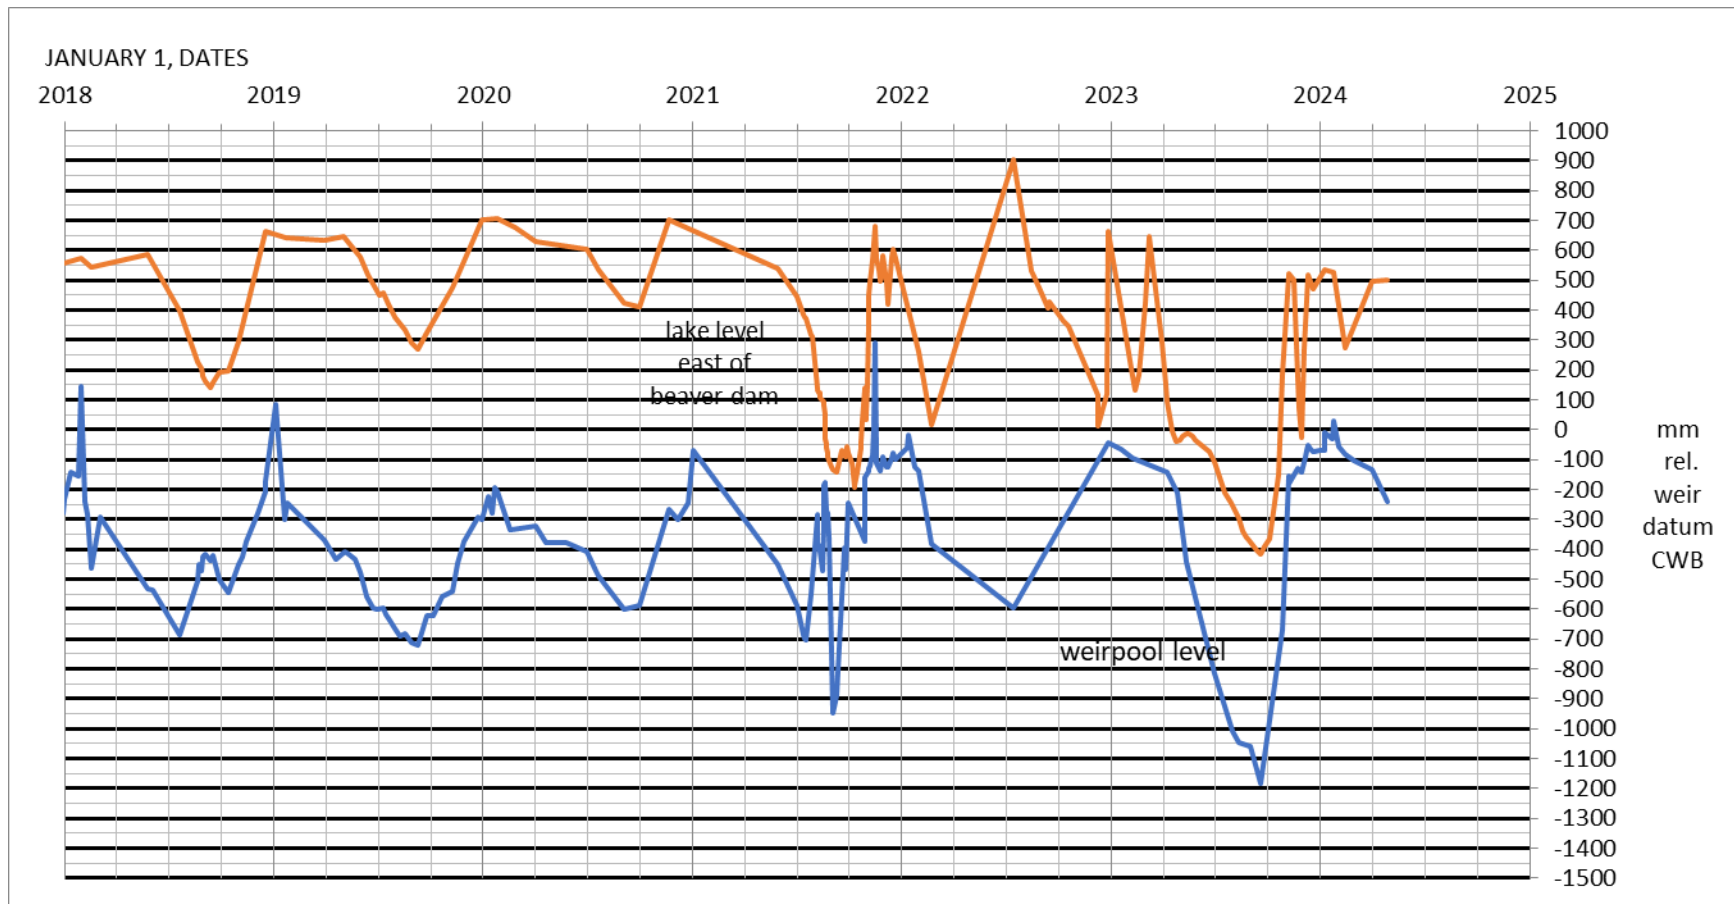
Figure 1a: Water levels

1. The winter 2010 observations are from the Management Plan.
2. The weir deck is flooded whenever the weir-pool level (blue) exceeds 0 mm. This has not happened since November 2021.

3. The beaver dam has significantly reduced the risk of the marsh drying out by the end of the dry season as evidenced by the rising annual low points of the red graph. The lake bed is everywhere above –1780 mm (rel, to CWB), and any drop of water level to less than –1000 mm below CWB would severely shrink its surface area and impact the ecology of the lake parafluvial margins.

4. Water was syphoned across the beaver dam by the RDN on July 23, 2021. The effect on the level of the main lake would have been small, ~10 mm, as its area is roughly 20 times greater than that of the weirpool (ref: CE/CW in [File 673u](#)). There would however have been a rise in the level of the weirpool solely due to the syphoning of ~200 mm as there was no outflow into Coats Marsh Creek (ref: [File 673x](#), pp.359-360).

5. Water was syphoned across the beaver dam by the RDN in early August severely dropping the level of the marsh, and causing Coats Marsh Creek to run (ref: [File 673x](#), pp.362-364).

6. A “permanent” syphon system across the beaver dam was installed by the RDN in mid-September but they’ve had finger-trouble getting it to function correctly. Some days all four syphons are working, some days only two, and some days none. Adjustment has also been made to the pond leveller at the weir. Levels in the weirpool particularly have not been stable. ([File 673x](#) and [File 673y](#)).

7. Since on-and-off syphoning began weirpool levels have been erratic and not recorded unless level is exceptionally high. An added complication is that there is now a beaver dam one to two metres upstream of the weir. The old RDN weirpool gauge is upstream of this small dam and hence the level it reads is no longer the level at the sill of the concrete weir.

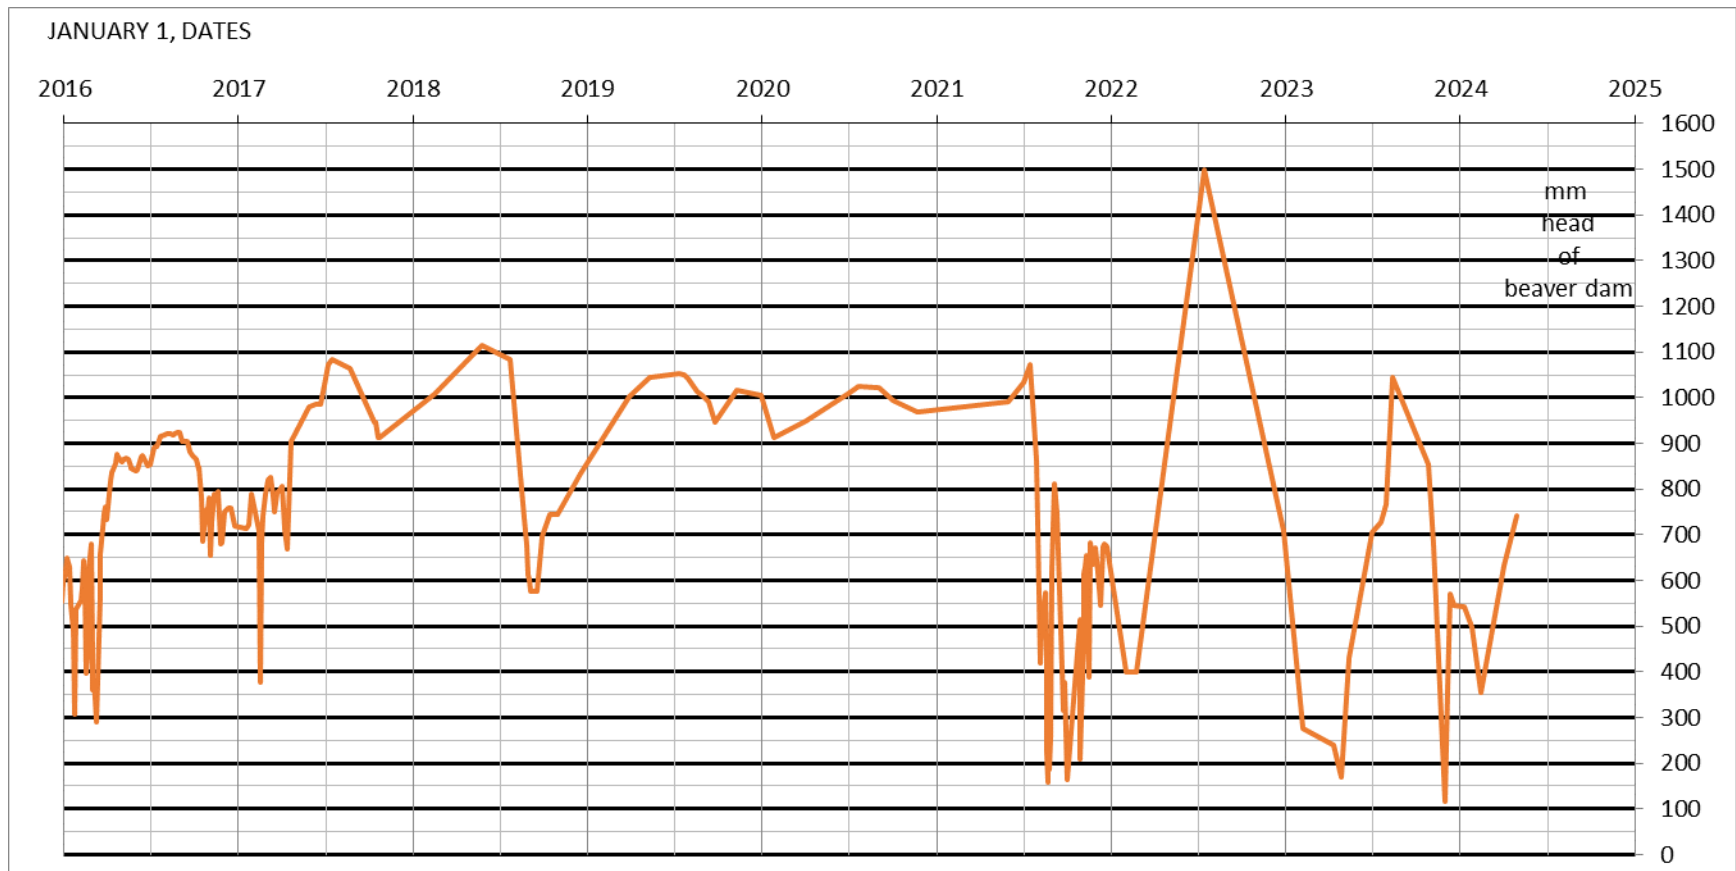
Figure 2: Beaver dam hydraulic head

1. The head (difference in water levels at the beaver dam) is usually highest in late summer. The exception in 2018 is due to the dam developing an underwater leak which the beaver had to repair.
2. Very low heads occur when water is overflowing at the dam in flood conditions. Recently overflow has been reduced and almost eliminated by the development of two spillways. Whether these pond levellers are a consequence of natural circumstances or the beavers have engineered them is not known, but they are effective in reducing flooding by reducing the volume of water in the lake in a controlled manner in anticipation of flooding.
3. See notes 4 and 5 on Figure 1.
4. See note 6 on Figure 1.
5. See note 7 on Figure 1.
