Gabriola Streamkeepers—Water levels and quality

Observations at Coats Marsh, Gabriola Island

Field observations—2021 (July—Sept.)

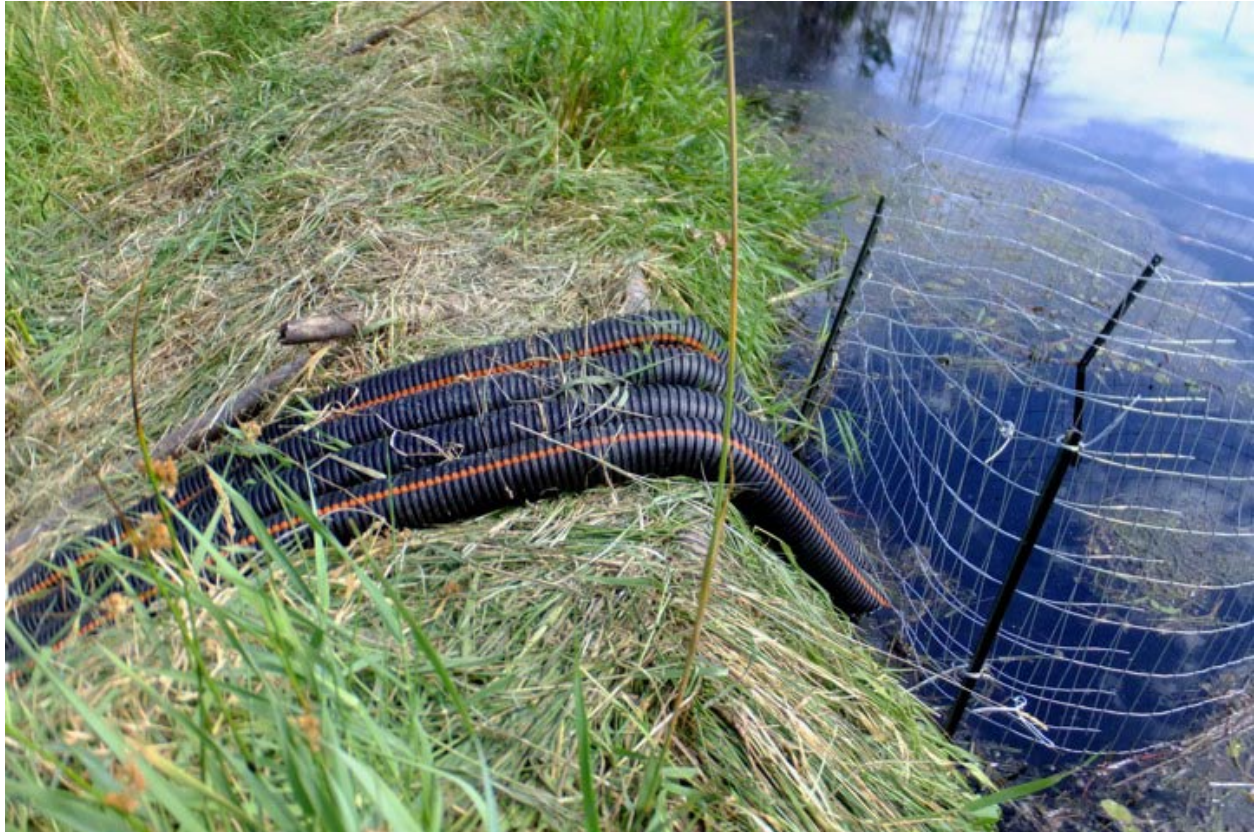
Syphon intake: [4 hoses 5"OD, 0.8m head, ~87 L/s total; my guess, simulating a 200mm ID PVC pipe]

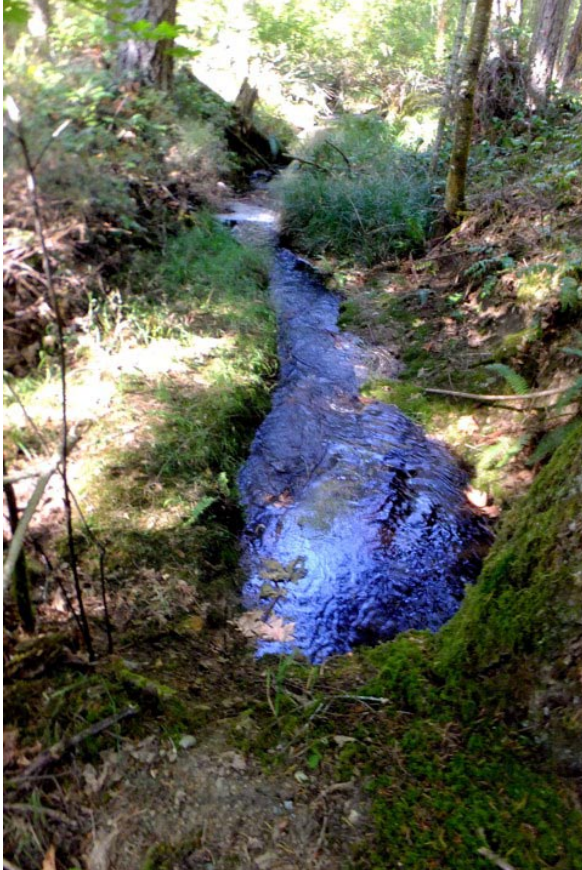
Coats Marsh Creek flowing in early August!
Carrying water from the marsh down through the forest to Hoggan Lake where it will eventually evaporate, be used for the greens, run-off into the sea, or who knows, improve the environment down there.

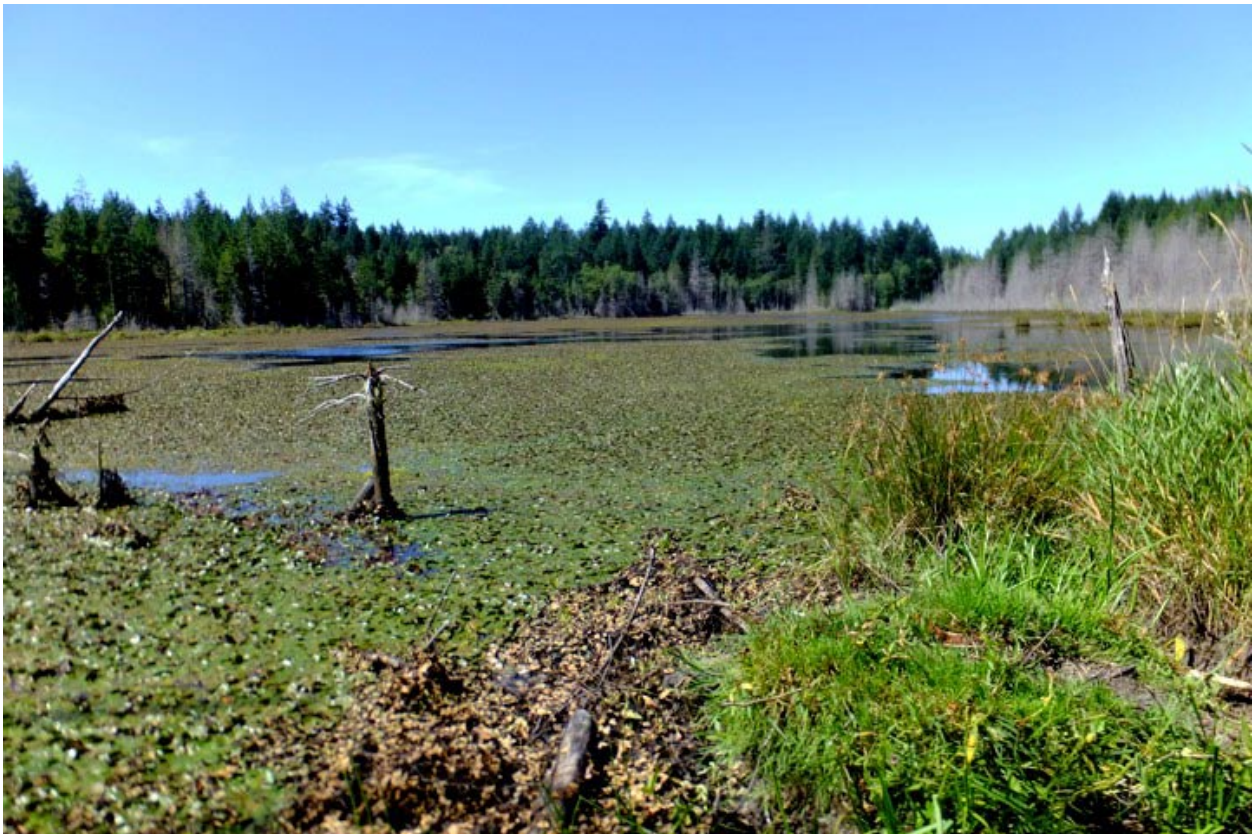
The lake at the east end looking devastated. I imagined that I had never seen the portion of the lake that is outside the regional park but within the community park (go figure!) looking so dried out, but then I must have. It is even questionable whether the level at the cistern datum I have been using for years is still valid it is so far from open water. There were three low-flying vultures circling around.

If the drought continues, the area threatens to become cloaked with rotting watershield. That's the brown stuff in the photograph nearest the shore; that's not dead tree leaves, it's former healthy habitat.

The RDN drawdown of 400 mm may eventually have added 100 days to the length of this summer's drought.

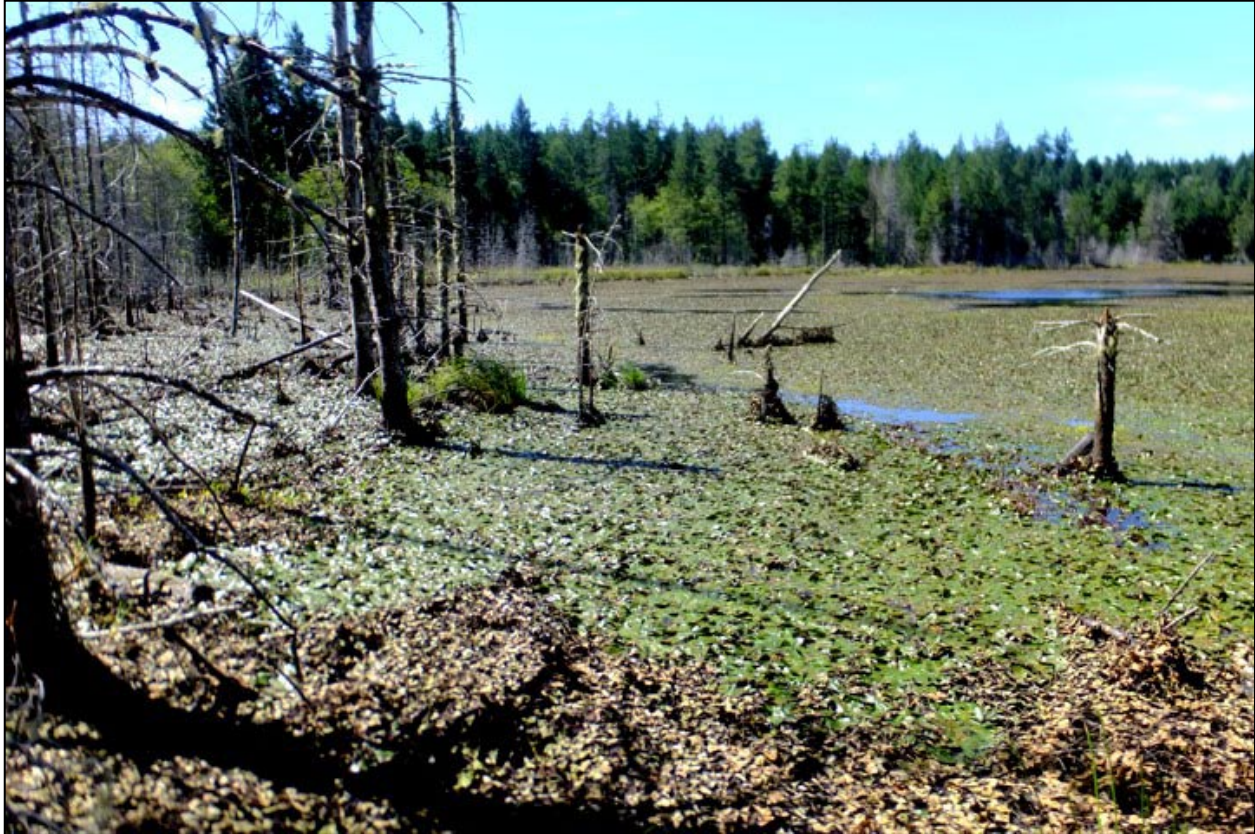
A week or so ago before draining commenced I had to wear my waders to stand where the photograph above was taken. I was wearing my town shoes yesterday. The east end of the marsh, where the experts seldom go, is relatively flat, so a small drop in water level makes a big difference to the surface area and location of the strand.

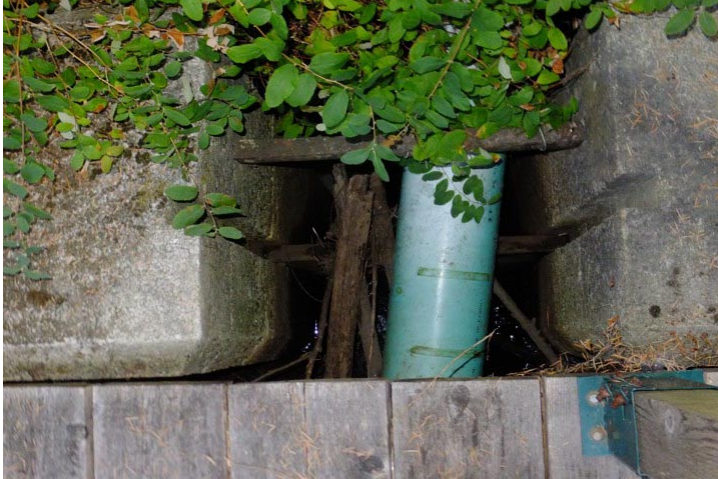
View from the downstream side of the deck (seen at the bottom of the picture) looking down at the gap in the middle of the concrete weir. In this view, water flows from bottom (the weir pool) to top (Coats Marsh Creek). The turquoise pipe below the re-bar is the outlet of the pond leveller running below the deck and above the sill.

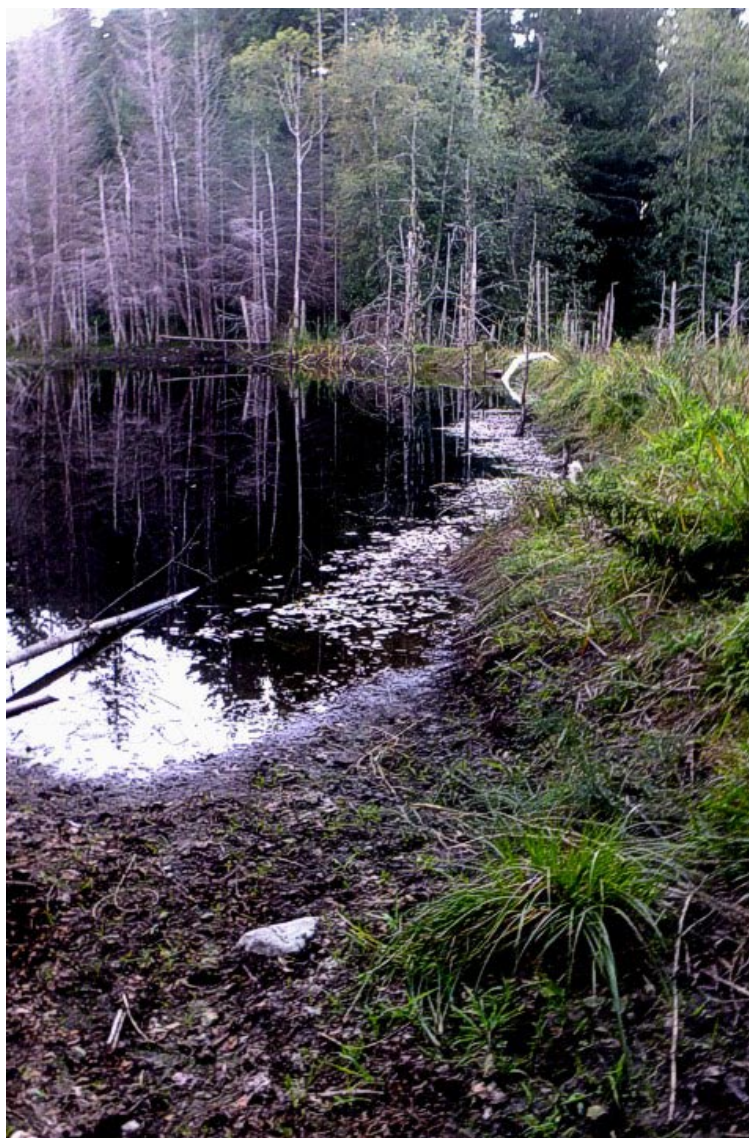
running again at the culvert but there is no flow over the sill or through the leveller. Two of the four syphons running.

The beaver has not been seen for some time and the local resident believes it may have abandoned the site. No tail-slapping in the evenings heard now and the weir has sprung a small leak at the edge of the concrete deep down on the north side, which should have attracted his attention.

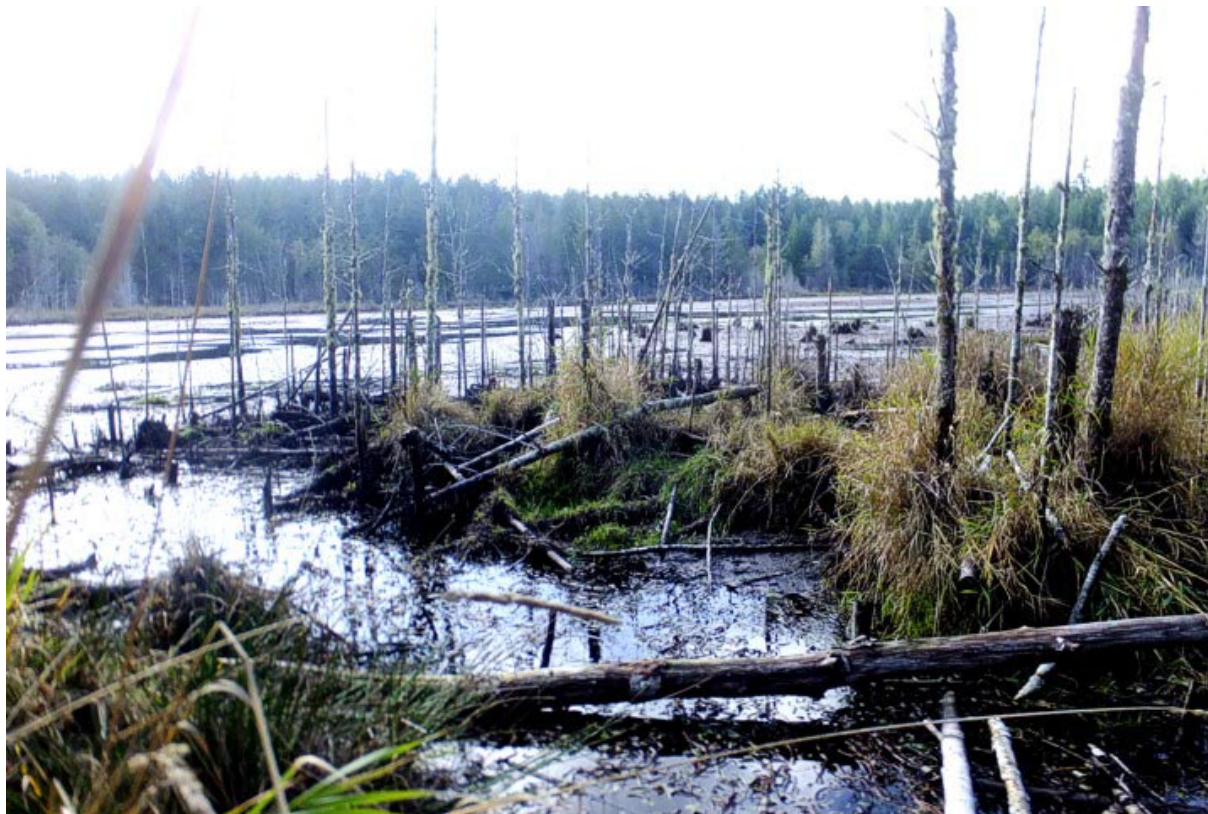
Coats Marsh Creek flowing at around 40-50 L/s, flow over the sill (depth 40 mm), pond leveller flowing but now pointing skyward ominously like a gun, the knuckles of all four syphons retro-fitted with bleed valves and their gate valves now all open.
