Gabriola Streamkeepers—Water levels and quality

Observations at Coats Marsh, Gabriola Island

Field observations—2023 (May—August)

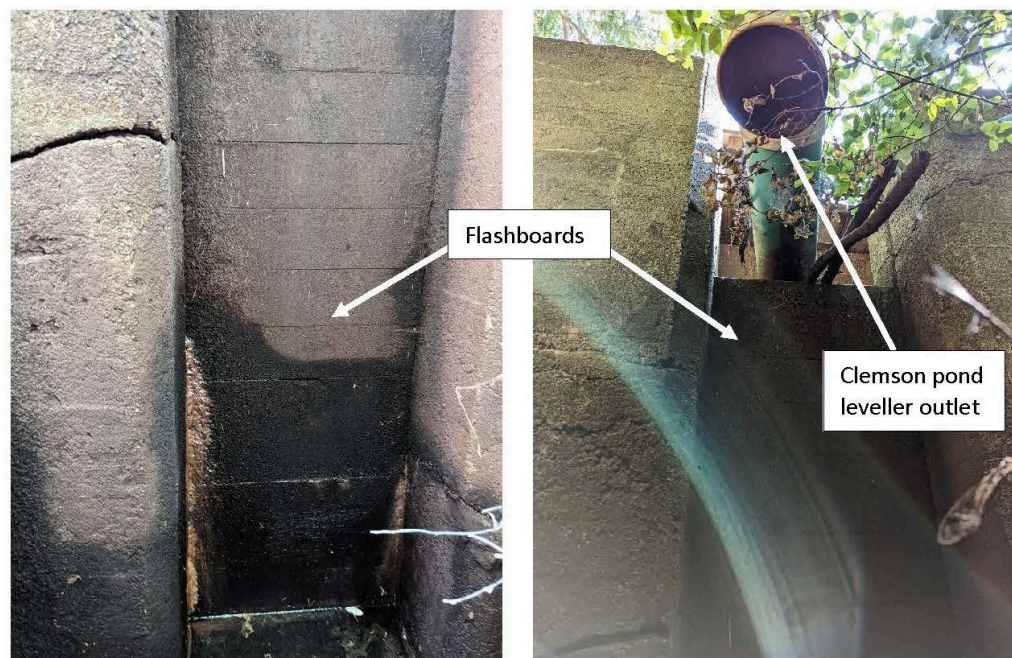
Photo 2.4 Lower (left) and upper (right) portions of the weir outlet slot and flashboards, viewed from the downstream channel. Note cracks in the concrete at several locations (NHC, Sep. 2022).

Interesting view of the baffle from the NHC 2023 Report. The notch is too narrow and the flashboards too high to contain floodwater.

(xvi) only lightly addressed in these discussions is the need to replace the wooden baffle with something more durable. Complete

failure of the baffle could result in draining the entire marsh. Replacing the baffle with a sluice gate, or replacing the flashboards with concrete might be part of the ideal solution; however, the current baffle is healthy and the need to address this issue is not urgent;

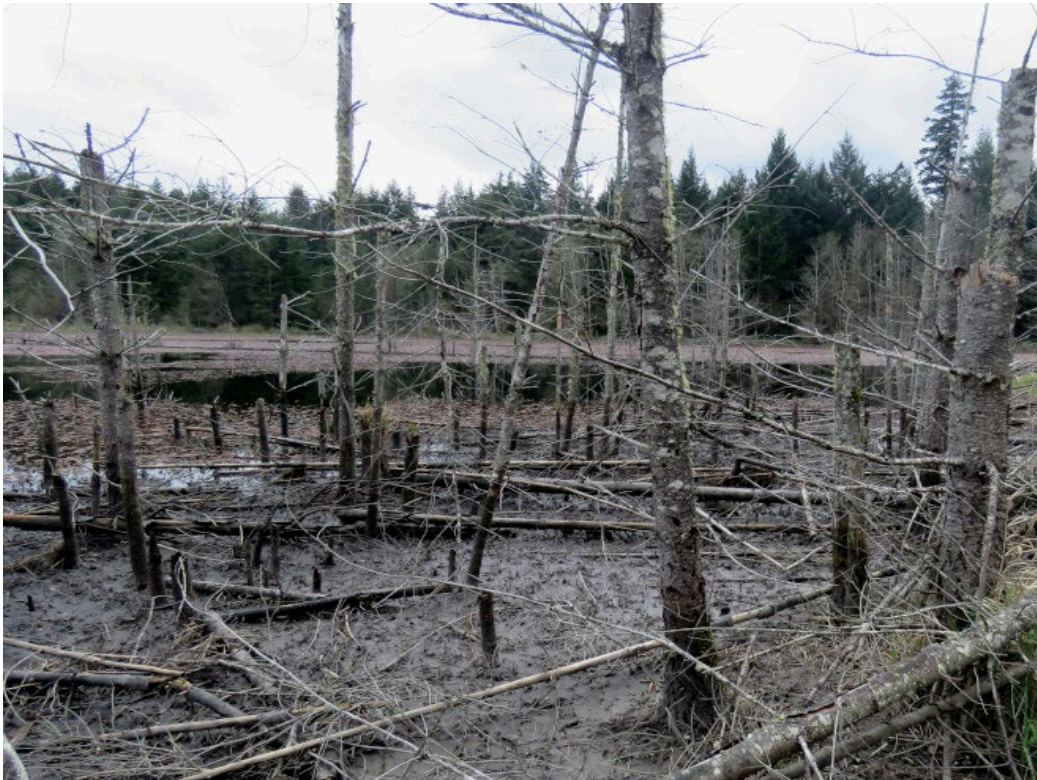
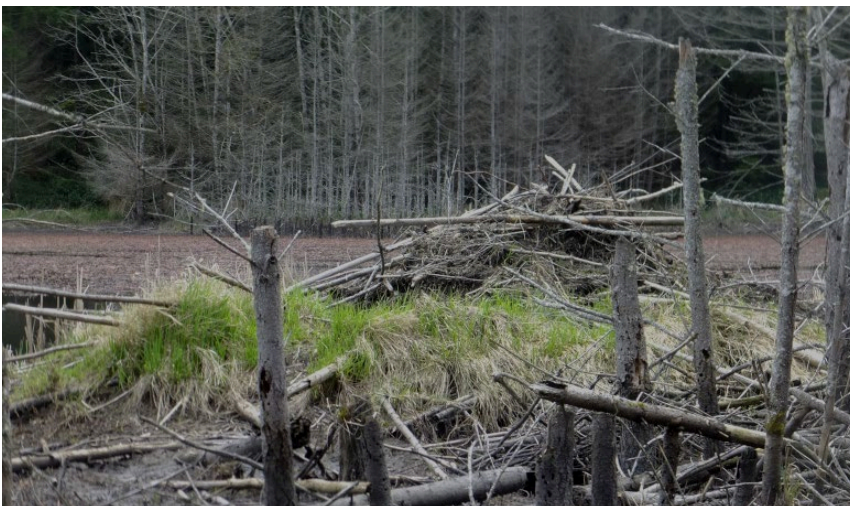
April 26, 2023:

(a) snags offer fledgling ducks and their parent(s) protection from predators, eagles, hawks, and owls. Hooded mergansers and wood ducks nest in tree cavities at the marsh. Whether they will again this year is still to be seen;

(b) the beaver's lodge, high and dry. Not "normal" at this time of year. Water level has not been this low before syhoning since the late summer of 2015.

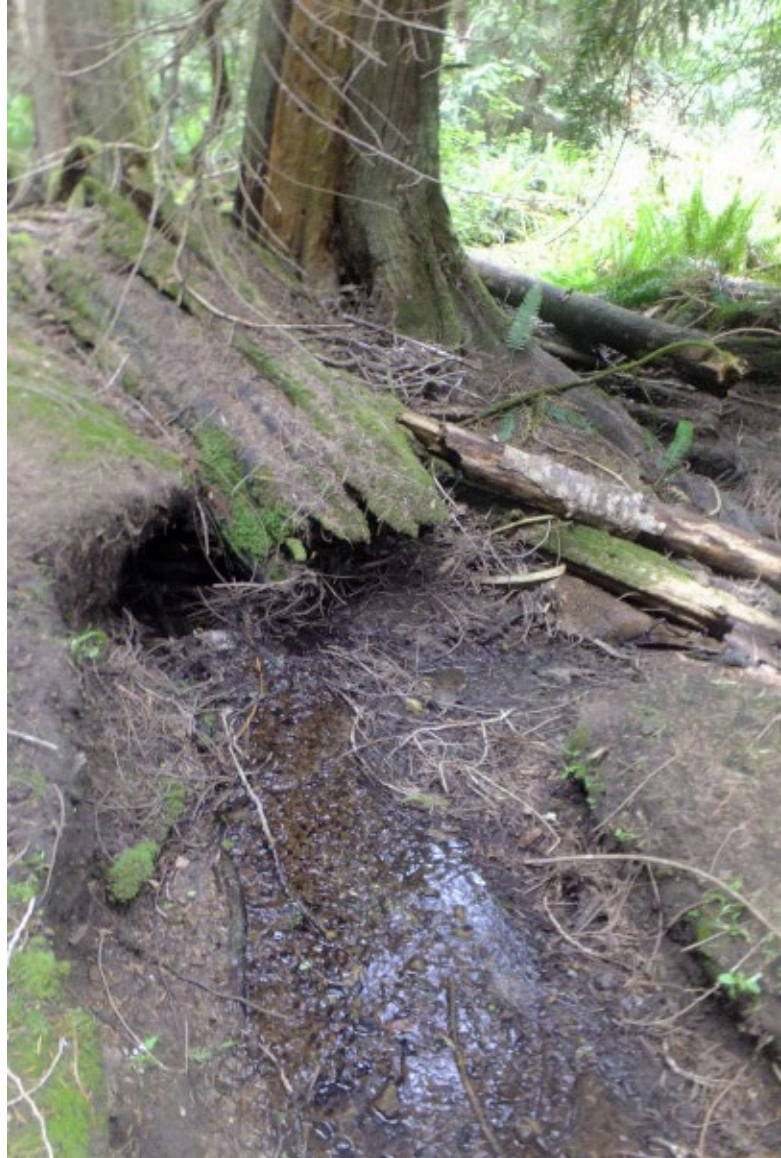
At this low level of flow, instead of by-passing the tree, the creek is disappearing into the root system and emerging at the other side of some large woody debris (LWD).

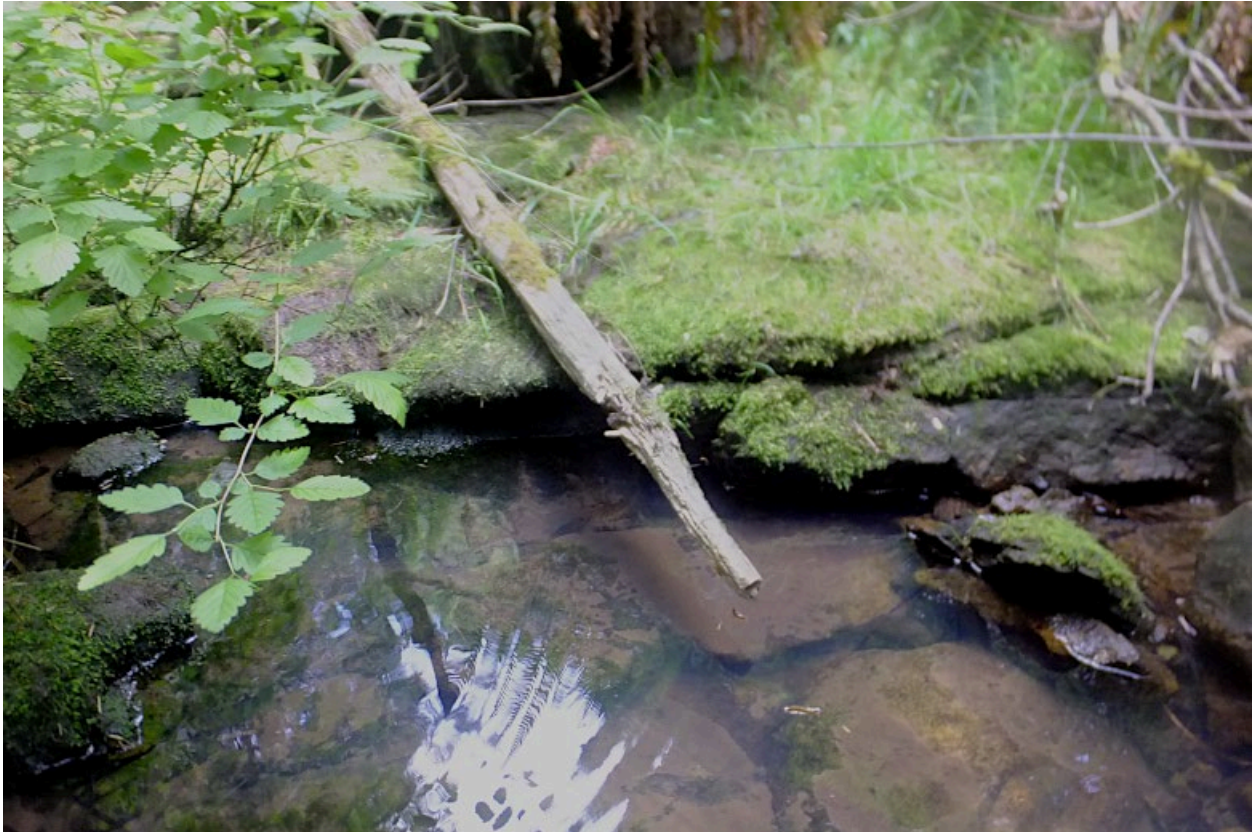
The highest point at which flowing surface water was seen was downstream of the wetlands that are near the CM-RP boundary. The water was an emerging subsurface flow shown here.

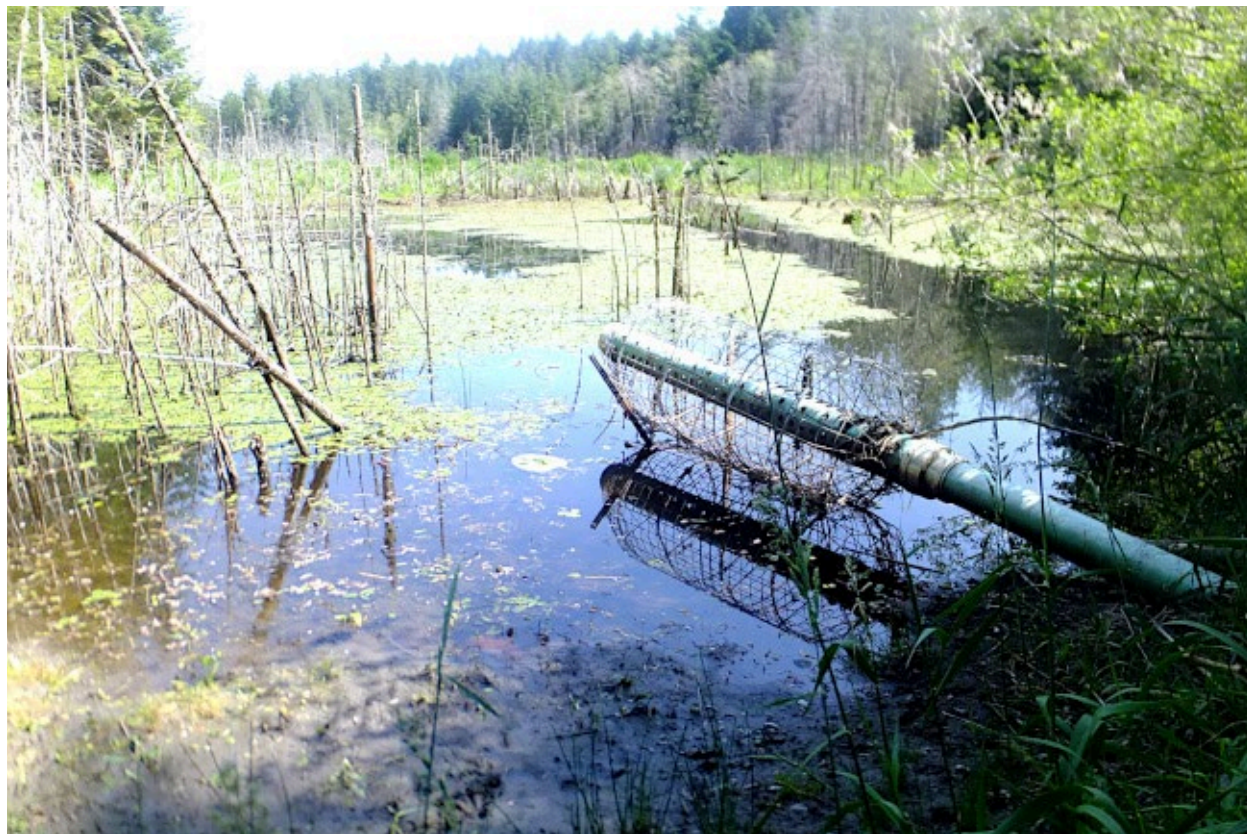
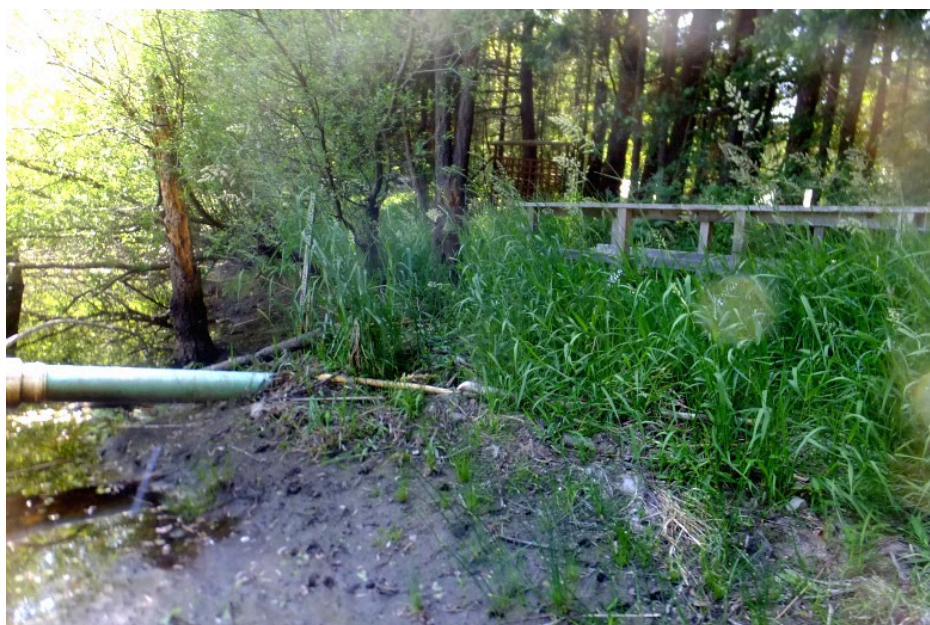
Water level in the weirpool very low. No outflow or drainage.

Beaver present and very active around the weir. It is now possible to walk comfortably across the weir using his dam. No ducks seen in the weirpool; the days are gone when you might see blue-winged teals here.

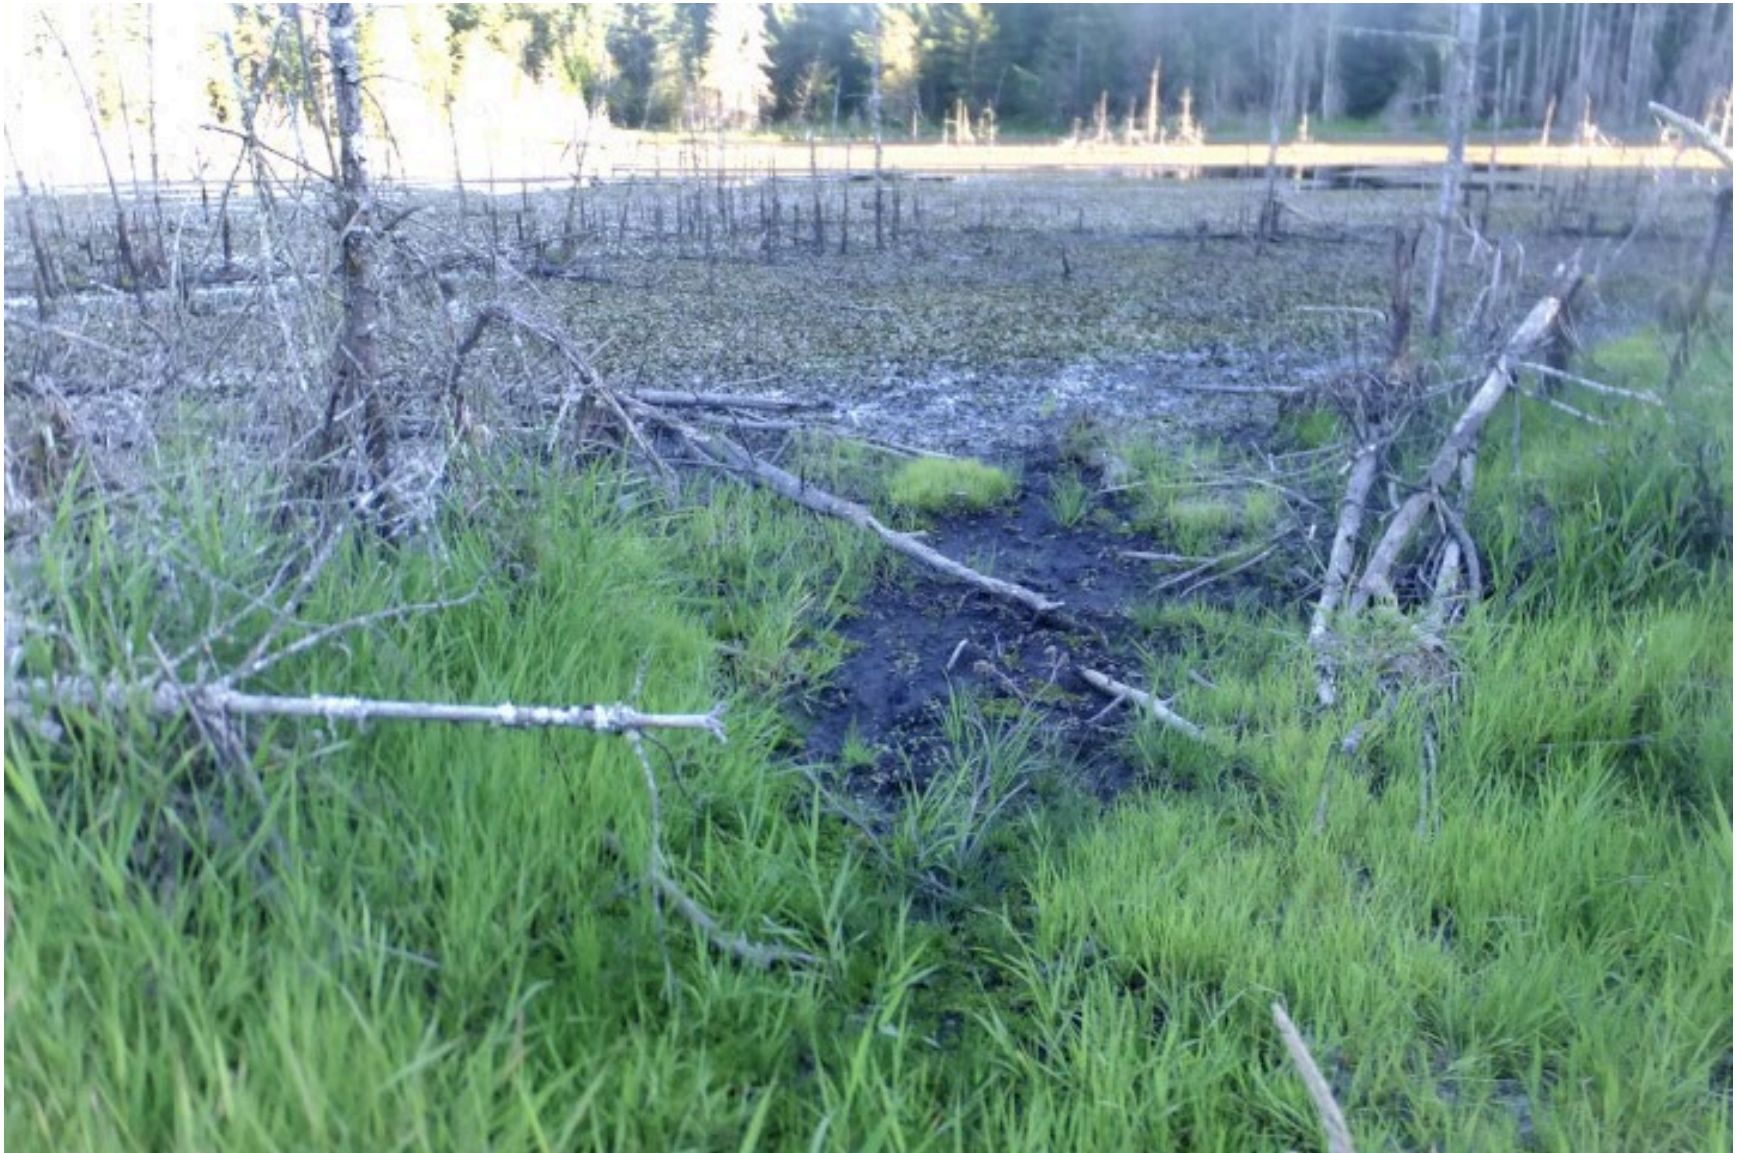
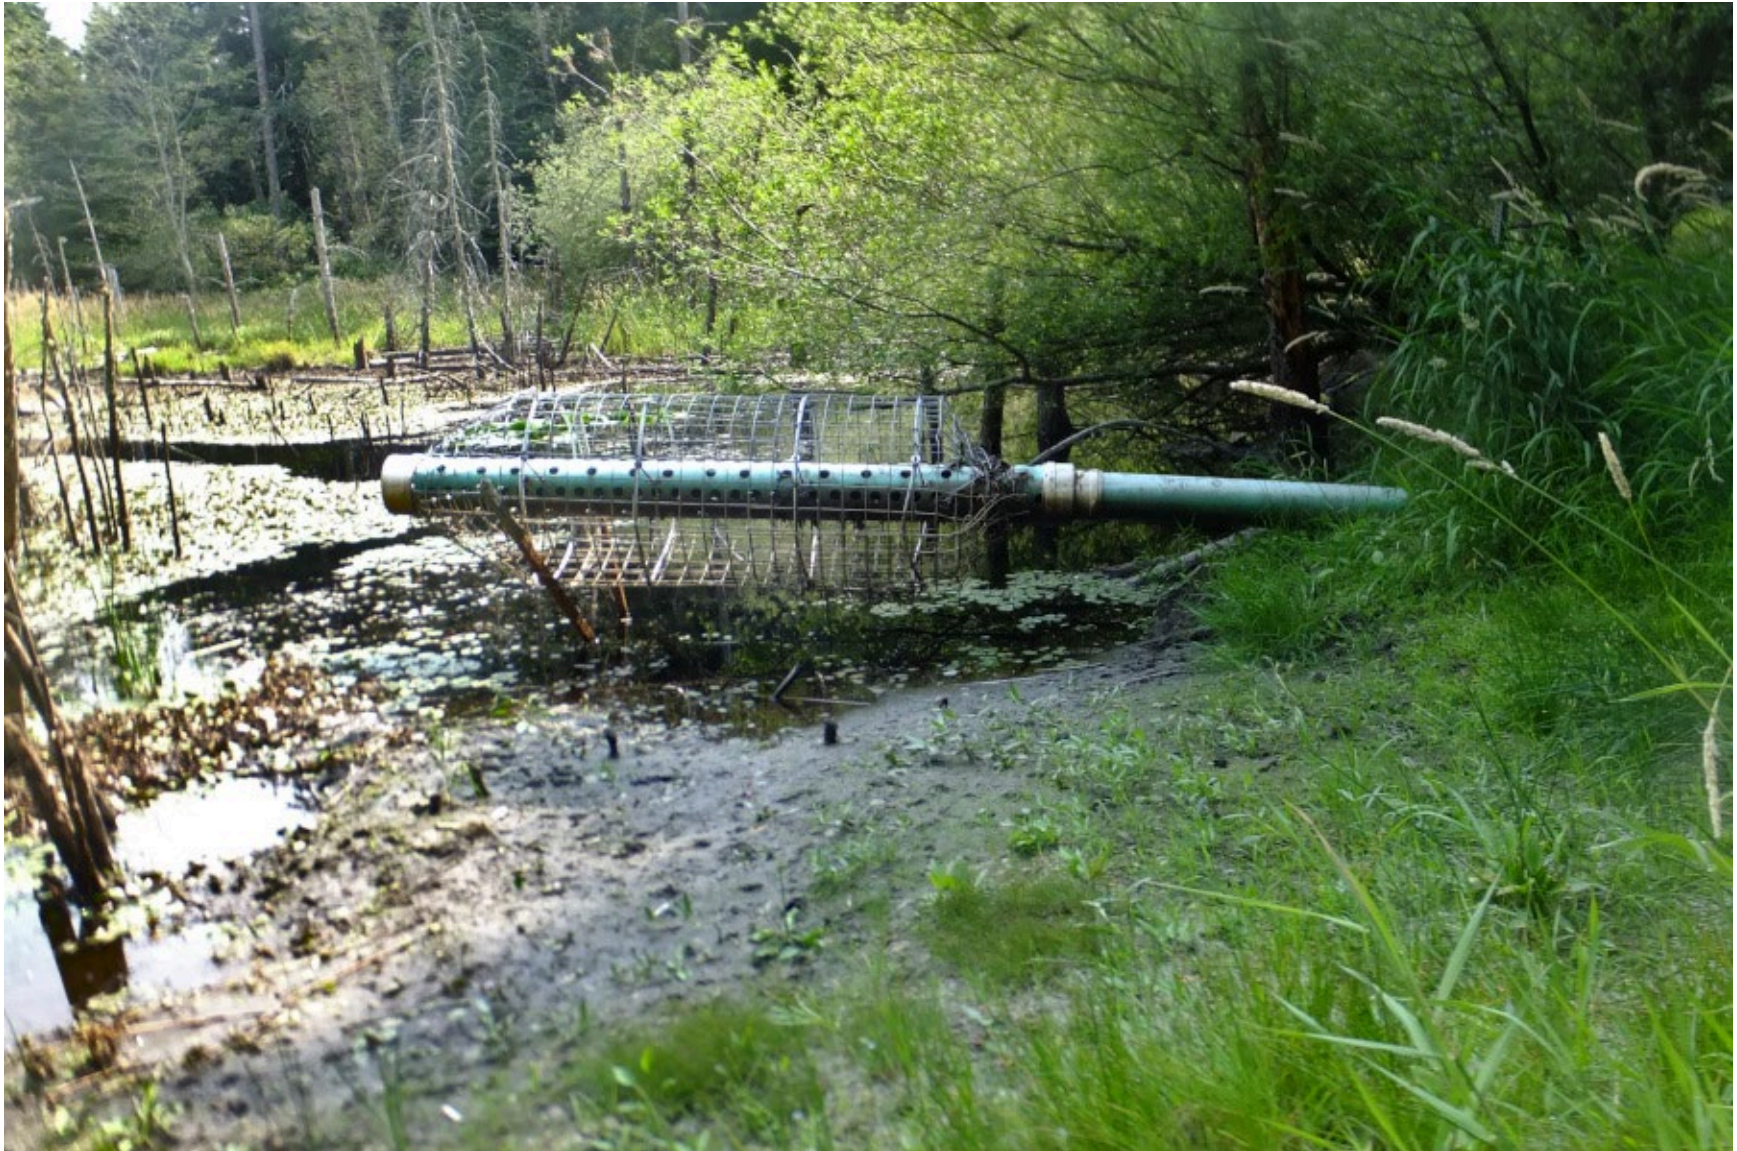
The Clemson leveller is a good design. The beaver has shown limited interest in attempting to block it. Its capacity is just too low for this application.

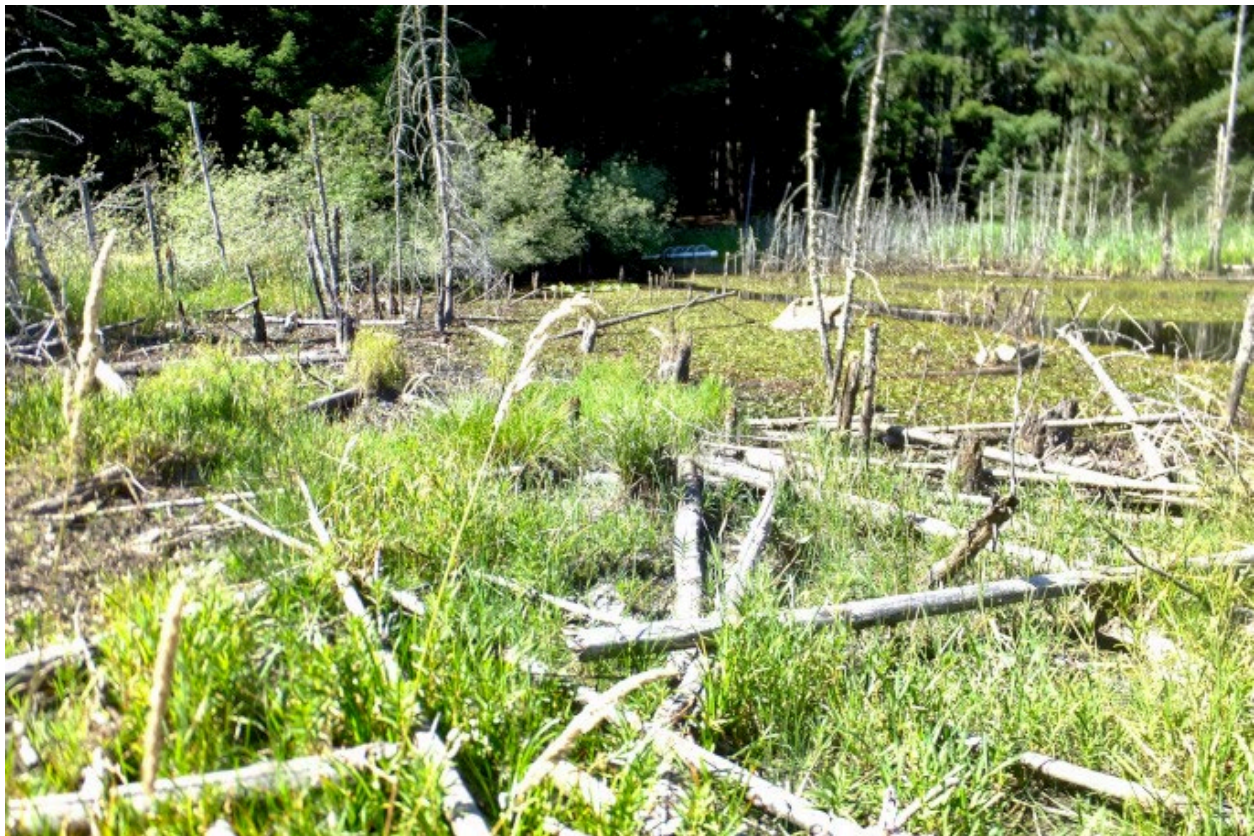
The weirpool is close to being completely drained.

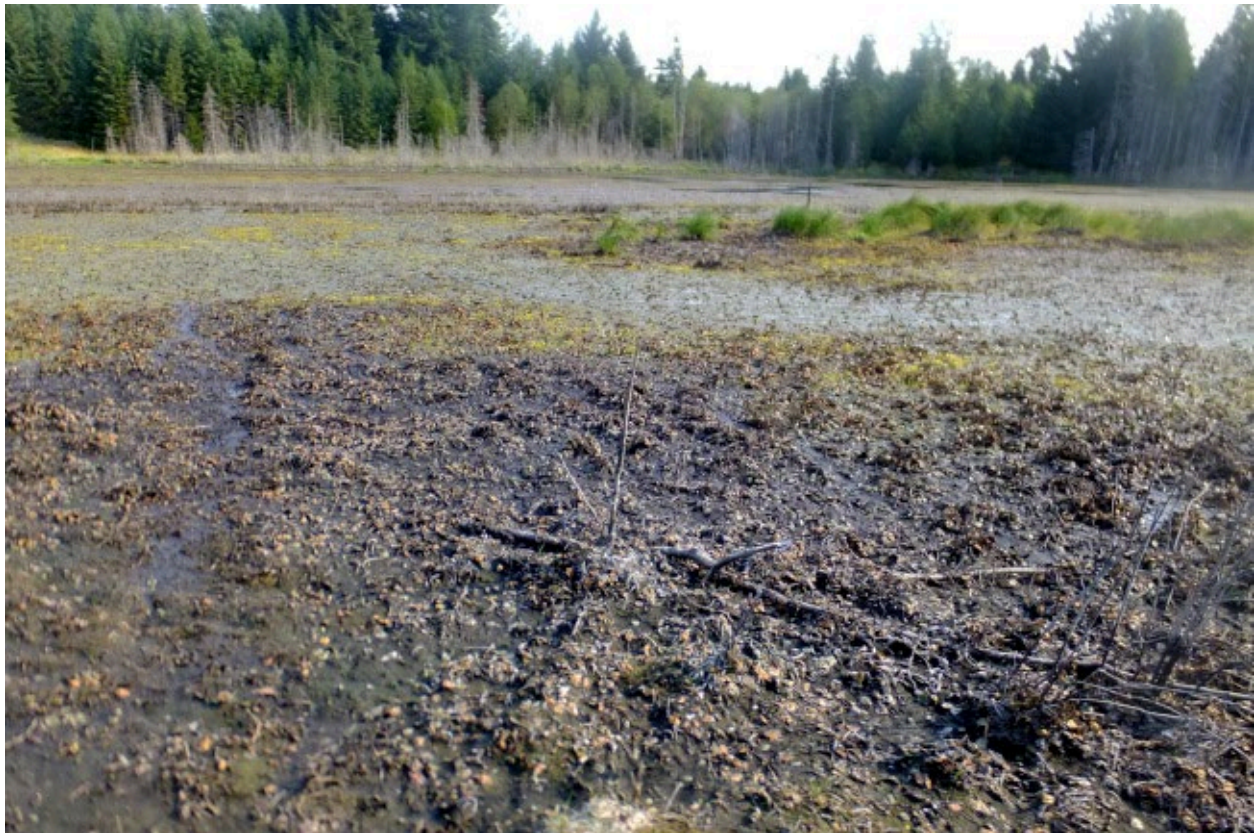
Substantial swathes of the perimeter of the "lake" have now become a thick, soft muddy morass. It's a simple enough message; you need to store water in winter in order to maintain an adequate water level in summer; and this hasn't been done. At the entrance to the RP at Stanley Place, visitors are now confronted with, not water, but mire, any water being far off toward the centre of the marsh.

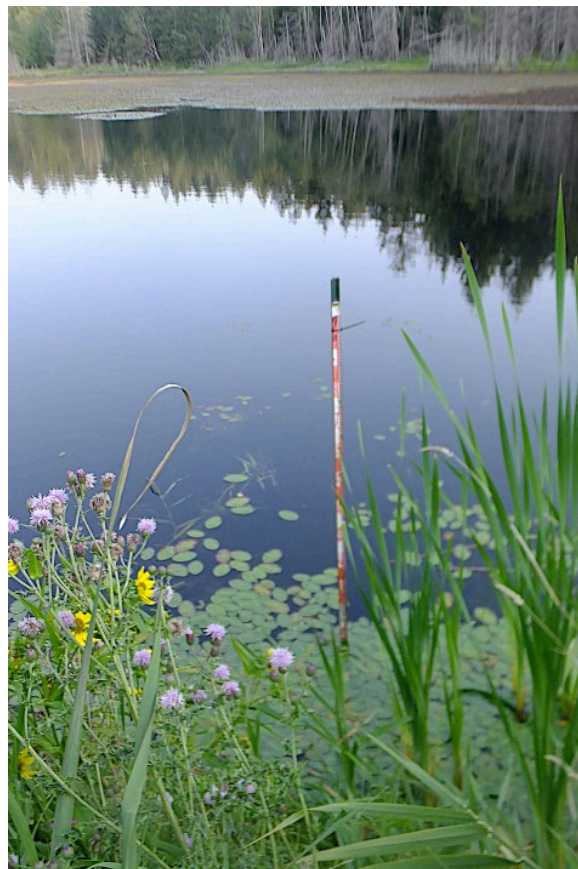
WATER QUALITY TEST: beaver dam upstream side; temperature surface 18.9°C. At depth temperature 16.6°C; specific conductivity 99 µS/cm; air pressure ≈100 kPa, dissolved oxygen (DO) measurement attempted with only partial success.¹⁹

Indications are that DO is at a level that's low enough (≈4 mg/L) to severely stress most aquatic organisms. The usual major causes

of low DO concentrations are high diurnal temperatures, and unusually high oxygen consumption by aerobic decomposers of dead aquatic plants. Nodding beggarticks (*Bidens cernua*) out on the beaver dam, the perfect habitat for this species.

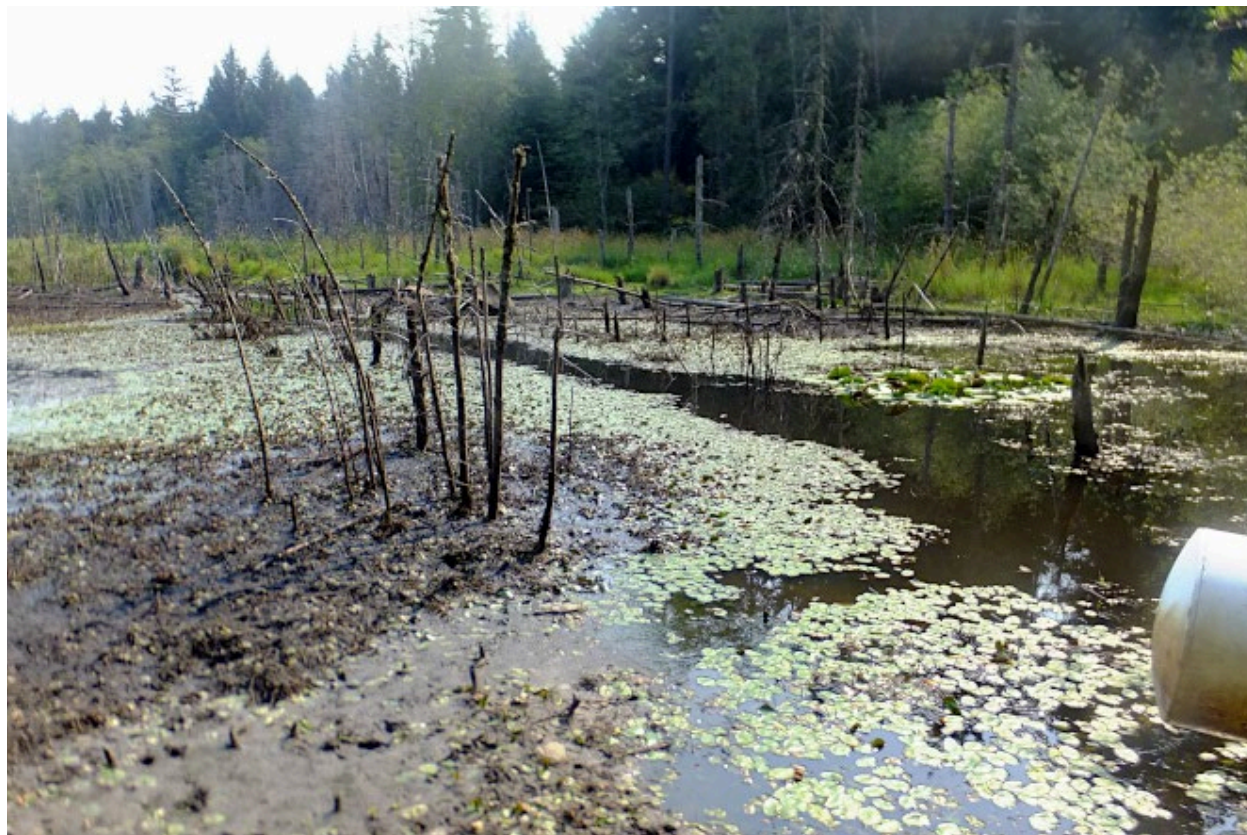
The weirpool almost completely de-watered but for Bill Coats's drainage channel that likely goes down to bedrock. Several mallards about, the usual residents in this pre-migration time-of-year, always relatively few in number.
