Gabriola Streamkeepers—Water levels and quality

Observations at Coats Marsh, Gabriola Island

—with notes on Coats Marsh Creek, East Path Creek, and Stump Farm Streams.

Summary of water-level measurements

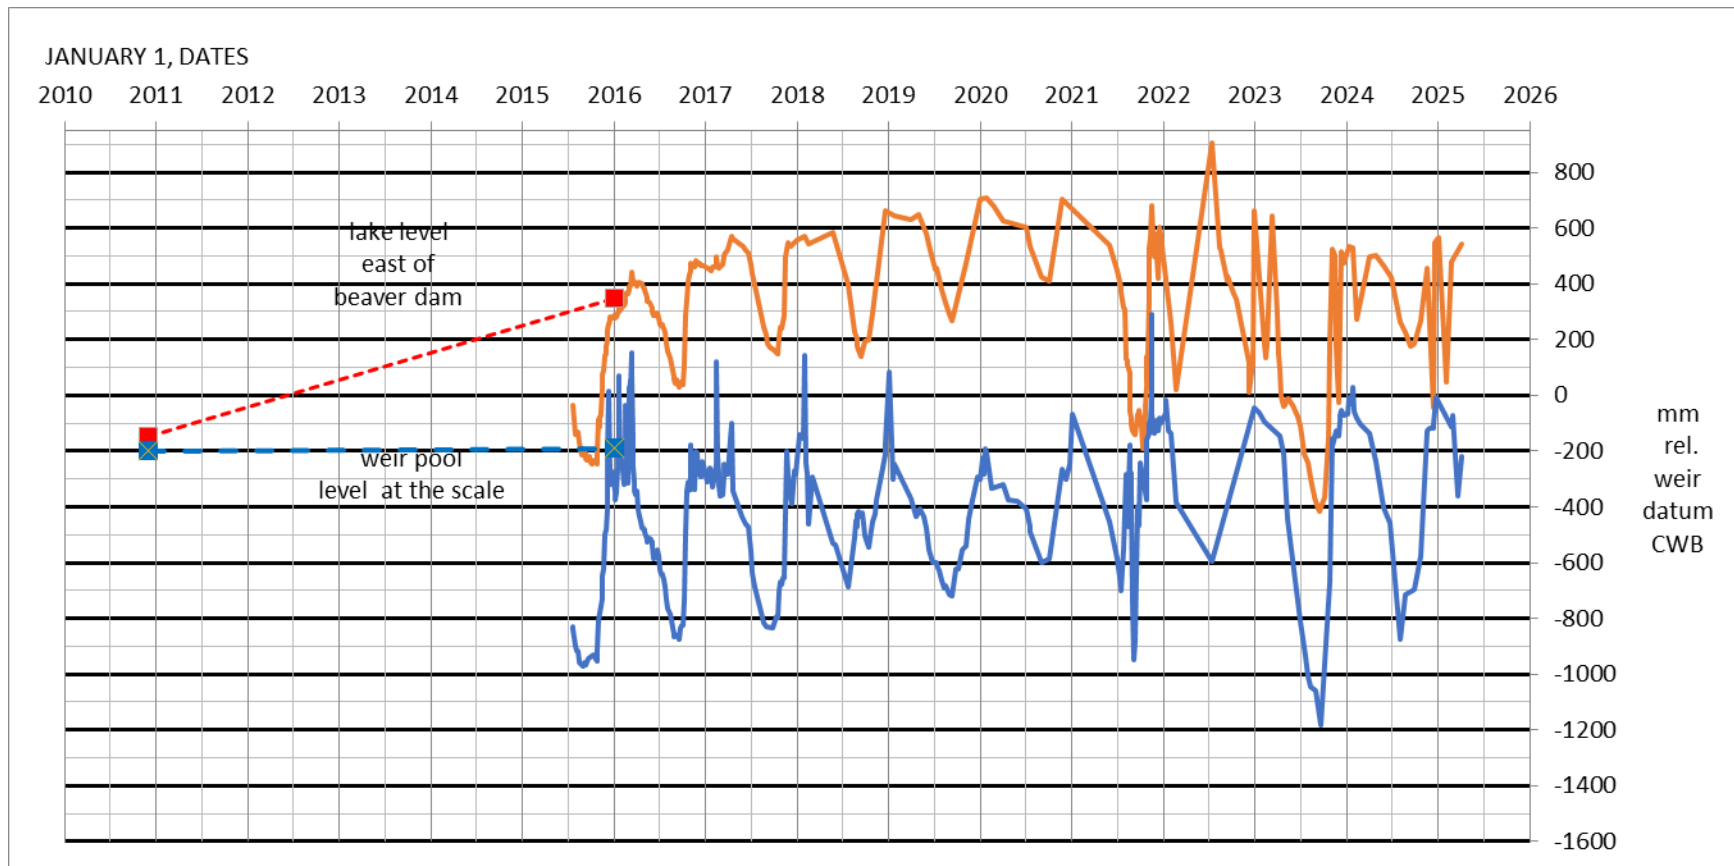
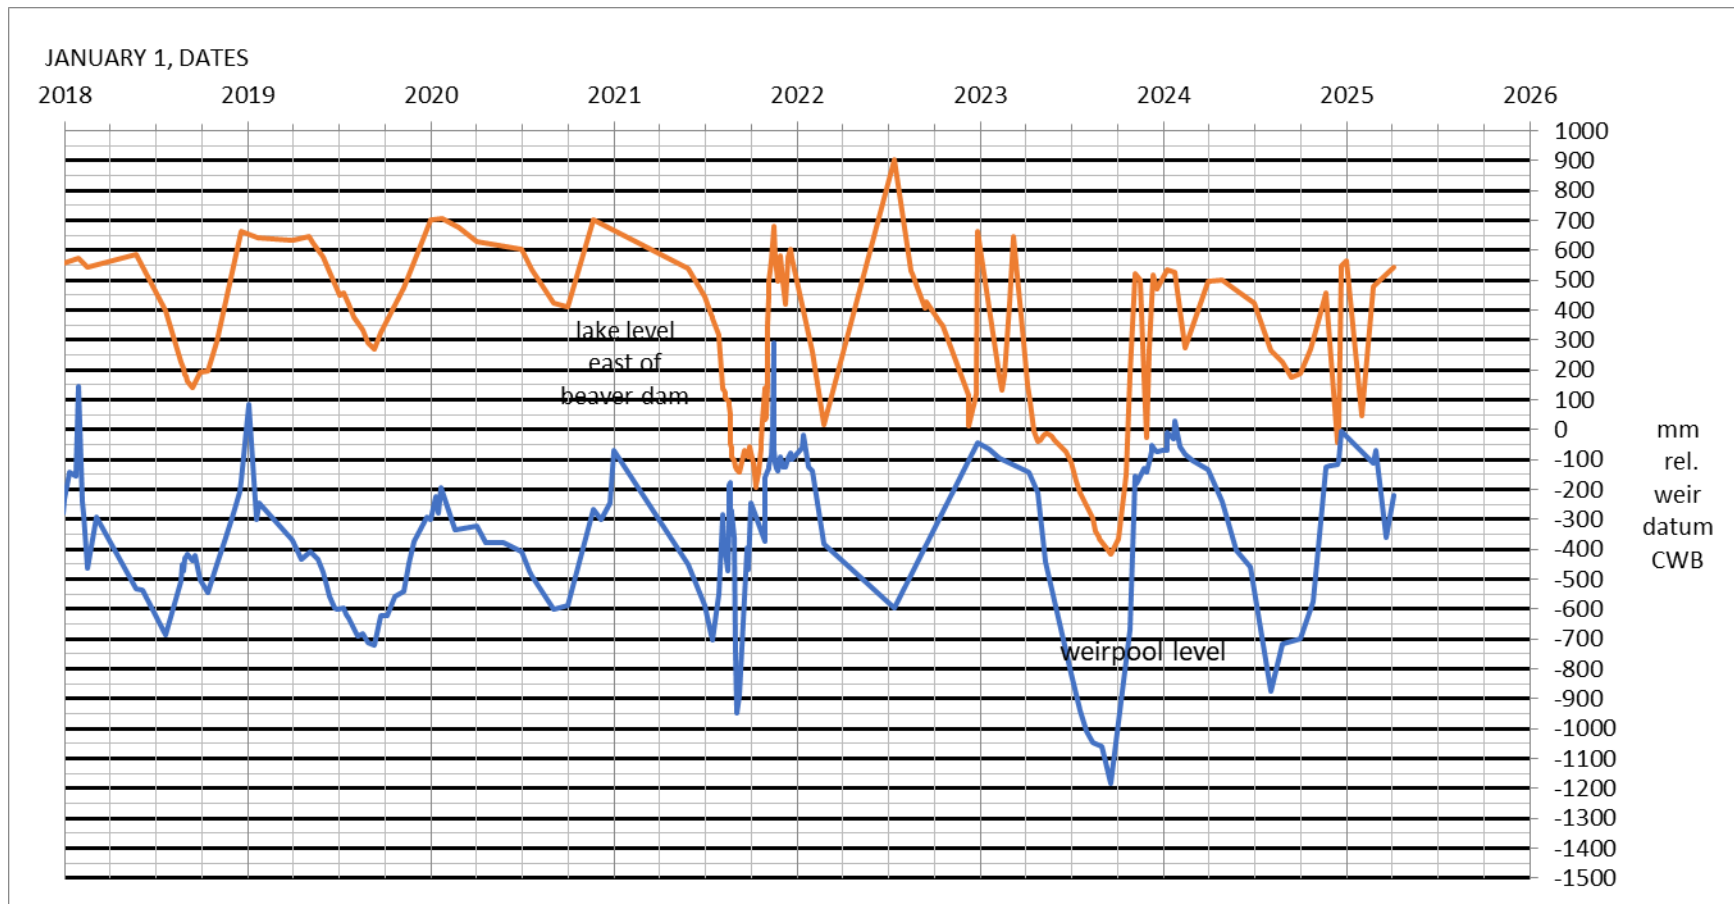
Figure 1a: Water levels

Notes on Figure 1:

1. The winter 2010 observations are from the Management Plan.
2. The weir deck is flooded whenever the weir-pool level (blue) exceeds 0 mm. This has not happened since November 2021.

3. The beaver dam has significantly reduced the risk of the marsh drying out by the end of the dry season as evidenced by the rising annual low points of the red graph. The lake bed is everywhere above –1780 mm (rel, to CWB), and any drop of water level to less than –1000 mm below CWB would severely shrink its surface area and impact the ecology of the lake parafluvial margins.

4. Water was syphoned across the beaver dam by the RDN on July 23, 2021. The effect on the level of the main lake would have been small, ~10 mm, as its area is roughly 20 times greater than that of the weirpool (ref: CE/CW in [File 673u](#)). There would however have been a rise in the level of the weirpool solely due to the syphoning of ~200 mm as there was no outflow into Coats Marsh Creek (ref: [File 673x](#), pp.359-360).

5. Water was syphoned across the beaver dam by the RDN in early August severely dropping the level of the marsh, and causing Coats Marsh Creek to run (ref: [File 673x](#), pp.362-364).

6. A “permanent” syphon system across the beaver dam was installed by the RDN in mid-September but they’ve had finger-trouble getting it to function correctly. Some days all four syphons are working, some days only two, and some days none. Adjustment has also been made to the pond leveller at the weir. Levels in the weirpool particularly have not been stable. ([File 673x](#) and [File 673y](#)).

7. Since on-and-off syphoning began weirpool levels have been erratic and not recorded unless level is exceptionally high. An added complication is that there is now a beaver dam one to two metres upstream of the weir. The old RDN weirpool gauge is upstream of this small dam and hence the level it reads is no longer the level at the sill of the concrete weir.

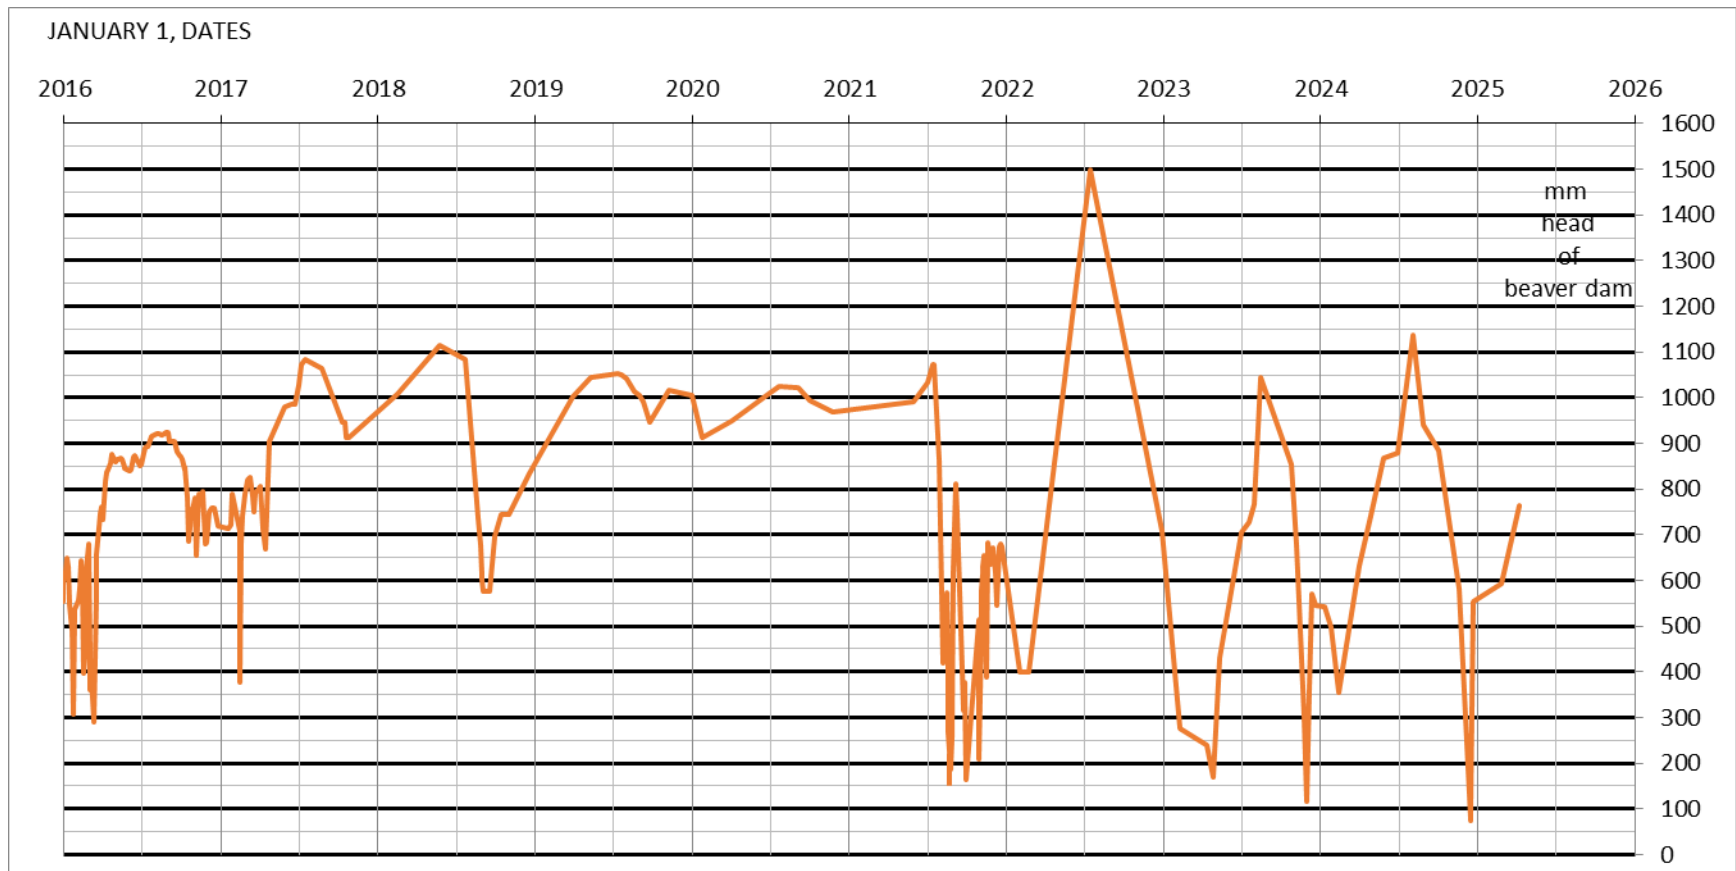
Figure 2: Beaver dam hydraulic head

Notes on Figure 2:

1. The head (difference in water levels at the beaver dam) is usually highest in late summer. The exception in 2018 is due to the dam developing an underwater leak which the beaver had to repair.
2. Very low heads occur when water is overflowing at the dam in flood conditions. Recently overflow has been reduced and almost eliminated by the development of two spillways. Whether these pond levellers are a consequence of natural circumstances or the beavers have engineered them is not known, but they are effective in reducing flooding by reducing the volume of water in the lake in a controlled manner in anticipation of flooding.
3. See notes 4 and 5 on Figure 1.
4. See note 6 on Figure 1.
5. See note 7 on Figure 1.
