Gabriola Streamkeepers—Water levels and quality

Observations at Coats Marsh, Gabriola Island

—with notes on Coats Marsh Creek, East Path Creek, and Stump Farm Streams.

Binder of supplementary files in the 673 series

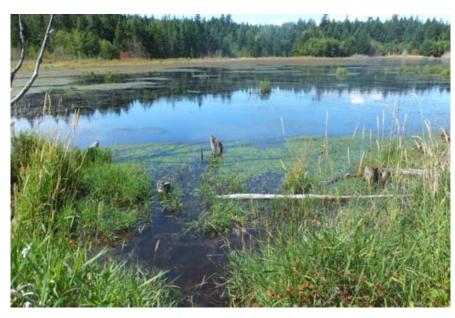
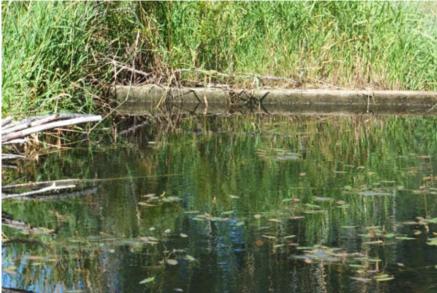
Photos left. The lack of rain, warm temperatures, and north-westerly wind is at last having an effect. There was a drop in the June water level of roughly 8 inches (200mm).

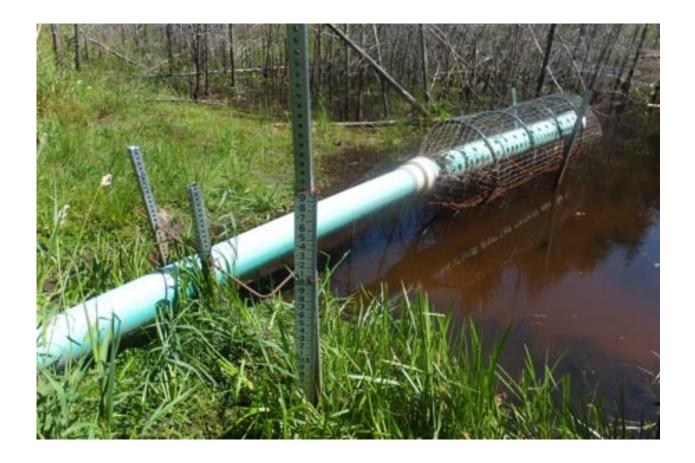
The water level was -300mm [previous day 0.95 ft = -290 mm] below the bottom of the

outlet pipe at the scale by the bridge. This is off the scale. Graduations are 0.1 ft. Photo below.

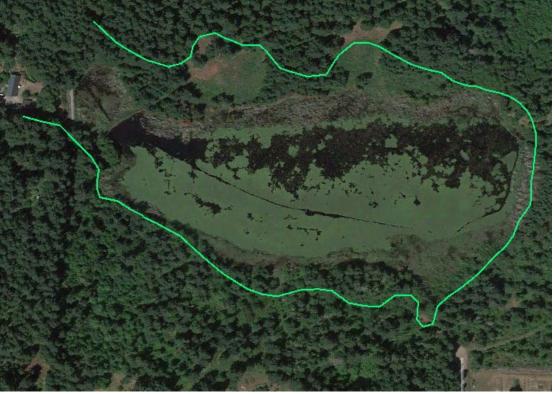
100.5 m contour

The 101.5-m contour quite plausibly defines the original glacial meltwater basin as defined by thick layers of gleysol and is, in this image, 1.8 times the area of open water. The extension beyond the summer waterline, as shown in the satellite imagery, in terms of area, is mainly along the north shore of the marsh and less so on the eastern side, even though drainage channels have been observed 20 m inland and gleysol 30 m inland on the east side.

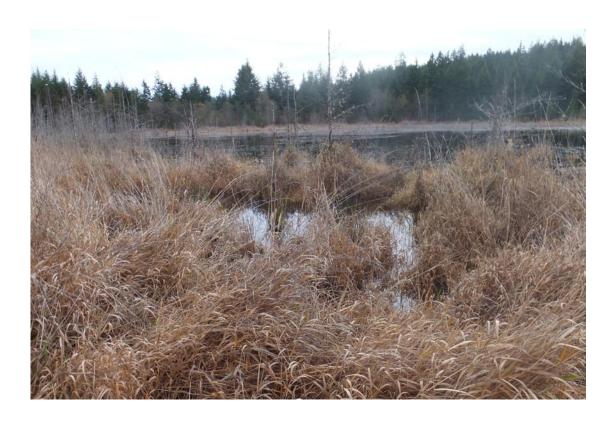
Flooding of the reed-canary-grass area of the marsh along the north shore extensive. The water is in channels, though the flow was not strong enough to be observed, extending visibly up to 60 m from open water. Green sedges are good indicators of their presence (photo left), which in one place that was observed goes right up to the edge of the forest (photo right).

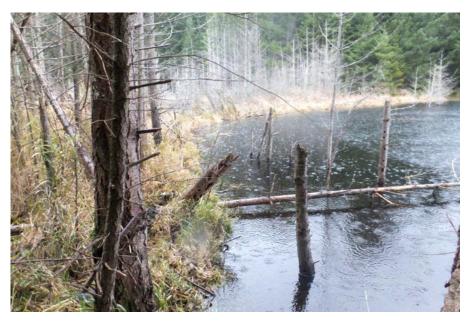
Photo: Beaver dam 38-metres long holding up well.

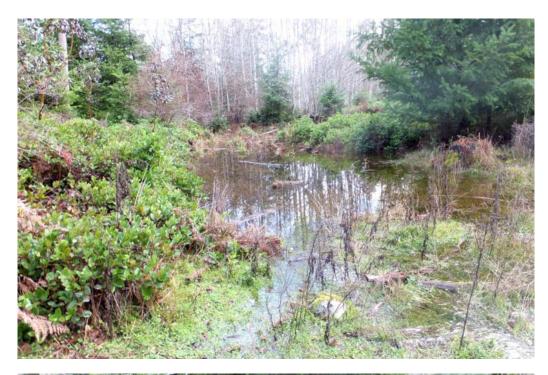
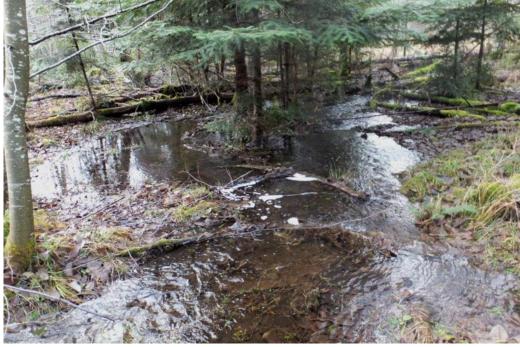
Photos. December 11, NE Arm of the marsh - a seasonal swamp (meadows, woodlands, and alder-groves) extending almost 500 metres to the east, now completely unable to soak up more rain.

The NE Arm and the East Path Creek, which drains land north of the orchard, only flow to the marsh during prolonged periods of heavy rain. The eastern NE Arm especially has been part of the marsh's catchment for only a few days this fall.

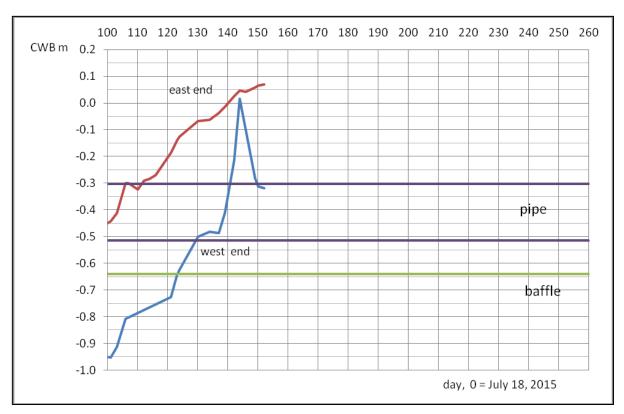
The land in the NE Arm to the east is full of swales and other depressions that fill with water when the ground can no longer absorb it. These are the reflection of the gently undulating sandstone bedrock whose fractures have become choked with mud. The swales and sumps are like saucers. All the while they are not full, no water flows out of them. But the moment they are full to the brim, every drop going in becomes a drop flowing out. Hence, the flash flooding. As soon as the rain eases off, even slightly, these outflows abruptly cease and the water reverts to being isolated pools, ponds, and puddles that leak, over the course of a week or less, down through fractured sandstone into the ground. I call it the "cracked-saucer-effect".

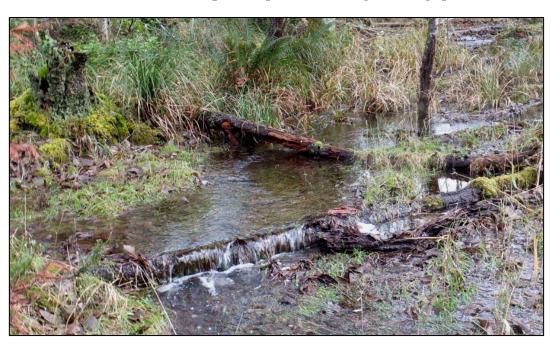
Photo: One of several ephemeral creeks in the NE Arm.

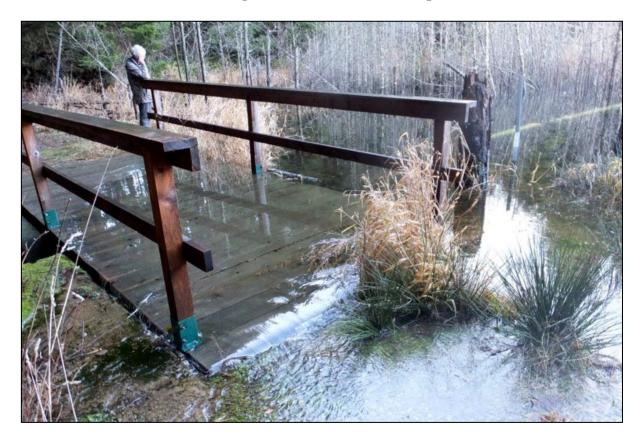
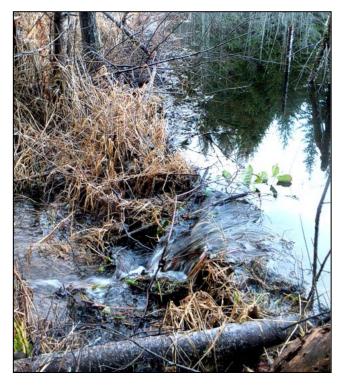
The new beaver dam (left) is still holding water back, but the over-the-top spillways are busy filling up the weir bay.

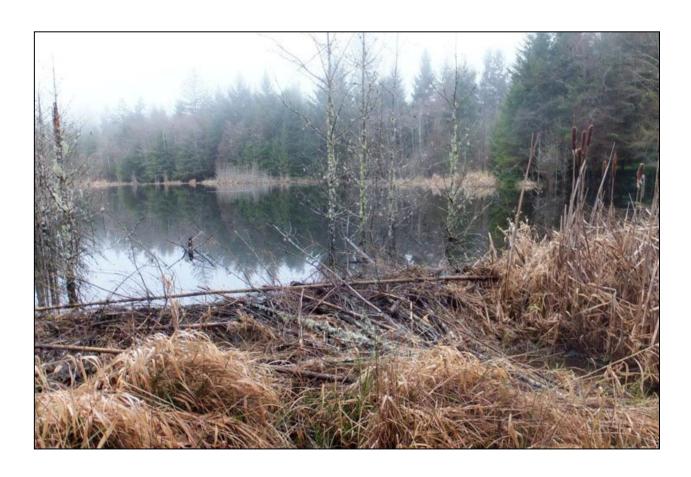
Buffleheads, goldeneyes, and maybe widgeons paddling back and forth quite purposefully, not just foraging. Frogs almost shrill at times. The bulrushed beaver dam (below) audibly leaking, but still allowing

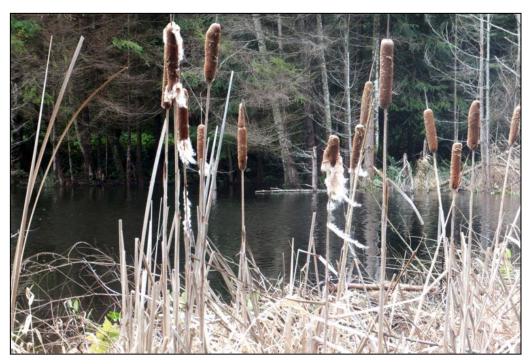
Bulrushes on the beaver dam

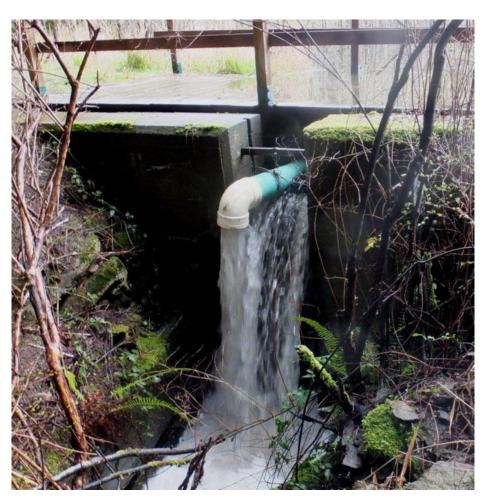
Deck partially flooded as before with a strong flow into the bypass slot along the deck's south side-the deck has become another sill; some flow also on the north side from the bank into a hole leading underneath the deck. Baffle sill +180 mm.

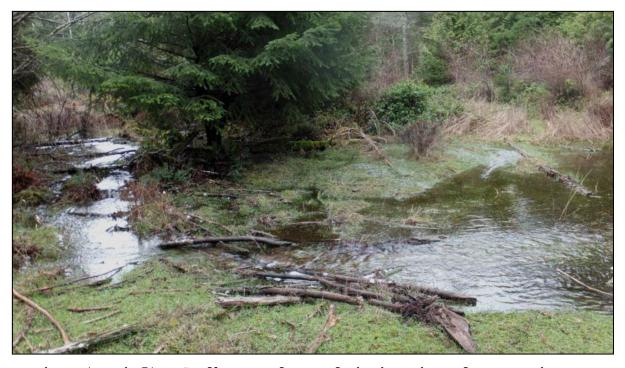
Photo (March 7): Confluence of two of the branches of East Path Creek as it approaches the lake. Looking upstream towards the path.

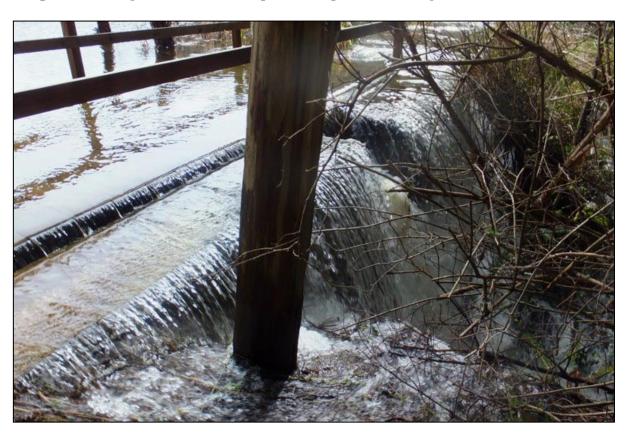
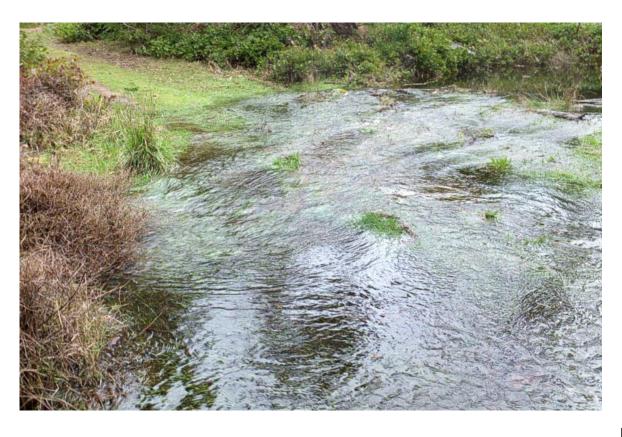
Flooding across East Path by East Path Creek (above) and across the NE Arm spillway (below).

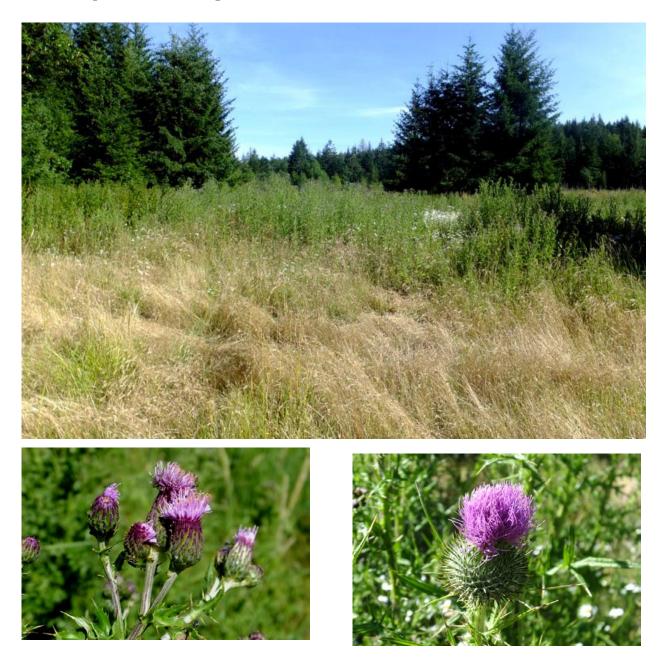
The east clearing particularly (shown) is infested now with thistles with a very prickly attitude. Mostly Canada thistle, *Cirsium arvense*, (left), but some bull thistle too, *Cirsium vulgare*, (right), which has just begun to bloom.

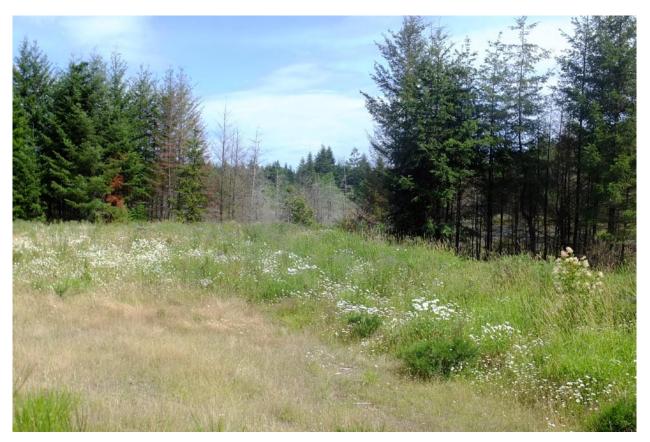
The west clearing (shown) has thistles too, but their numerous companions are ox-eye daisies, stinging nettles, and broom. But that's far from all there is. There 're horsetails for a start!

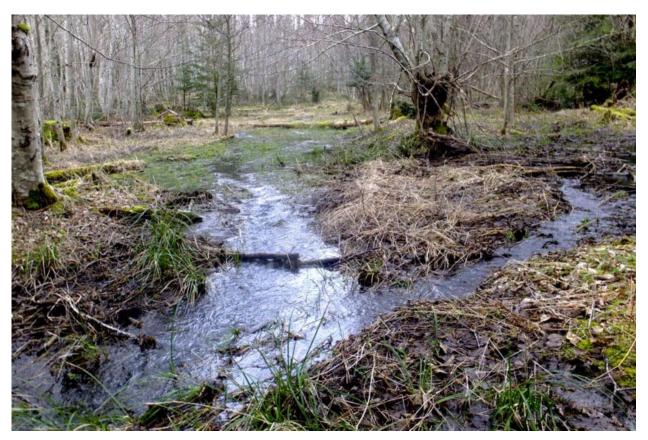
Rills and rivulets from the NE Arm just short of the eastern shore of the lake. The fabled spring that those that know like to talk about?

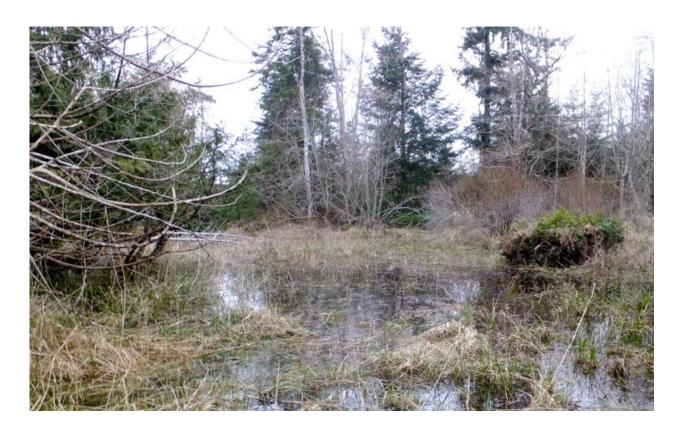
The SE Arm wetlands, the East Path Creek reservoir of water coming down from High Point Meadows and McGuffies Swamp. The other fabled spring of the desktop explorers.

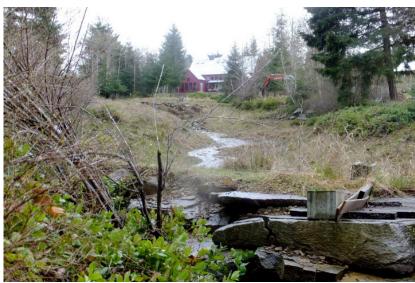
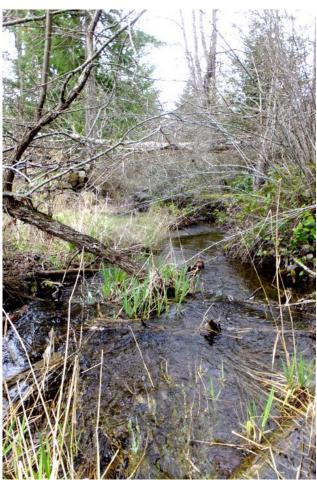
Left: Views of East Path Creek.

Top: Looking upstream to the Appleyard ponds.

Below left:
Looking downstream
from almost the same
vantage point just
before it reaches the
East Path culvert. At
the moment, a very
lively stream.

Below right: An Appleyard pond outlet.

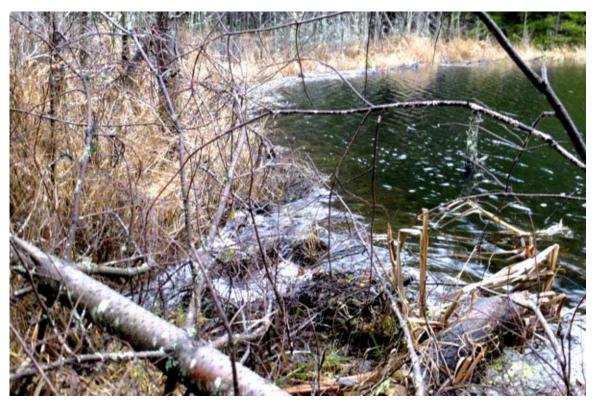
NE Arm wetland living up to its name. Frogs to be heard here all winter and occasionally you see mallards. The beaver dam is overflowing in two or three places, but no flooding at the weir deck yet. The pond leveller is just holding its own.

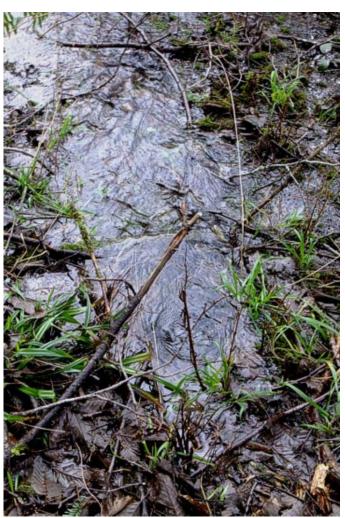
<u>January 27, 2020</u> (day 1654, 1461+193): NanRG cum. 534.7 mm. Two long-sought-after springs discovered in the East Path Creek delta. Account written up in <u>File:668</u>. Emerging from among cedar tree roots at the bottom of the 1-2 metre incline marking the shoreline of the paleo-meltwater-lake. East Path Creek in full flood, the most likely source. Photographs show the NE spring *left* and the SW spring *right*.

The late-Pleistocene lake level, as marked by thick gleysol, was slightly higher than the present level even though the lake is flooded at present and the level has been raised by the beaver dam. Possibly indicates that the meltwater lake was at the time of its formation around 11500 BC dammed with ice at the western end.

Creek flows becoming much less everywhere after the January deluges and falls of snow. The originally-observed two springs discovered in January have stopped flowing, but the character of the SW one has changed. The SW spring location now shows a patch of silty-clay mud, the colour of dark chocolate, located a little below the originally observed hole, from which numerous small seepages are "boiling" up. The flow from the puddle they create, possibly around 10 litres/second in all, is in poorly-defined, trinkling watertracks leading from the forest into the reedy margin of the lake.

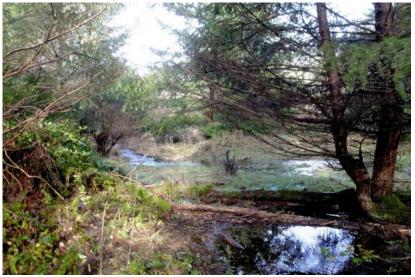
Below: East Path Creek near where it crosses under Coats Drive after its steep descent from High Point Meadows and joins and leaves the SE Arm wetland, another often overlooked riparian area.

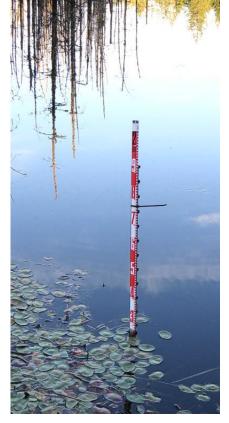
The new metric gauge reading was 1265 mm, which for the time-being I take to be equivalent to my +0.315 m [calibrated] at the cistern at the east end of the lake, a difference of 0.950 m, to be subtracted from the RDN gauge to get the calibrated CWB level.

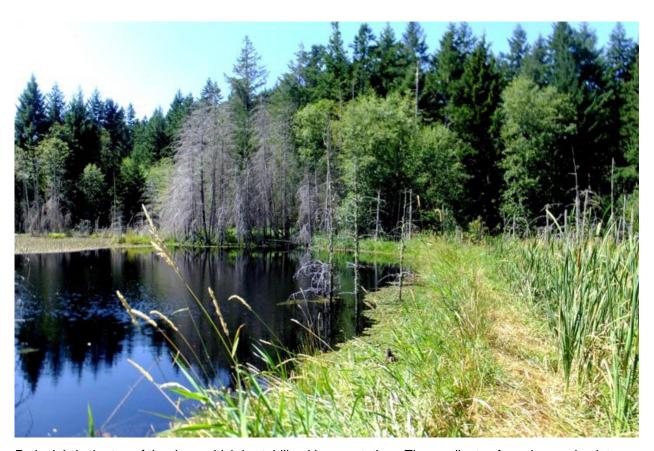
Path *right* is the top of the dam, which is stabilized by vegetation. The gradients of creeks running into the shallow-water wetland (East Path and NE Arm) are low, making for a low-energy environment overall.

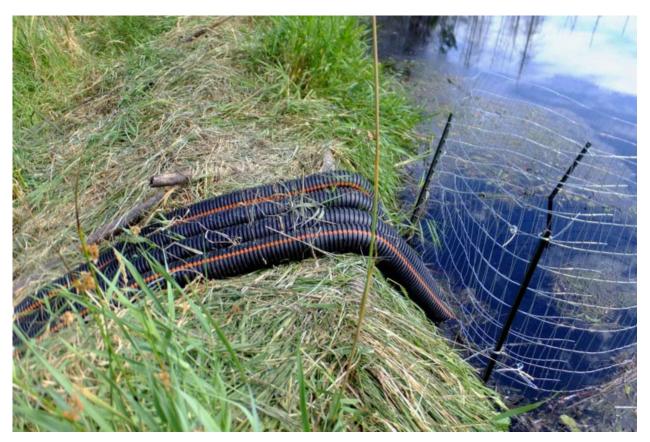
Syphon intake: [4 hoses 5"OD, 0.8m head, ~87 L/s total; my guess, simulating a 200mm ID PVC pipe]

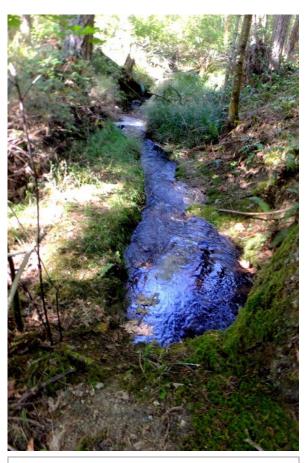
Coats Marsh Creek flowing in early August!
Carrying water from the marsh down through
the forest to Hoggan Lake where it will
eventually evaporate, be used for the greens,
run-off into the sea, or who knows, improve
the environment down there.

In places, the shoreline has already retreated six feet leaving behind numerous disoriented young frogs and stranded aquatic plants. A mature bald eagle patrolling the lake margin is also not comforting. No sign or sound of ducks.

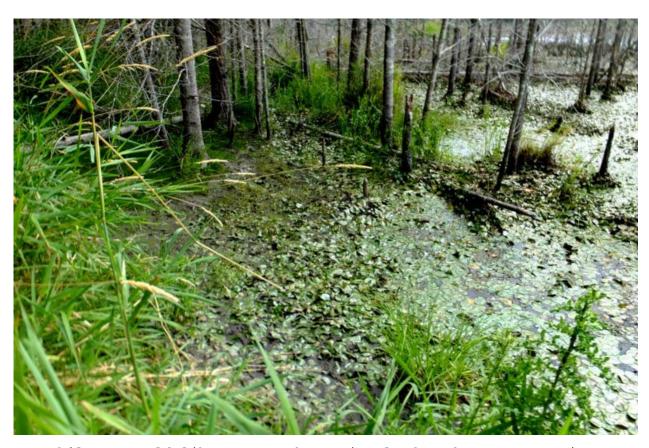
Coats Marsh Creek is still running at a modest pace. There is something slightly amiss with the weir calibration as the pond leveller is only trickling with its bottom just in the water while the calibrated old gauge says the level of the bottom of the leveller is at -0.450 mm and the sill at -0.640 mm. In any case, the weir pool level is still falling but the RDN syphon across the beaver dam has practically stopped draining the outer marsh. It's just dribbling at the rate of a kitchen tap. Will try to recalibrate both gauges next week.

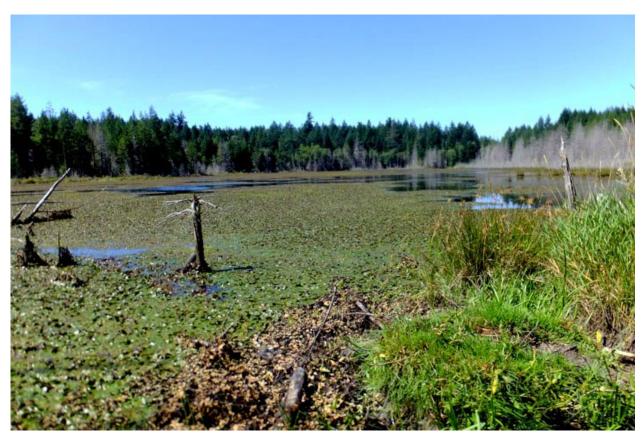
The lake at the east end looking devastated. I imagined that I had never seen the portion of the lake that is outside the regional park but within the community park (go figure!) looking so dried out, but then I must have. It is even questionable whether the level at the cistern datum I have been using for years is still valid it is so far from open water. There were three low-flying vultures circling around.

If the drought continues, the area threatens to become cloaked with rotting watershield. That's the brown stuff in the photograph nearest the shore; that's not dead tree leaves, it's former healthy habitat.

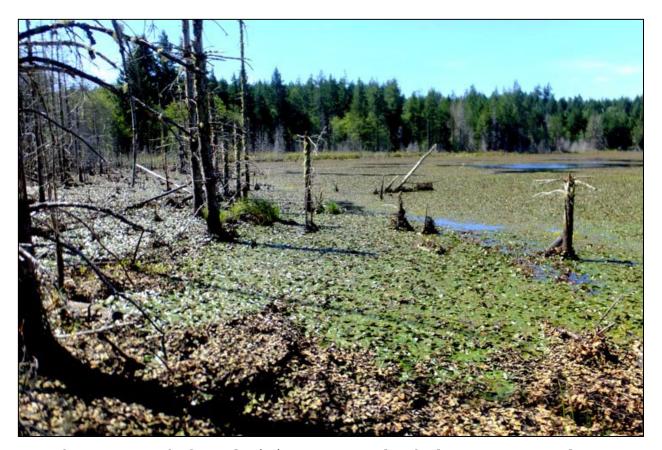
A week or so ago before draining commenced I had to wear my waders to stand where the photograph above was taken. I was wearing my town shoes yesterday. The east end of the marsh, where the experts seldom go, is relatively flat, so a small drop in water level makes a big difference to the surface area and location of the strand.

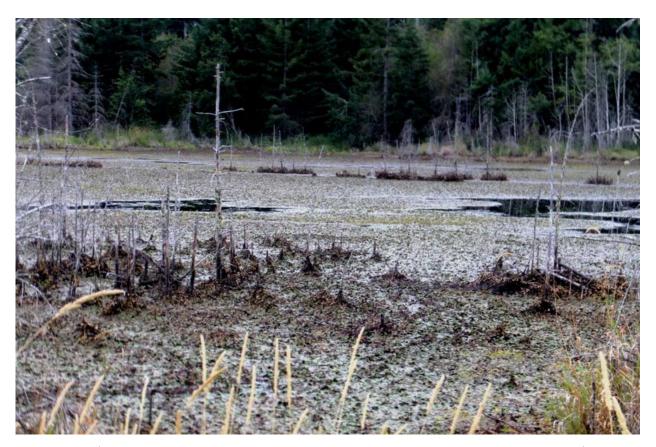
Drawdown continuing unabated. By my reckoning now 42 cm. Marsh is looking stressed with open water breaking up into ponds, and a distinct smell of rot in the air. There were a dozen or more ducks abandoning the drying-out sedgey fringes of the "lake" now not much more than a pond, and the beaver at the east end of the lake is frequently breaking the surface because the water has become so shallow.

The flow in Coats Marsh Creek from the pond leveller has turned inky black presumably as the syphons dredge up gyttja.

One of the hazards of allowing both the dam and the weir baffle to dry out is that wood rots far faster in aerobic environments than anaerobic ones. Whether or not this has been considered in the plan is not known.

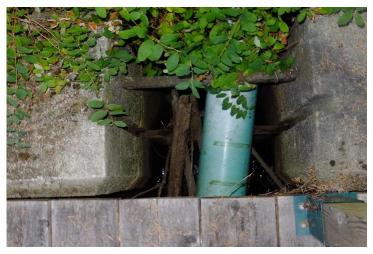
View from the downstream side of the deck (seen at the bottom of the picture) looking down at the gap in the middle of the concrete weir. In this view, water flows from bottom (the weir pool) to top (Coats Marsh Creek). The turquoise pipe below the re-bar is the outlet of the pond leveller running below the deck and above the sill. The woody debris below the pipe has just been put there by the beaver and is on top of the baffle. You can see the slots in the concrete sides of the gap that used to be used for sliding the baffle up and down, thus controlling the flow of water, long before the leveller was installed.

The industrious beaver has managed to stop the flow over the sill, so that flow through the weir is now only via the pond leveller. The sill measured in August 2015 was at -0.640 m, what is I believe a quite arbitrary level set by the previous owner before 2008, some 0.360 m below the present weir-pool level.

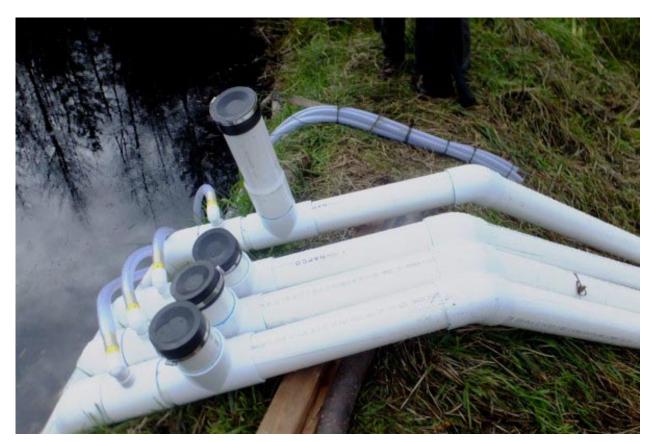
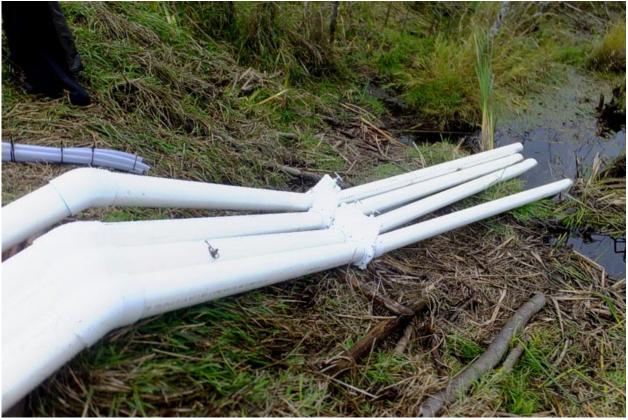
New syphon installed but not in operation. Looks to be a simple system, nothing automatic. Four 4" PVC pipes, each starting when primed with a pump that has to be brought out on to the dam. Should be interesting in foul winter weather when the trumpeter swans are there.

Not clear what the snorkels without fittings are for. The syphons can be closed manually each pipe has a gate valve.

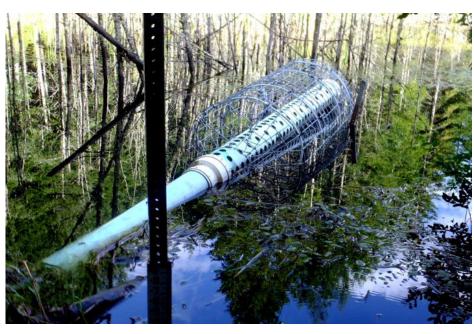
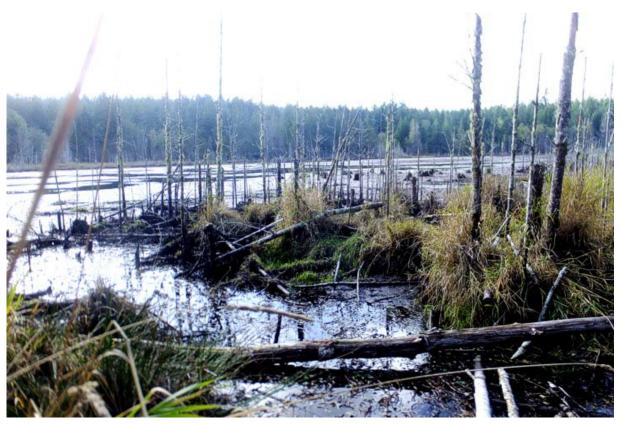
Coats Marsh Creek flowing at around 40-50 L/s, flow over the sill (depth 40 mm), pond leveller flowing but now pointing skyward ominously like a gun, the knuckles of all four syphons retro-fitted

with bleed valves and their gate valves now all open.

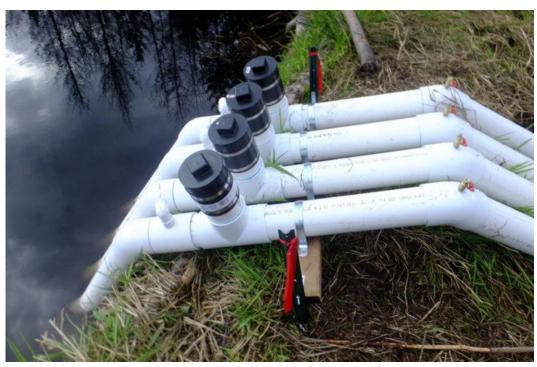
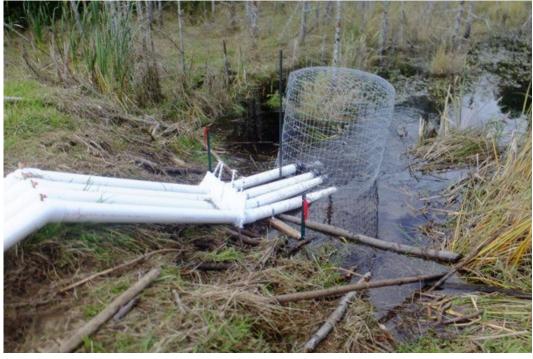
More mods. Syphons running. Lots of Jubilee hose clamps seems to have been the answer. Gate valves rather elaborately clamped open, and bleed valves closed though the two outer ones lack plugs.

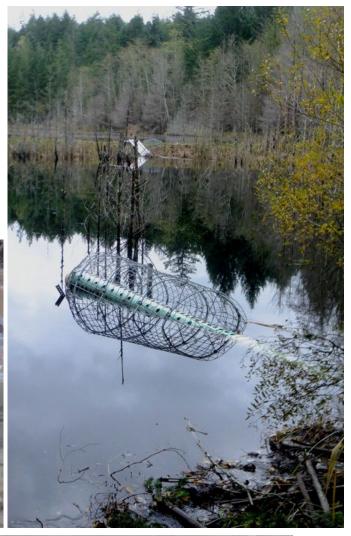
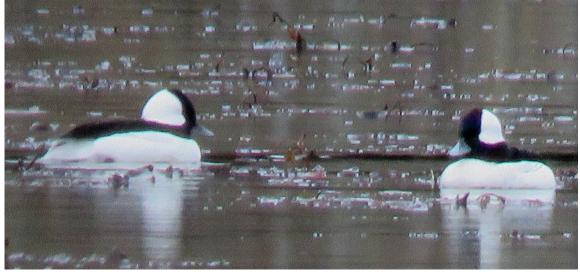
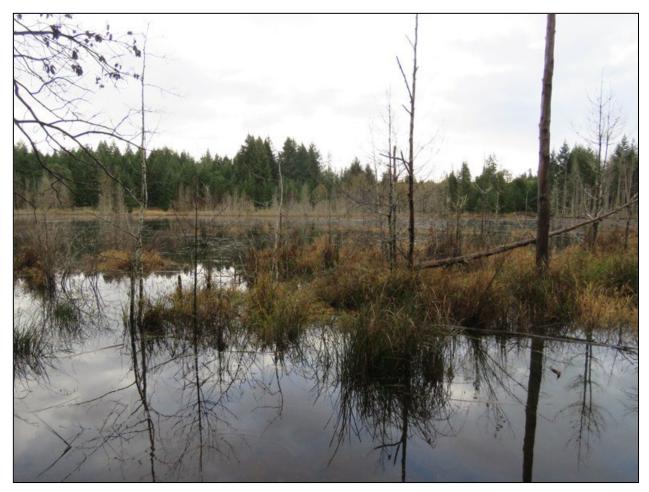
From afar look's like the beaver's been trying to plug the syphons, defeated of course by the wire cage.

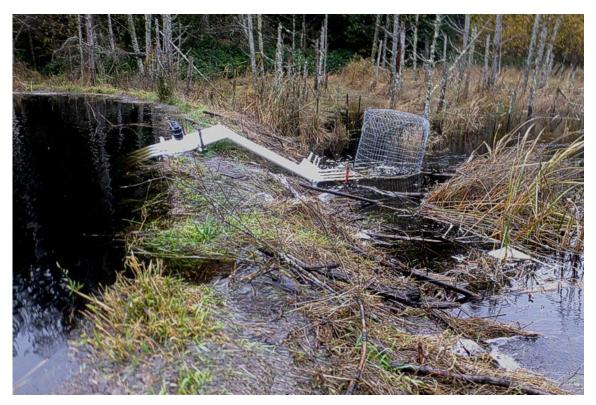
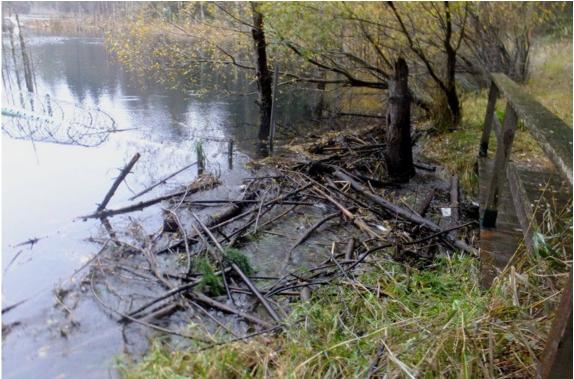
The spillways on the beaver dam are working; but it's hard to tell whether the syphons are.

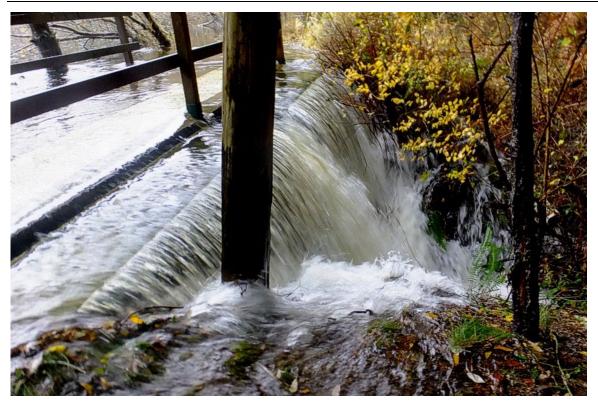
Numerous spillways over the beaver dam but no sign of any looming failure. Whether the syphons are working or not has become irrelevant.

The only downstream structure affected is a 24-inch culvert that is submerged and forcing water to circle harmlessly around it

through the woods. The log cabin is dry and not in danger.

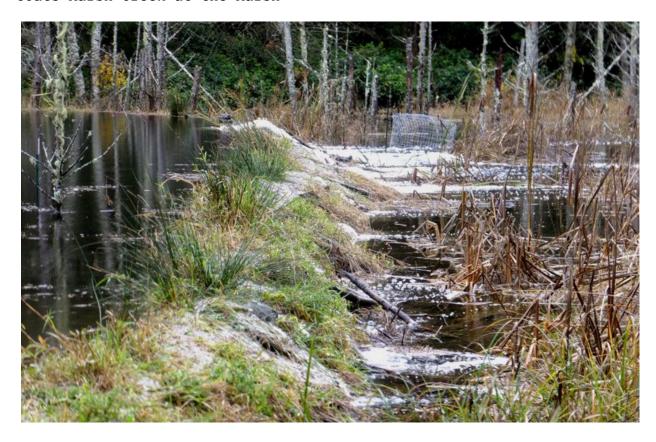
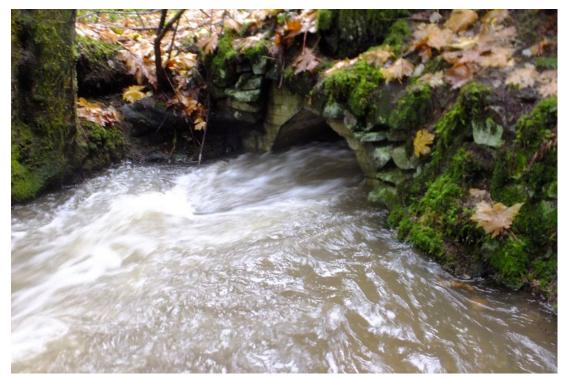
Coats Marsh Creek culvert outlet at the Marsh Nov. 15, 2021

No measurement of the flow in Coats Marsh Creek at the Marsh

Trail culvert, but it's more than anything I've ever measured, meaning it's more than 500 L/s.
[estimated 565 L/s File:673,c15]

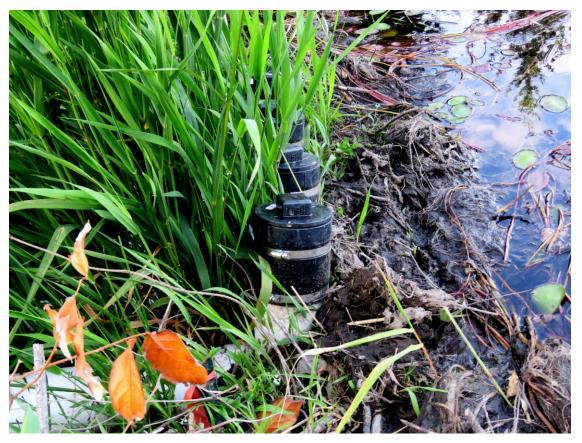
With the increased water-depth, some open water. Good to see.

Mud berms now reducing flow around the ends of the dam. Syphon system not functioning and almost buried. No longer an eyesore.

The syphon experiment has been a failure. The syphons capacity is far too low, becoming irrelevant in flood conditions; the pipes are an eyesore; drawing the lake water-level down in summer is destructive on account of the wetland's shallowness, and is in any case ineffective because the "lake" replenishes itself in just two or three weeks in the fall; liability is largely a fiction; and the need for a regular human presence on the dam for maintenance of the syphons seriously disturbs the wildlife and wastes park operators' time.

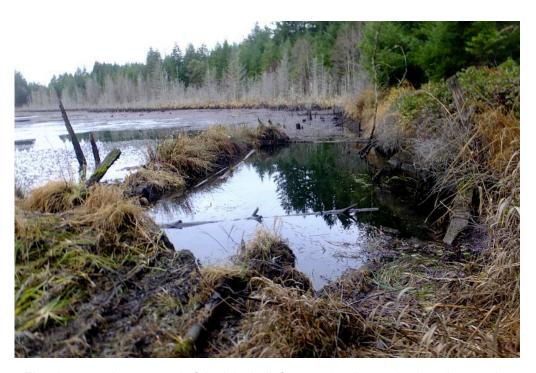
The cistern at the east end of the lake built for watering livestock when the marsh was drained. Normally the concrete walls are below water level. For some reason, the water in the cistern often remains ice-free when the lake surface is frozen. At such times, it used to serve as a refuge for ducks and it was not safe to come here until, as here, there was a thaw. Happens less often these days.

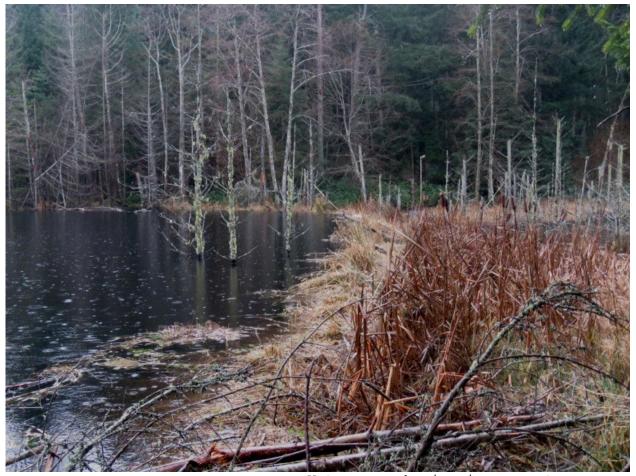
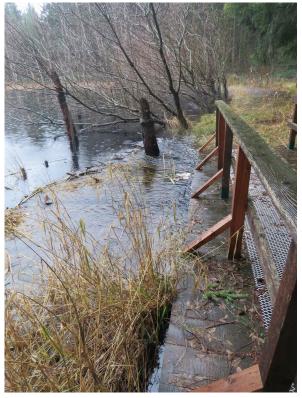
Wet season begins in earnest. Cistern startlingly transformed to look like it usually does at this time of year (photo above).

Two spillways on the beaver dam flowing, and lake water is trickling over the whole of the crest of the dam, within inches of overflowing (photo above);

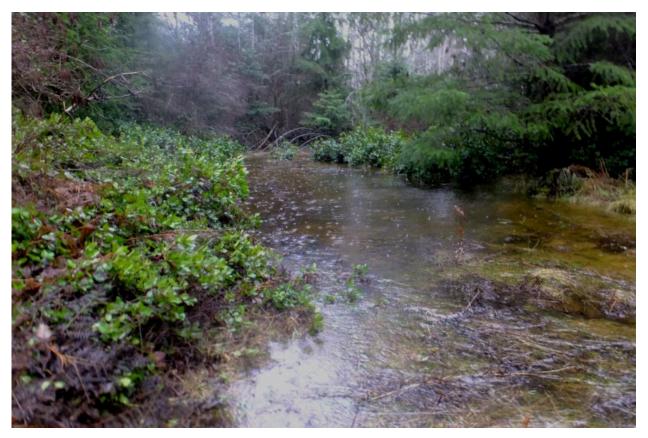
Flow from the NE Arm moving over East Path and through the trail's rocky substratum as it does most winters (photo above);

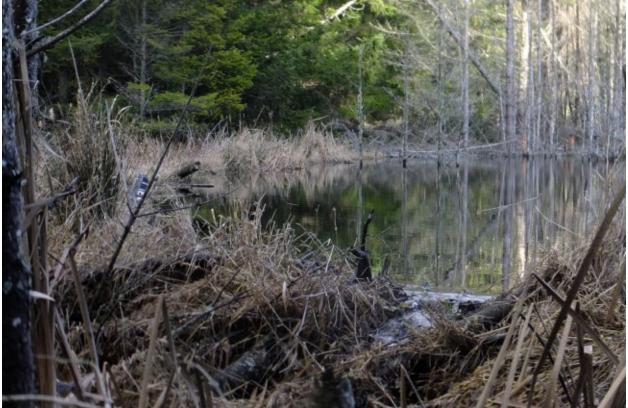
The "lake" is close to being full with water gently moving through the

several spillways that the beaver allows in its bigger dam.

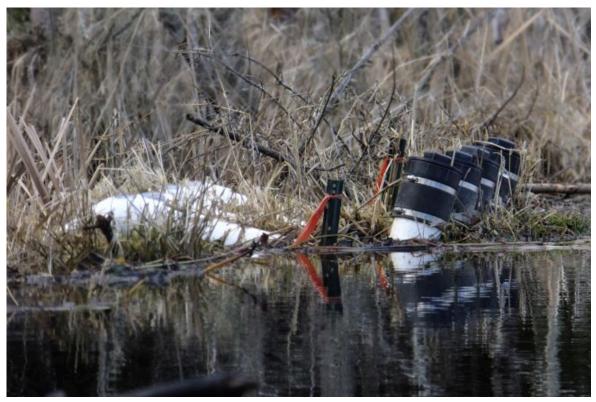
The syphons evocative of images of RMS *Titanic*.

- (v) the syphon system installed to relieve pressure on the dam and weir in flood conditions has proved inadequate. Flood volumes are far more that the syphons can handle. Assertions to the contrary are misinformation;

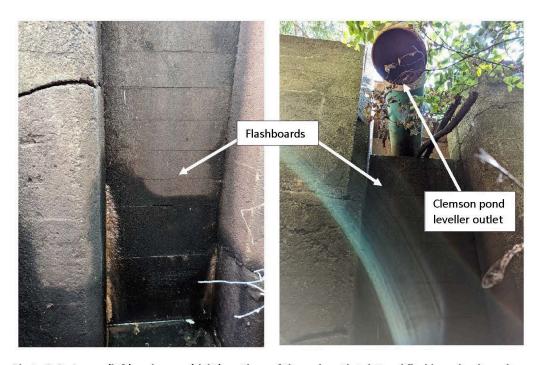
Photo 2.4 Lower (left) and upper (right) portions of the weir outlet slot and flashboards, viewed from the downstream channel. Note cracks in the concrete at several locations (NHC, Sep. 2022).

Interesting view of the baffle from the NHC 2023 Report. The notch is too narrow and the flashboards too high to contain floodwater.

- (xv) construction of the weir was not the initial step in creating the wetland. A wetland existed there long before a landowner blasted through rock to create an outlet channel in the mid-20th century; (xvi) only lightly addressed in these discussions is the need to replace the wooden baffle with something more durable. Complete

failure of the baffle could result in draining the entire marsh. Replacing the baffle with a sluice gate, or replacing the flashboards with concrete might be part of the ideal solution; however, the current baffle is healthy and the need to address this issue is not urgent;

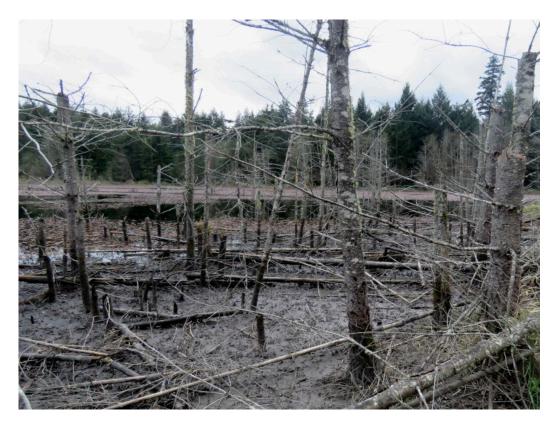
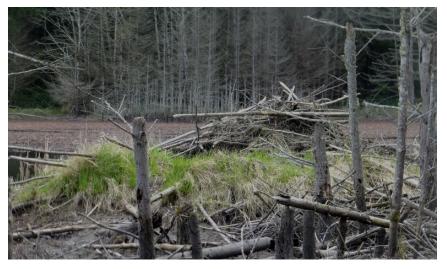
April 26, 2023:
(a) snags offer fledgling ducks and their parent(s) protection from predators, eagles, hawks, and owls. Hooded mergansers and wood ducks nest in tree cavities at the marsh. Whether they will again this year is still to be seen;

(b) the beaver's lodge, high and dry. Not "normal" at this time of year. Water level has not been this low before syphoning since the late summer of 2015.

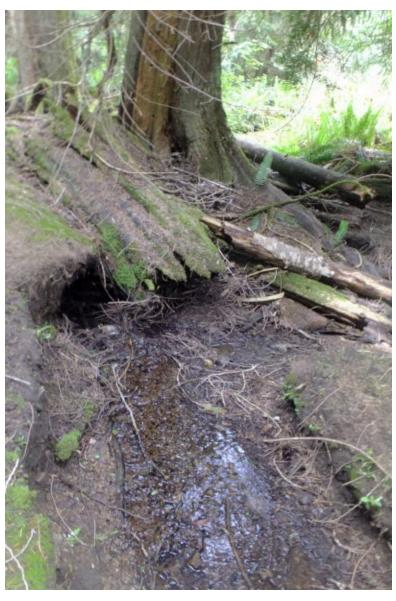
At this low level of flow, instead of by-passing the tree, the creek is disappearing into the root system and emerging at the other side of some large woody debris (LWD).

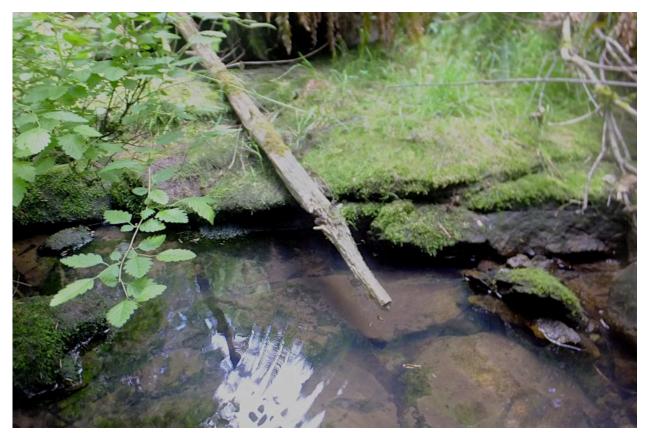
The highest point at which flowing surface water was seen was downstream of the wetlands that are near the CM-RP boundary. The water was an emerging subsurface flow shown here.

At the present water level, the flow from Little Creek is not contributing directly to surface flow in upper CMC but must be contributing to the reservoir (wetland surface or subsurface) that is the source of this water.

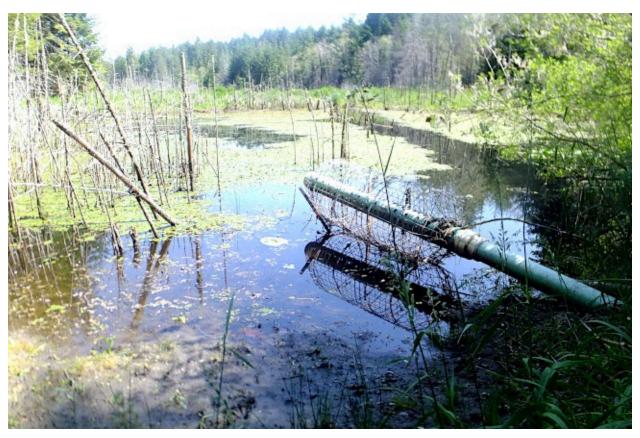
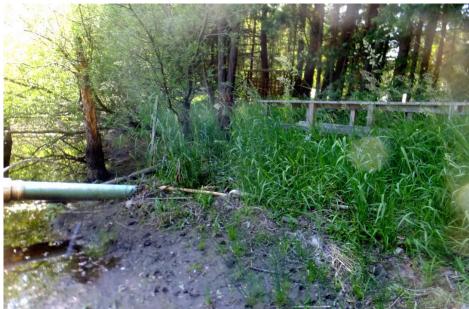
Water level in the weirpool very low. No outflow or drainage.

Beaver present
and very active
around the weir.
It is now
possible to walk
comfortably
across the weir
using his dam.
No ducks seen in
the weirpool;
the days are
gone when you
might see bluewinged teals
here.

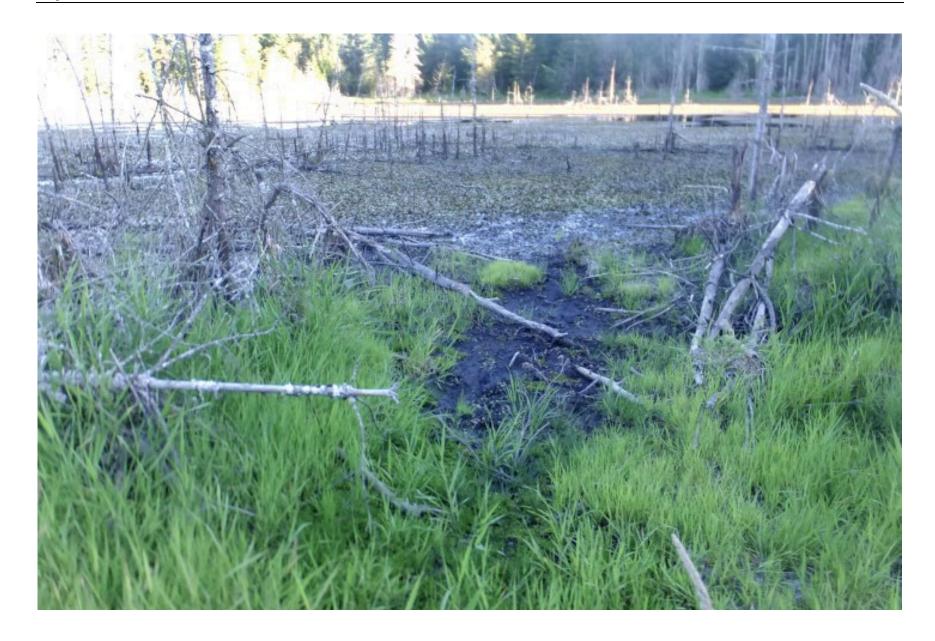
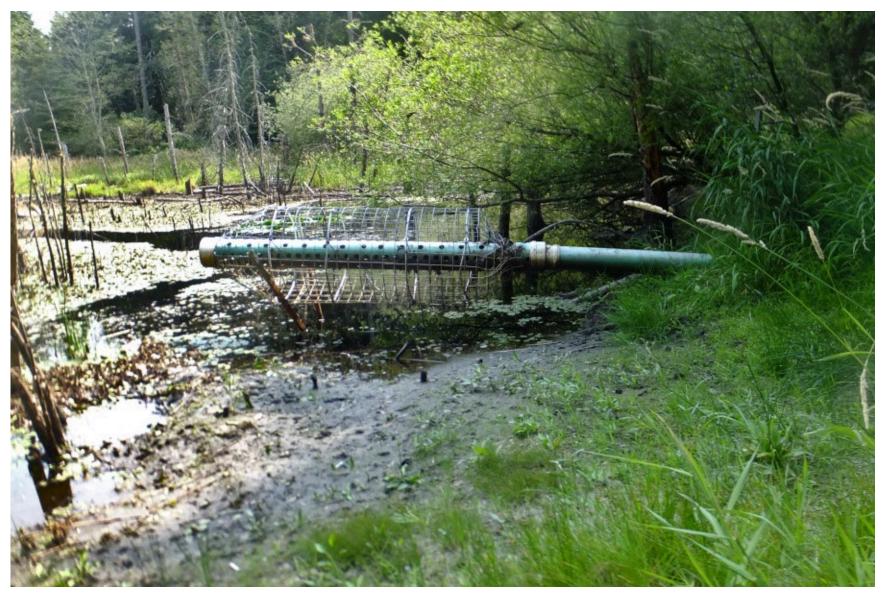
The Clemson leveller is a good design. The beaver has shown limited interest in attempting to block it. Its capacity is just too low for this application.

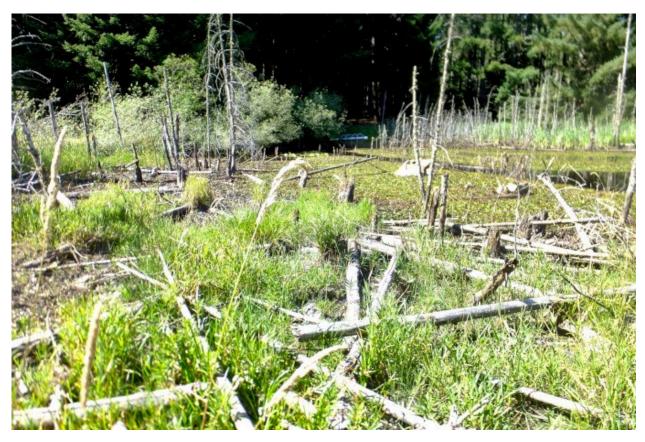
The weirpool is close to being completely drained.

Precise determination of the volumetric flow at the weir is complicated by the presence of the deck. In light of the relatively small freeboard of the berm, I think it would help if the deck was raised to a level where it does not obstruct floodwater. Overflow of the concrete weir and wooden deck can be more significant than it looks because the width of the weir is ten times that of the notch.

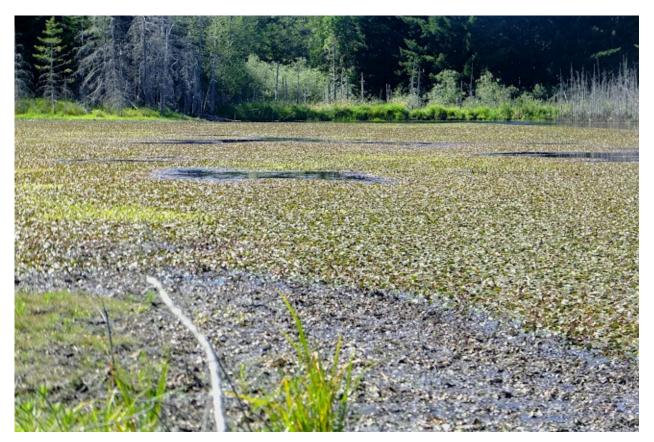
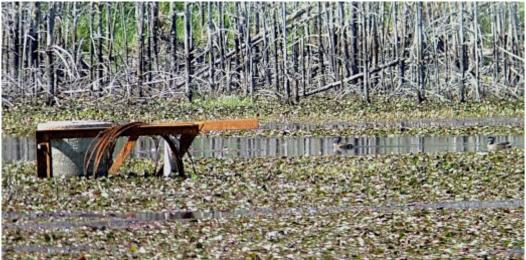
Above: View from the shore of the "lake" of the beaver dam (green strip between snags *top right*). *Below*: Part of the foundation of the 20th-century radio-tower installation once occupying the site. Some islanders remember walking the meadow here and flushing snipe.

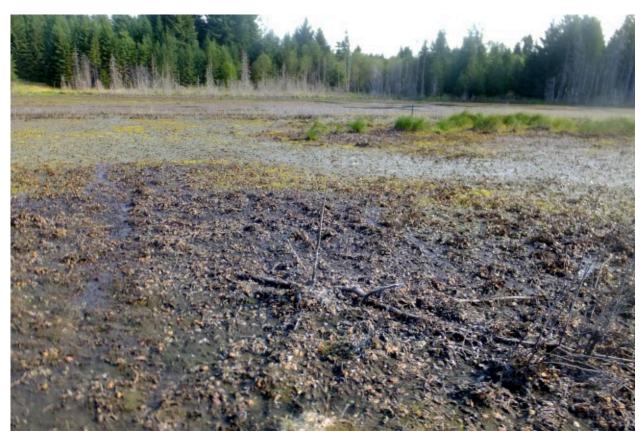
Substantial swathes of the perimeter of the "lake" have now become a thick, soft muddy morass. It's a simple enough message; you need to store water in winter in order to maintain an adequate water level in summer; and this hasn't been done. At the entrance to the RP at Stanley Place, visitors are now confronted with, not water, but mire, any water being far off toward the centre of the marsh.

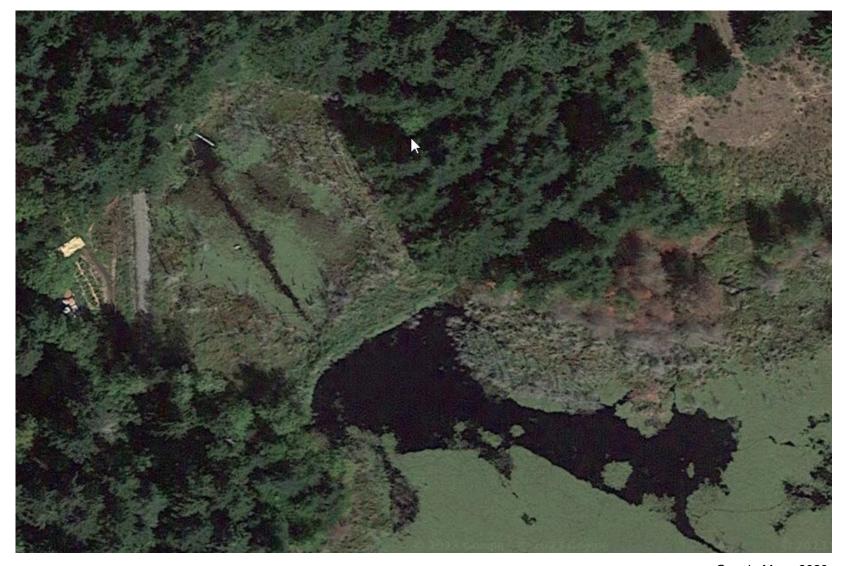
Google Maps 2023.

The drained weirpool, the beaver dam, and the west end of the marsh beyond the dam. In past winters, flowing water in this area has delayed freezing when the marsh to the east is iced over, thus providing a refuge for winter resident waterfowl. Draining this spring by the syphons installed at the bequest of the RDN/NTBC has been so severe that it is doubtful these conditions will continue this winter.

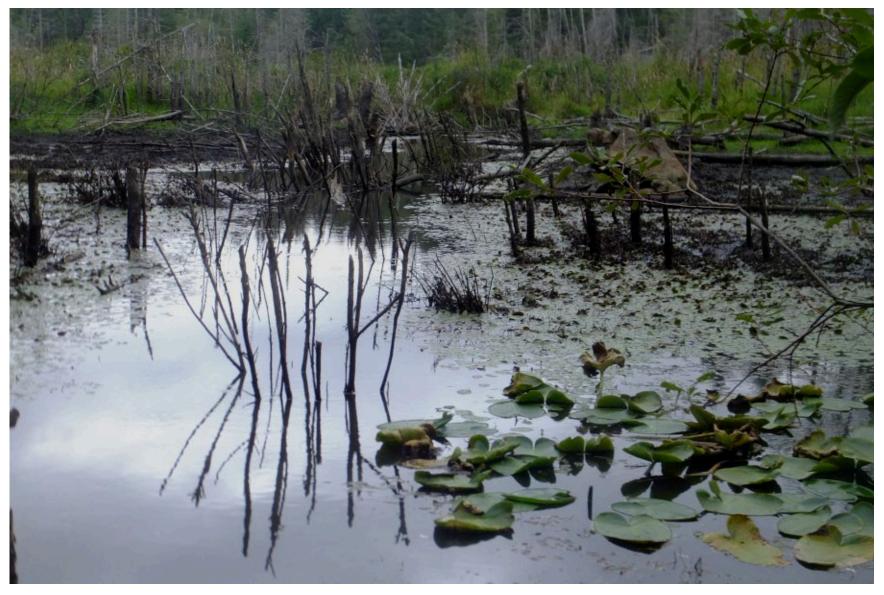
The weirpool seen from the berm with the beaver dam in the background. Aquatic plants in the foreground on the right are yellow pond-lilies (*Nuphar variegata*). These are uncommon outside the weirpool embayment. The water seen here is mostly in the old drainage ditch.
