Gabriola Streamkeepers—Water levels and quality

Observations at Coats Marsh, Gabriola Island

—with notes on Coats Marsh Creek, East Path Creek, and Stump Farm Streams.

Binder of supplementary files in the 673 series

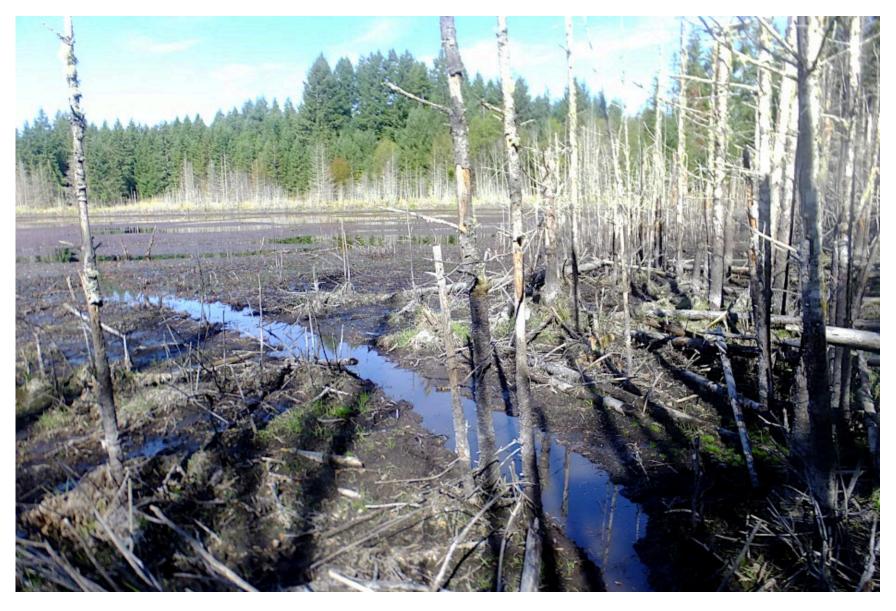
Old drainage channel? Normally submerged. In the vicinity of the mouth of East Path Creek.

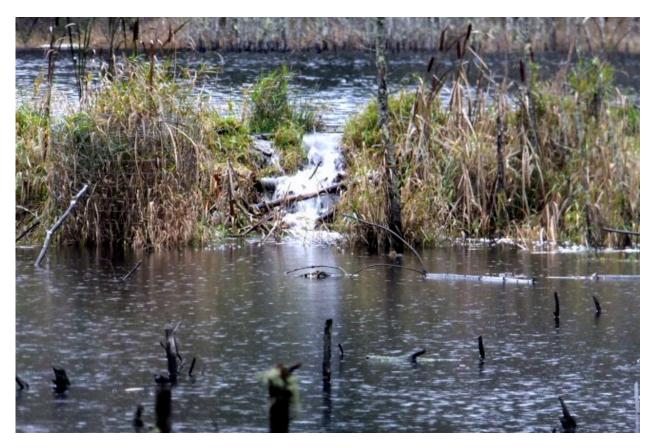
Above: The largest natural spillway in the main beaver dam. Used by the beaver both to reduce overflow and to move back and forth across the dam. The syphon system seen here on the left of the spillway is hidden in vegetation. *Below*: the pond leveller currently doing its job.

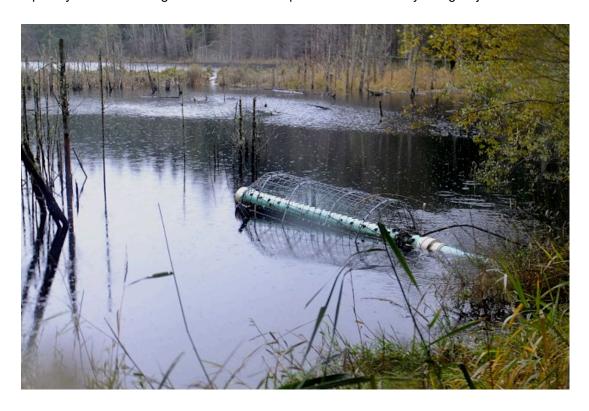
Water flowing over the crest of the baffle (at the sill) is contributing water, but the volume is less than that flowing through the leveller and seems less than it has been in the past given the level of the weirpool.

The difference between the level of the sill and the water level of the weirpool is currently (0.640-0.153) = 0.49 m; yet the depth I measure at the sill is only about 0.08 m.

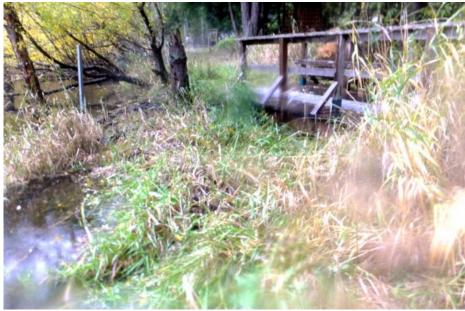
Above: The debris, now an engineered beaver dam, reducing the flow over the baffle. [Blurring due to raindrops on the lens]

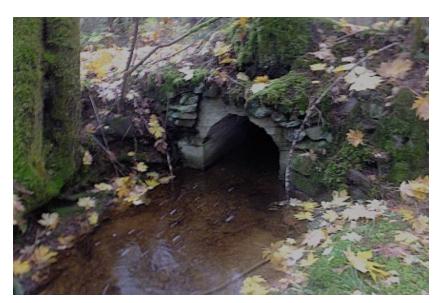
Below: Coats Marsh Creek flowing modestly at the culvert under the Marsh Trail.

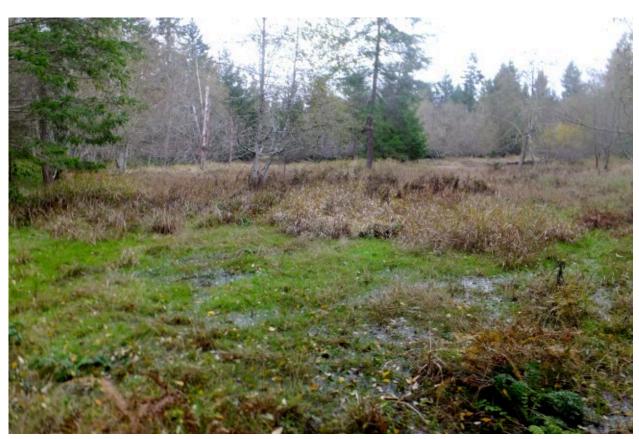
The NE Arm wetland. A squelchy solitude, not yet ready to shed surplus water.

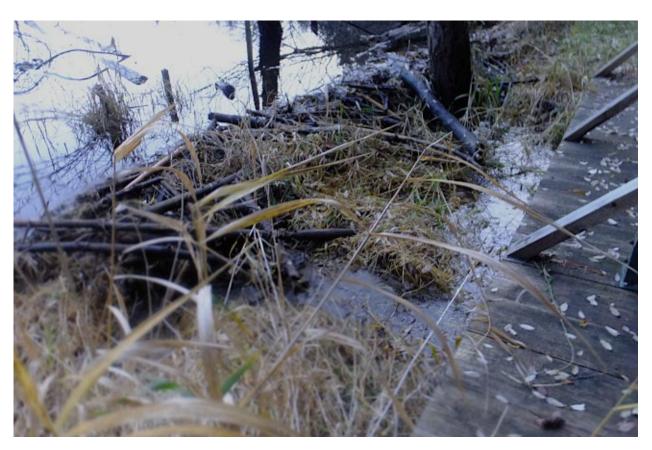
The debris/dam at the weir, December 8, 2023. More than one engineer been working on it?

Delta is the weirpool level less the sill water level, which is approximately the amount the beaver's dam/debris is allowing the level of the weirpool to rise. Delta is of course subject to alteration by the beaver and humans clearing away some of the dam/debris.

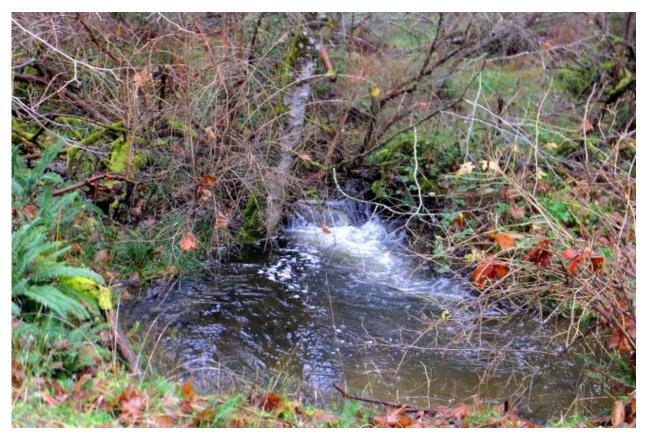
The last pool of upper Coats Marsh Creek. Known to be fish habitat despite conjectures by off-island experts to the contrary.

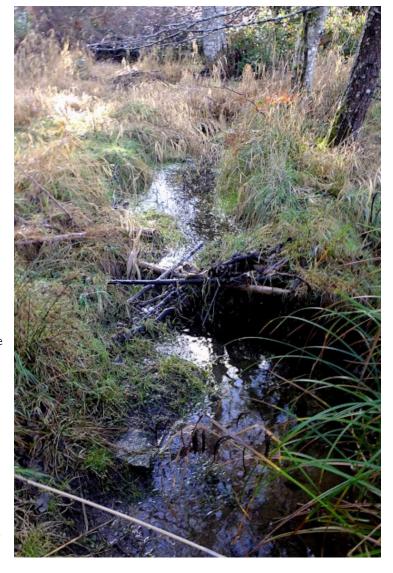
One interesting discovery was what appeared to be a drainage channel noted last summer when the lake water level was extraordinarily low (File: 673zc, p.ZC 544). On investigation today (there were no ducks

around), I found that this channel extends into the bush where it is obviously natural. The channel was ponded but no flow could be observed, even though EPC was flowing gently at the culvert; however, there was little doubt that at times this is a significant ephemeral watercourse. It and other smaller ones nearby appear to have attracted the beaver's passing interest.

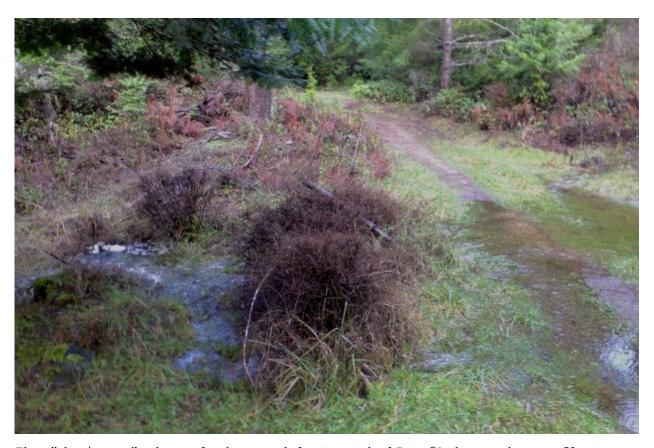
Heavy rain with passage of a cold-front overnight. EPC culvert full. NE Arm spillway (shown below) flooded with a flow over and under East Path comparable with that observed at the EPC culvert.
