COATS MARSH REGIONAL PARK

2011-2021 Management Plan

Ecological Features and Management Recommendations for
Coats Marsh Regional Park – Gabriola Island

Coats Marsh Regional Park Building Condition Report 2010

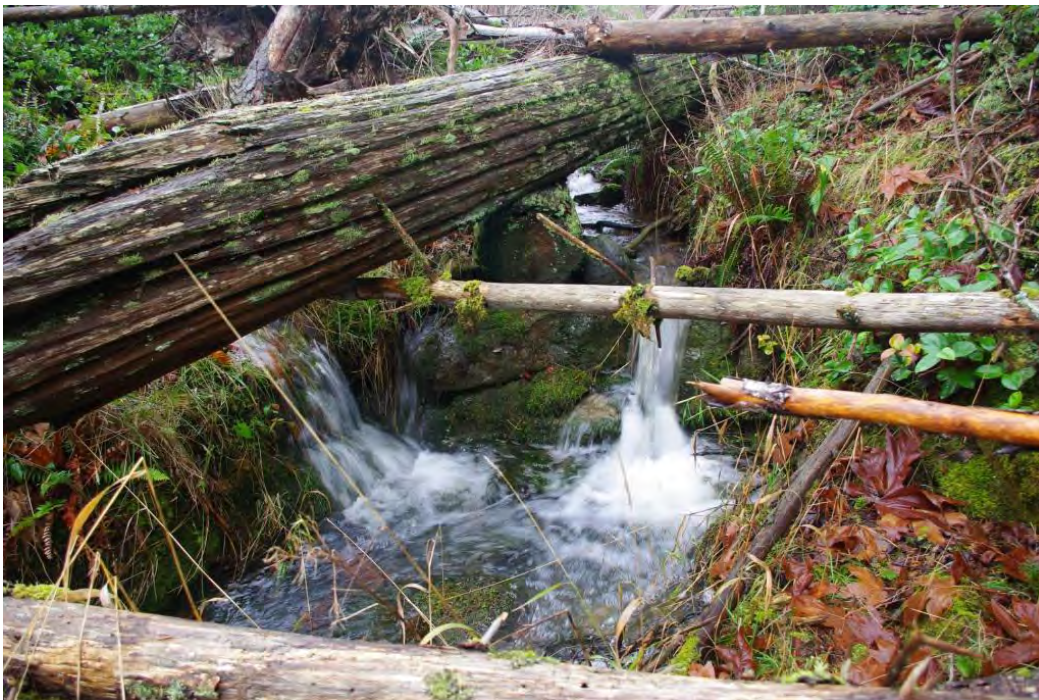
Photograph 6: View of a small rock fall along the Watercourse 1. It is at this point that the watercourse appears to switch between ephemeral and permanent.

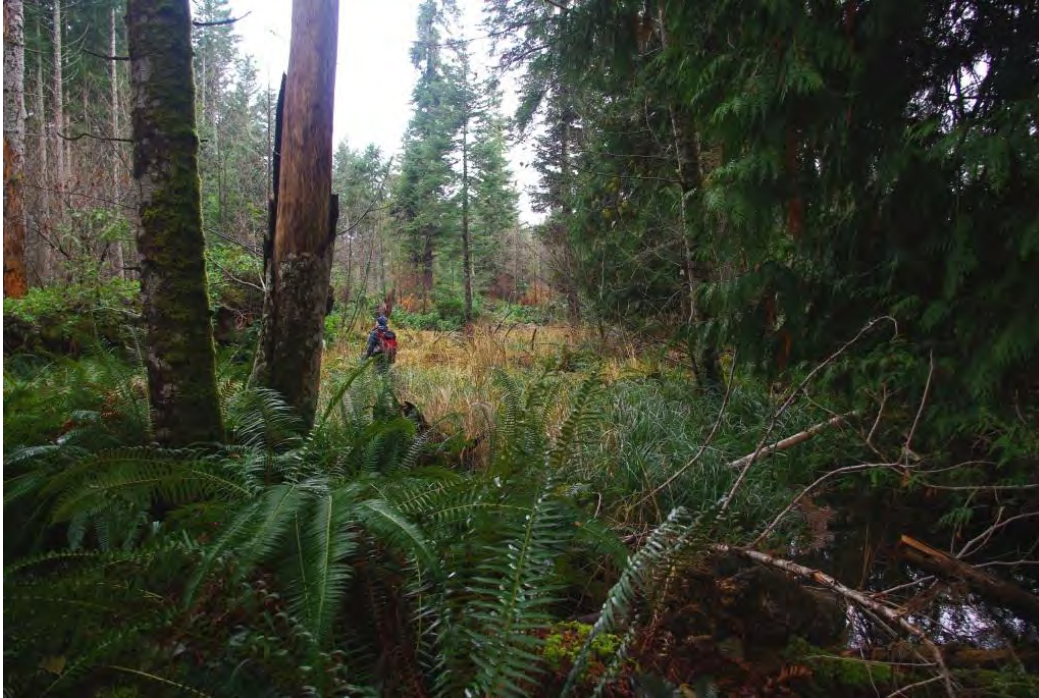
Photograph 7: Water catchment area near the west park boundary. High wildlife value

Downstream of the park road (Photograph 13), Watercourse 3 flows rapidly down a naturally steeper grade before joining Watercourse 1 in a shallow water catchment basin at the site of Photograph 7.

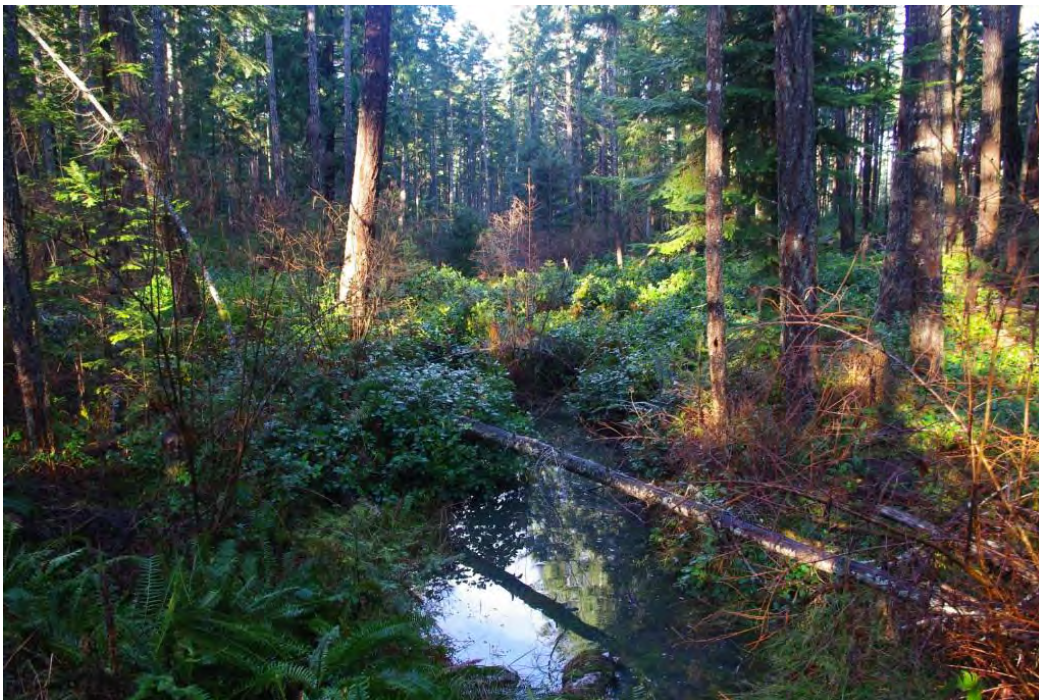
Photograph 8: Watercourse 2 looking downstream from the park road

Watercourse 2 flows from the east through most of the centre of the park. Its origin is separated from Watercourse 1 by what might be classified as a low terrace or is possibly an old dune. The landscape is a shallow swale. Water flow appears to be ephemeral and represents a high water table as much as a true watercourse. On the 17th of December, following a few days of rain, there were many shallow ponds ranging from 0.2m to 0.4m in depth (Photograph 8). In a few locations there was no sign of surface water.

- Much of the park south of Watercourse 1, including all of the area of Watercourse 2, appears to have been logged between 50 and 60 years ago (Photograph 8). It is naturally regenerating and would be classed as a Young Forest - self-thinning evident, canopy layers developed, generally 40 to 80 years (Table 2)

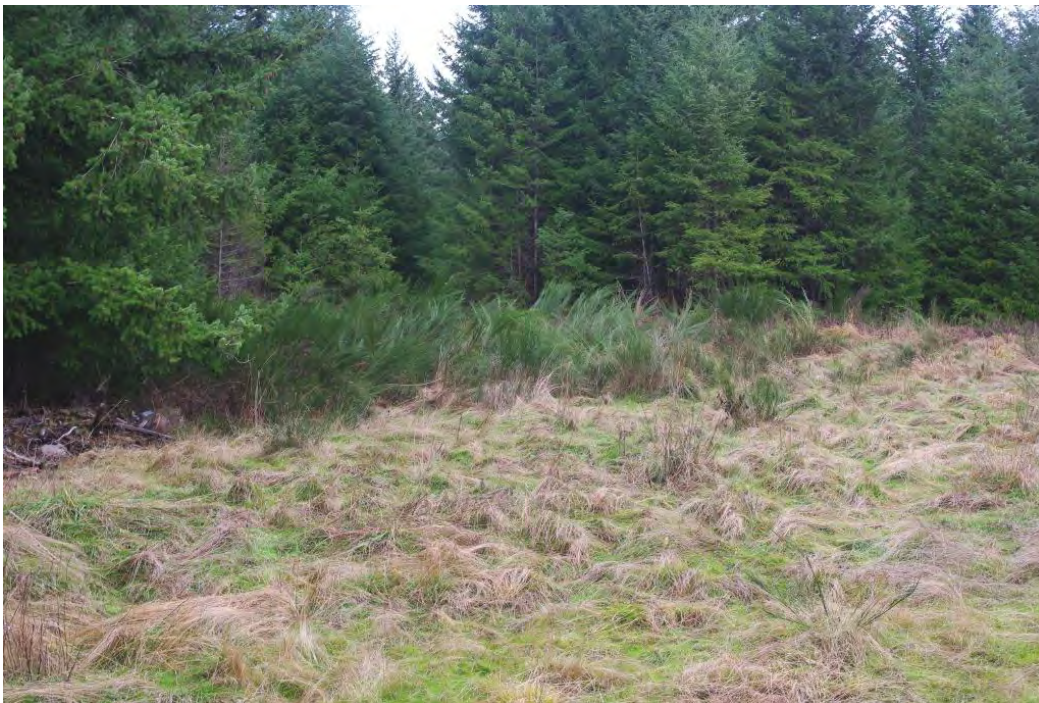
- Scotch Broom was observed as a few isolated plants along the roadways and in larger density within the two burn pile clearings (Photograph 16). In comparison to other sites, the infestation of scotch Broom would be considered very manageable. Scotch Broom becomes established when soil is disturbed. Tilling the soil and attempting to remove the roots may increase the problem. The accepted method for removal at this scale of site would be to cut plants off at ground level just as the plants have flowered but before seed pod production. If this is repeated each year for three to five years the scotch broom would likely be eliminated.

Photograph 16: Scotch broom along the edge of one of the Burn pile clearings.

- With most invasive plants, disturbance of the soil will lead to increased infestation. If the burn pile clearing are to remain as clearings, then regular mowing will likely keep the invasive plants in check. To return the burn pile areas to natural vegetation typical of the surrounding area, mechanical removal of invasive plants, as described below, coupled with the planting of native species will likely be successful.

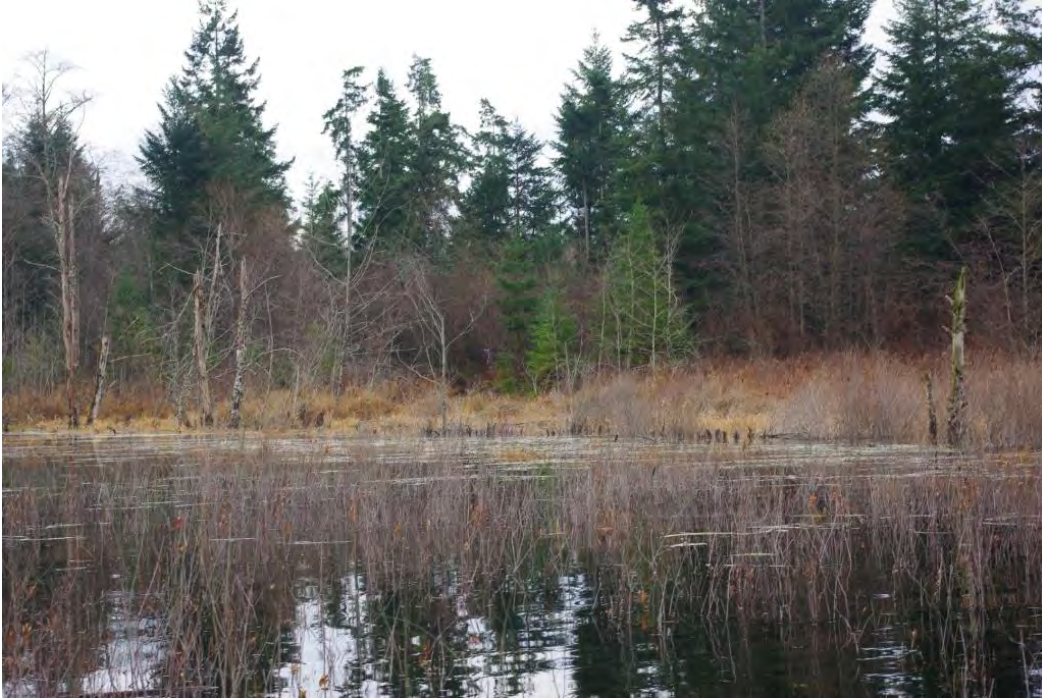
Photograph 19: The south-east portion of Coats Marsh in the vicinity of Aiden Road. Flagging at the park boundary is visible near the centre of the photograph.

- A section of boardwalk and a viewing platform off of Aiden Road (in the vicinity of Photograph 19) would offer excellent long views of the marsh area with good light aspects for photography (Map 6). If in the future a trail is planned around the east shore of the marsh it should be back from the open marsh and give the occasional pocket views. Ideally these viewpoints could be concealed such that they are not visible from each other.

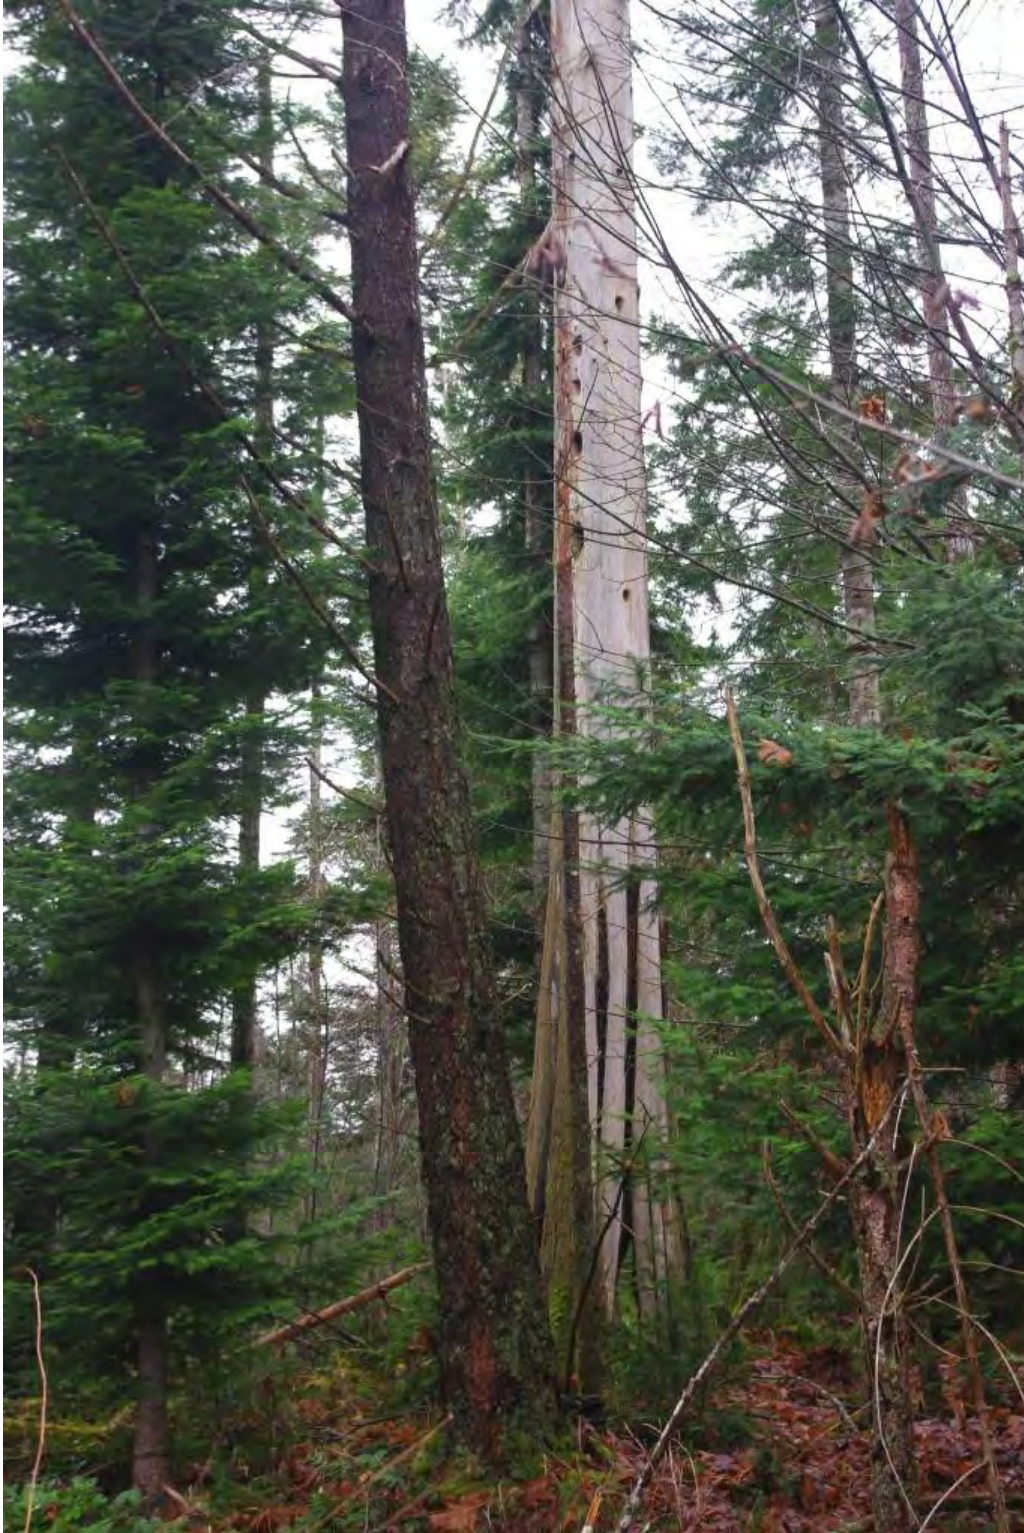
- Aside from the marsh, an area of high value avian wildlife habitat is shown on Map 4. This area has many dead or decaying trees that are very important to wildlife, especially cavity nesting birds and bats. Two trees are identified on Map 4, a cedar snag (Photograph 20) and a veteran Douglas fir (Photograph 21).

Photograph 20: Western red cedar snag/ wildlife tree

- The wildlife habitat area as shown on Map 4 has a large proportion of mature, dying, and dead alder and maple, plus a cedar snag and a veteran fir. All of these trees have high wildlife value. These trees are potentially more hazardous to park users than trees in most other area of the park. We suggest that this area not be identified on park maps

and that trails not be located in immediate proximity to this area. It would be best to not bring attention to this area and to leave it to the birds, bats and other wildlife.

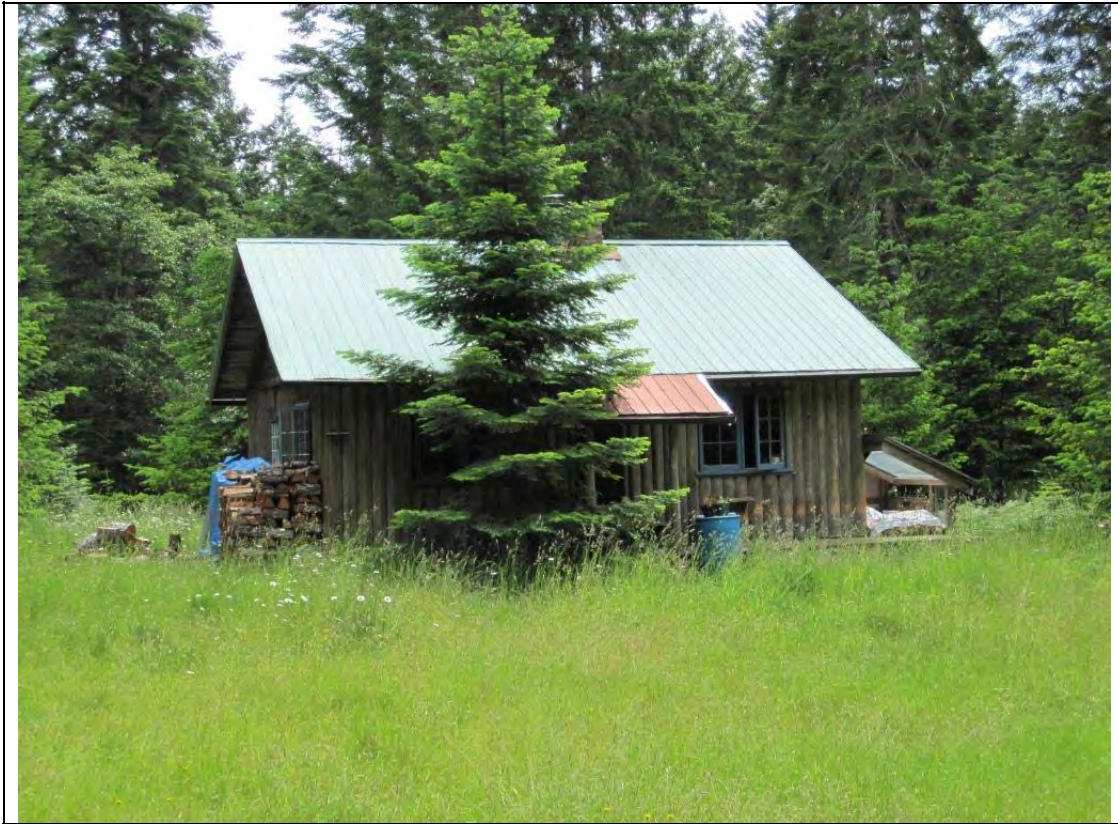
Building Name: Coats Marsh Regional Park Caretakers Dwelling

- Wood heat and Oil lamps present an increased fire hazard risk.
- Response time for Emergency vehicles may be hampered by location and site access conditions.
- Clearance and protection around and above the propane stove are inadequate and should be improved to at least minimum code requirements.

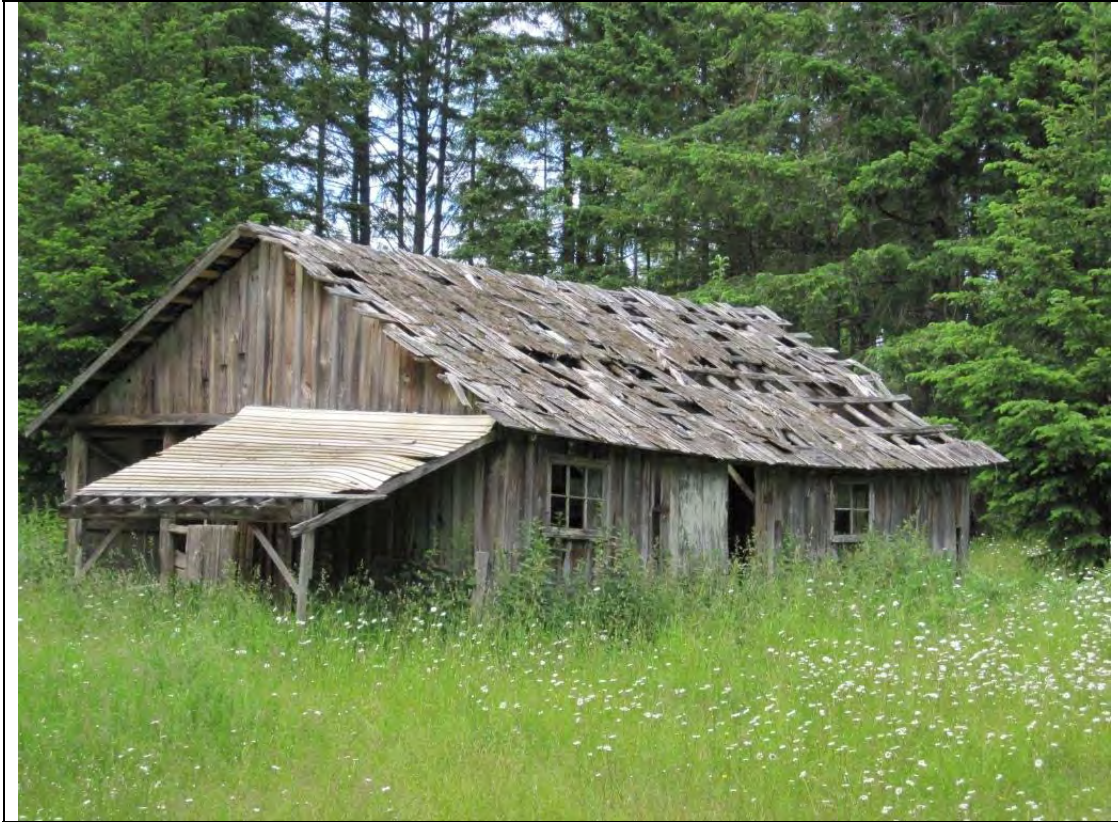
Building Name: Coats Marsh Regional Park Barn

The loss of structural integrity due to decay and deterioration will eventually reduce the buildings ability to resist environmental forces resulting in collapse.

This building is beyond a reasonable level of repair, and has no asset value.

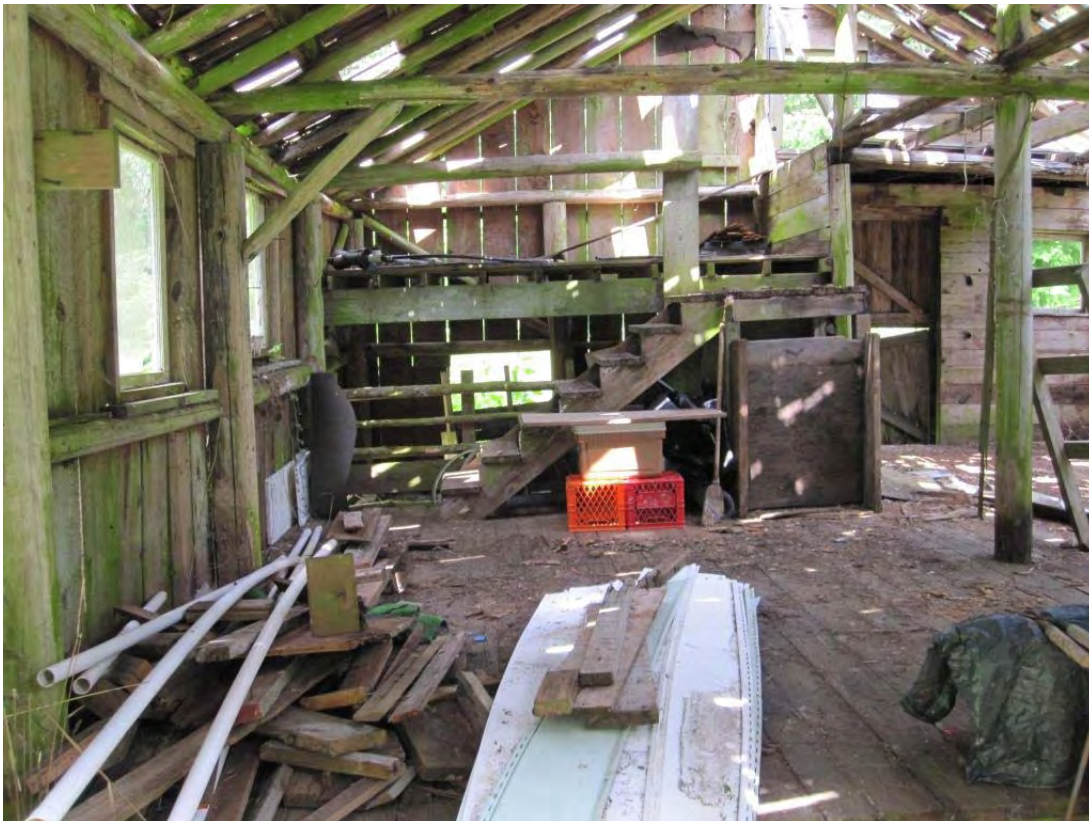
Interior view of barn.

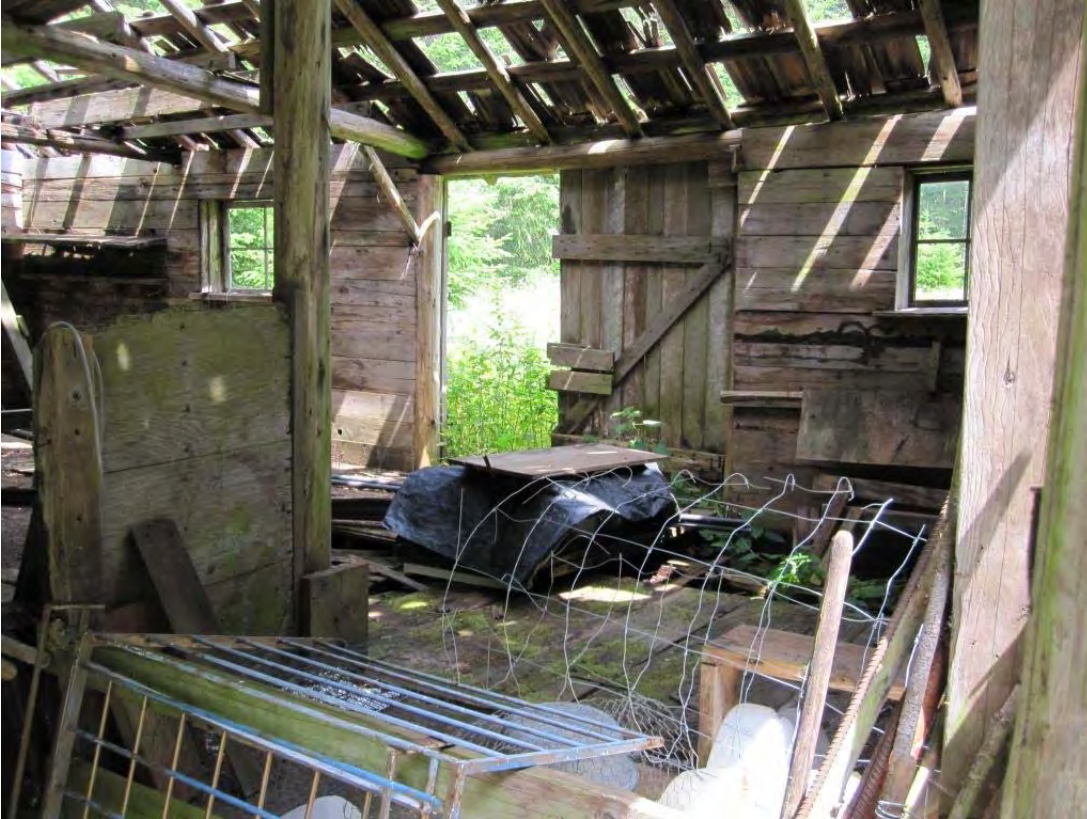
Interior view of Barn.

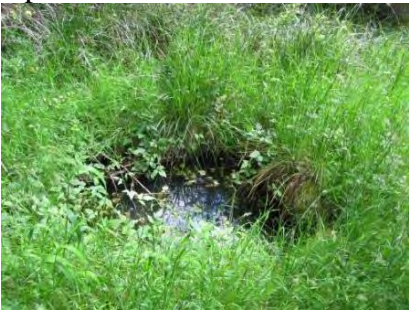
Open surface well at Coasts Caretakers House.
