**GABRIOLA ISLAND RIPARIAN AREA
REGULATION STREAM IDENTIFICATION
UPDATED REVISED VERSION FEBRUARY 24, 2012**

**Chloe Fox
Island Planner (Gabriola Island Local Trust Committee)
700 North Road, Gabriola Island, BC, V0R 1X3**

**Trystan Willmott, B.Sc. A.Sc.T.
Justin Lange, B.Sc., B.I.T., A.Sc.T.
MADRONE ENVIRONMENTAL SERVICES LTD.
1081 Canada Avenue, Duncan, BC, V9L 1V2**

February 24, 2012

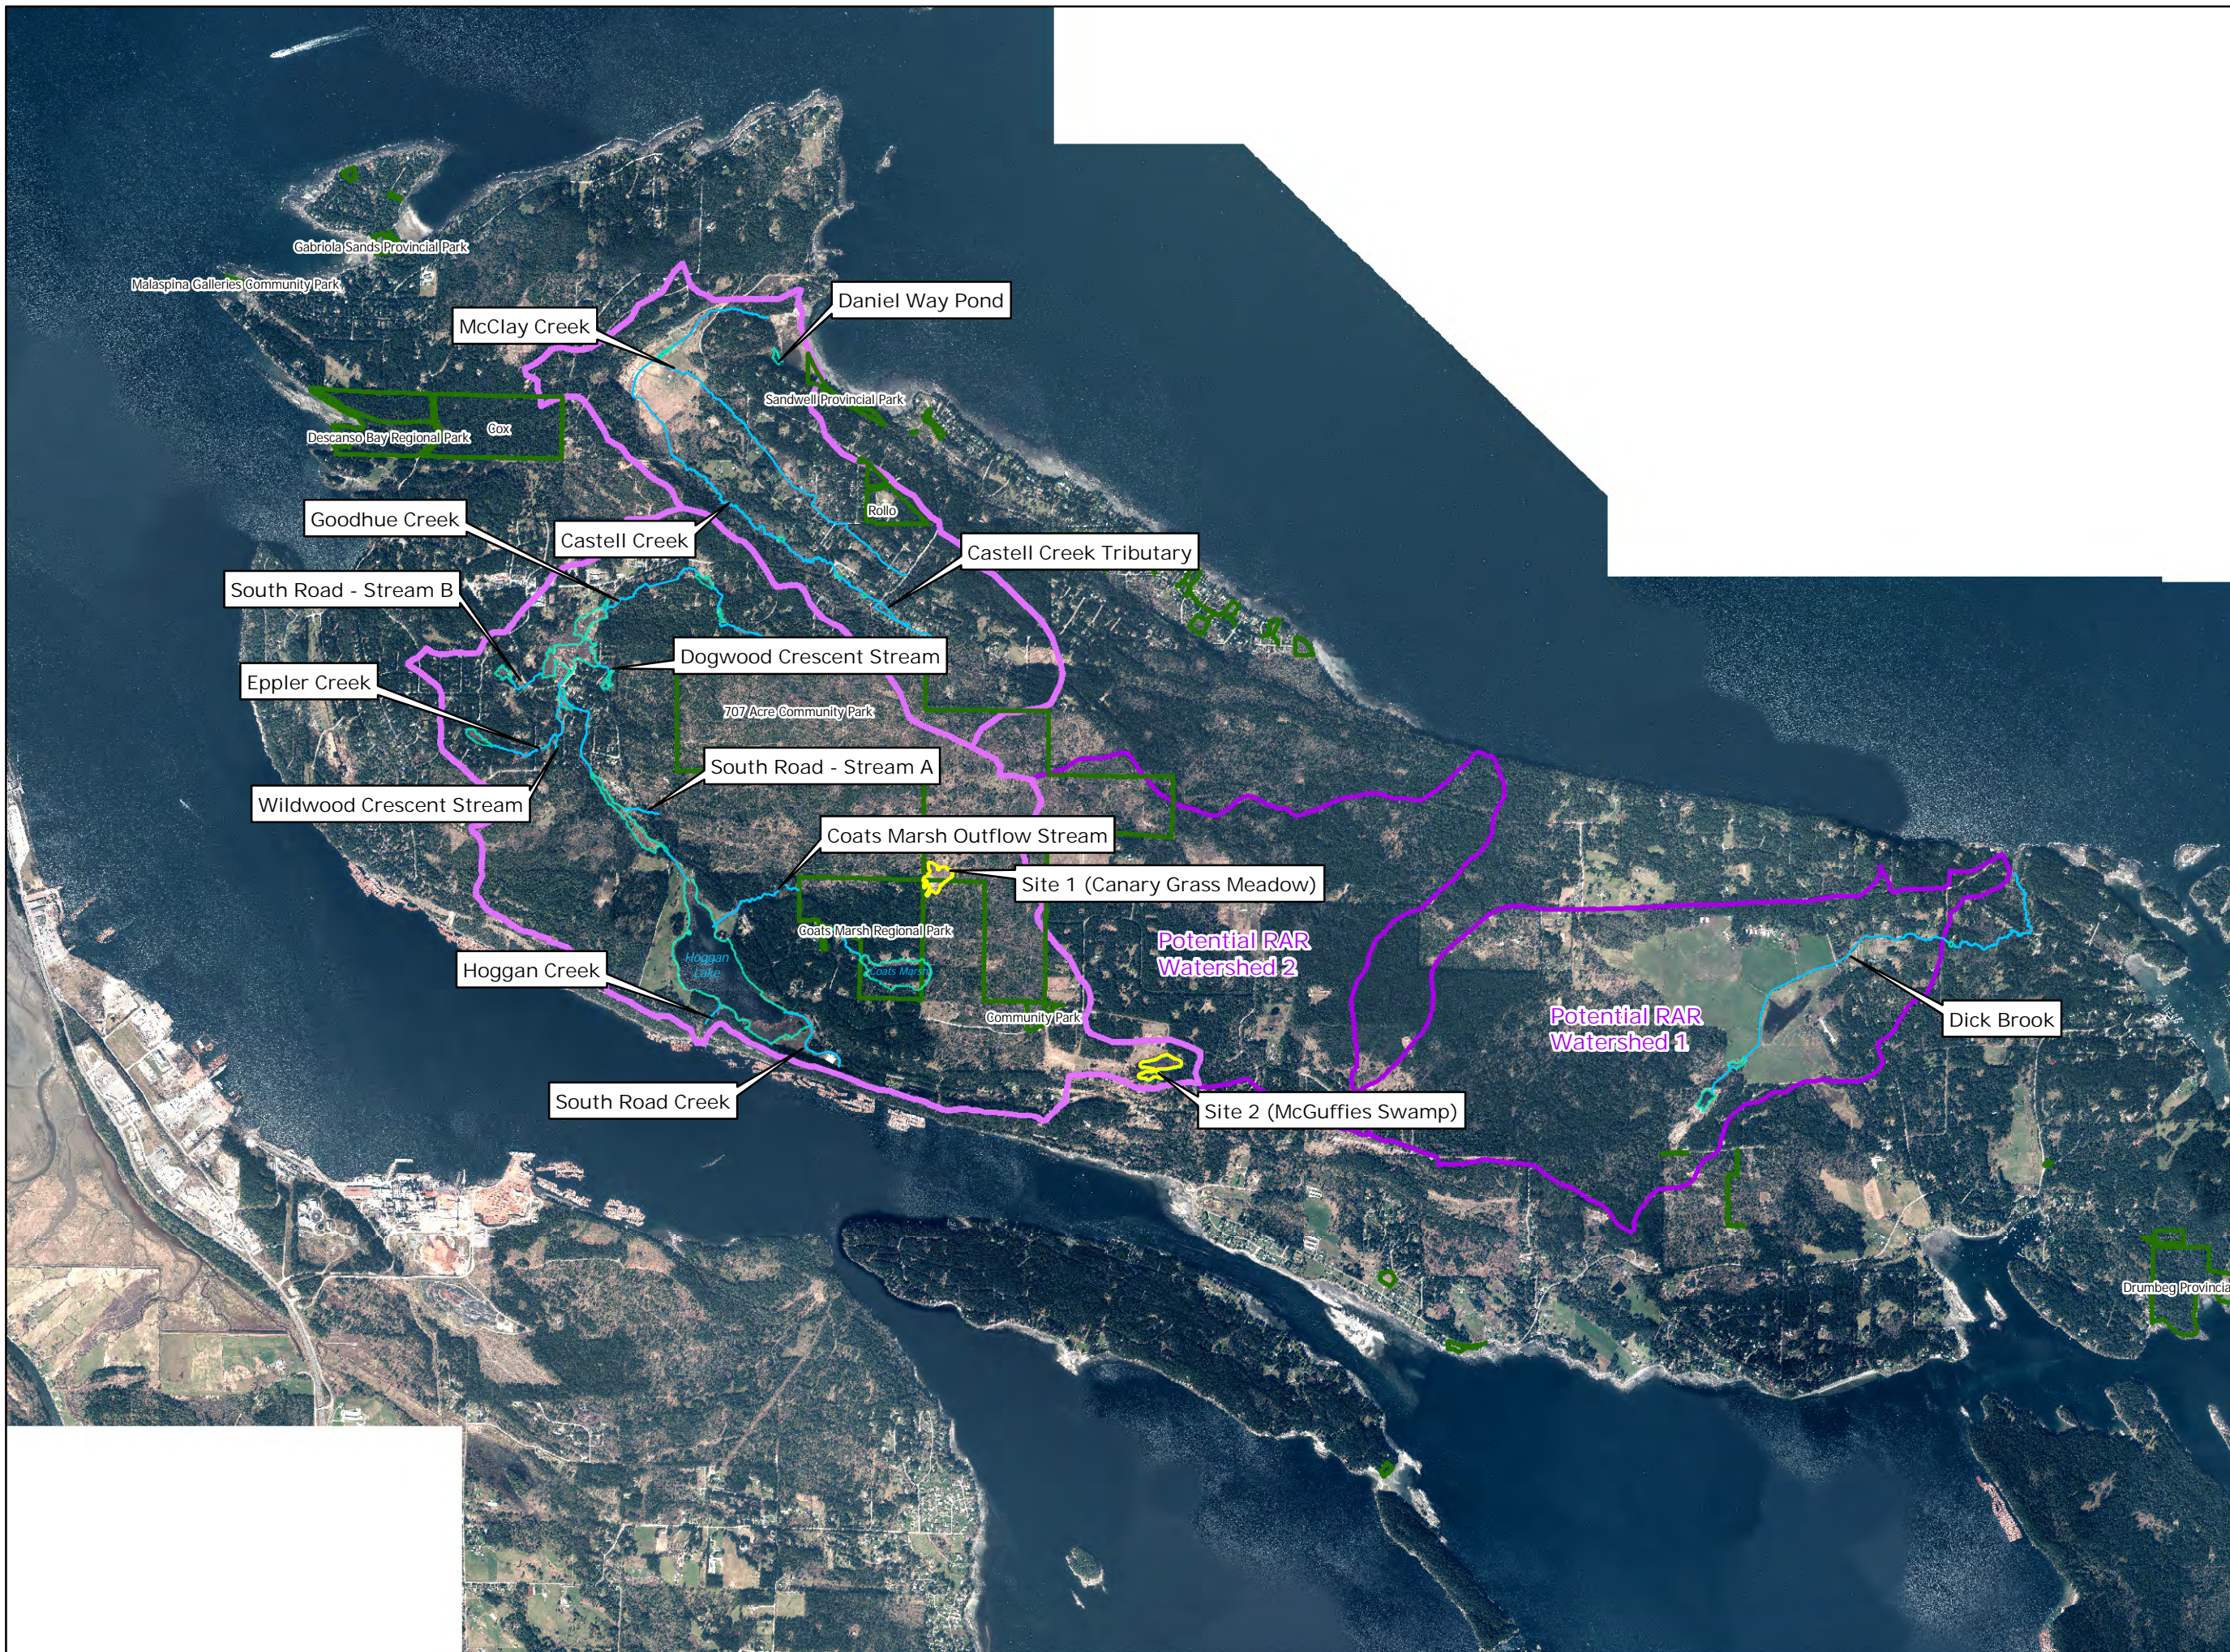
Figure 1:
Overview of RAR Applicable
Streams in Focus Watersheds

A focused search for additional drainages that do not apply to the RAR (e.g. isolated wetlands) did not form part of the scope of this assessment. Streams that apply to the definitions and methodology under the RAR in the identified watersheds (Figure 1) were included in the study. Isolated wetlands encountered during the assessment did result in the identification of two additional sensitive sites. Site 2 (McGuffies Swamp) has been identified as a sensitive ecosystem as part of the SEI. Both sites represent candidates for protection through Islands Trust bylaws. Further work is recommended to ensure that wetland and riparian ecosystems are identified throughout the island, which should also include watersheds beyond those which formed the focus of the RAR stream identification.

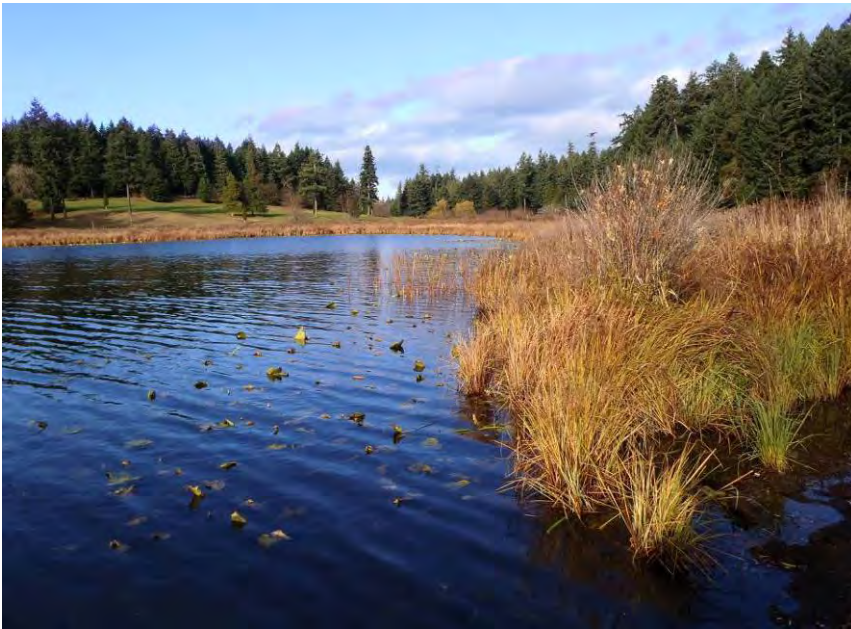
Looking north east over Hoggan Lake from the point where Coats Marsh outflow stream enters the lake.

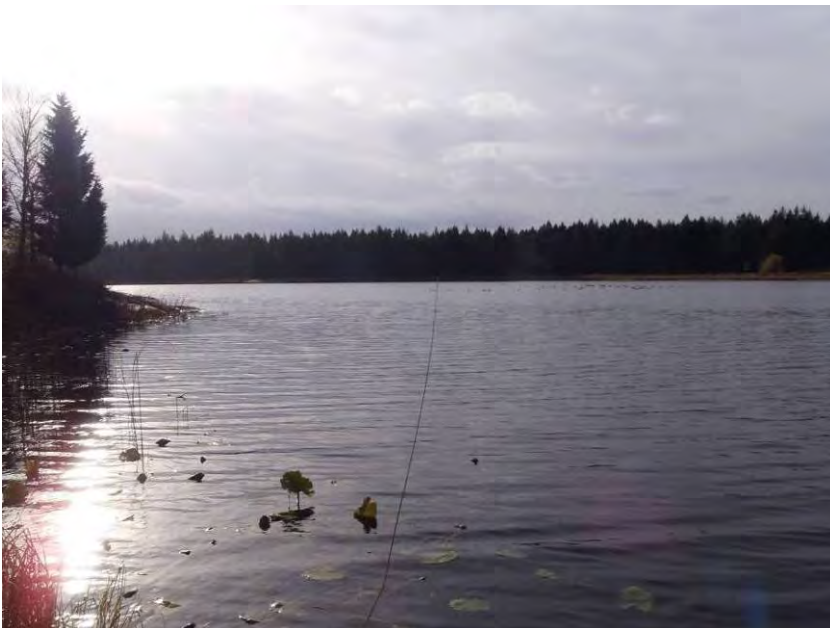
Looking south west over Hoggan Lake from the point where Coats Marsh outflow stream enters the lake. Note raft of trumpeter swans on the lake.

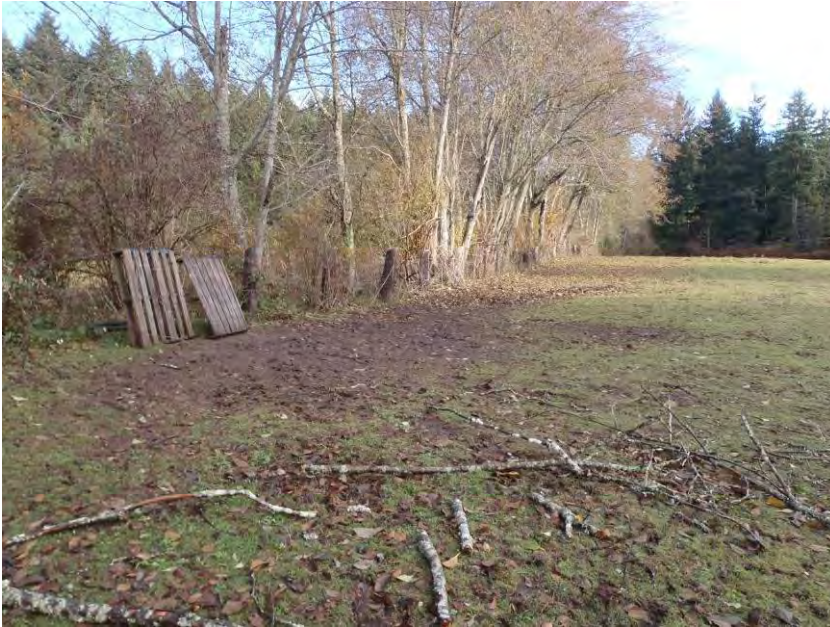
Looking upstream (north) over the fringe of riparian vegetation adjacent to the stream immediately upstream of the confluence with Hoggan Lake.

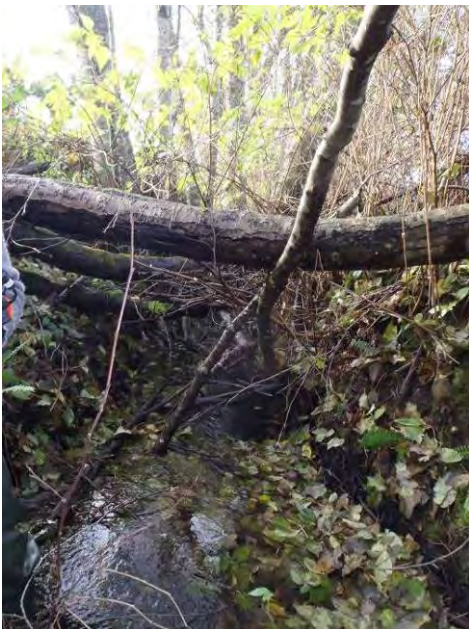
There is the potential for fish to access the lower portion of the stream, due to the direct connectivity with Hoggan Lake. Fish habitat attributes are extremely limited, however, based on the historical straightening of the channel. The side-walls of the ditch are steep, with evidence of erosion from high, concentrated flows. The substrate is comprised mainly of organic material, although short sections of alluvial deposits also occur.

Typical characteristics of the lower reach of the stream. Note lack of natural sinuosity and high sided, eroded banks.

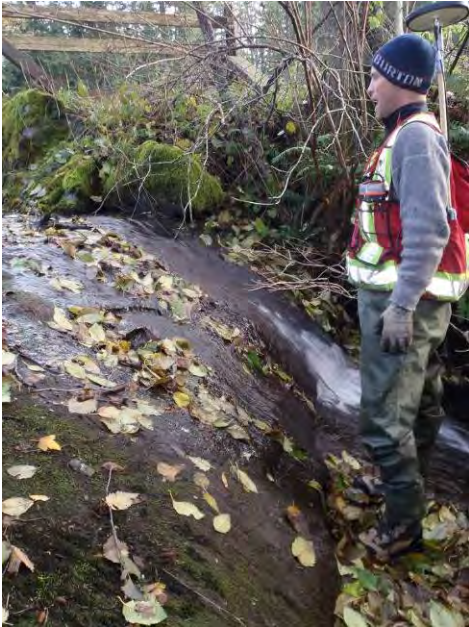
Approximately 50 m from the lake, a bedrock step represents a barrier to the upstream movement of fish. Based on the length and gradient of the step, there is no reasonable potential for fish originating from the lake to pass upstream of this point. The step consists of a drop of 50% over a distance of more than 2 m. Immediately downstream of South Road, the stream exhibits more of a natural channel, with meanders and deposits of sand and gravel occurring.

Bedrock step located downstream of South Road. Resident fish from Hoggan lake would not be able to move upstream of this feature. The gradient is too steep, no plunge pool exists and the water is shallow and fast over the smooth bedrock.

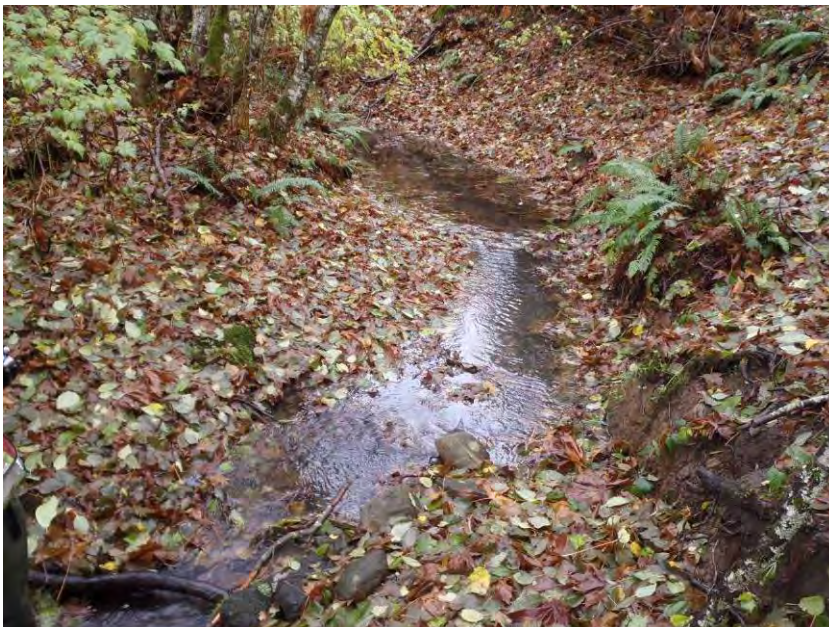
Looking north (upstream) along the stream immediately downstream of South Road. Note the limited degree of sinuosity.

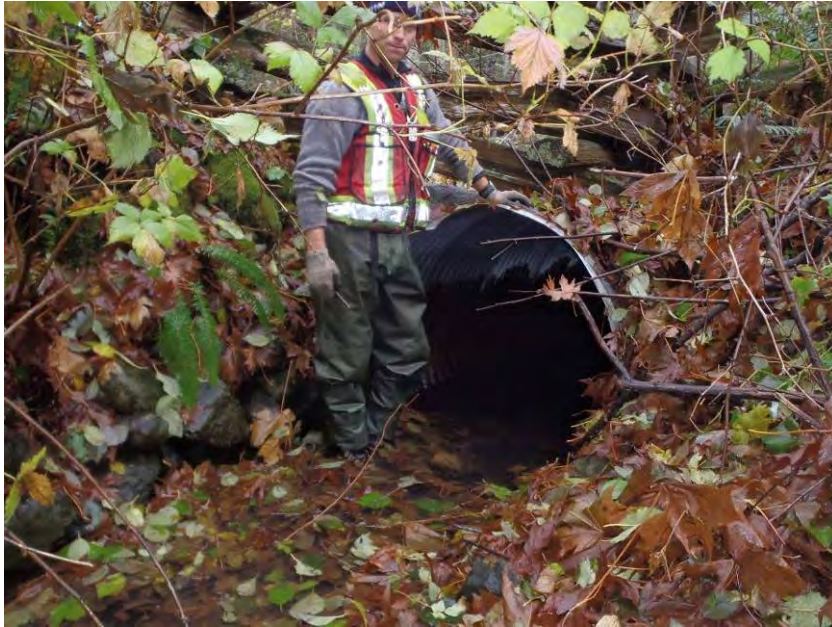
Outflow of the culvert under South Road.

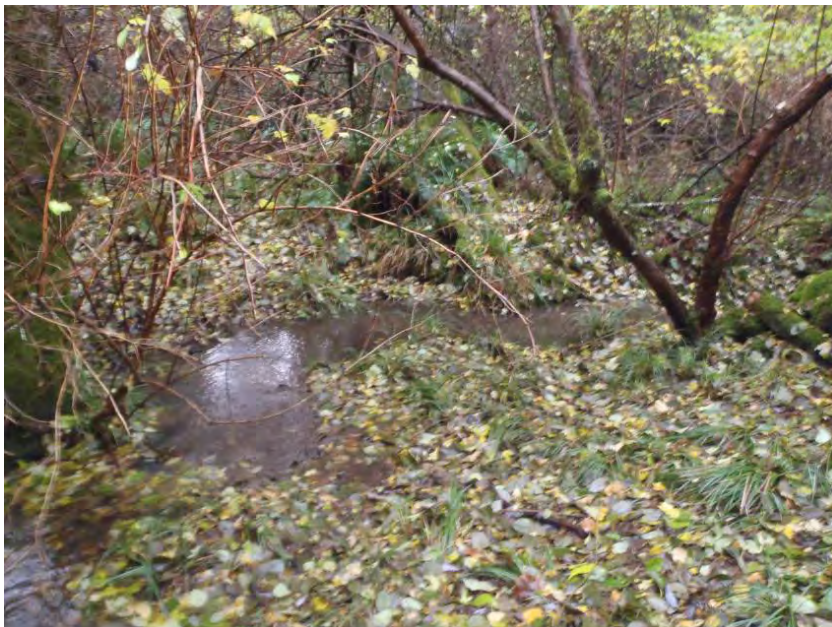
Above and below: typical conditions of the Coats Marsh outflow stream to the north (upstream) of South Road. Note general lack of channel definition.

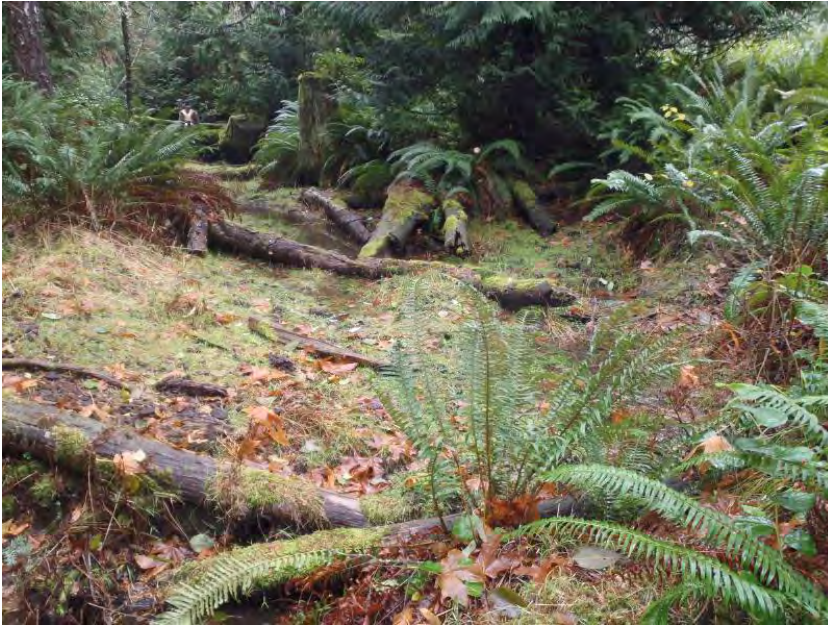
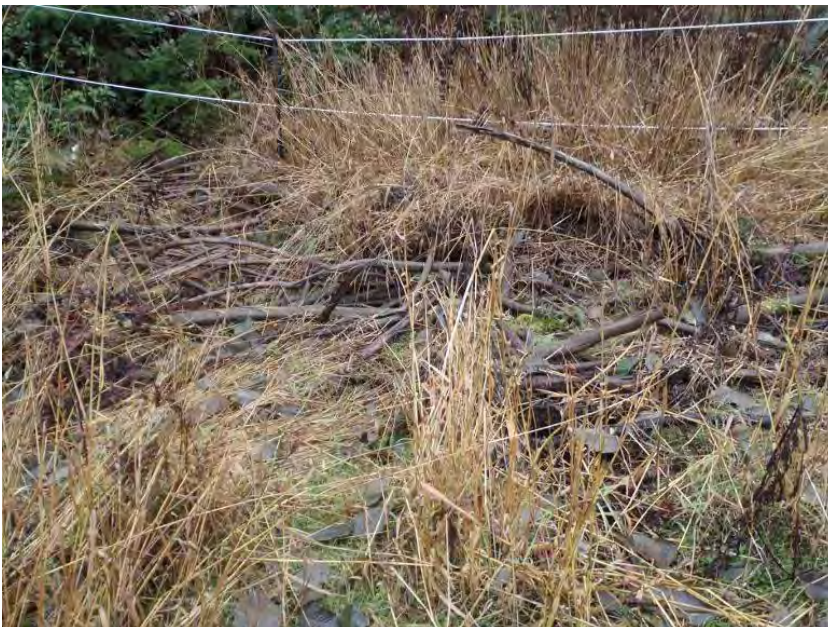
Approximately 100 m upstream of South Road, the watercourse becomes poorly defined over an organic substrate through patchy slough sedge and skunk cabbage. At the Coats Marsh park boundary, the watercourse becomes extremely poorly defined for a distance of approximately 70 m, with minimal seepage over an organic substrate. In this area, connectivity by surface flow would only occur during very high flows.

Above and below: extremely poorly defined characteristics of the stream at the point where it crosses the Coats Marsh park boundary.

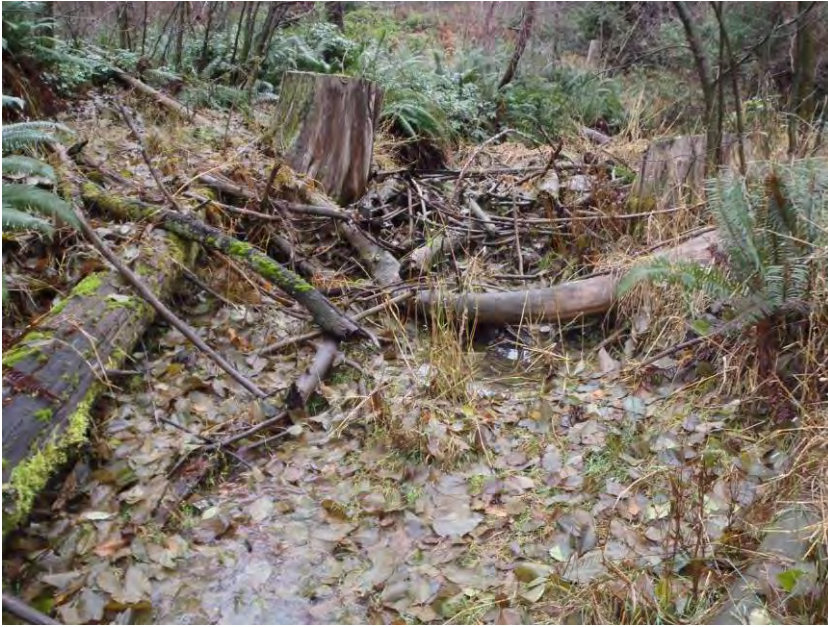
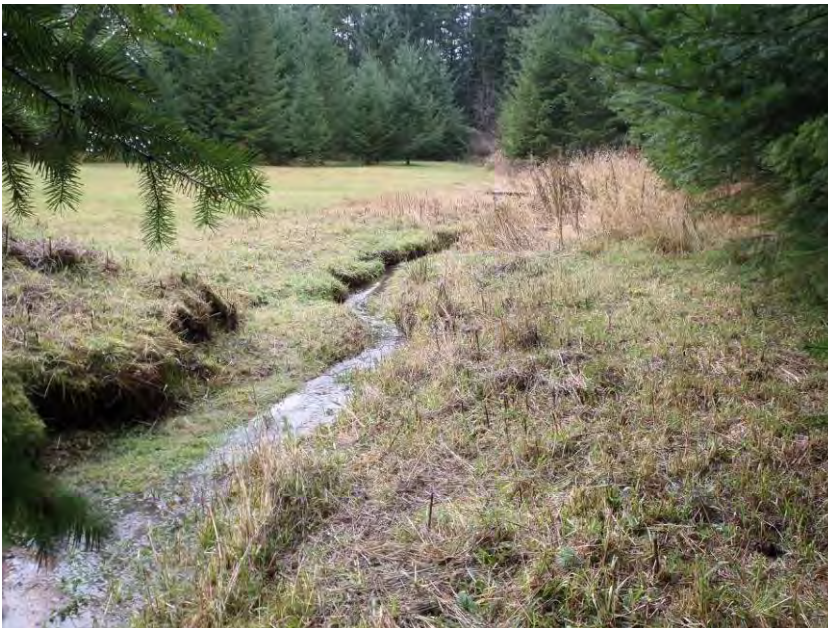
Looking downstream (north west) along the stream where it flows through residential property after emerging from the Coats Marsh park area.

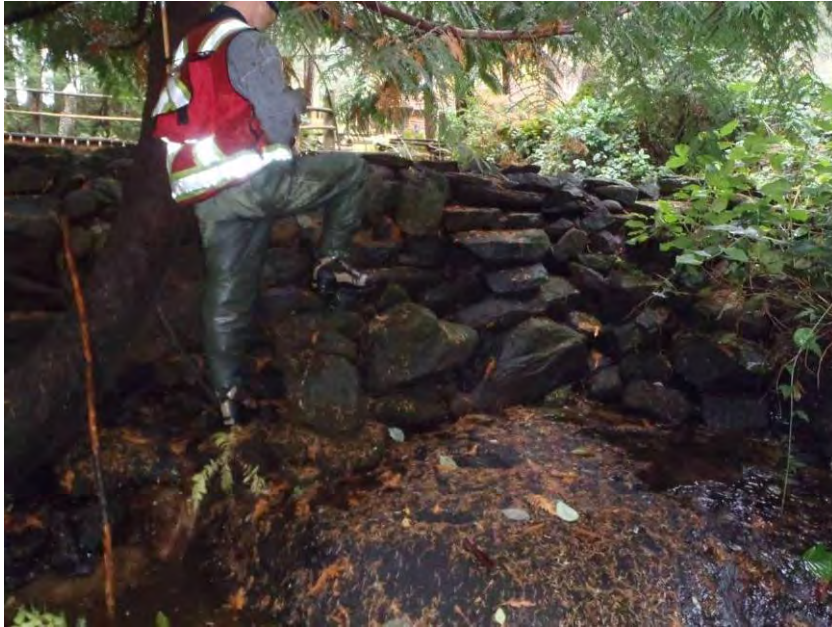
Beyond the park boundary, the stream flows as a well defined ditch adjacent to residential property. A rock wall/dam has been constructed approximately 100 m downstream of Coats Marsh, which backs up the water to form a pond. Water seeps through the rock wall and there is no weir or control structure. From the eastern edge of the pond, the stream continues as a well defined, high sided channel constructed through bedrock to Coats Marsh. The outflow from Coats Marsh is via a concrete weir structure and pond leveller device, which has been placed through an active beaver dam located at the outlet.

Constructed rock dam located on residential property downstream of Coats Marsh.

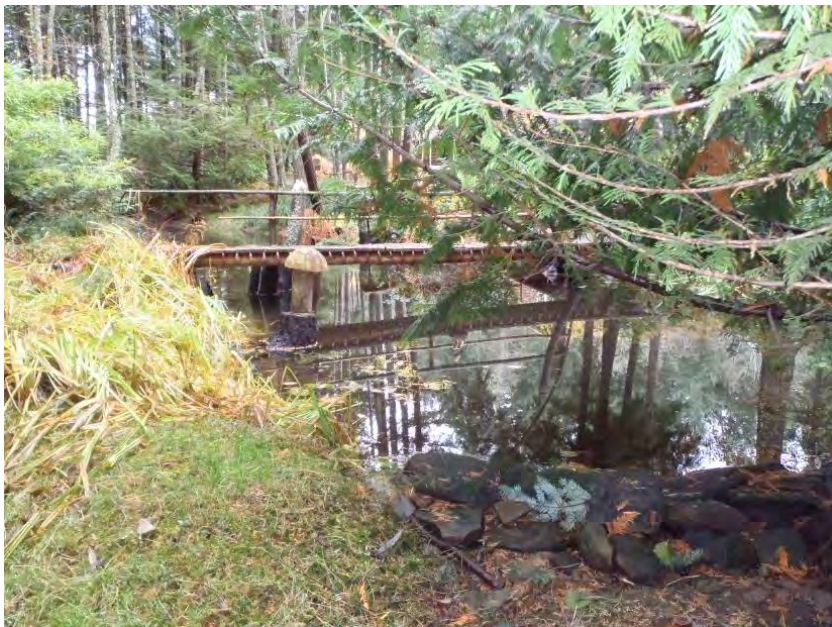
Looking south east over the pond created by the rock dam pictured below.

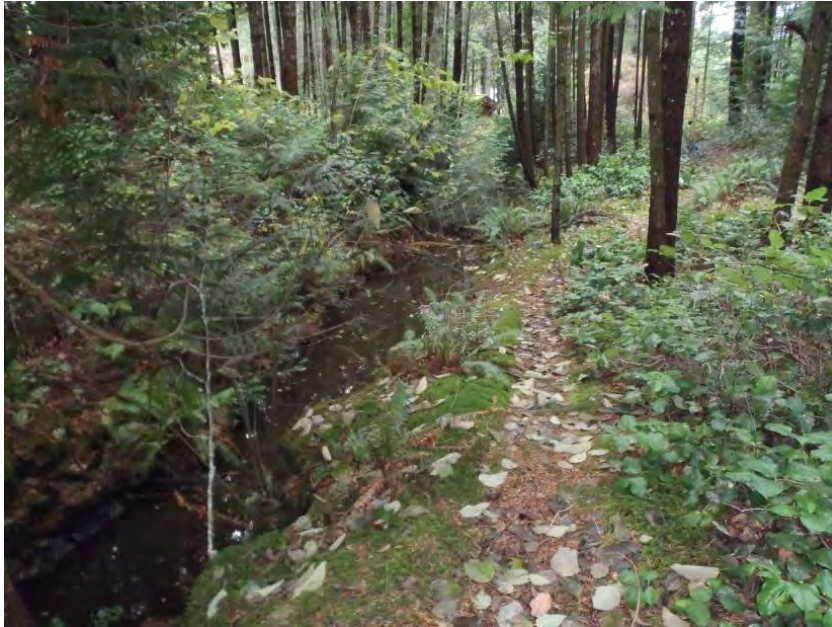
Looking downstream (north west) along the Coats Marsh outflow stream immediately below Coats Marsh. Note lack of natural sinuosity, resulting from historical straightening activities.

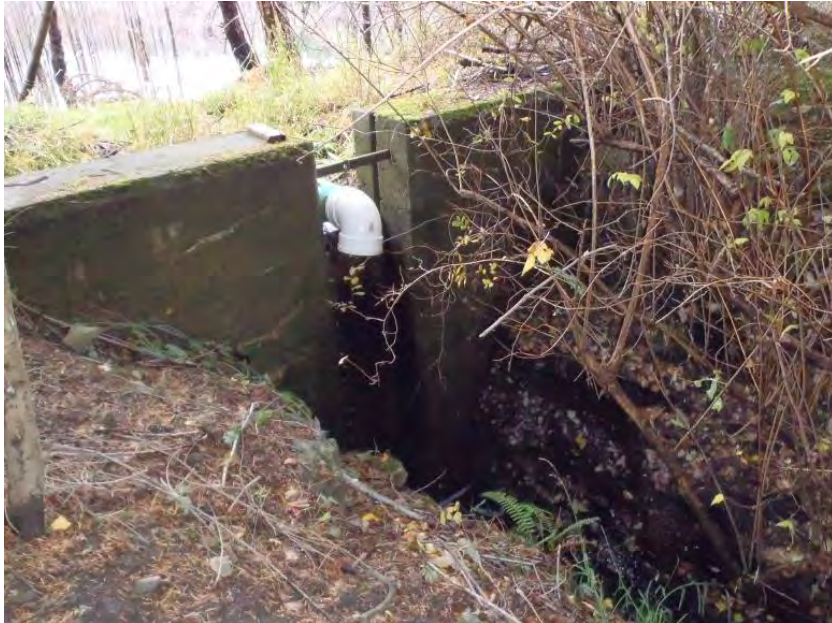
Weir and pond leveler representing the origin of the Coats Marsh outflow stream.

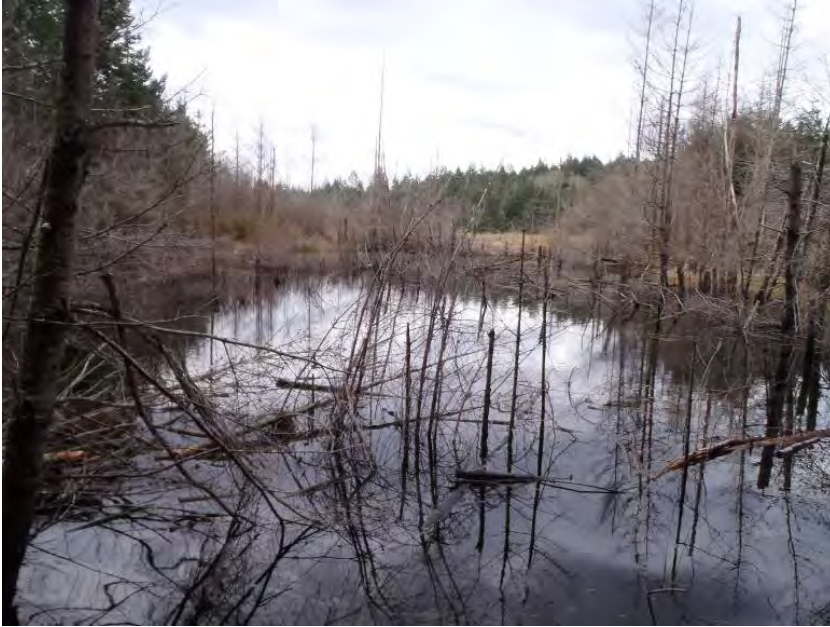
Looking east over Coats Marsh. Note recent inundation of the wetland margins, likely caused by the action of beavers at the main outlet.

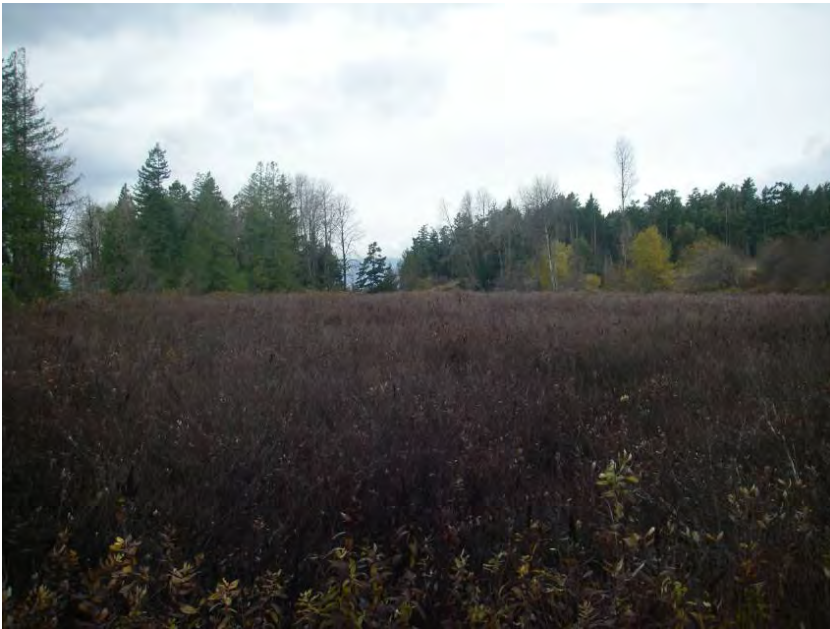
Site 2 – McGuffies Swamp

Looking south over the dense hardhack vegetation typical of the Site 2 wetland.
