## **REQUEST FOR PROPOSALS No. 22-064**

### **Coats Marsh Replacement Weir Elevation Study**

## **POST CONSTRUCTION REPORT - COATS MARSH FLOOD PROTECTION BERM**

**September 12<sup>th</sup> 2013**

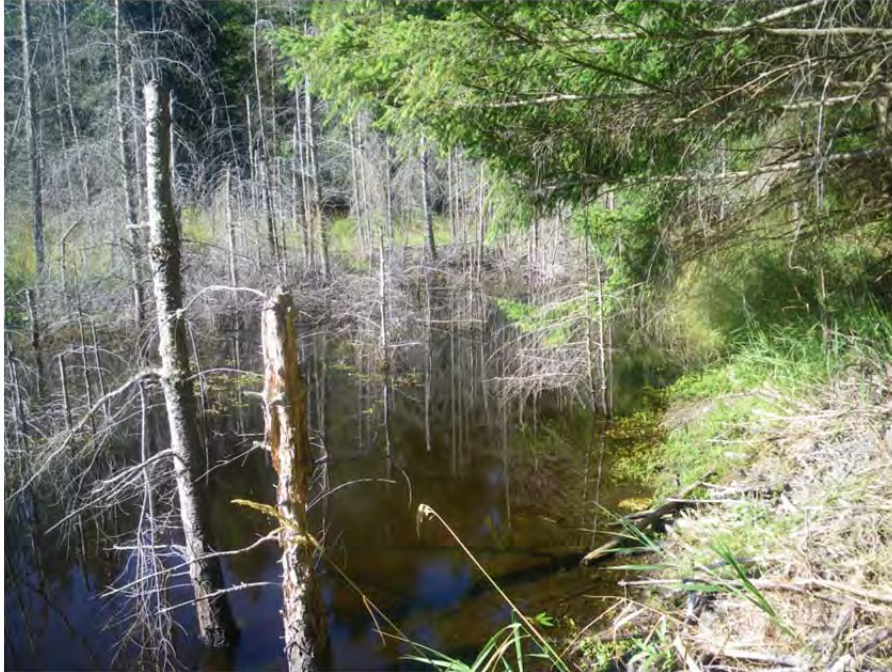
Looking south across the berm construction footprint prior to the beginning of construction.

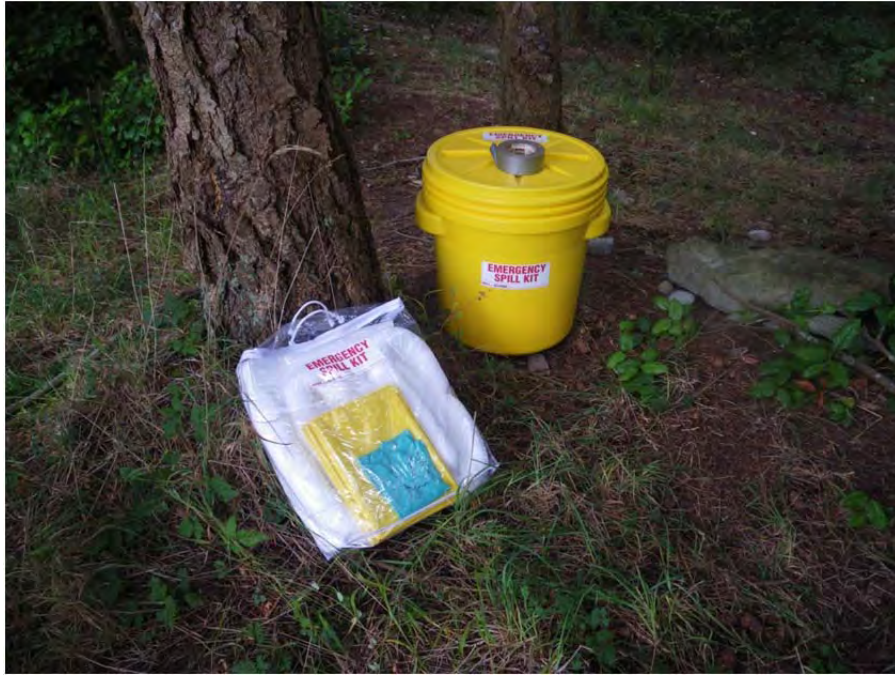
Adequate spill kits in central location on site.

As per the EMP, an adequate spill kit was located on site, in an easily-accessible location. The excavator and backhoe that were on site were clean and free from leaks, and the contractor confirmed that the hydraulic fluid in the machines had been changed to a non-toxic biodegradable product.

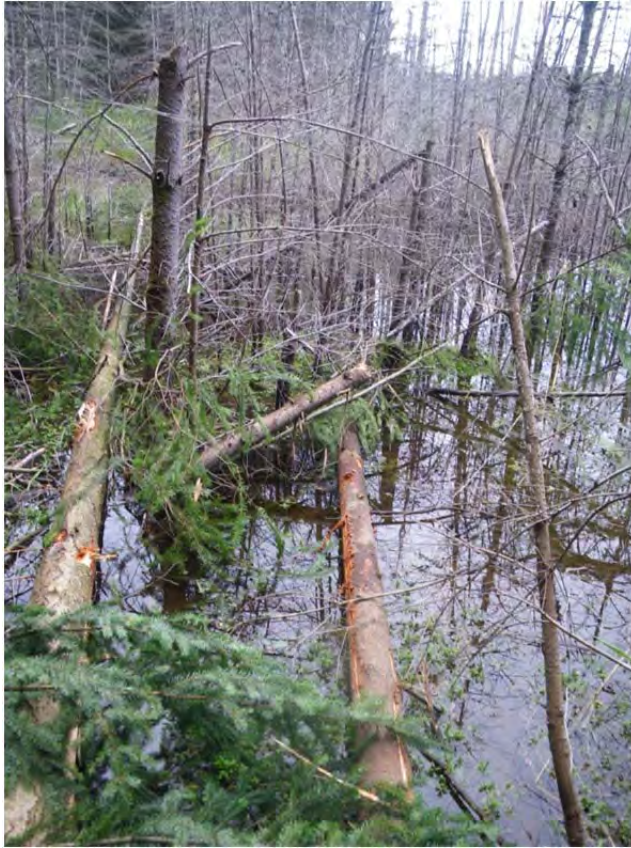
Two Douglas-fir trees removed to allow machine access placed within wetted edge of the wetland. These trees will provide cover/security habitat for amphibians.

Two Douglas fir (*Pseudotsuga menziesii*) trees had been removed from the riparian area to the north of the weir to allow adequate maneuvering space for machinery. These trees were approximately 20 cm Diameter at Breast Height (DBH) and had been placed into the wetland, as requested, with root wads attached. The trees will provide cover and security habitat for amphibians around the margins of the wetland. The configuration of the northern end of the berm had been modified during the previous onsite meeting to avoid removal of a significant Douglas fir from the riparian zone.

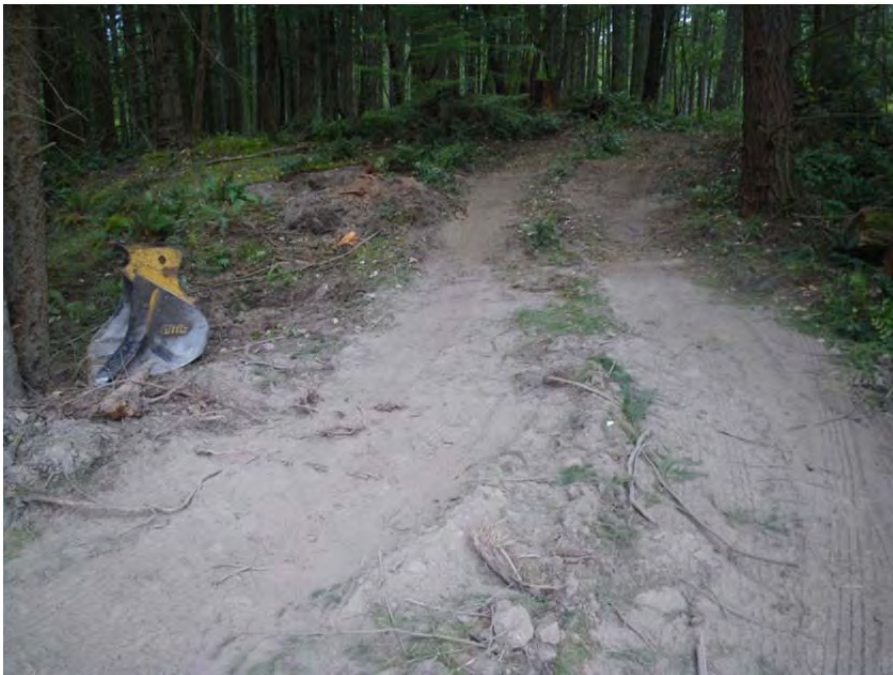
Surface of access road following use by excavator, backhoe and dump truck.

Operations associated with construction of the berm began on August 14<sup>th</sup> 2013. In addition to the contractor, Trystan Willmott, Bruce Grayson (Madrone), David Palidwor and Chris van Ossenbruggen (RDN) were also present. The access road down to the site followed an existing old road bed vegetated with low growing salal (*Gaultheria shallon*). No grubbing had occurred on the access road, with machines running over the vegetated surface.

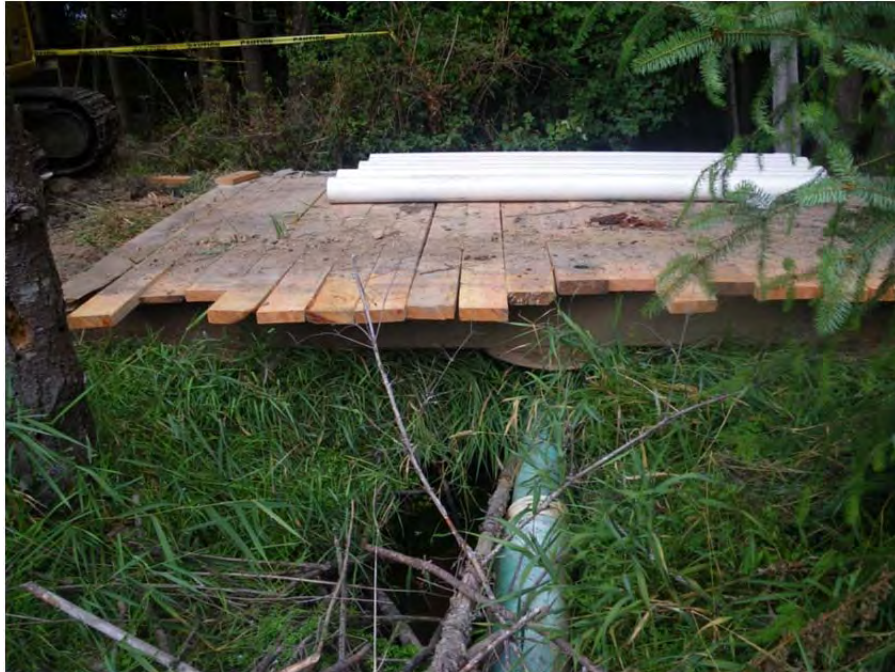
Clear-span steel girder/timber bridge place over outlet drainage and pond leveler pipe to allow machine access.

It was noted that site access over the weir/outlet drainage had been achieved through the placement of clear-span steel girders and heavy wooden timbers at the terminus of the access road. The banks and channel of the outlet drainage remained undisturbed, due to the fact that the access bridge spanned from bank to bank.

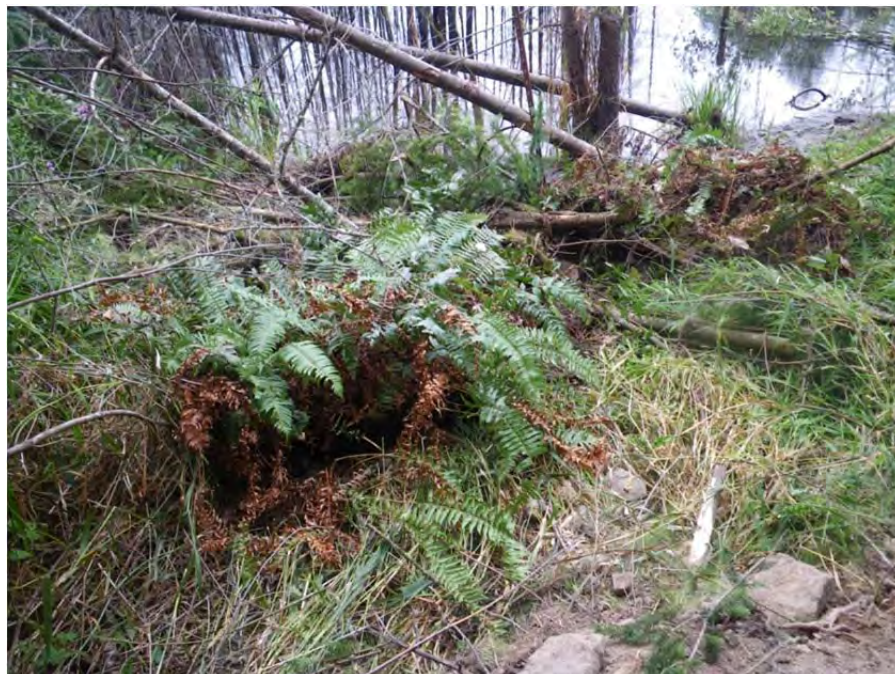
Clumps of vegetation removed by excavator during clearance of fill stockpile area set aside to allow potential for regeneration from root stock.

An area of approximately 10 m<sup>2</sup> had been cleared at the end of the access road to provide an area for machine turn around and also to allow for the stockpiling of fill material. Prior to being cleared, this area consisted of low growing shrubs, dominated by salal, with sword fern (*Polystichum munitum*) also occurring. As requested, the vegetation and topsoil were “peeled” off this cleared area and placed nearby, to allow for potential regeneration of the removed vegetation from root stock.

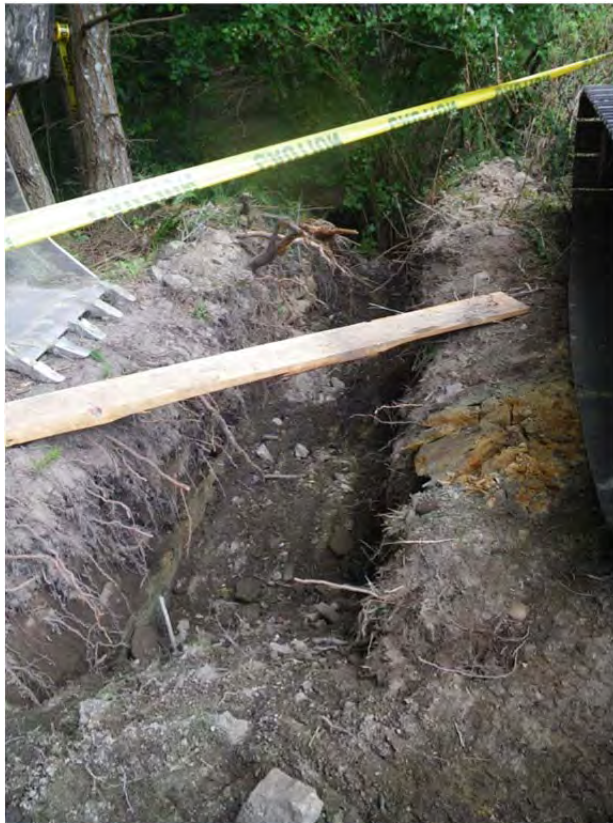
Trench constructed for drainage pipe, connecting to Coats Marsh outflow watercourse downstream of concrete weir.

A trench had already been constructed for installation of the PVC pipe to be installed on the landward side of the berm, which would drain to the Coats

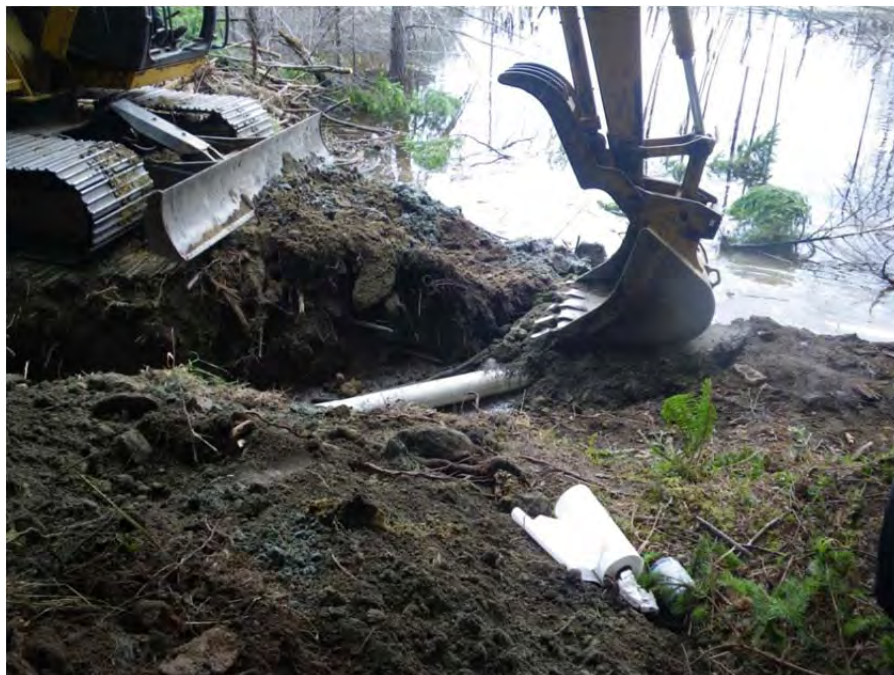
Backfilling trench following breaching of plug at wetland end of the trench and placement of drainage pipe.

The inlet side of the pipe (end capped) was placed into the wetland in the area that was to be on the landward side of the berm. Placement of the drainage pipe necessitated the breaching of the wetland edge at the end of the trench. Removing the “plug” resulted in turbid water flowing through the trench and into the outlet drainage. After removing the plug, the pipe was set at the correct elevation, and material was quickly placed back over the pipe, thus sealing the temporary breach.

Removing the plug, placing the pipe and re-sealing the breach took approximately 2 minutes. During this short period of time, turbid water flowed into the Coats Marsh outlet drainage, but was effectively contained within the ponds on the subject property. Based on the time of year, the outlet drainage was completely dry immediately downstream of the ponds, which prevented any of the turbid water flowing further downstream. Following installation of the pipe, the trench was backfilled.

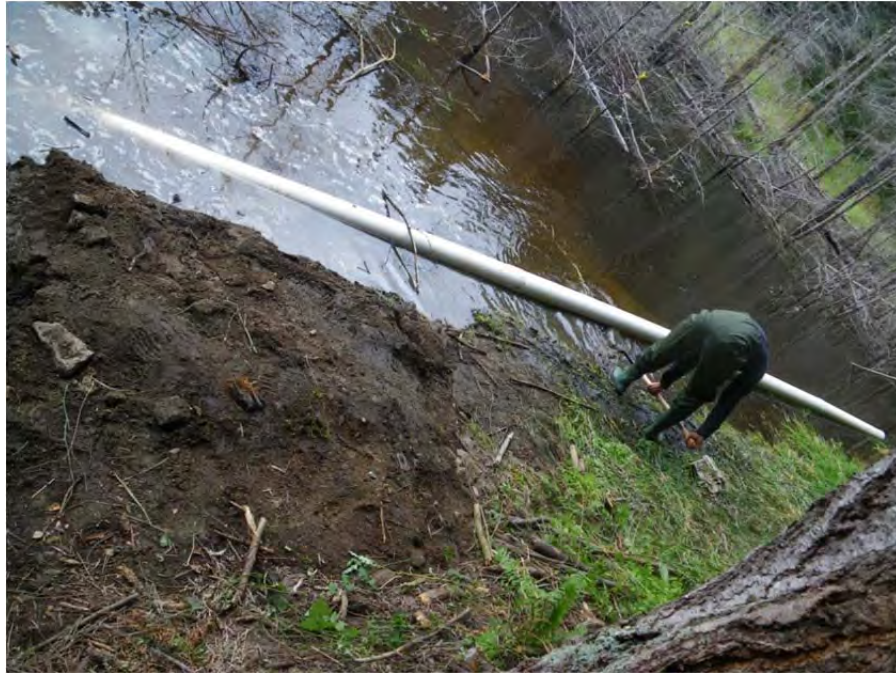
Placing drainage pipe by hand in area to the landward side of the berm.

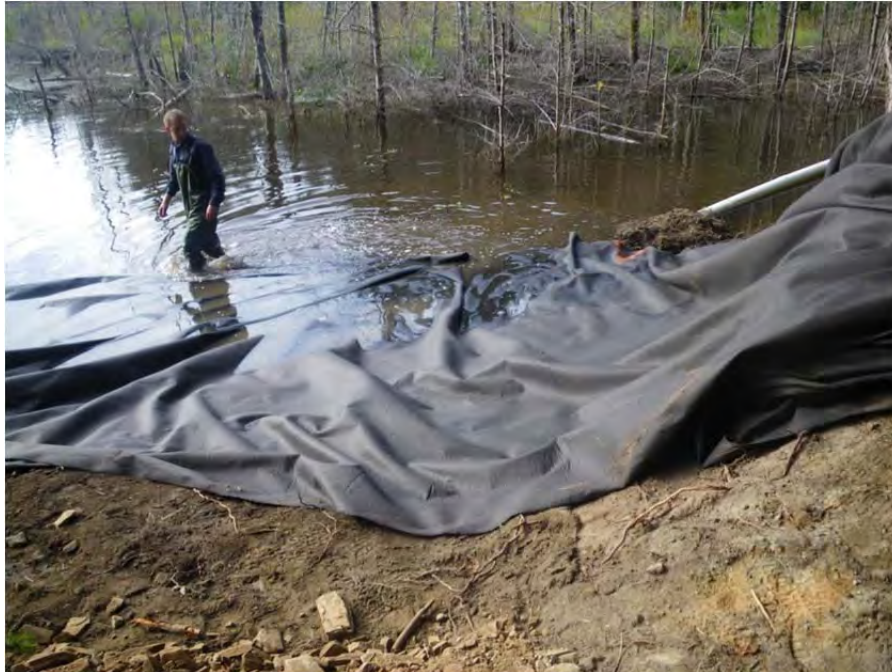
Placing geofabric material over wetted portion of wetland prior to placement of fill.

After placing the geofabric over the water, the backhoe and excavator worked in tandem, with the backhoe delivering fill to the excavator. The excavator then placed the fill on top of the geofabric. For the most part, the geofabric contained the turbidity associated with the fill placement process, due to the fact that there was always at least 1 m of overlap at the end of the geofabric.

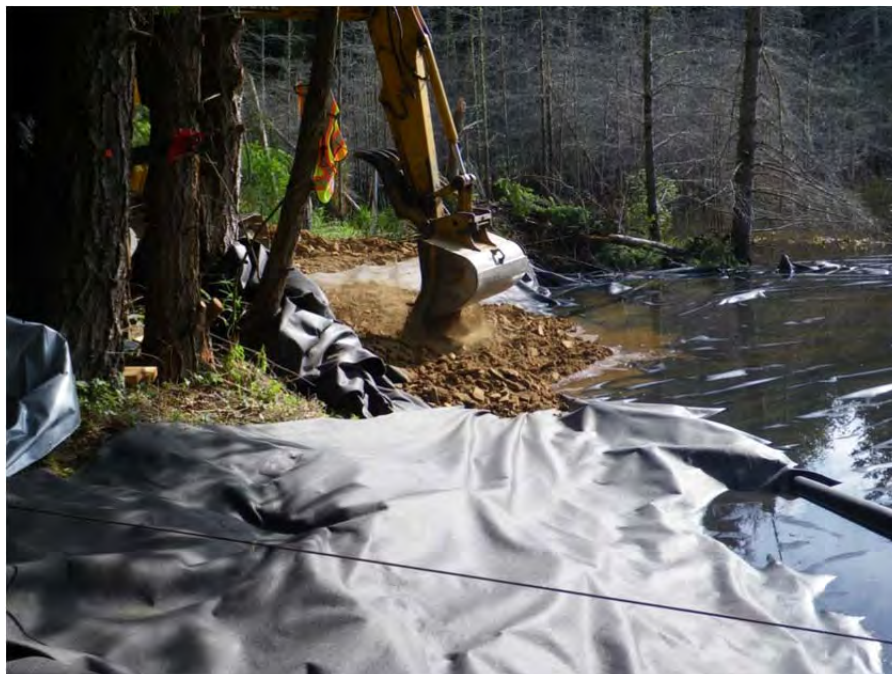
Placement of fill over the geofabric. Note that the geofabric is containing the majority of sediment generated within the immediate construction area.

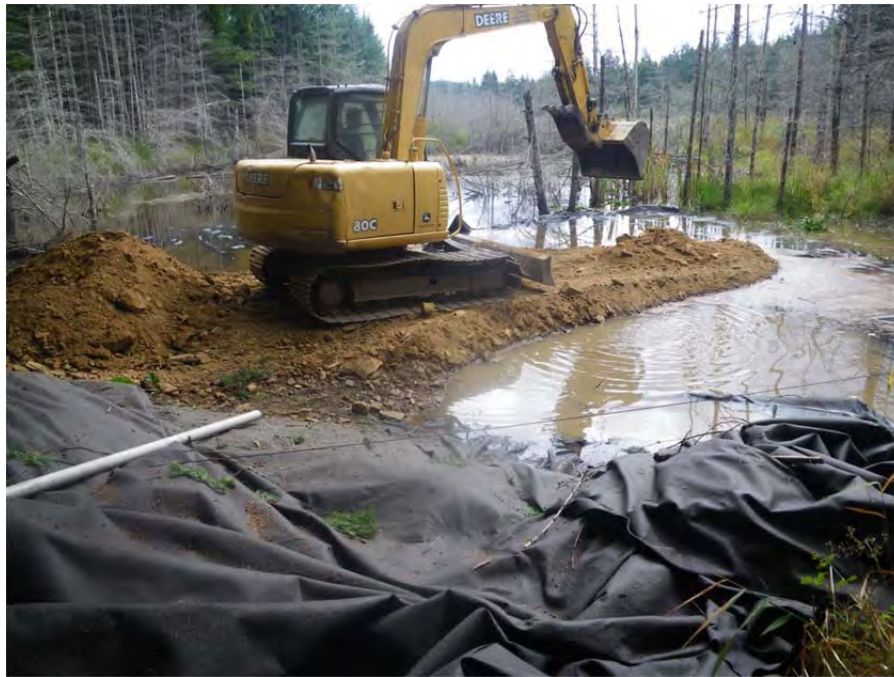
Constructing berm out over the geofabric.

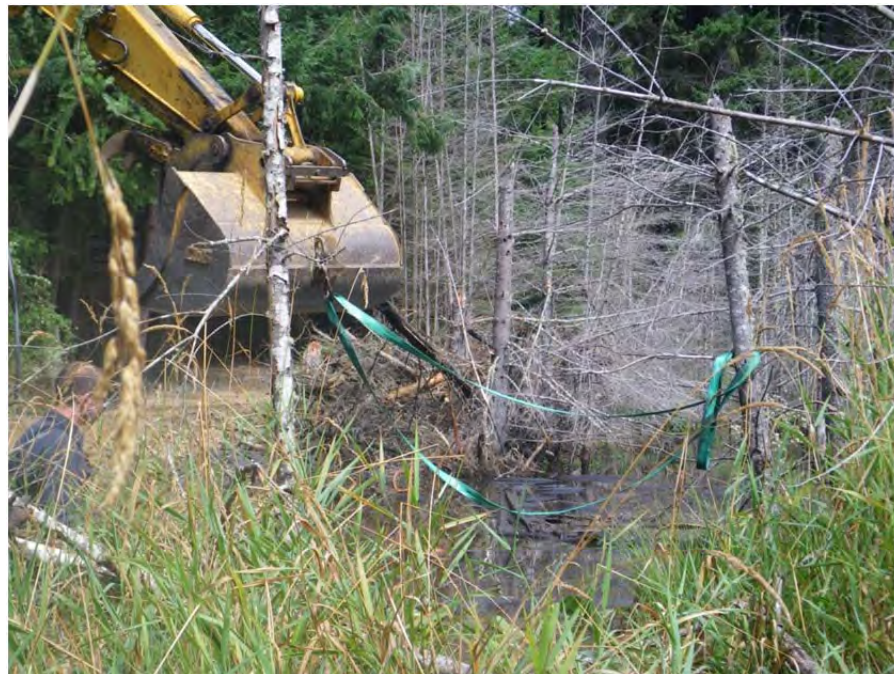
Snags being removed from the berm footprint area with straps attached to the excavator bucket.

Snags situated in the wetted footprint of the berm construction area were removed by attaching straps to the snags and pulling them out with the excavator arm. All woody debris that was removed was stockpiled on the edge of the site access road for habitat enhancement purposes.

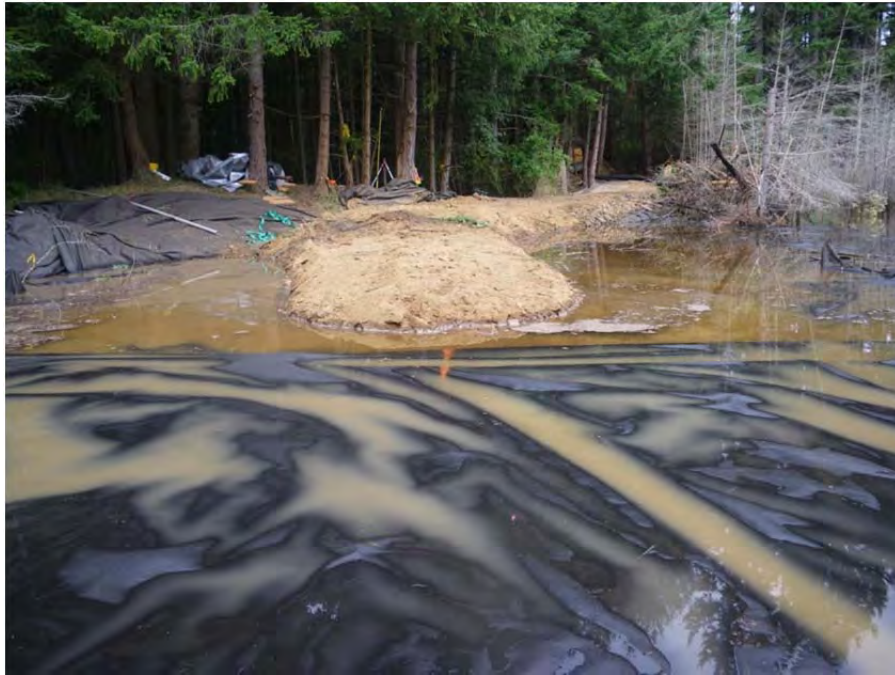
Looking north west along the berm construction footprint area. Note that the geofabric is containing the majority of sediment generated during the fill placement process.

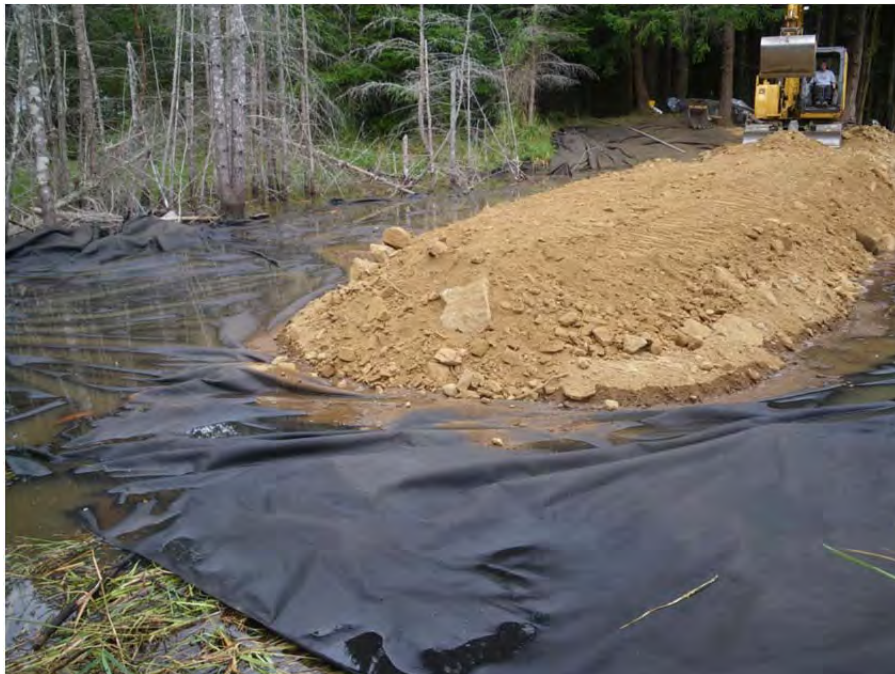
Continuation of fill placement over the geofabric.

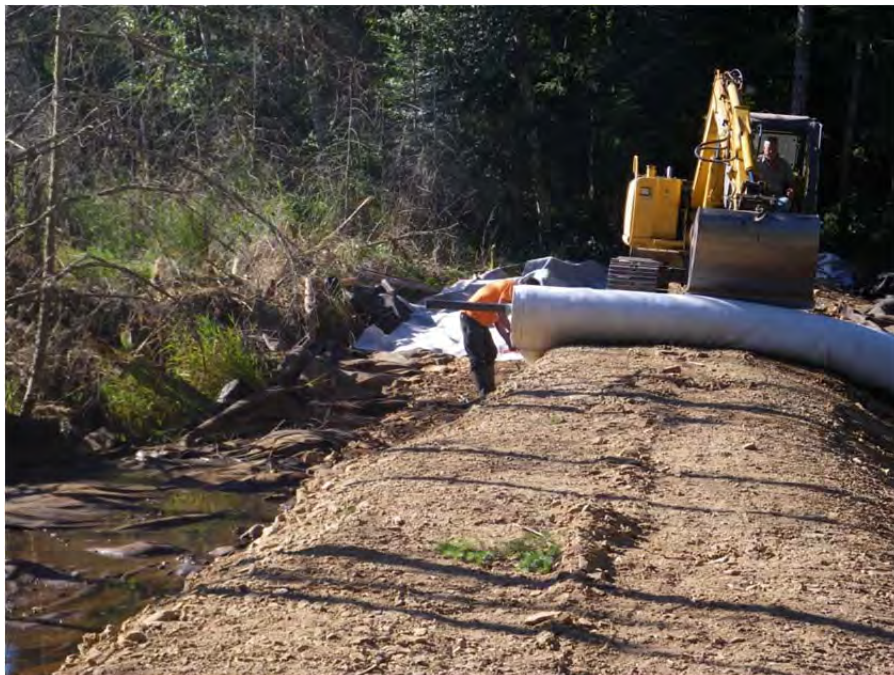
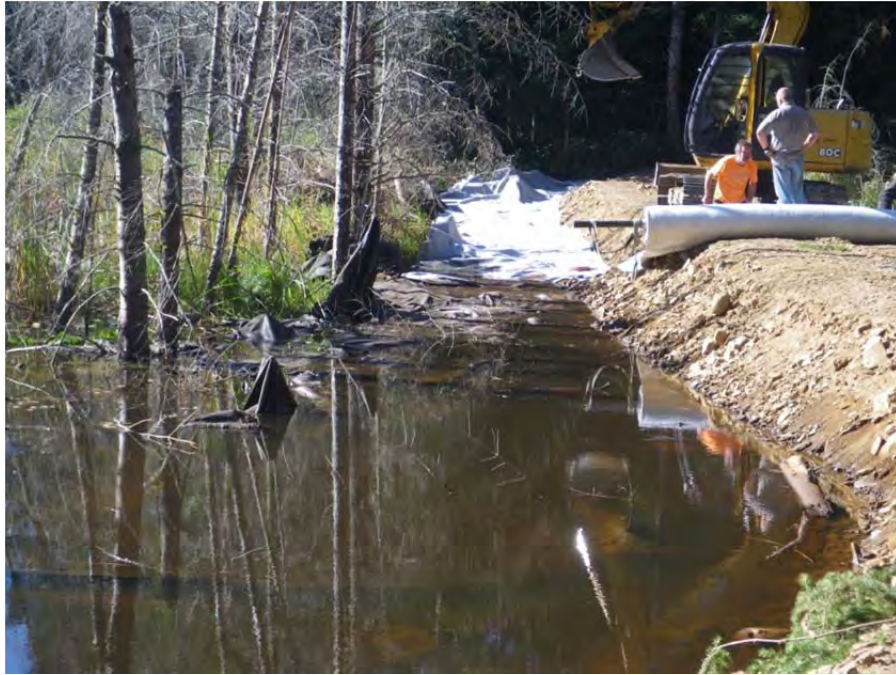
Rolling out geosynthetic clay liner for installation on the wetland side of the berm.

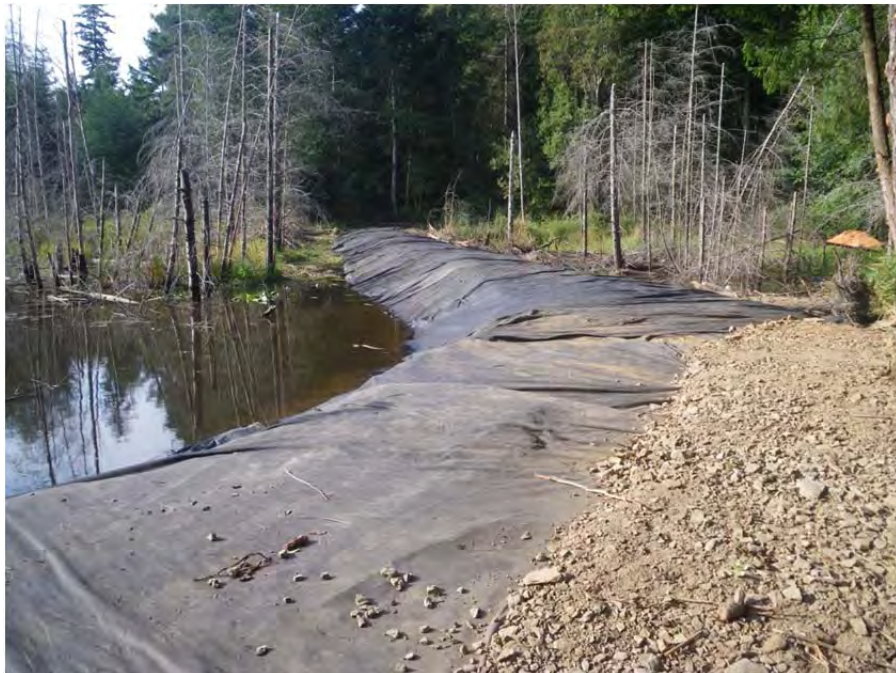
Looking south across the berm following the installation of the clay liner and overlapping with geofabric.

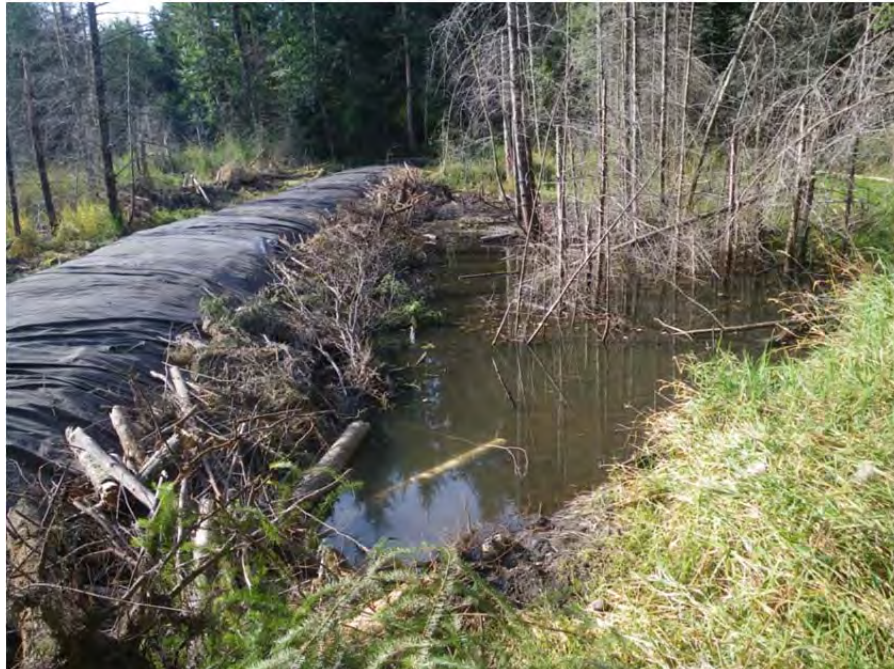
LWD placed along the edge of the berm will provide cover/security habitat for amphibians.  
Note inlet of PVC drainage pipe in the foreground.

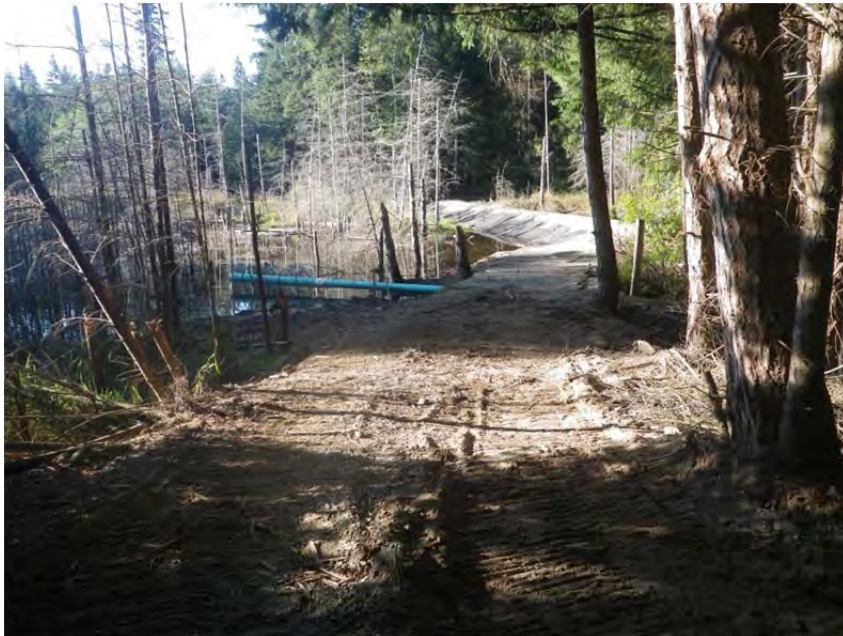
Looking north towards the completed berm, showing the new pond leveler.

During the September 11<sup>th</sup>, 2013 site visit, it was also noted that a new pond leveler had been installed. This work was beyond the scope of the berm construction monitoring. Confirmation of the elevation and capacity of the leveler indicates that the winter high water mark of the wetland will remain unchanged, which will retain the existing area of seasonally wetted habitat around the margins of the wetland.

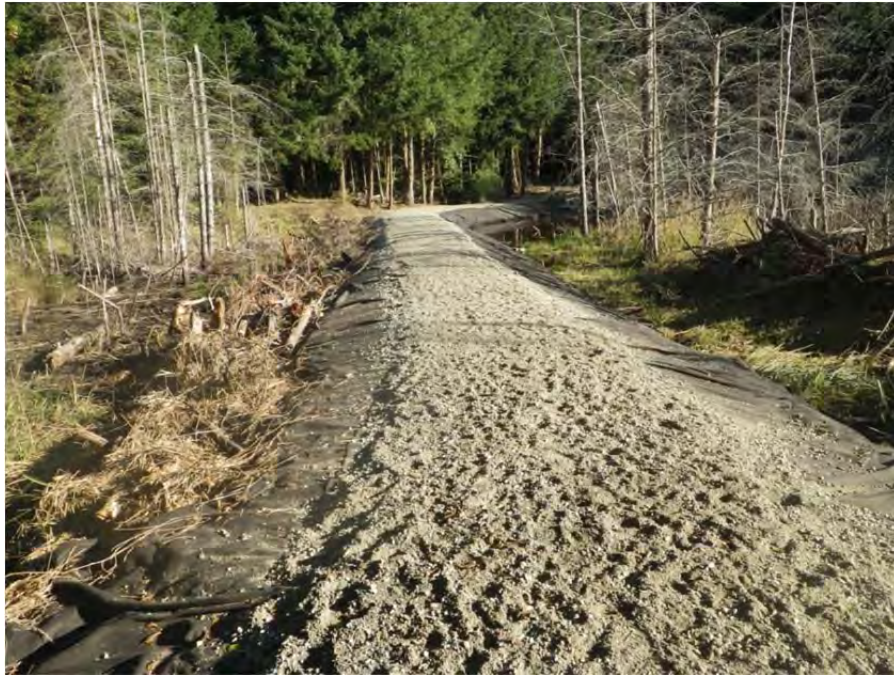
Looking north over the berm, showing the gravel surface. Tracks are primarily from deer.

The last site visit was conducted on September 11<sup>th</sup>, 2013, in order to inspect the final configuration of the berm. The only change to the berm was that a layer of gravel had been placed over the surface of the berm, in order to provide a surface for walking on. It is understood that the surface of the berm will be used as a walking trail for the public.

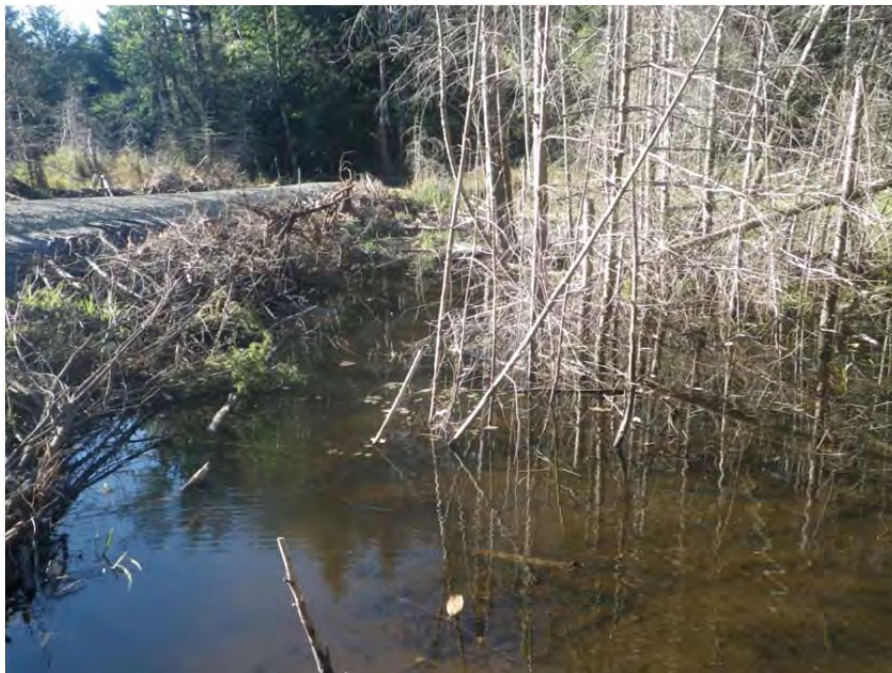
The area on the landward side of the berm will continue to provide, at the least, seasonal breeding habitat for native amphibians.

It was noted that flow through the drainage pipe had slowed considerably (discussed in more detail in Section 3.3). The area on the landward side of the berm still contained water (albeit at a lower level than before). The water level may decrease in this area over time, as seepage under the berm decreases. It is likely that it will continue to contain water on a seasonal basis, due to inundation from rainfall and surface run off, with complete drying possible during the late summer months if seepage through the berm ceases.

The area on the landward side of the berm will, therefore, continue to provide breeding habitat for native amphibians, which can complete their lifecycle in seasonally inundated areas. As the area will dry slowly over a long time period during each summer period, associated with an expected drop in seepage through the berm each year, any northwestern salamander larvae or neotenes will be able to metamorphose.
