## **A Proposed Strategy for Water Level Management – Coats Marsh, Gabriola Island, BC**

**September 14<sup>th</sup>, 2021**

## Proposed Water Level Management Strategy – Coats Marsh

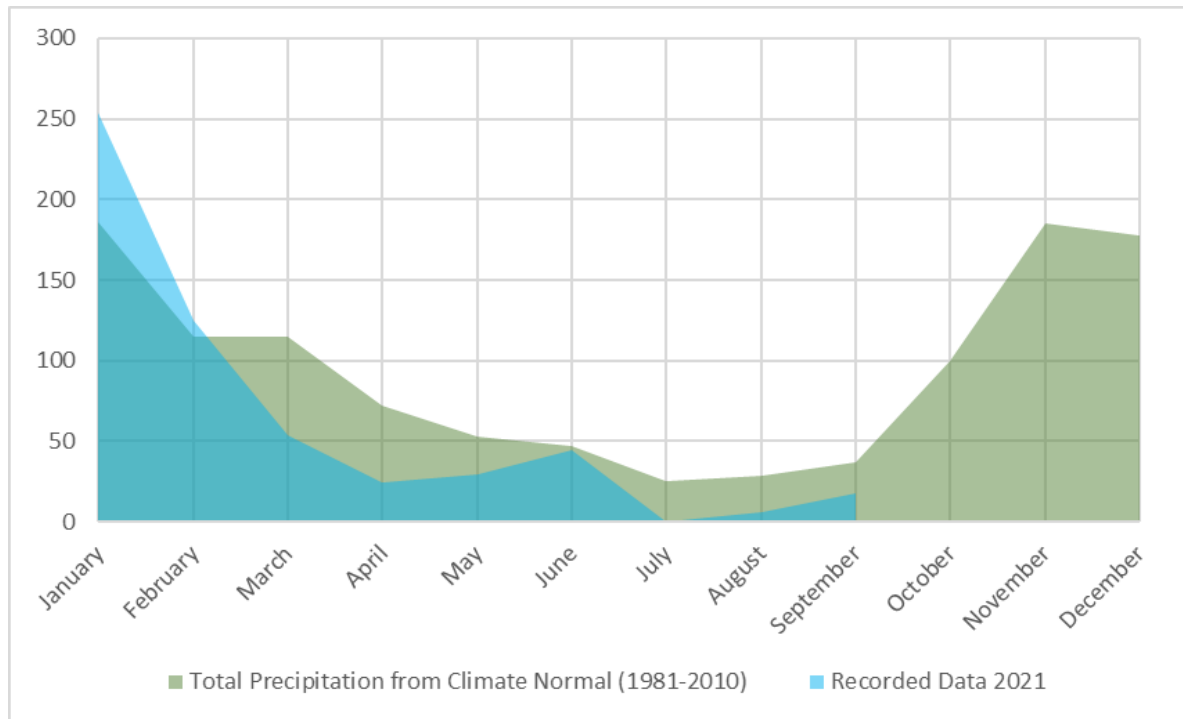
Figure 3. Comparison of recorded precipitation data and climate normal data at Nanaimo City Yard Environment Canada Weather Station (Environment Canada, 2021).

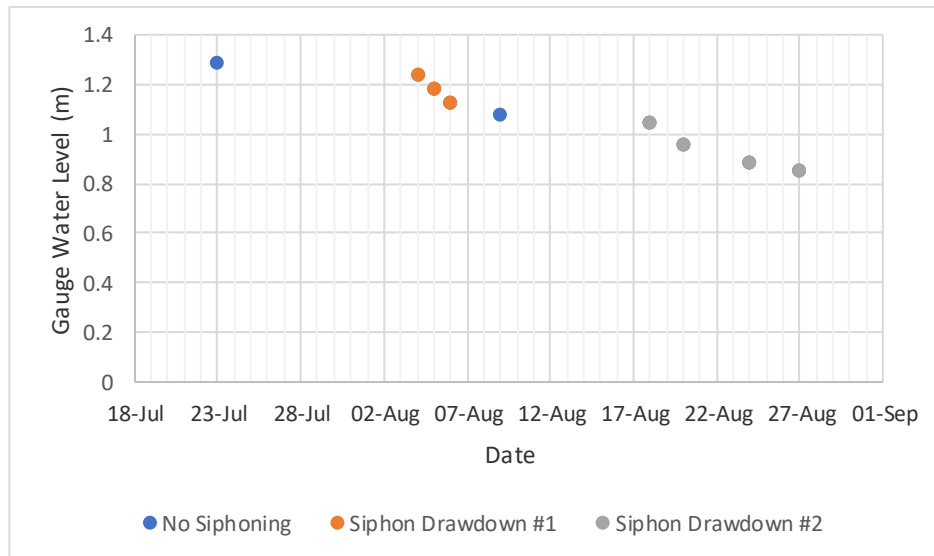
Figure 4. Wetland water level during siphon drawdown

- The first blue gauge measurement represents the initial siphon test on July 23<sup>rd</sup>.
- The second blue dot on August 9<sup>th</sup> indicates the gauge measurement following the unexpected loss of siphon flow over the weekend of August 7<sup>th</sup> to 8<sup>th</sup>.
- The rate of drawdown during August 18<sup>th</sup> to August 24<sup>th</sup> seems to flatten out slightly. This is likely due to the loss of suction on one of the siphons sometime during August 21<sup>st</sup> to 24<sup>th</sup>.

The marsh drawdown was measured during and between siphon tests by referring to a temporary gauge installed on the highwater side of the dam. All surveyed measurements were corrected to match the elevations on the gauge for ease of reference. Figure 4 summarizes how the wetland water level changed throughout the drawdown efforts. Note that the water levels are set to an arbitrary datum to allow for comparison and do not reflect the actual water depth at a particular point.

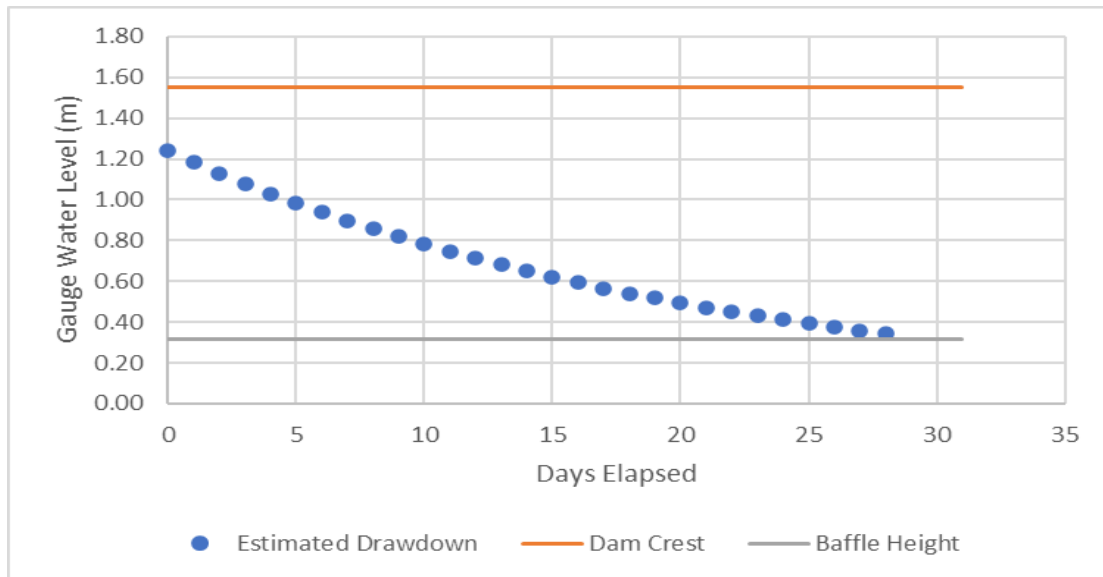
Figure 5. Estimated drawdown curve based on experimental data

Using the drawdown data from the first siphon drawdown effort (August 4<sup>th</sup> to 6<sup>th</sup>), we fit a trendline to the data and extrapolated the expected drop in water level over time. This curve assumes that all four siphons continue to operate at a consistent flow rate. However, as the head differential between the high-water side of the dam and the weir baffle decreases, flow rate will also decrease causing a slower drawdown.

We note that this curve is extrapolated from the recorded data near the top end of the gauge (1.24 m to 1.13 m depth) causing the uncertainty in the estimated rate of drawdown to increase towards the lower end of the curve. Additionally, the topography of the wetland at lower depths may result in a different curve. This curve should be updated with operational data once the permanent siphon system is in place. The estimated curve is shown in Figure 5.

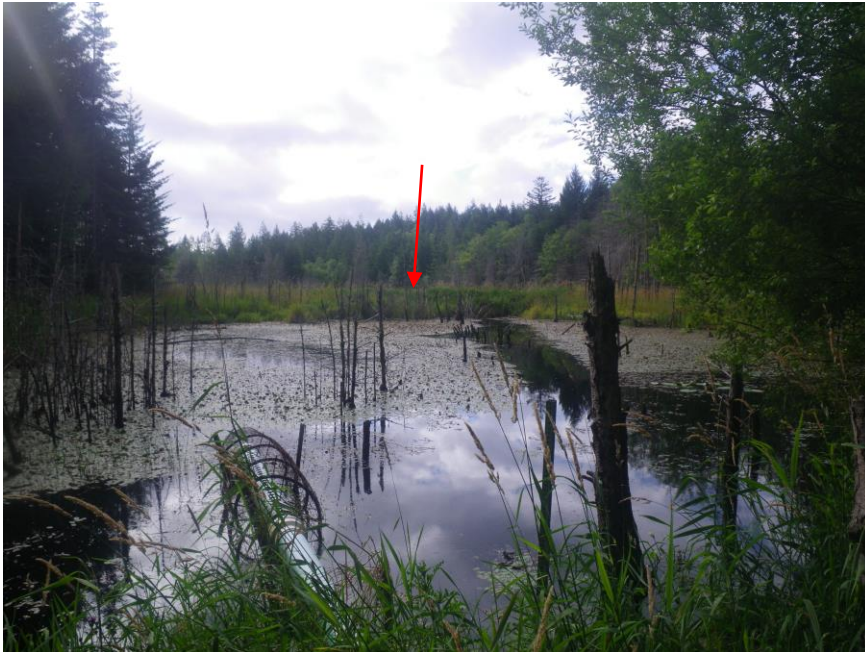
Photo 1. Looking southeast from the concrete outlet weir over the embayment that has been isolated by the current beaver dam. Location of the beaver dam has been highlighted. Existing leveling structure can be seen in the foreground. July 22<sup>nd</sup>, 2020.

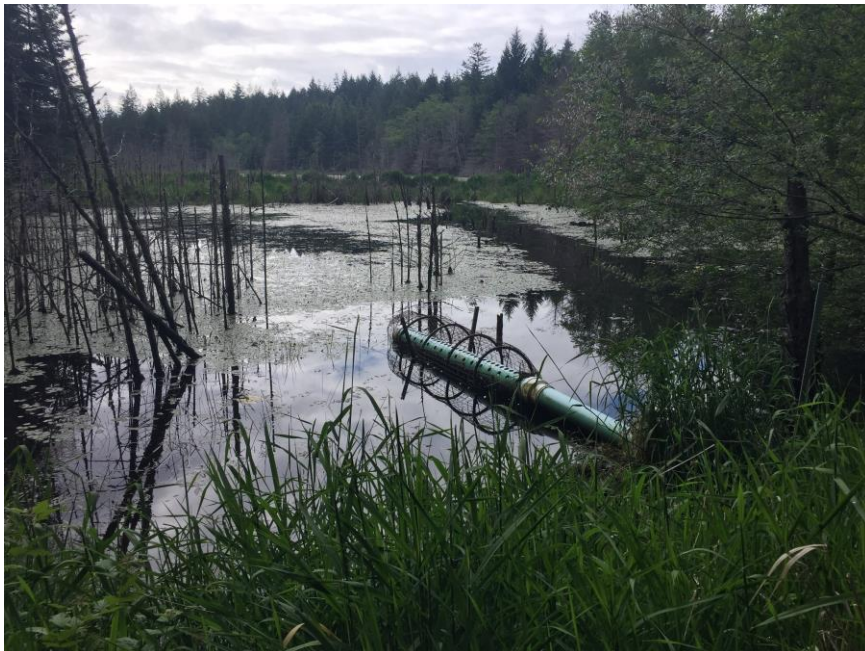
Photo 2. Similar view from May 25<sup>th</sup>, 2021. Note beaver dam appears stable in both photos.

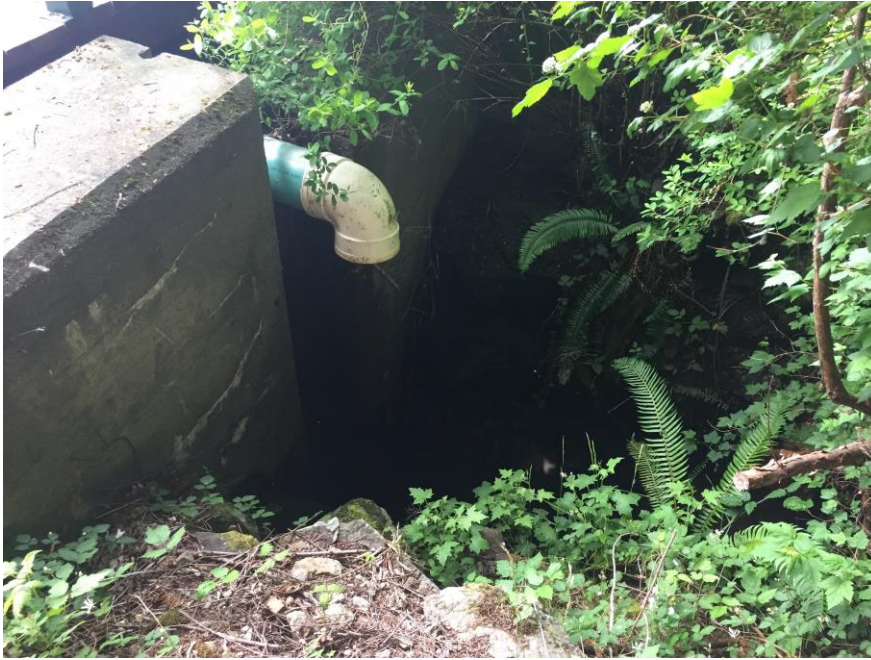
Photo 3. Outlet of the leveling device – May 25<sup>th</sup>, 2021. Note lack of flow, which is expected based on time of year.

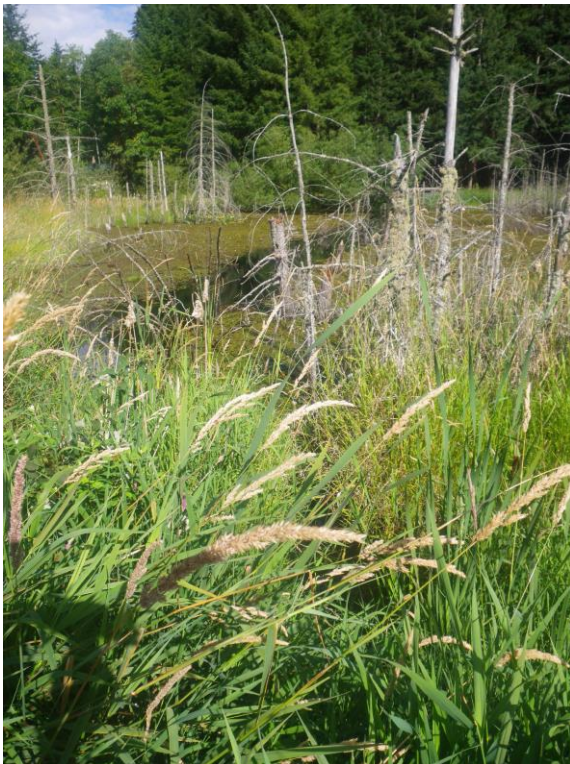
Photo 4. Looking northwest from the beaver dam towards the outlet weir and isolated embayment. July 22<sup>nd</sup>, 2020.

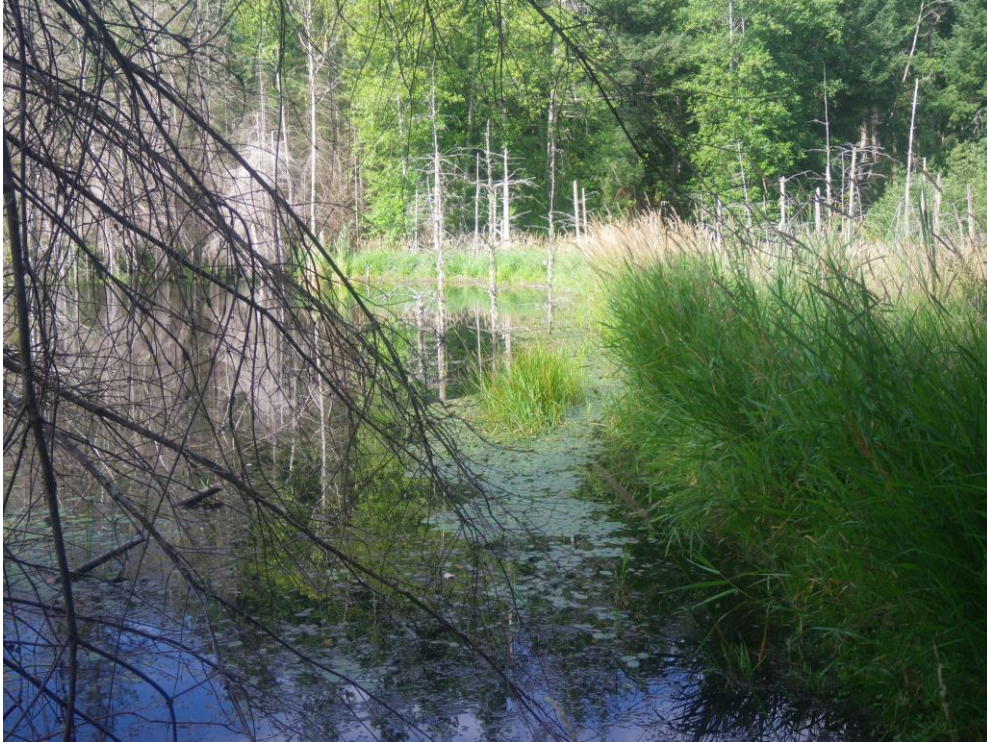
Photo 5. Looking southwest over the wetland, showing linear extent of the beaver dam. July 22<sup>nd</sup>, 2020

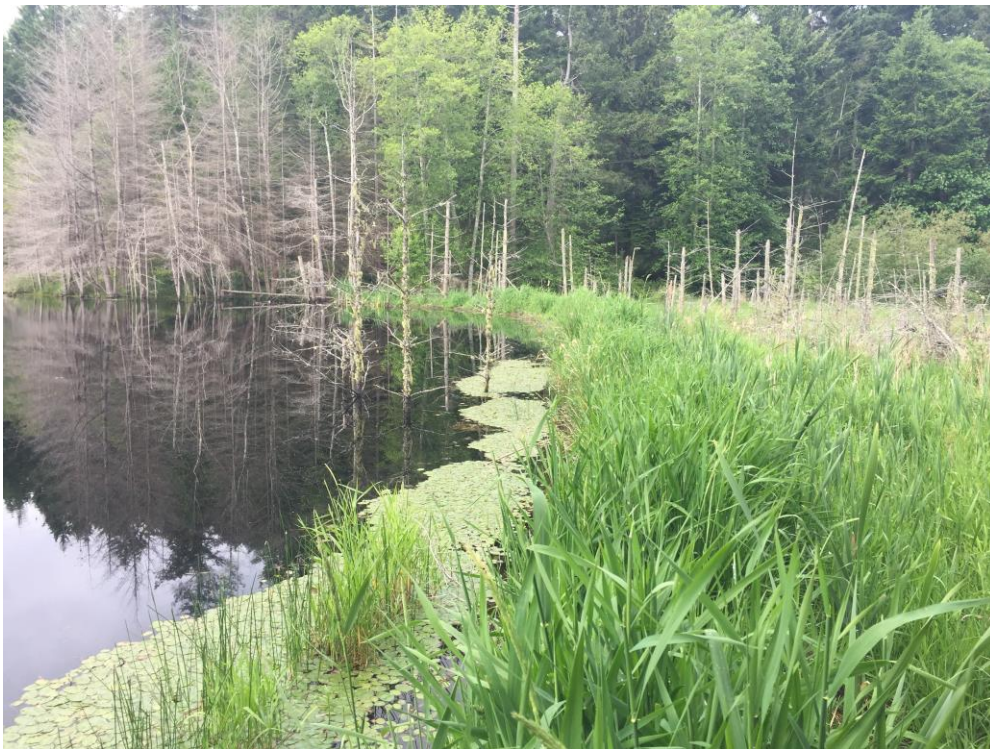
Photo 6. Similar view on May 25<sup>th</sup>, 2021, across beaver dam. Note established, apparent stability of dam in both photos.

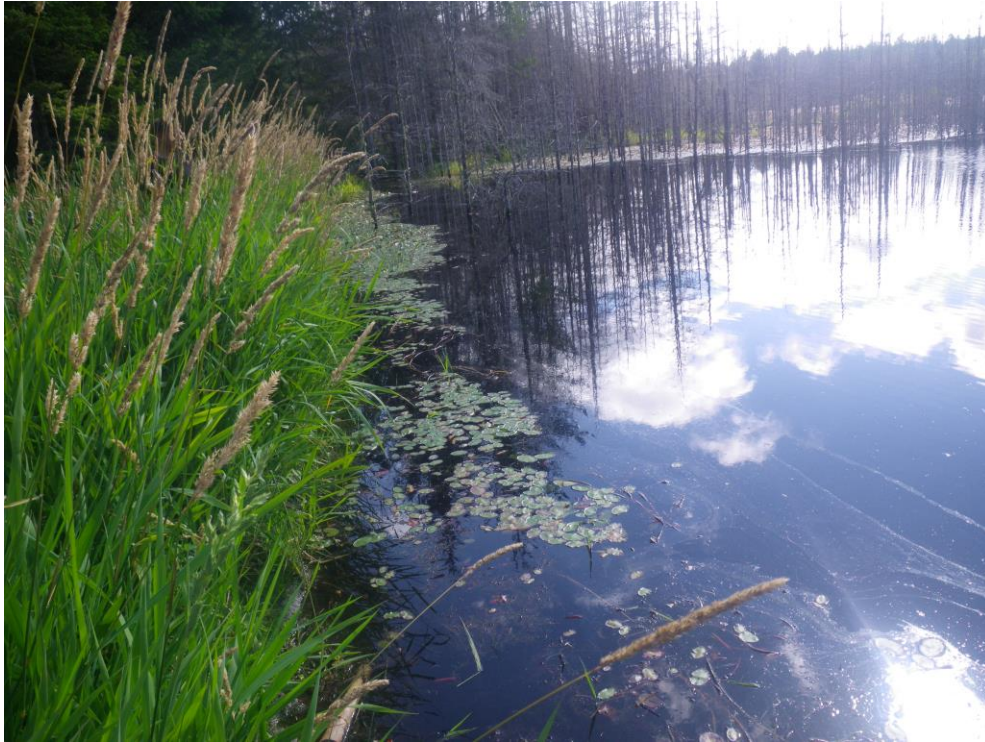
Photo 7. Looking northeast across the beaver dam. July 22<sup>nd</sup>, 2020.

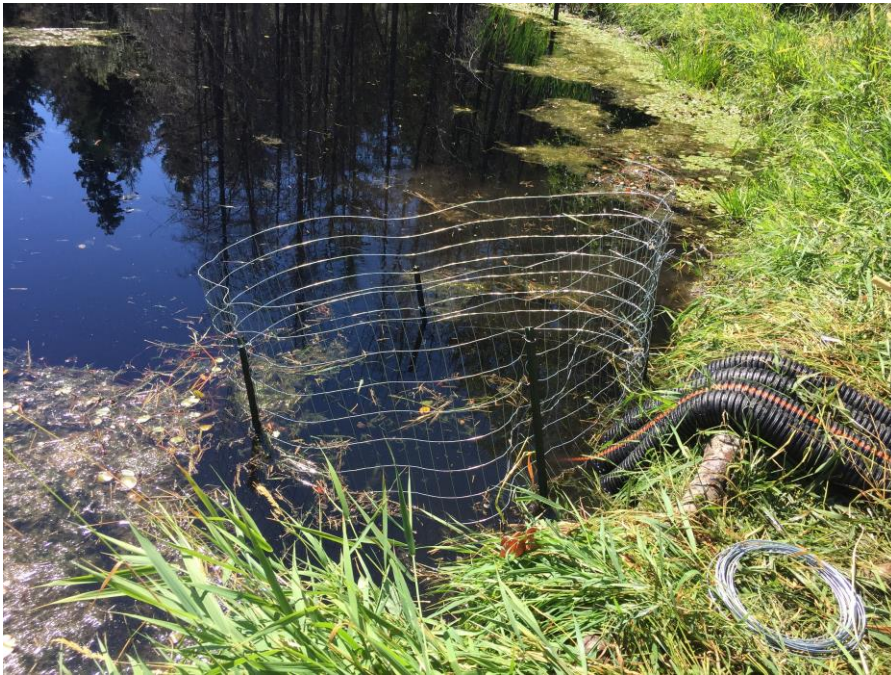
Photo 9. Inlet of temporary draw down siphons (caging is to offer protection from beavers). August 4<sup>th</sup>, 2021.

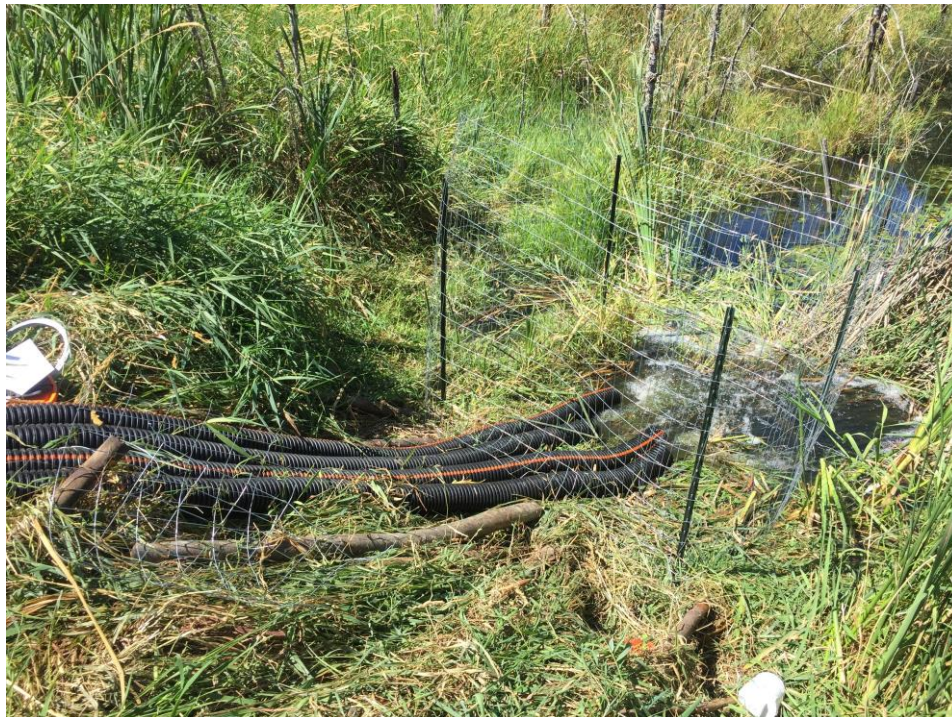
Photo 10. Outlet of temporary draw down siphons. August 4<sup>th</sup>, 2021.

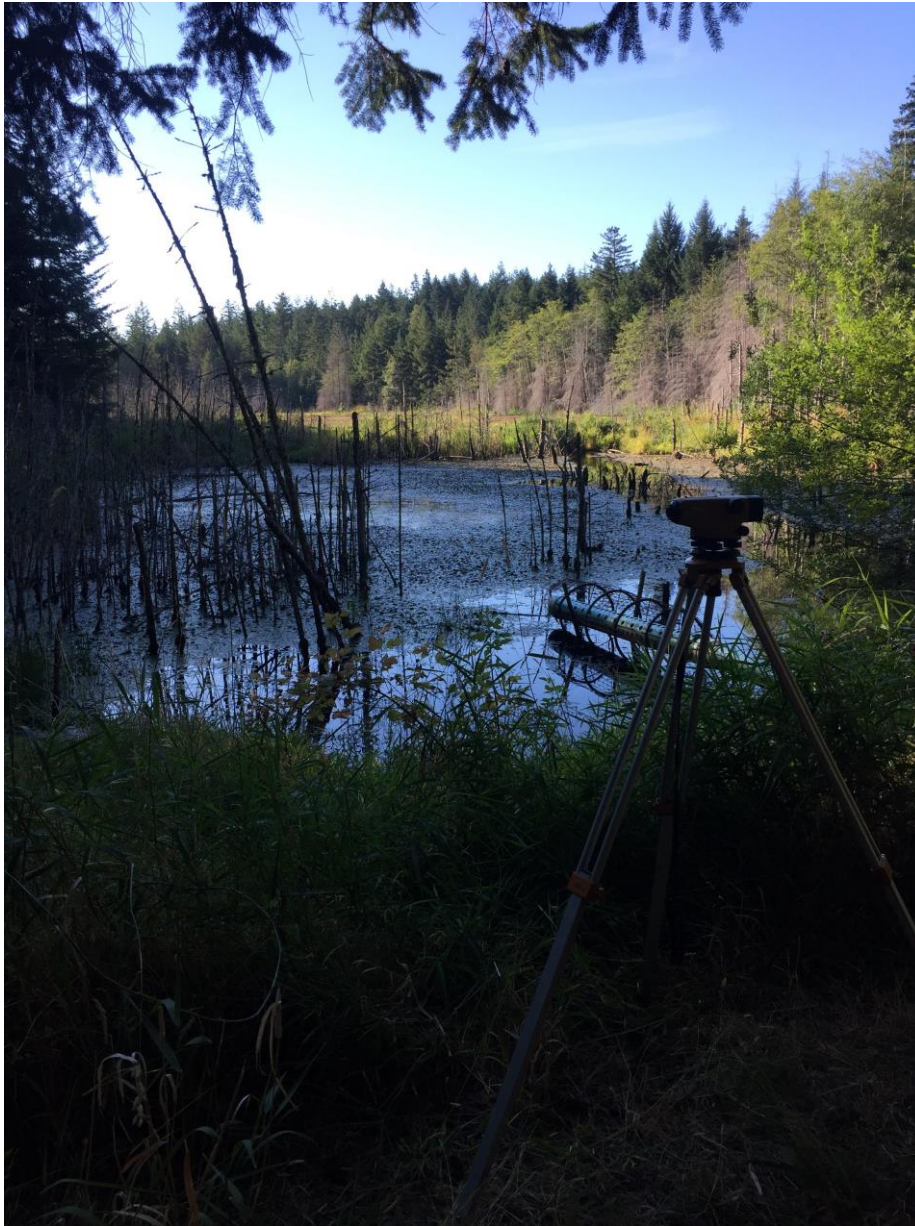
Photo 11. Looking southeast from the concrete outlet weir over the embayment that has been isolated by the current beaver dam. This shows characteristics prior to installation of the siphons on the morning of August 4<sup>th</sup>, 2021.

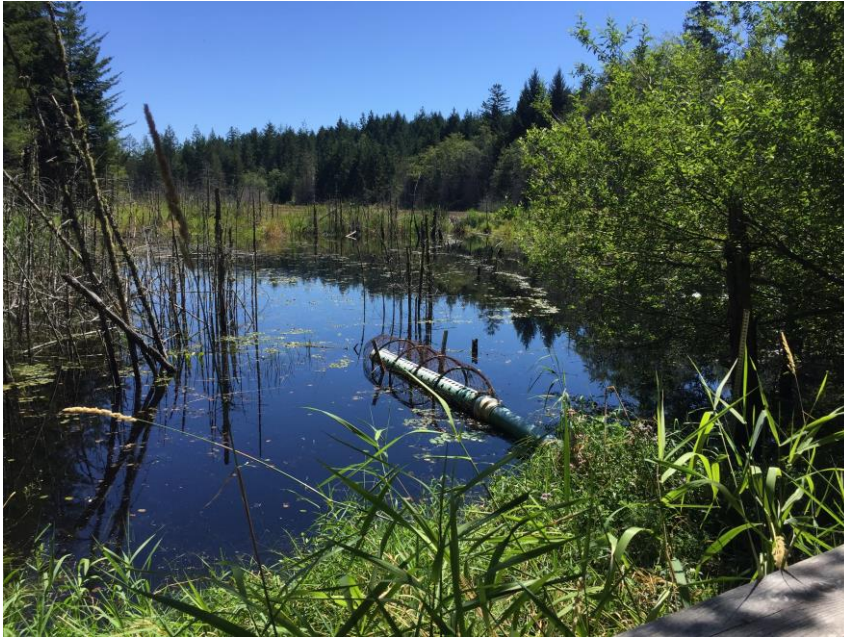
Photo 12. Similar view as the previous photo, showing elevated embayment levels after installation of the draw down siphons on the afternoon of August 4<sup>th</sup>, 2021. Flow over the weir, and through the leveler, was initiated following draw-down siphoning over the course of the day.

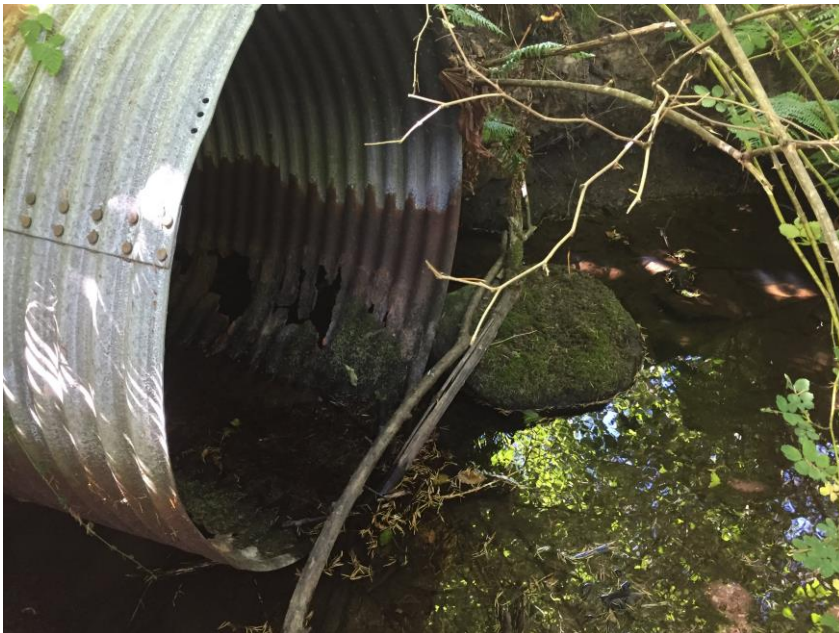
Photo 13. Flow conditions at the inlet of the South Road culvert on Coats Marsh outlet stream on the afternoon of August 4<sup>th</sup>, 2021, immediately following influx of flow over the concrete weir and through the leveler. Note lack of turbidity.

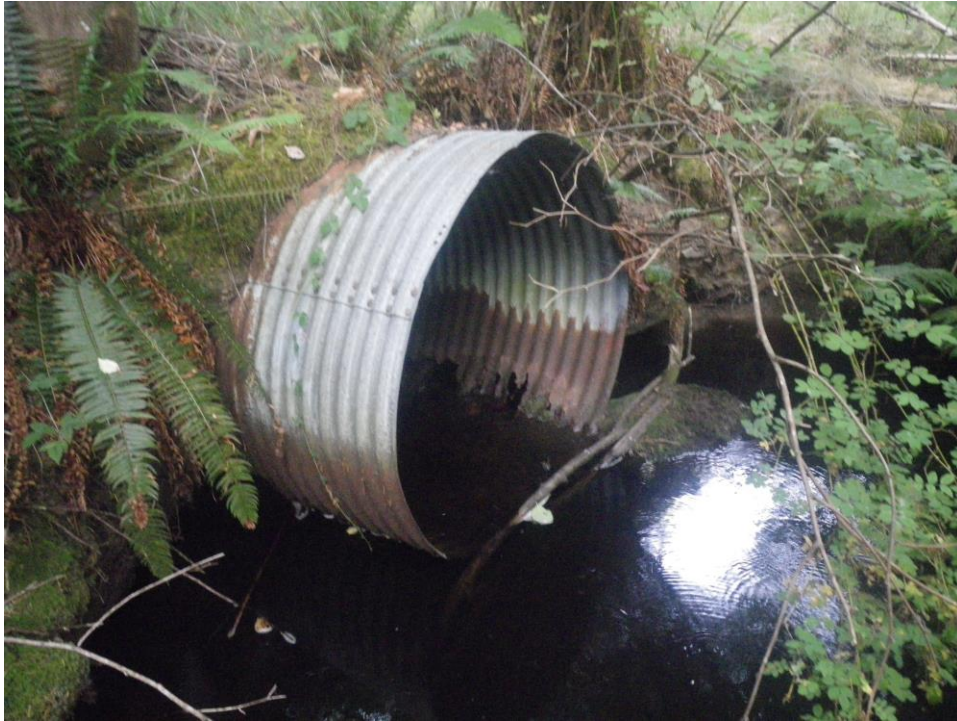
Photo 14. Increased, but stable flow conditions at the inlet of the South Road culvert on Coats Marsh outlet stream on the morning of August 6<sup>th</sup>, 2021. Note continuing lack of turbidity.

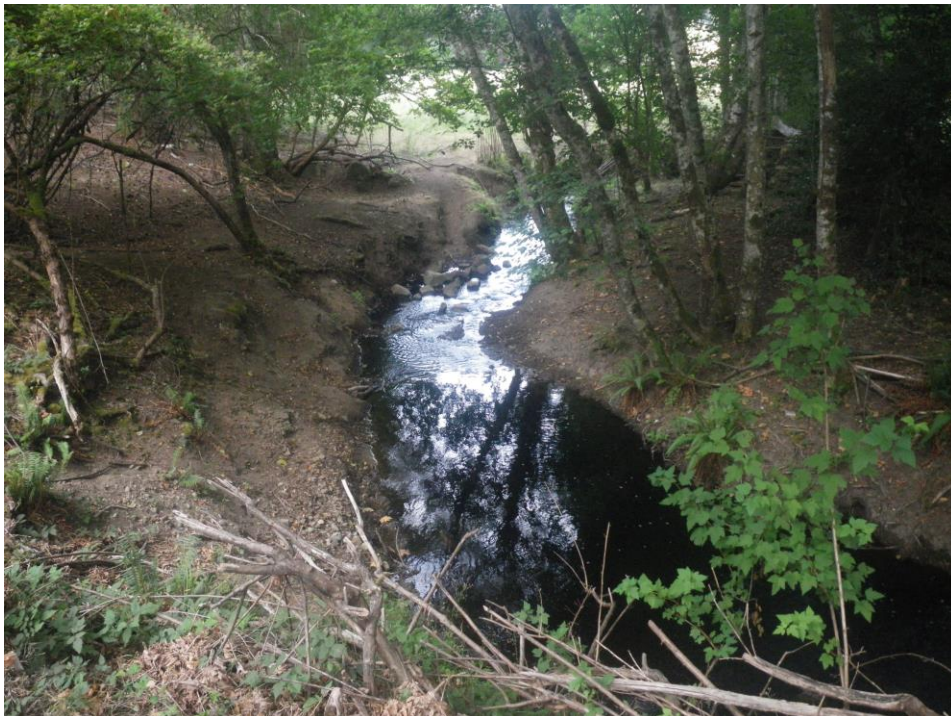
Photo 15. Stable flow conditions downstream of South Road on the morning of August 6<sup>th</sup>, 2021. Note lack of turbidity.

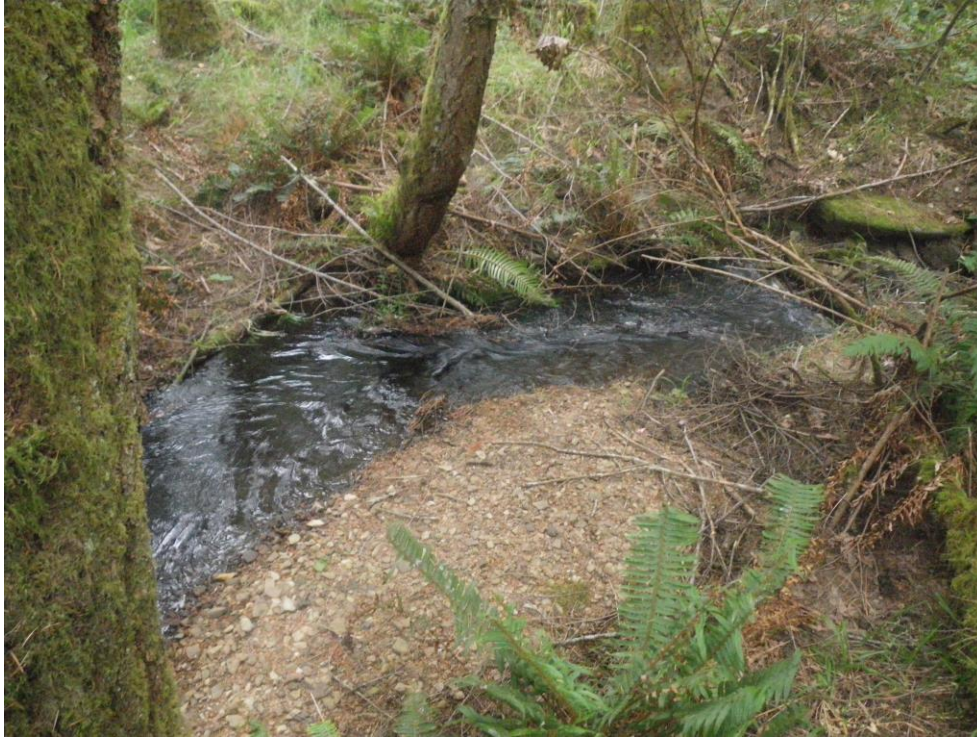
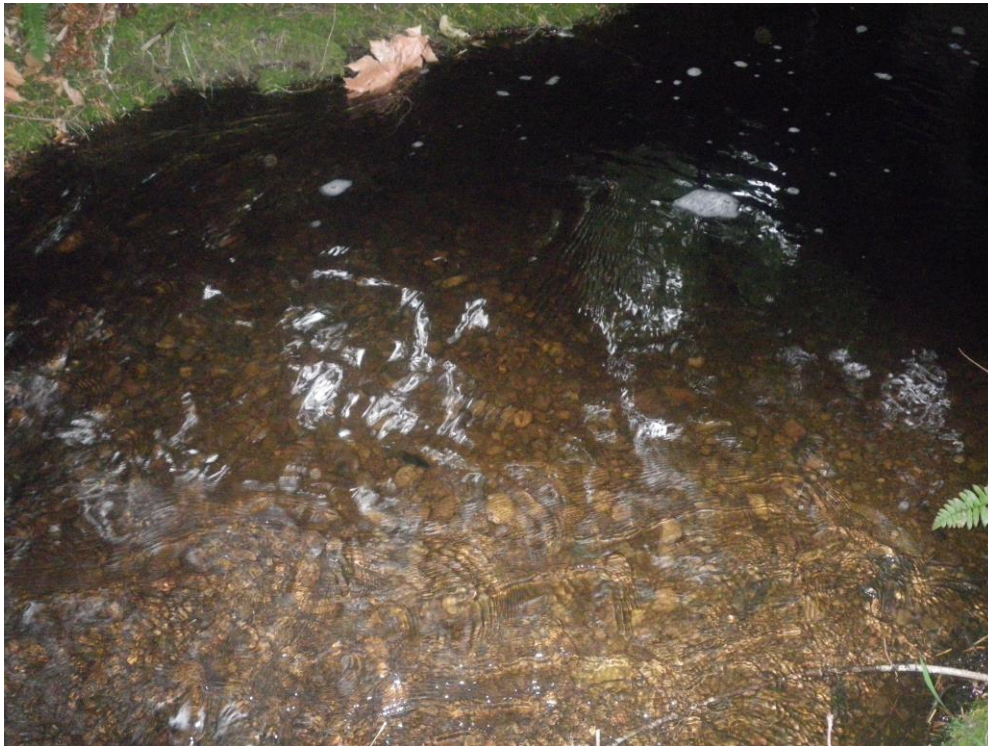
Photo 16 & 17. Above and below: moderate, stable and clean flow in Coats Marsh outlet stream on the morning of August 6<sup>th</sup>, 2021.

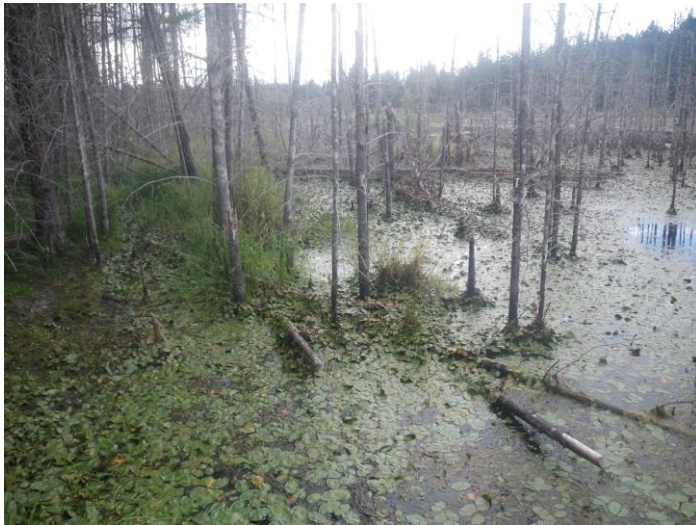
Photo 18. Gradual drying of wetland margins above the beaver dam following two days of siphoning draw down on the morning of August 6<sup>th</sup>, 2021. Note fringing dead conifers indicating areas that were inundated behind the beaver dam.

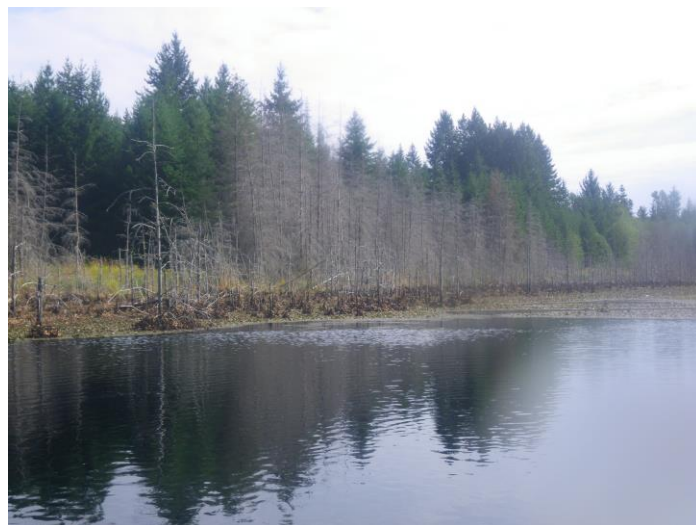
Photo 19. Looking towards the northern shore of Coats Marsh showing area that was inundated following completion of the subject beaver dam (marked by zone of dead conifers). It is expected that this inundated area will first transition into pioneering deciduous shrubs and trees, which would likely extend down to form a forested swamp zone, with conifers expected to become re-established in drier upper areas. Depth of open water would decrease, with replacement by shallow water marshy areas should the wetland be maintained at the current weir elevation. August 18<sup>th</sup> 2021 – following initial draw down phase initiated on August 4<sup>th</sup>, 2021.
