Addendum to report on Texada “goop” used on Gabriola

Magnesium/calcium silicate scaling

The “corrosion” problem—real or imagined?

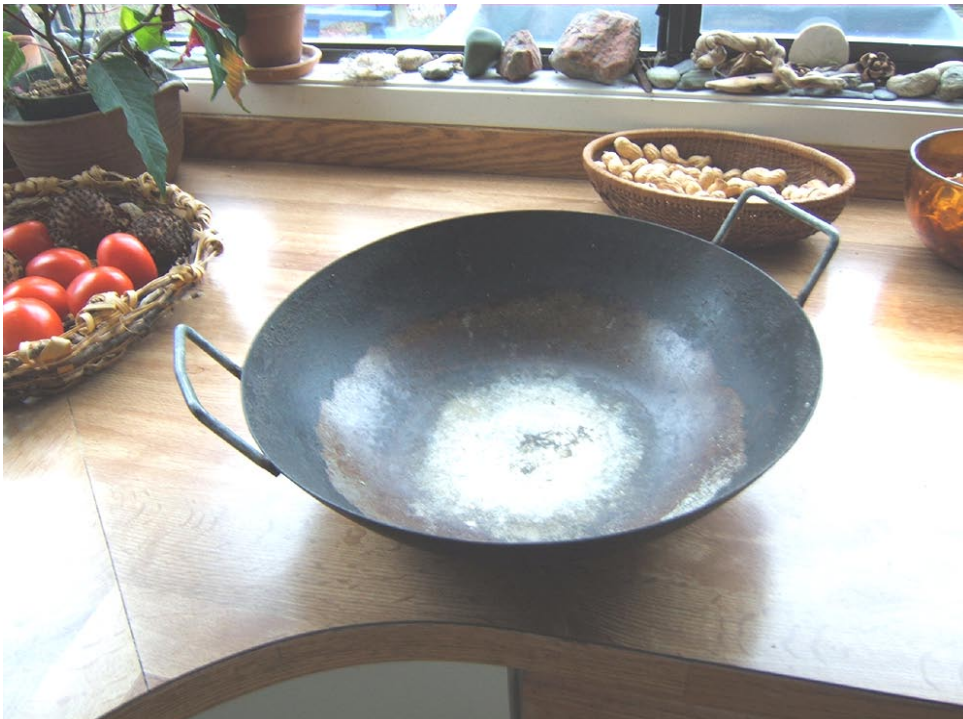
To confirm that I was not going off on a technological tangent, I did the simple experiment of slowly removing the water from a goop sample in a warm wok on the kitchen stove. After the water had gone, I discarded all the powdery material, and was left with a wok with a thin white film on the bottom adhering to the metal surface. This could not be removed by vigorous washing or rubbing with fingers, but it could be using a regular plastic dish scrubber.

I showed my wok to the owner of the Gabriola Automotive Company (Tim Nicklom), who services many “gooped” vehicles on the Island. He assured me that the stuff in my wok had all the physical qualities and appearance of the material he was seeing on the inside of brake drums. It is therefore a reasonable supposition, I think, that part of the “corrosion” problem is silica scaling. Jeremy Baker has observed the formation of a silica gel in goop-laden water, likely initiated by a drop in pH. Smectite clays are, as are all clays, rich in silica.
