Hydrogeology of Coats Marsh, Gabriola Island (2015—2024)

Coats Marsh on Gabriola Island is within the boundaries of a park administered by the Regional District of Nanaimo (RDN); their management plan for the park was published on August 29, 2011.

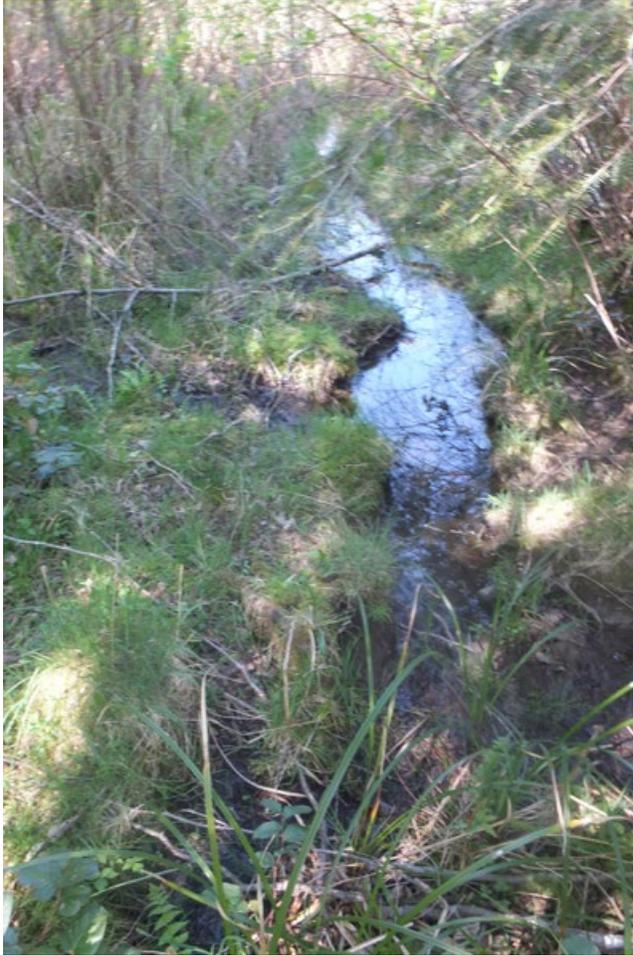
Watercourse at the southeast end of the marsh, about 20 metres from open water (early May 2015). There was no discernible flow in this and other similar channels, indicating that despite their distance from open water, they were just flooded.

In the wet season, they probably are drainage channels for water collected in adjacent inland areas that were formerly below the lake high-water level.

There was no suggestion in this area that the water in these channels was sourced from groundwater springs.

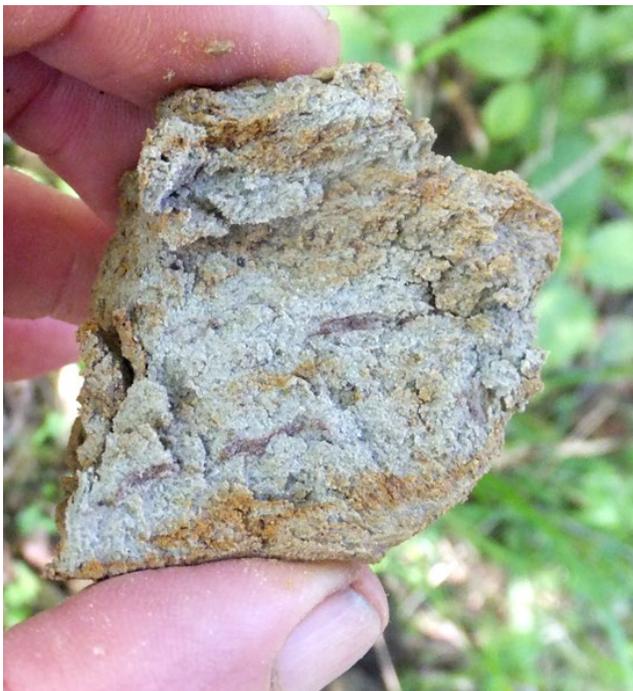
Gleysol underlying the marsh retrieved from the southeast end of the marsh beyond the park boundary about 30 metres from open water.

The gleysol is predominately anaerobic (grey-blue) at depth, and dry, despite being below the surface water level.

Similar material retrieved from McGuffies Swamp on Gabriola has been radiocarbon dated to 11530 BC at the very end of the Pleistocene (ice age).

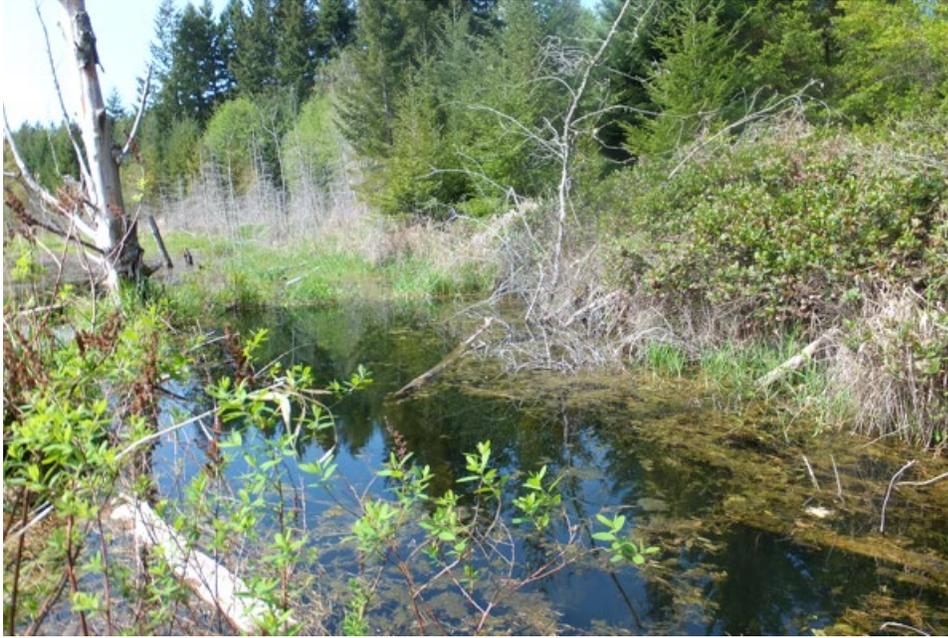
49°09.115'N, 123°48.570'W. Located with help of John Peirce.

An old rectangular concrete storage cistern near the water's edge, possibly used back in the 1930s when the marsh was dry in summer. It may be the origin of the use of the word "spring", which in the old days commonly meant any damp depression in the landscape. There is an old barbed wire fence (for cattle?) along here too. There was no water flowing from this cistern when observed in May 2015—it was just flooded.

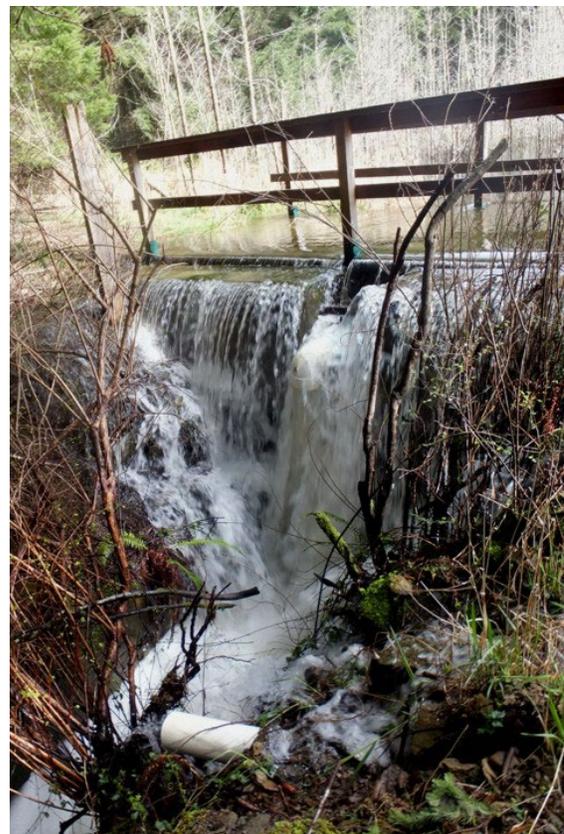
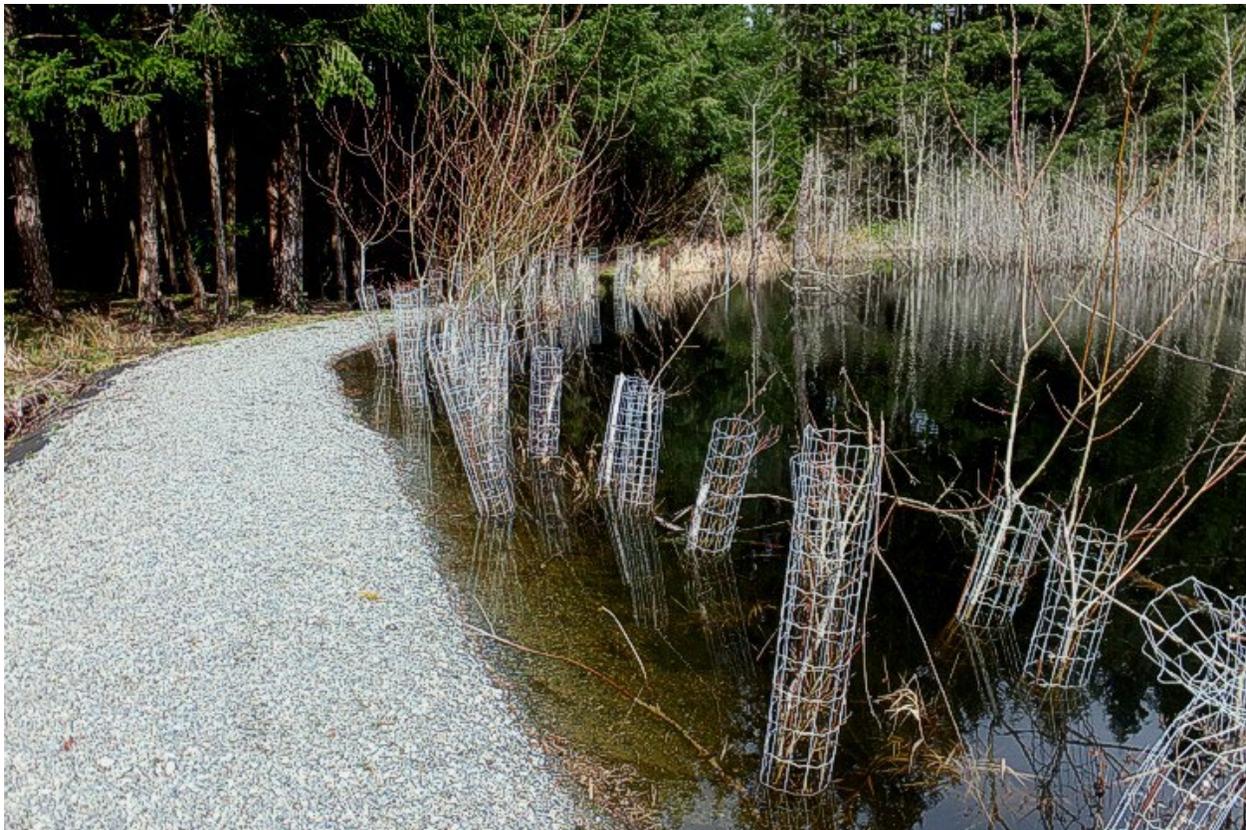
Observed flood levels in the weir pool have been:

- +0.017 m (Dec.9, 2015)
- +0.069 m (Jan.22, 2016)
- +0.155 m (Mar.10, 2016) photo
- +0.121 m (Feb.15, 2017)
- +0.145 m (Jan.29, 2018)
- +0.085 m (Jan.4, 2019)
- +0.099 m.

At these levels there is a substantial flow over the baffle as well as from the pond leveller and over the deck. These levels are contained by the berm and there has never been an observed flow over the causeway (photo, March 10, 2016). There is during these events minor wash-out around the ends of the deck, but the flooding is otherwise of no great concern.

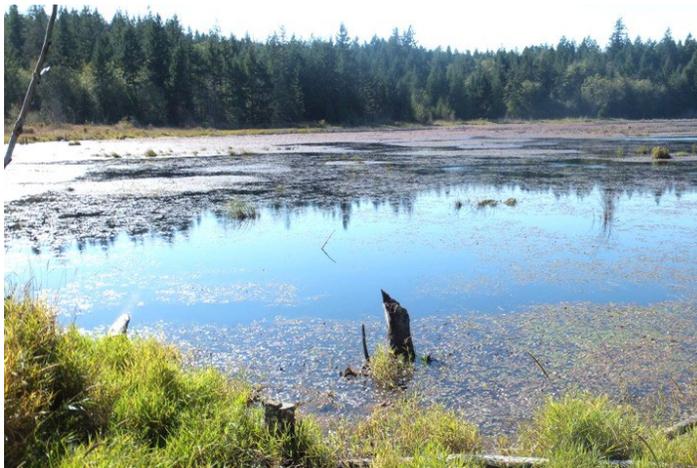
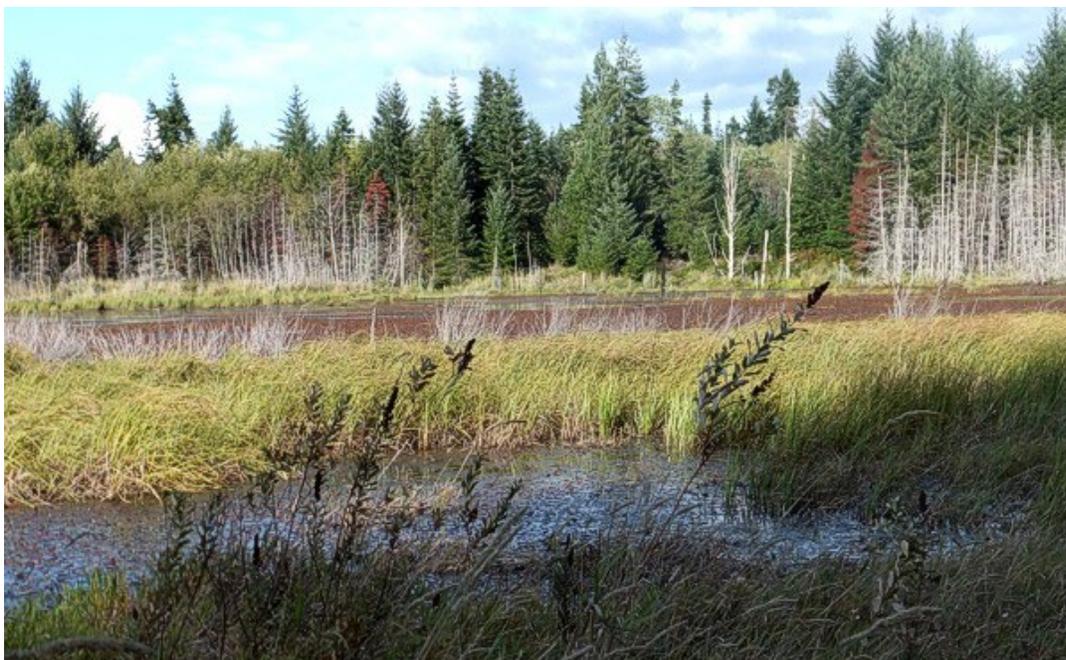
Left: Oct. 25, 2015

—the water level in the weir pool differs from that in the (outer) marsh because the beaver has built a dam that spans the whole width of the weir pool just 50 metres upstream of the outflow pipe. At times this dam acts to absorb inflow into the marsh, allowing the water level in the marsh to rise, at others, when the marsh is near full capacity, it allows flow through spillways across it to add to seepage through it into the weir pool, thus raising the weir pool's level.

When the water level in the weir pool is at the level of the sill of the baffle, -0.64m , water levels in the marsh on the east side of the beaver dam have been observed as:

+0.073 m (Nov.18, 2015) datum is as re-measured August 30, 2018, [File 673](#)
+0.246 m (Jul.13, 2016)
+0.200 m (*ca.* Oct.12, 2016)
+0.417 m (*ca.* Jul.12, 2017)
+0.288 m (Nov.12, 2017)
+0.362 m (Jul.28, 2018)
+0.300 m average dam height (Δ) = +0.94 m

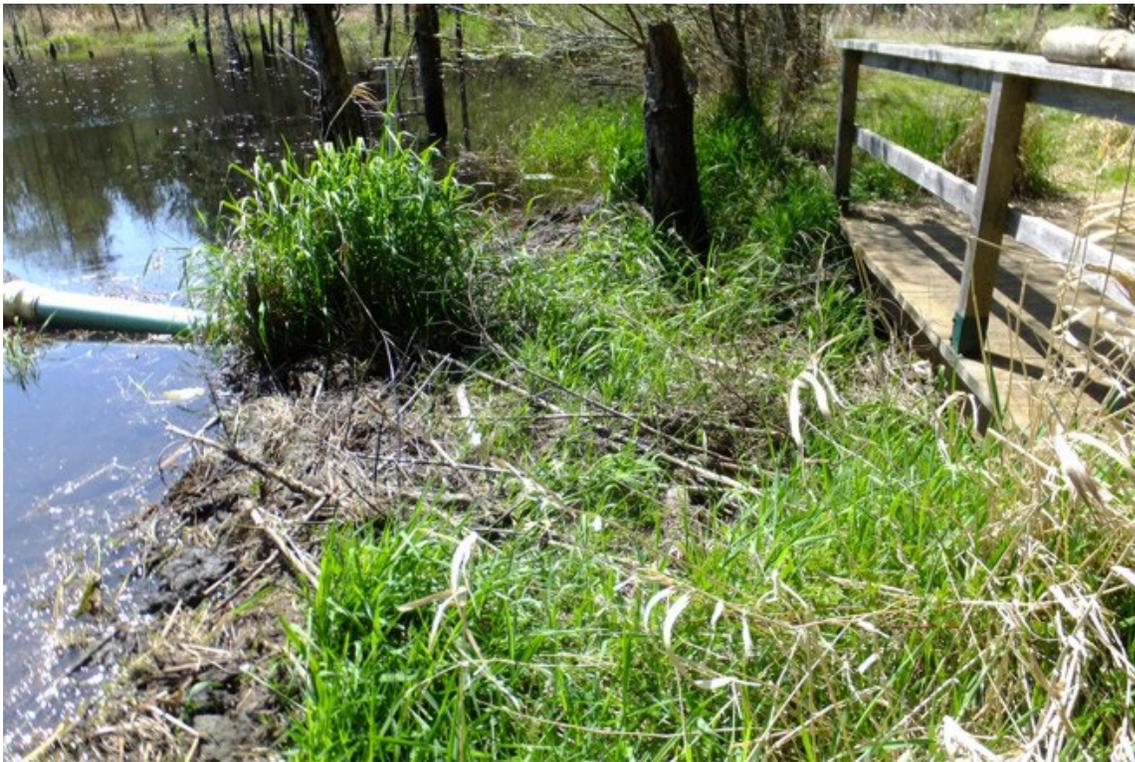
Weir pool level in 2020 influenced by the beaver consolidating debris at the bridge holding back water from the sill (photo April 2020).

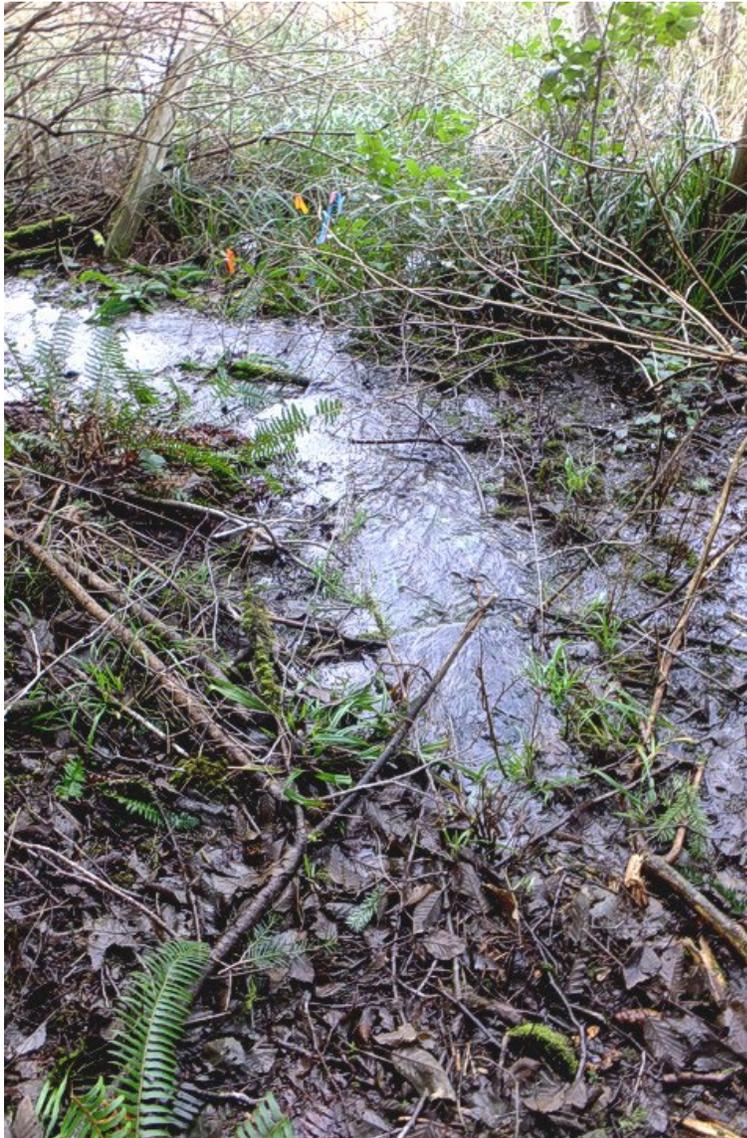
In occasional visits to this particular area over the years since, I have never observed any indication of springs; however, on January 27, 2020, I saw for the first time flows of water emerging from two small holes in the ground in the East Path Creek delta that must have been what were originally observed in 2010 and identified as springs. Each hole was about 20 cm in cross-section.

Of the two flows, the one from the more north-easterly hole was at the time, the largest, and is shown in the photograph *left*. However, when observed again on February 16, 2020, the flow from this spring had stopped. The hole was full of static water and there was only an inconsequential trickle slightly lower down from beneath a near-by tree.

The flow from the more south-westerly hole, which was a smaller flow in January, had in February also ceased; however, the drop there in water level revealed numerous small seepages welling up from a patch of mud (photograph *next page*) looking like the surface of boiling water, slightly below the originally-observed hole. The total flow toward the lake from this patch of seepages was estimated roughly to be in the range 10–20 litres/sec.

These springs are only observed in flood conditions and don't appear to have a distant or deep underground source. As soon as the flow of East Path Creek abates, so does the flow from the springs, which accounts for the fact that they are not observed under more usual conditions.

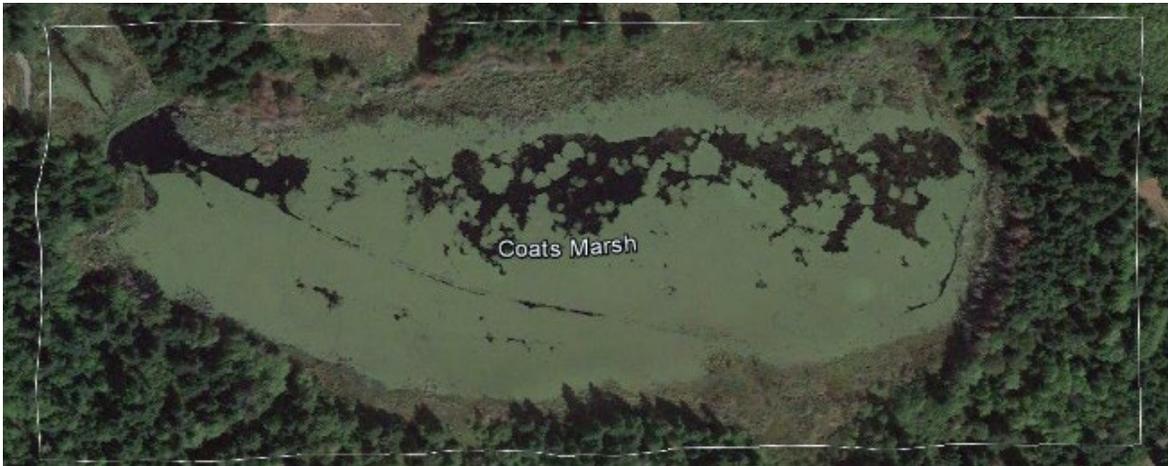
The following graphs should be used cautiously given that they are based on a simplistic geometry and a lack of accurate measurement data. They are only intended to illustrate trends. The lowest level of the lake bed B is taken to be -1.79 m relative to the concrete-weir datum.

In drawing down the level from the top of the weir to the top of the baffle, the strand has retreated 15.2 m (50 ft.). The volume has dropped 50%. The average depth has dropped -0.427 m from 1.193 m to 0.767 m.

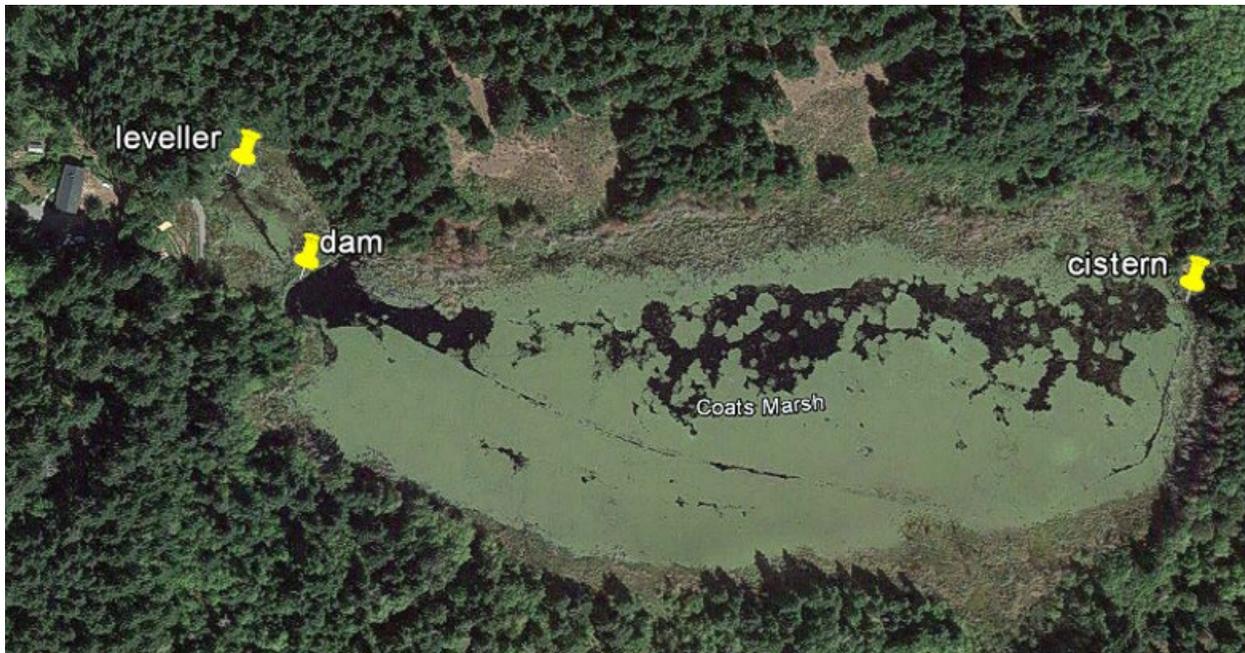
Google Earth: August 2016

One of the several important benefits of raising the level of water in the marsh is that it prevents the leaves of the aquatic plant watershield (*Brasenia schreberi*) from completely covering the surface leaving no open water anywhere in late-summer. Watershield grows from rhizomes in the “lake” bed, and thrives in water depths in the 1-6 ft. (0.3–1.8 m) range but doesn’t grow in water deeper than that.

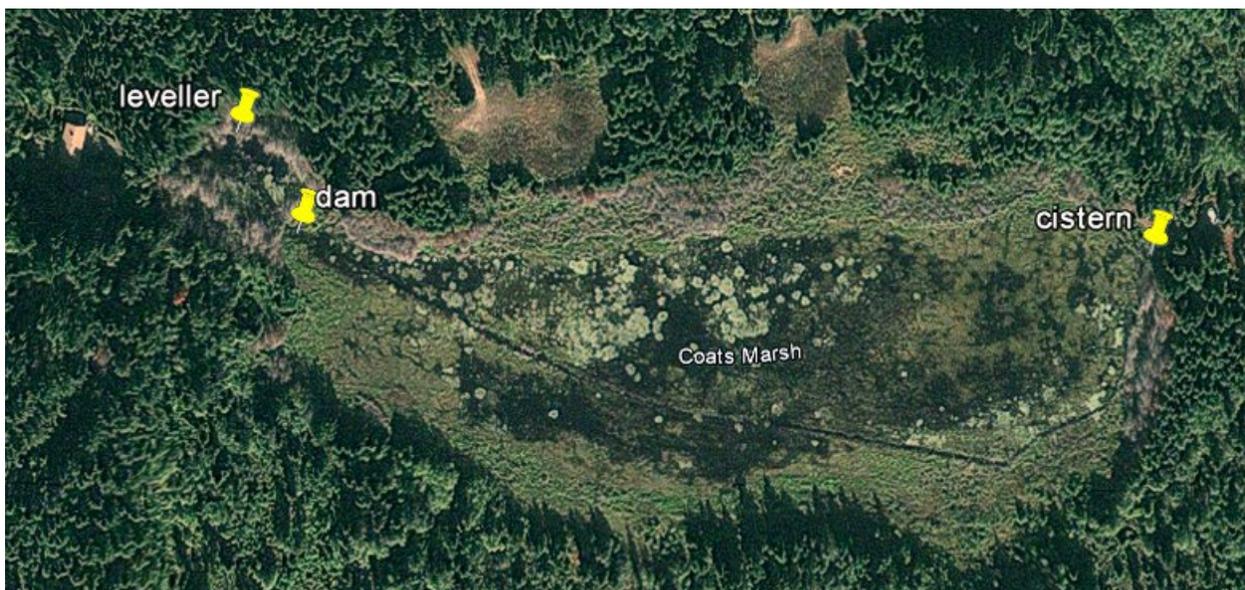
Google Earth: September 2009. The light green spots may be shrubs or small trees.

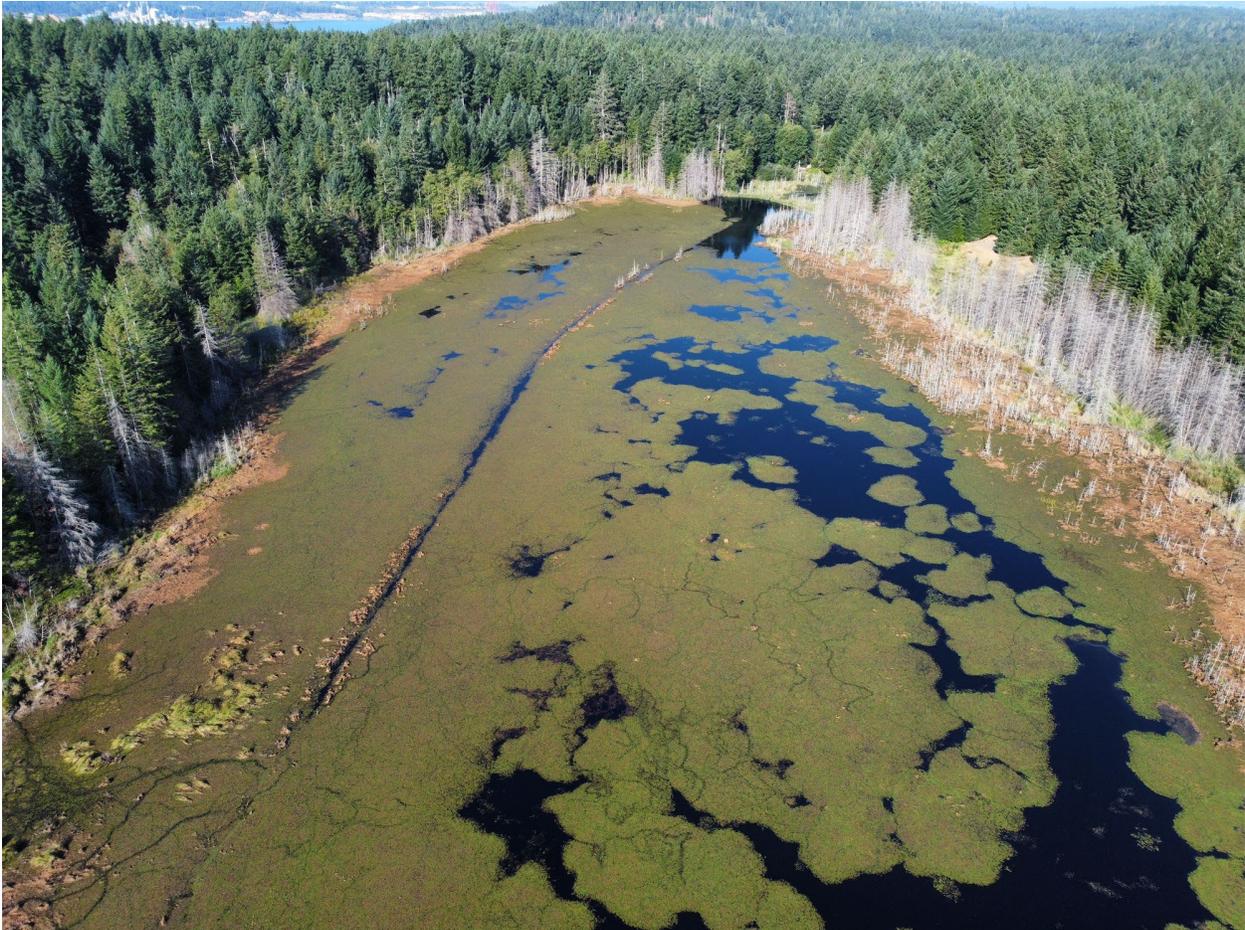
The Nature Trust of BC: late August 2021 during the RDN drawdown, looking west. Open water here reflects watershed growing conditions earlier in the year and also culling of the plant by the beaver.

Another twist to the story. On July 23, 2021, the RDN installed a syphon across the large beaver dam to lower the water level in the main “outer” marsh. This inevitably raised the level of the weirpool and Coats Marsh Creek, quite unseasonably, started to flow. Then on August 10, it was noted that the flow from Lot 5 had also unseasonably started to flow. Normally flow ceases around August 20, but there’s been no rain since mid-June. As of August 18, it was still flowing, re-opening the question as to whether this is subsurface flow beneath the berm.
