Gabriola Streamkeepers—Water levels and quality

Observations at Coats Marsh, Gabriola Island

—with notes on Coats Marsh Creek, East Path Creek, and Stump Farm Streams.

Field observations—2023 (Sept.—Dec.)

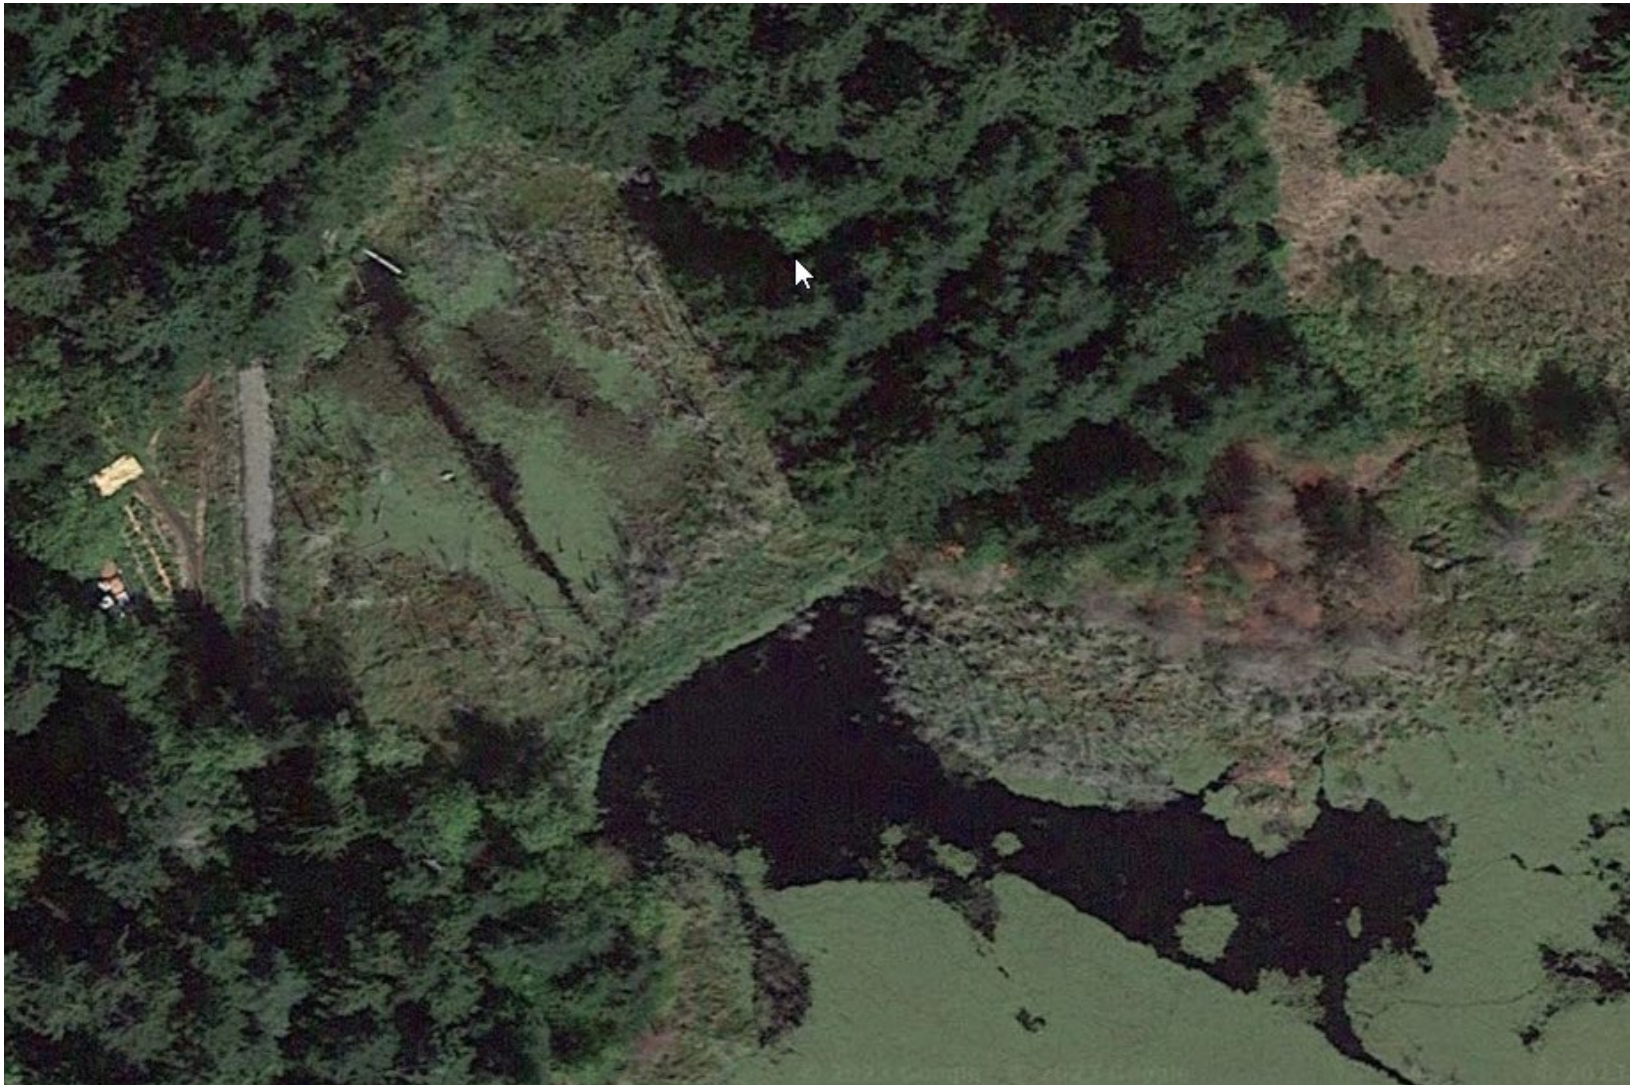
Google Maps 2023.

The drained weirpool, the beaver dam, and the west end of the marsh beyond the dam. In past winters, flowing water in this area has delayed freezing when the marsh to the east is iced over, thus providing a refuge for winter resident waterfowl. Draining this spring by the syphons installed at the bequest of the RDN/NTBC has been so severe that it is doubtful these conditions will continue this winter.

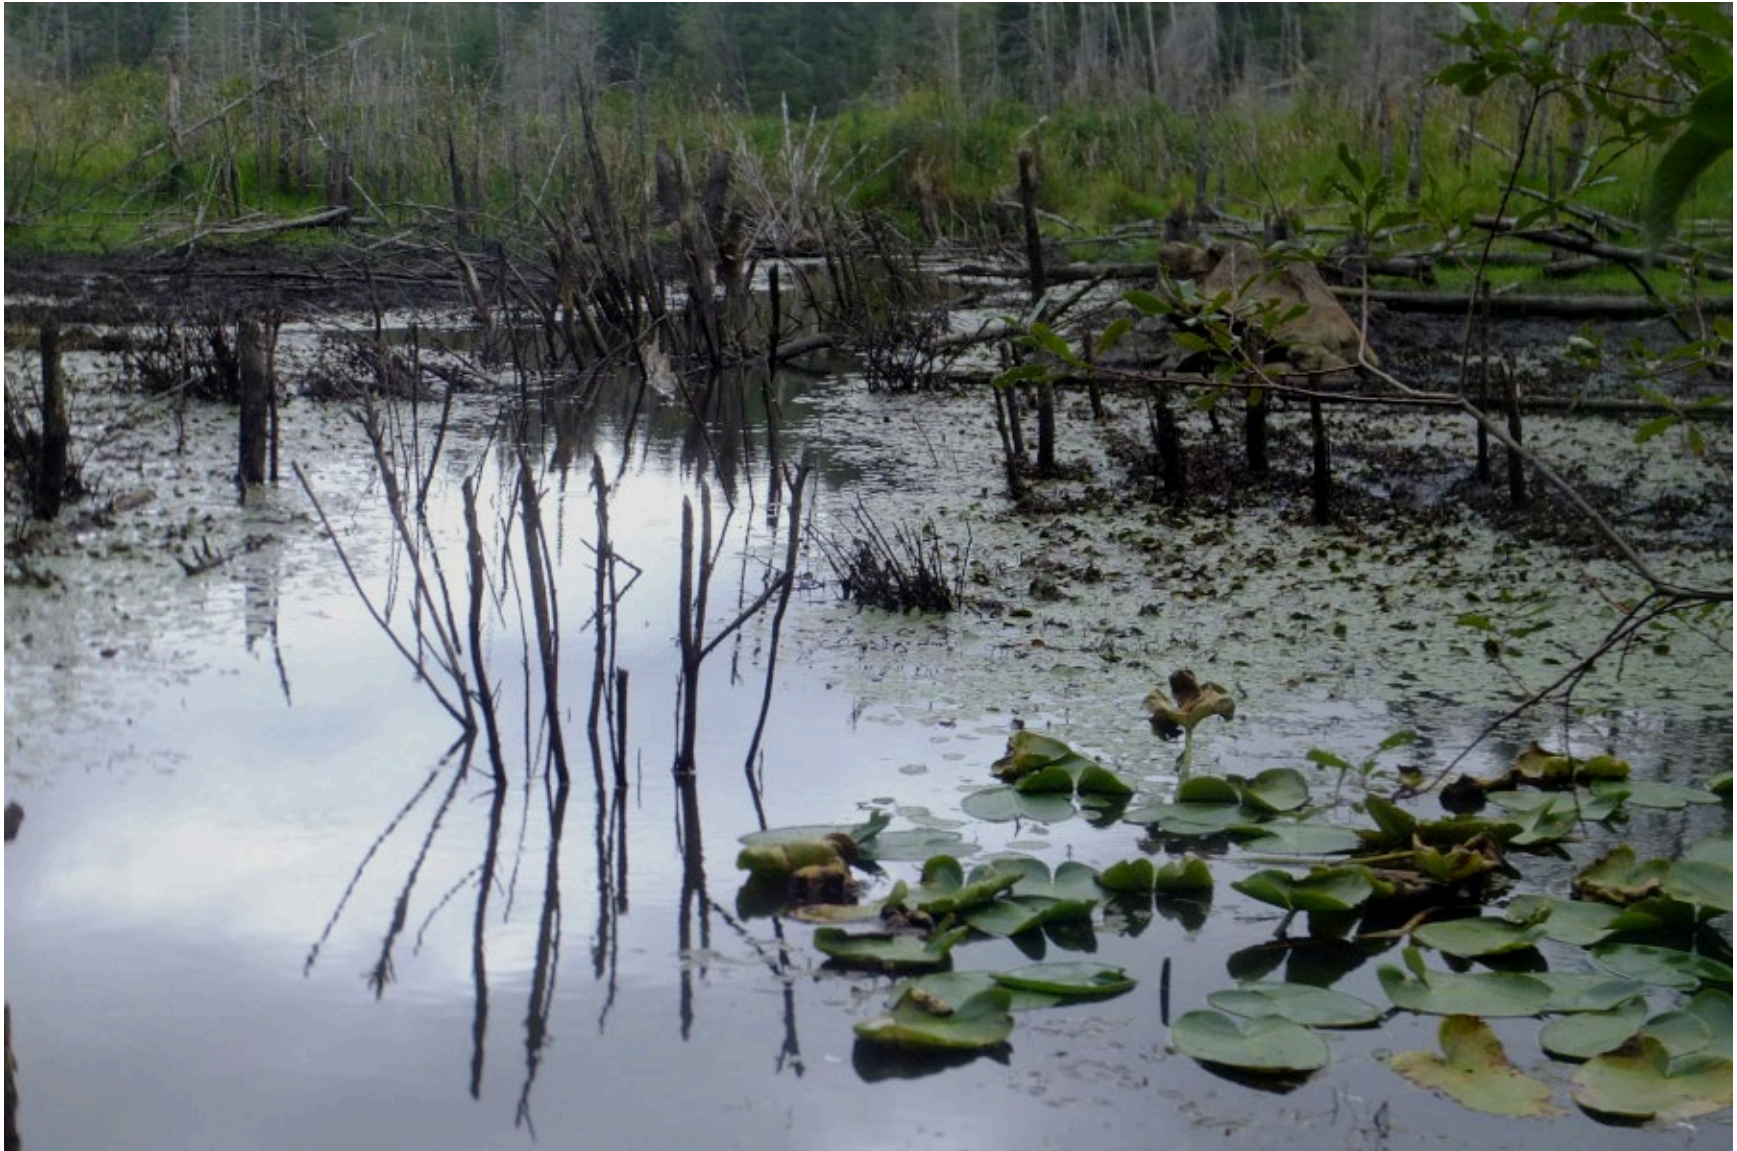
The weirpool seen from the berm with the beaver dam in the background. Aquatic plants in the foreground on the right are yellow pond-lilies (*Nuphar variegata*). These are uncommon outside the weirpool embayment. The water seen here is mostly in the old drainage ditch.

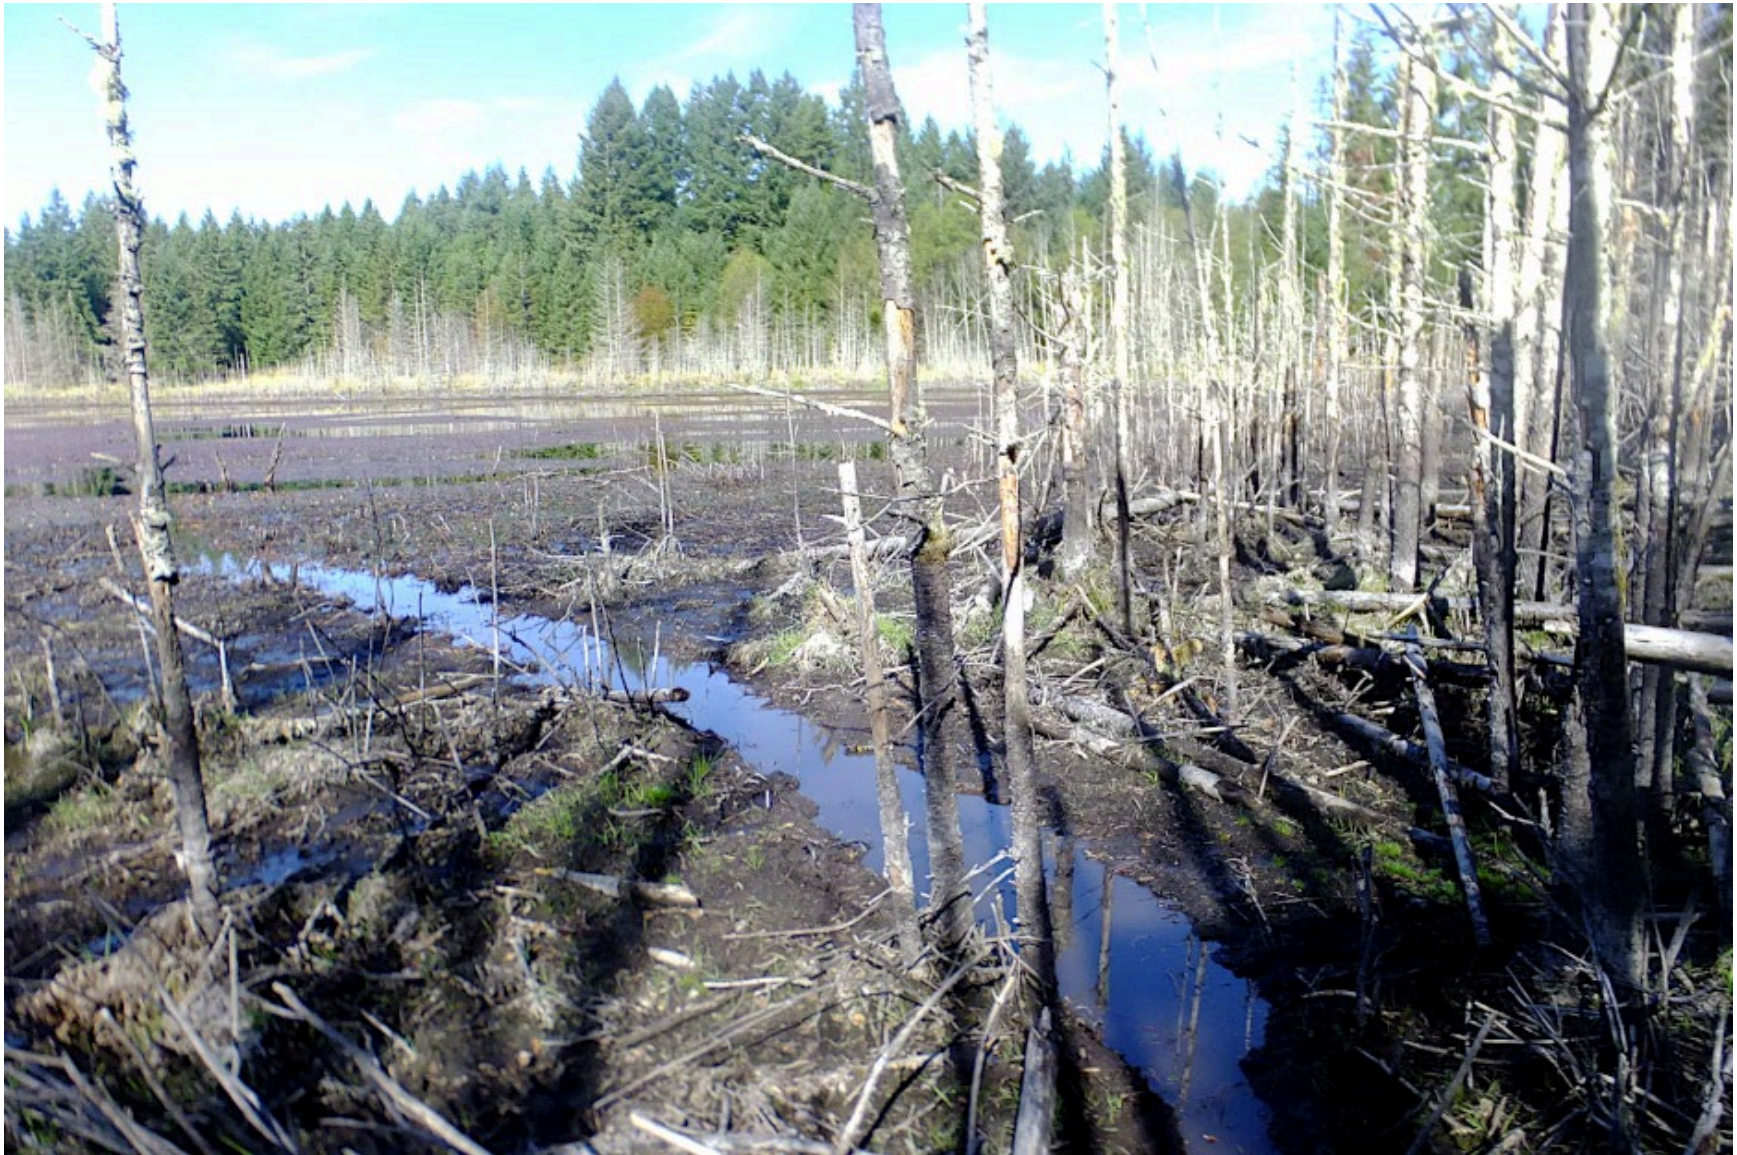
Old drainage channel? Normally submerged. In the vicinity of the mouth of East Path Creek.

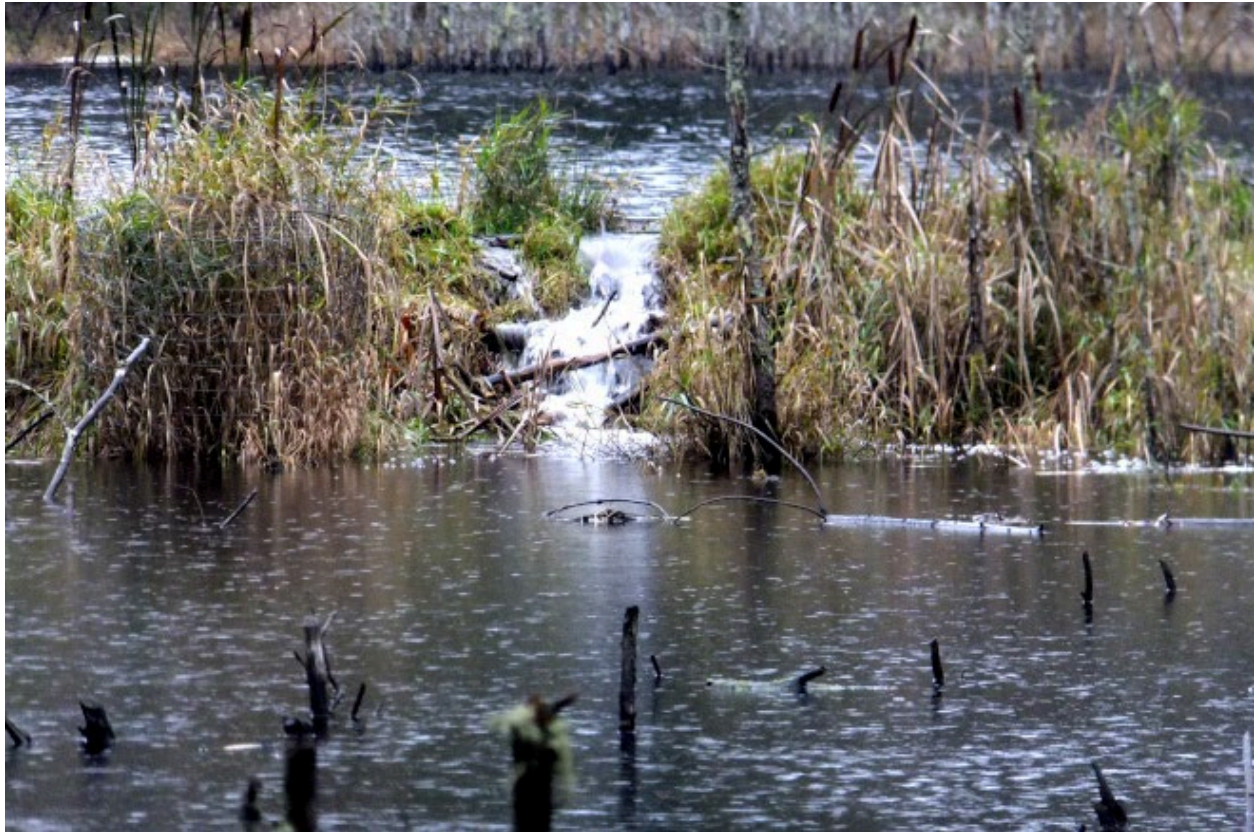
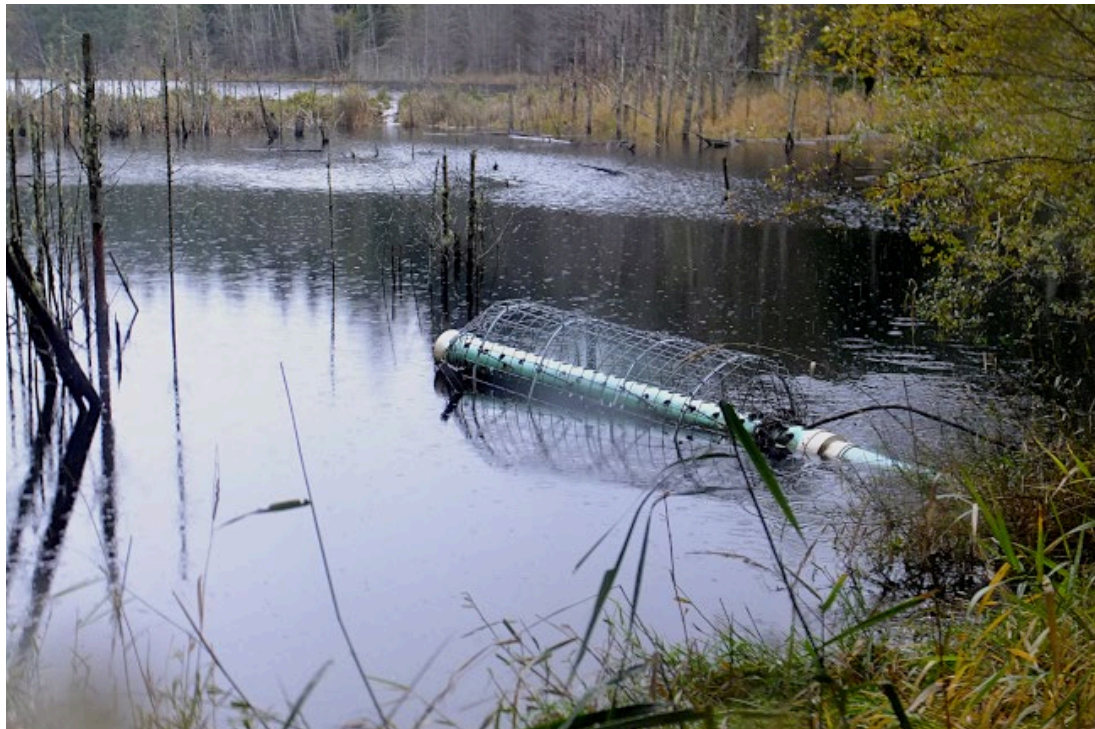
Above: The largest natural spillway in the main beaver dam. Used by the beaver both to reduce overflow and to move back and forth across the dam. The syphon system seen here on the left of the spillway is hidden in vegetation. *Below:* the pond leveller currently doing its job.

Water flowing over the crest of the baffle (at the sill) is contributing water, but the volume is less than that flowing through the leveller and seems less than it has been in the past given the level of the weirpool.

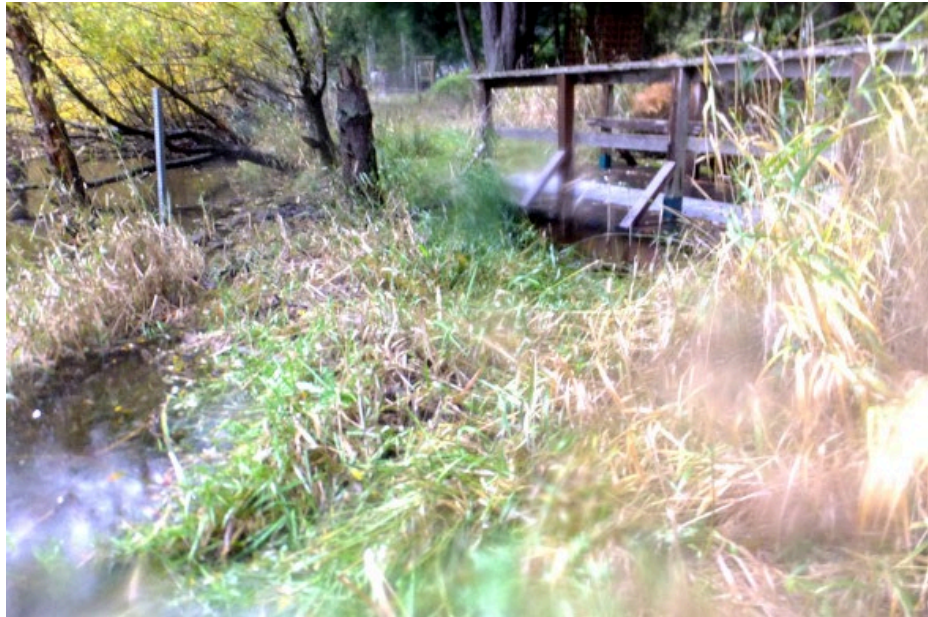
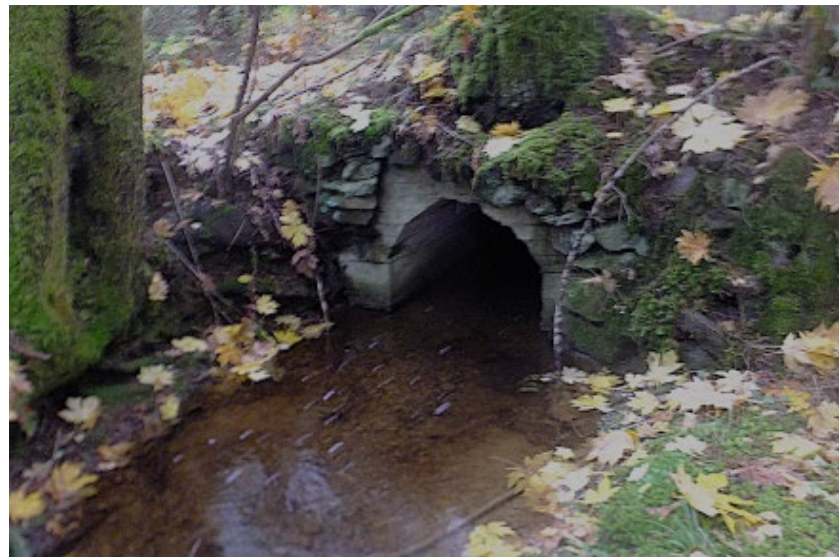
Above: The debris, now an engineered beaver dam, reducing the flow over the baffle. [Blurring due to raindrops on the lens]

Below: Coats Marsh Creek flowing modestly at the culvert under the Marsh Trail.

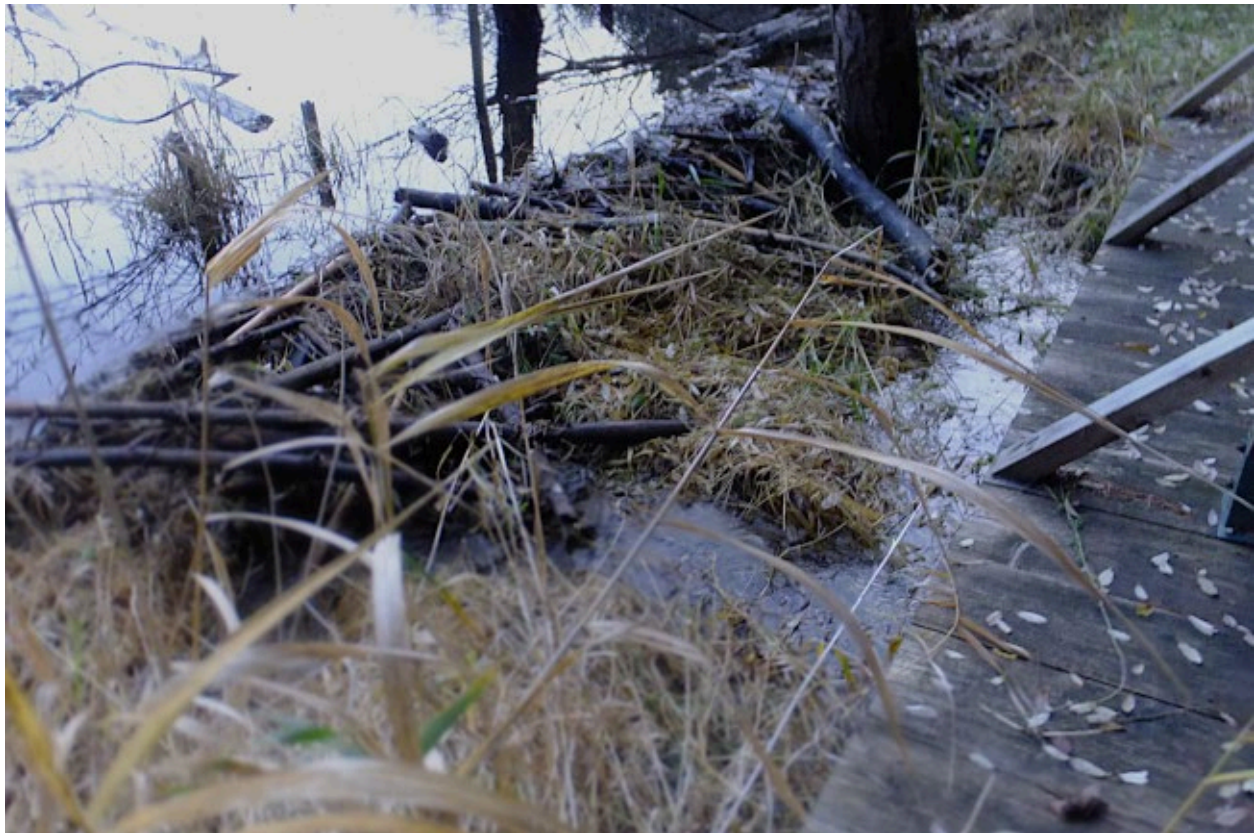
The debris/dam at the weir, December 8, 2023. More than one engineer been working on it ?

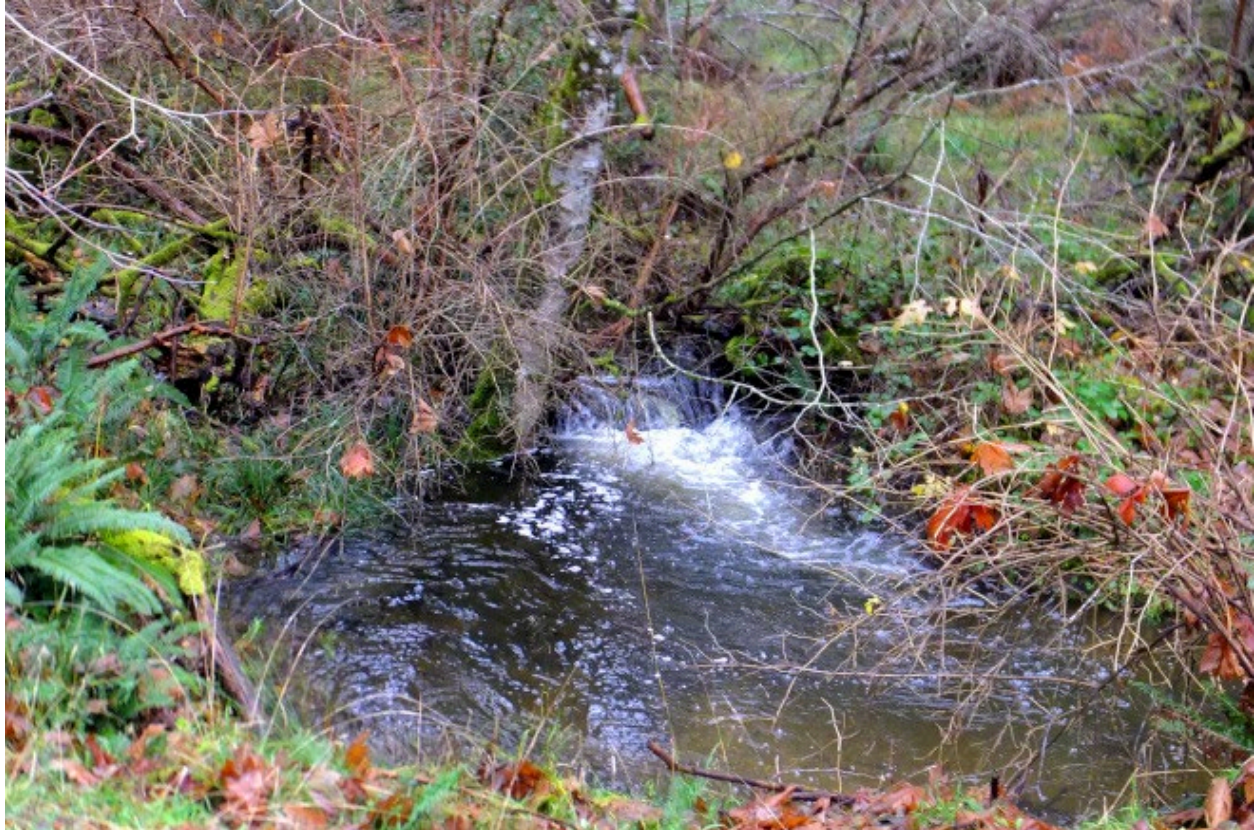
The last pool of upper Coats Marsh Creek. Known to be fish habitat despite conjectures by off-island experts to the contrary.
