Gabriola Streamkeepers—Water levels and quality

Observations at Coats Marsh, Gabriola Island

—with notes on Coats Marsh Creek, East Path Creek, and Stump Farm Streams.

Field observations—2024 (Jan.—)

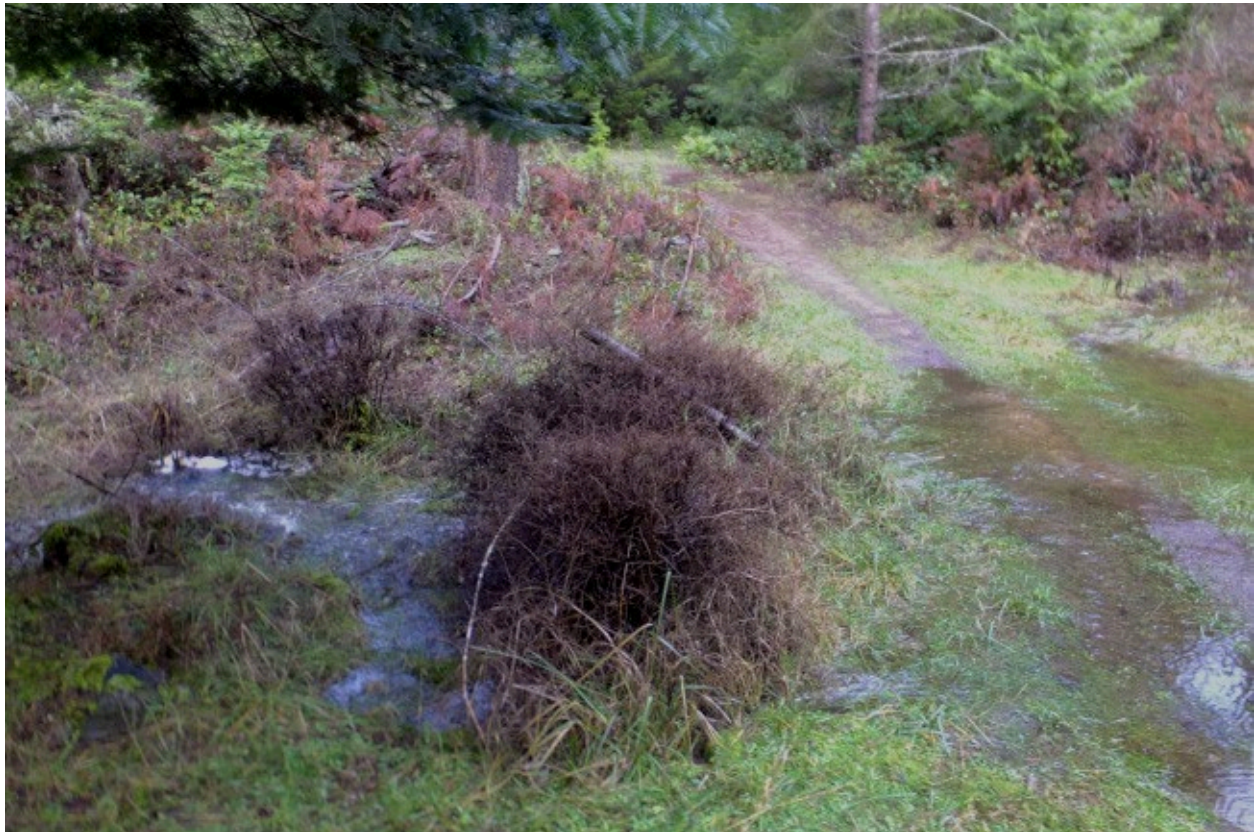
Heavy rain with passage of a cold-front overnight. EPC culvert full. NE Arm spillway (shown below) flooded with a flow over and under East Path comparable with that observed at the EPC culvert.

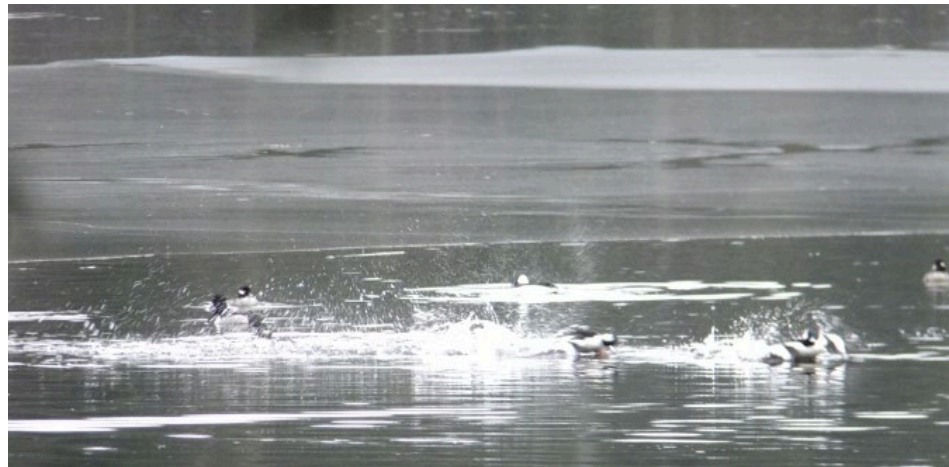
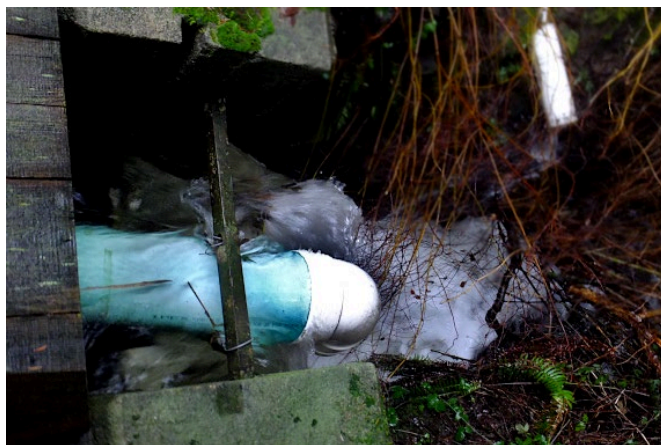
Discharge into Coats Marsh Creek. Rather more than the submerged pond leveller can handle (hard to see in the photo, but the level of water over the sill is higher than the top of the leveller).

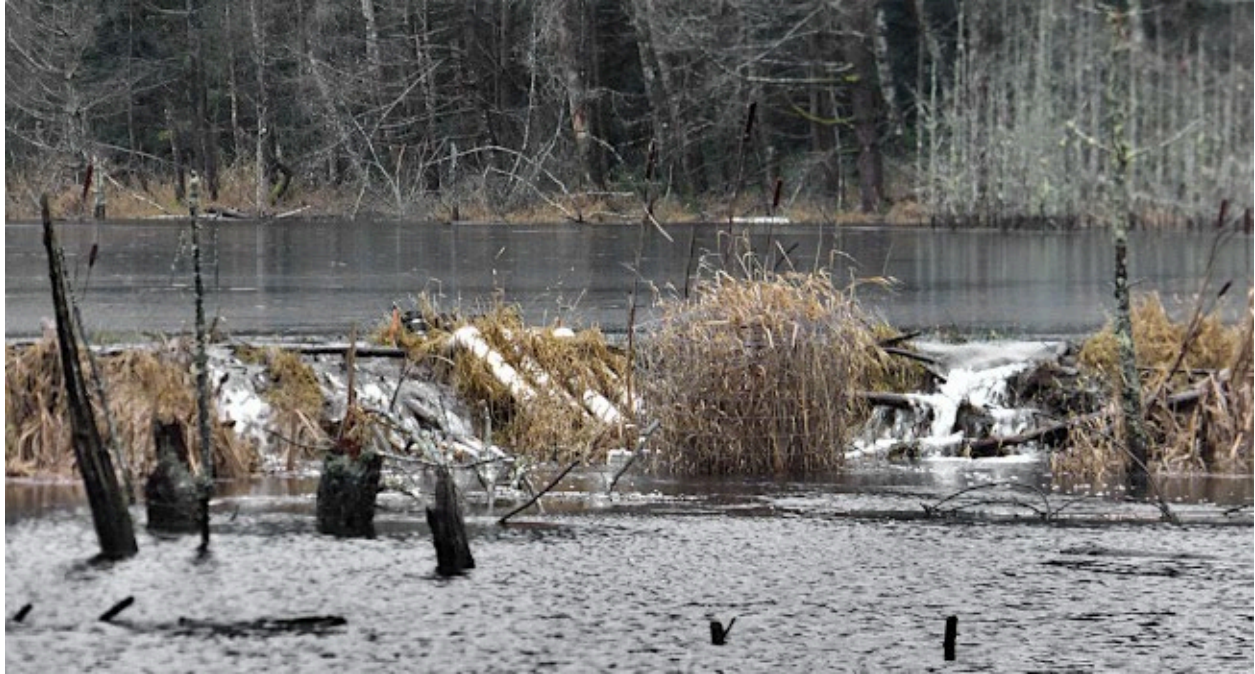
The beaver doesn't need the siphons to release potential floodwater. It also looks a bit dangerous to go out there to attend to the siphons. *Below:* The second beaver dam by the weir is raising the weirpool level.

In one month (Oct. 4 to Nov. 6, 2023), rainfall raised the lake level from -37 cm below the crest of the concrete weir to +52 cm above the crest of the concrete weir. At the same time, the level in the weirpool rose from 54 cm below the level of the sill (a severe drawdown) to 49 cm above it (partially blocked by the beaver).

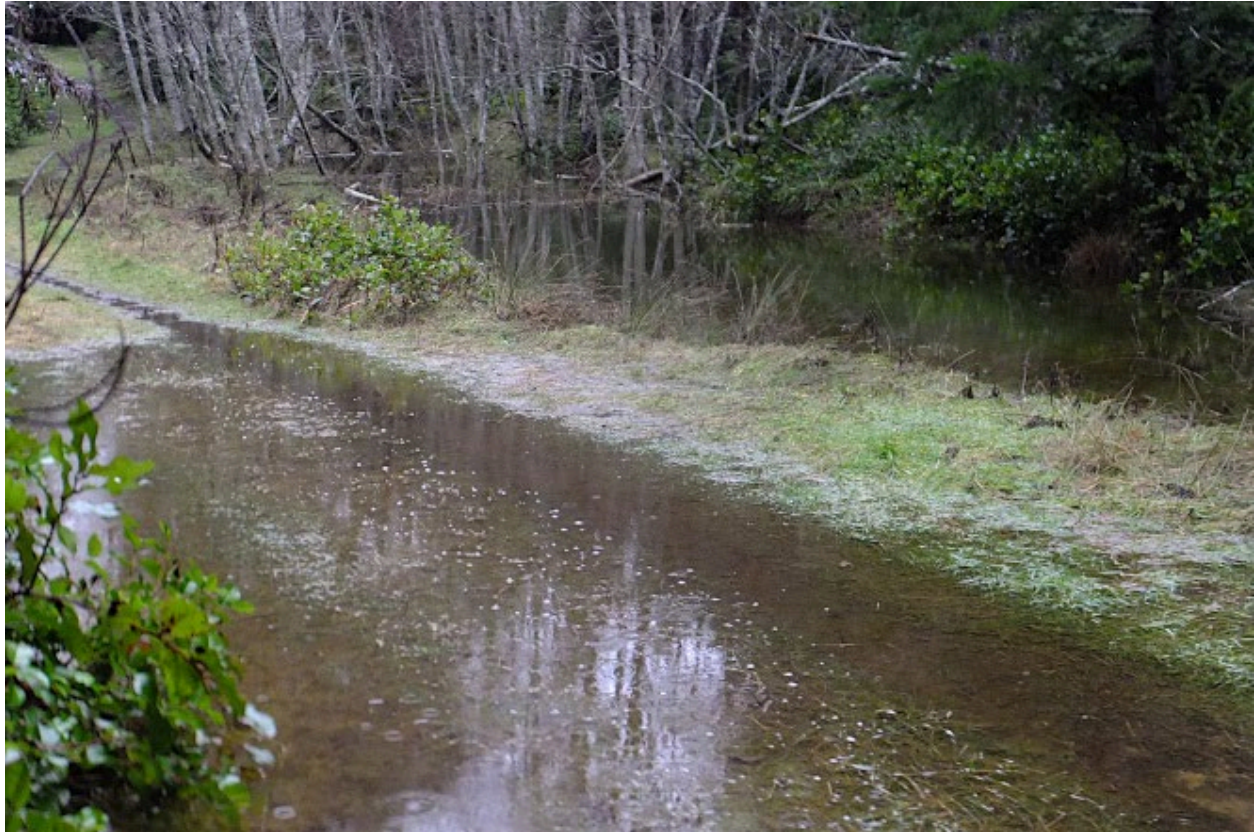
NNE Arm spillway. Not nearly as substantial as the NE Arm Creek, which it joins, more ephemeral, but contributes to “flash” flooding. Flows in watertracks rather than recognizable channels.

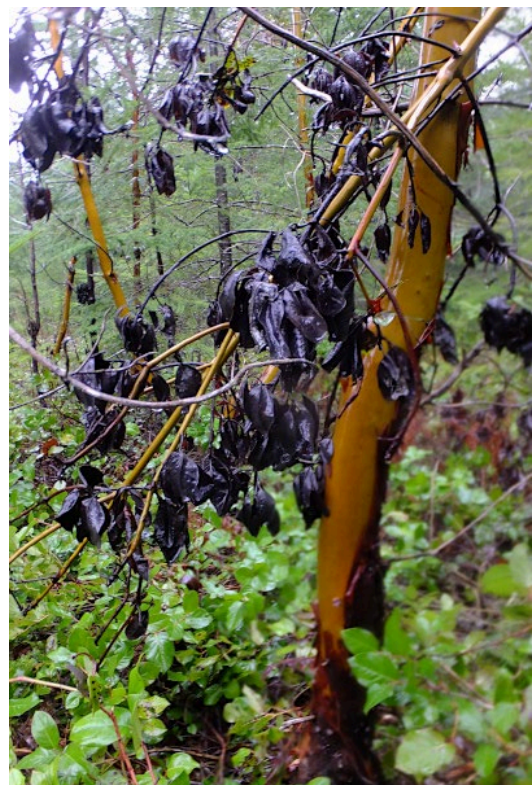
No change in the beaver debris/dam's height.

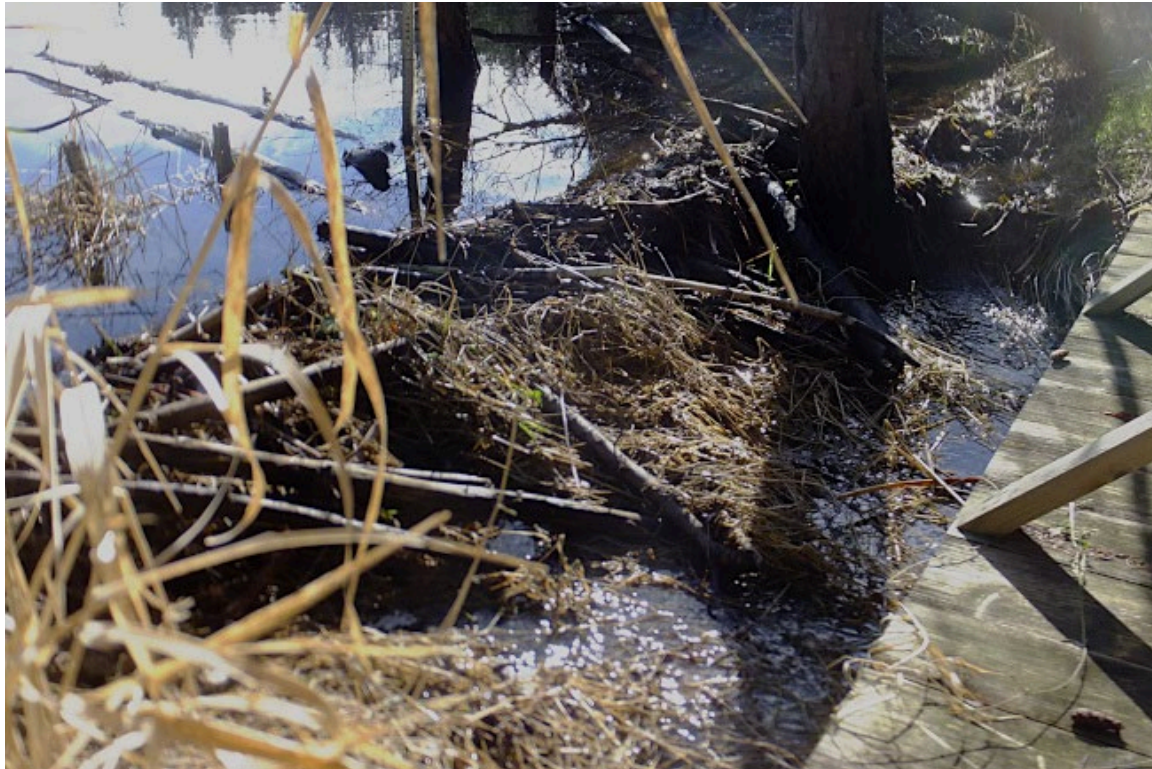
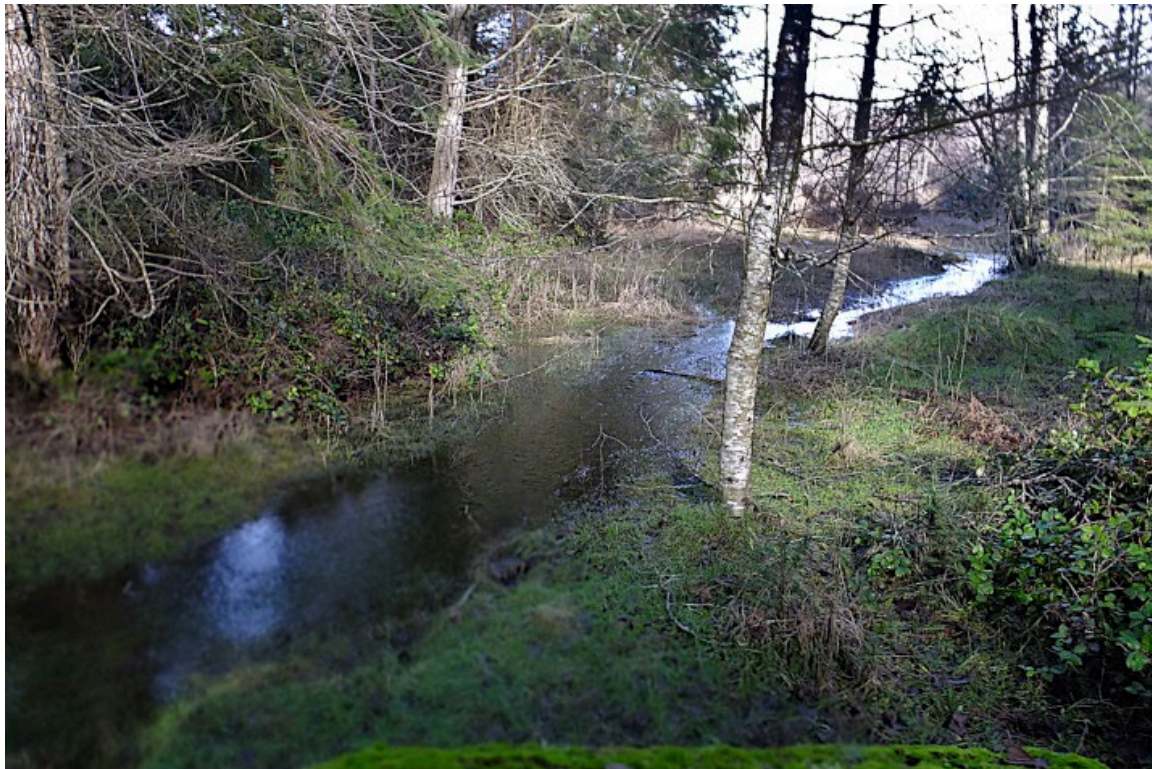
Stump Farm Number 1 Stream as it leaves Canary Grass Meadow (looking upstream, NE).

Established by a tortuous bushwhack around deadfalls and through sometimes thorny thickets, following trickling water, puddles, waterlogged grassy patches and other hydrophytic vegetation, that Stump Farm No.2 Stream² is readily traceable upstream from the Stump Farm Trail culvert³ eastward to a culvert on the Marsh Trail,⁴ which, measured along the trail, is about 60 metres west of the entrance to the western burn-pile clearing. It's often ponded on the NE side of the Marsh Trail at the culvert location.

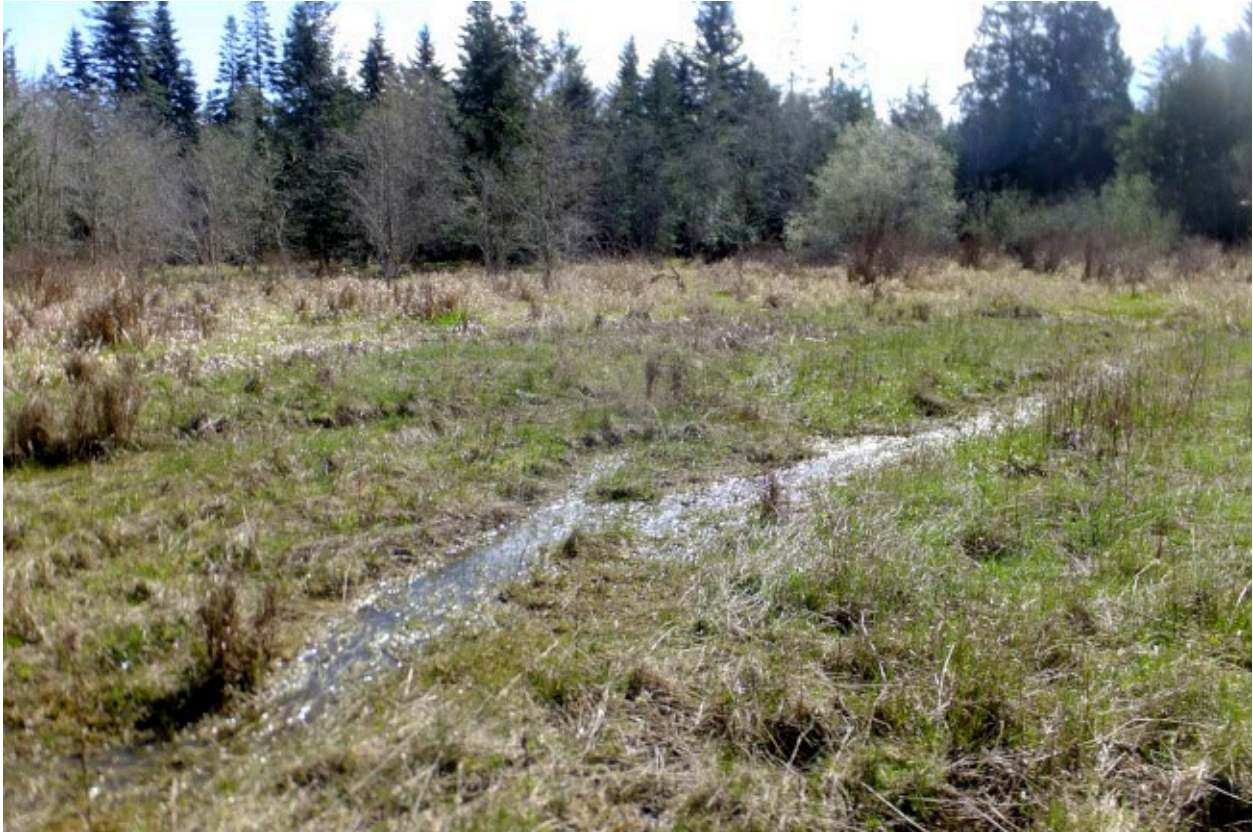
This wetland, along with the NE Arm and SE Arm wetlands doesn't hold water for more than a few weeks at the start of the dry season because of infiltration into the fractured-sandstone bedrock.

Although the beds of these wetlands are layered with clay-rich gleysol (the result of the weathering of plagioclase-rich glacial-flour that accumulated when these were meltwater lakes at the end of the Pleistocene), this gleysol layer is evidently far from being perfectly impervious, unlike the thicker layer of the same material underlying the main Coats Marsh wetland.

Dredging the main Coats Marsh wetland, by thinning or removing altogether its metre-thick layer of gleysol, would remove its exceptional ability to retain water throughout the dry season.
