Gabriola Streamkeepers—Water levels and quality

## Observations at Coats Marsh, Gabriola Island

—with notes on Coats Marsh Creek, East Path Creek, and Stump Farm Streams.

### Brief history of the weir

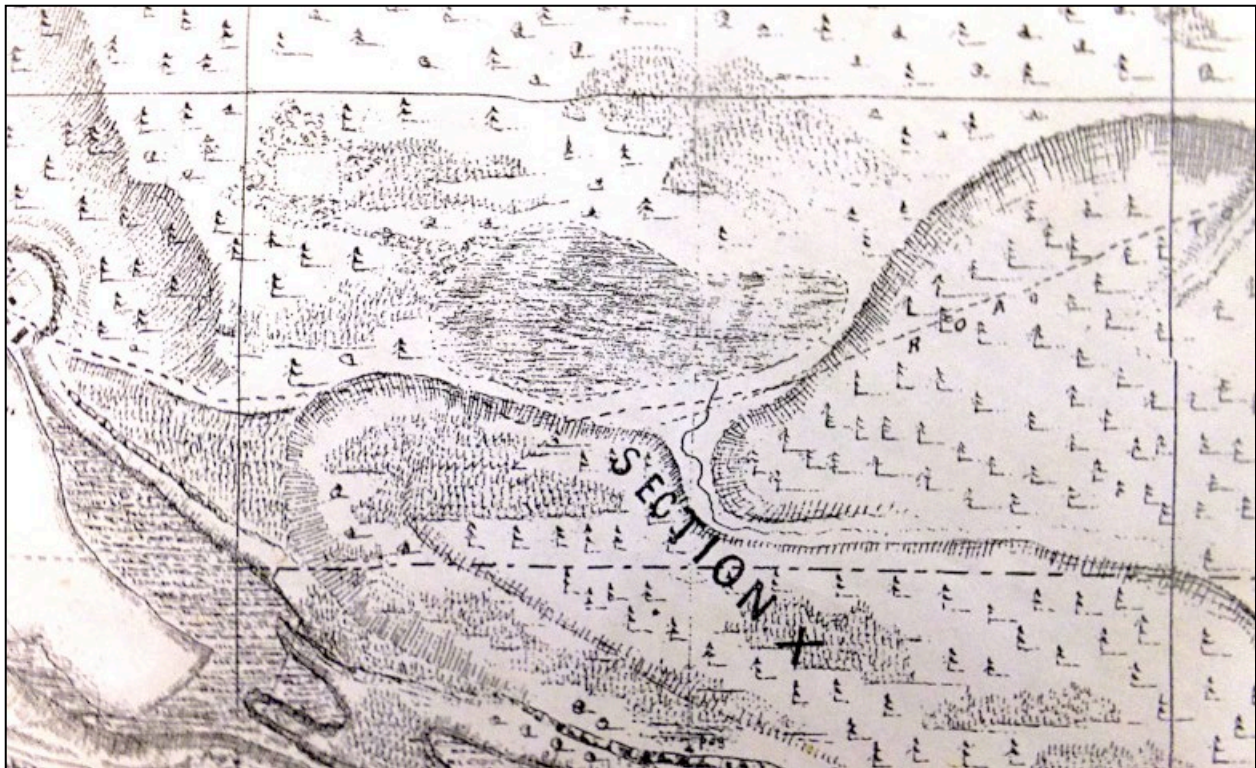
Survey 1874/5 showing the NW¼ and NE¼ of Section 10 owned at the time by William Hoggan. Coats Marsh is outlined and shown as unforested swamp in the centre, straddling the two quarter-sections as it does today. Early maps were careful to include swamps because land unsuitable for agriculture did not count toward the area being pre-empted. East Path Creek (the solid wavy line) is traceable all the way back to McGuffies Swamp, but no similar outlet from the marsh down to Hoggan Lake on the left is apparent.

The significance of the lightly dotted line running E-W through the middle of the marsh, parallel to, and north of, the bold dotted “Road to Easson’s” heading off NE, is unclear. If a trail, then was it used when the swamp was dry or very shallow in summer, or when it was iced over in winter? This marking is copied in some later maps.

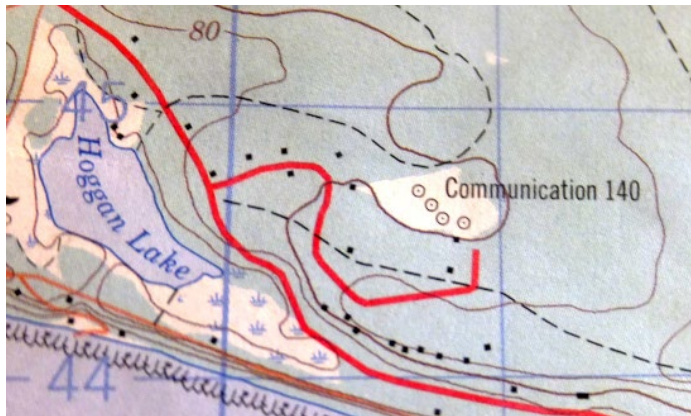
NRC topographical map 92G/4 Nanaimo, Edition 5 from 1989 data. The 140 presumably is the height of the top of the antenna(s) above sea level. The four tower foundation remnants are usually submerged.

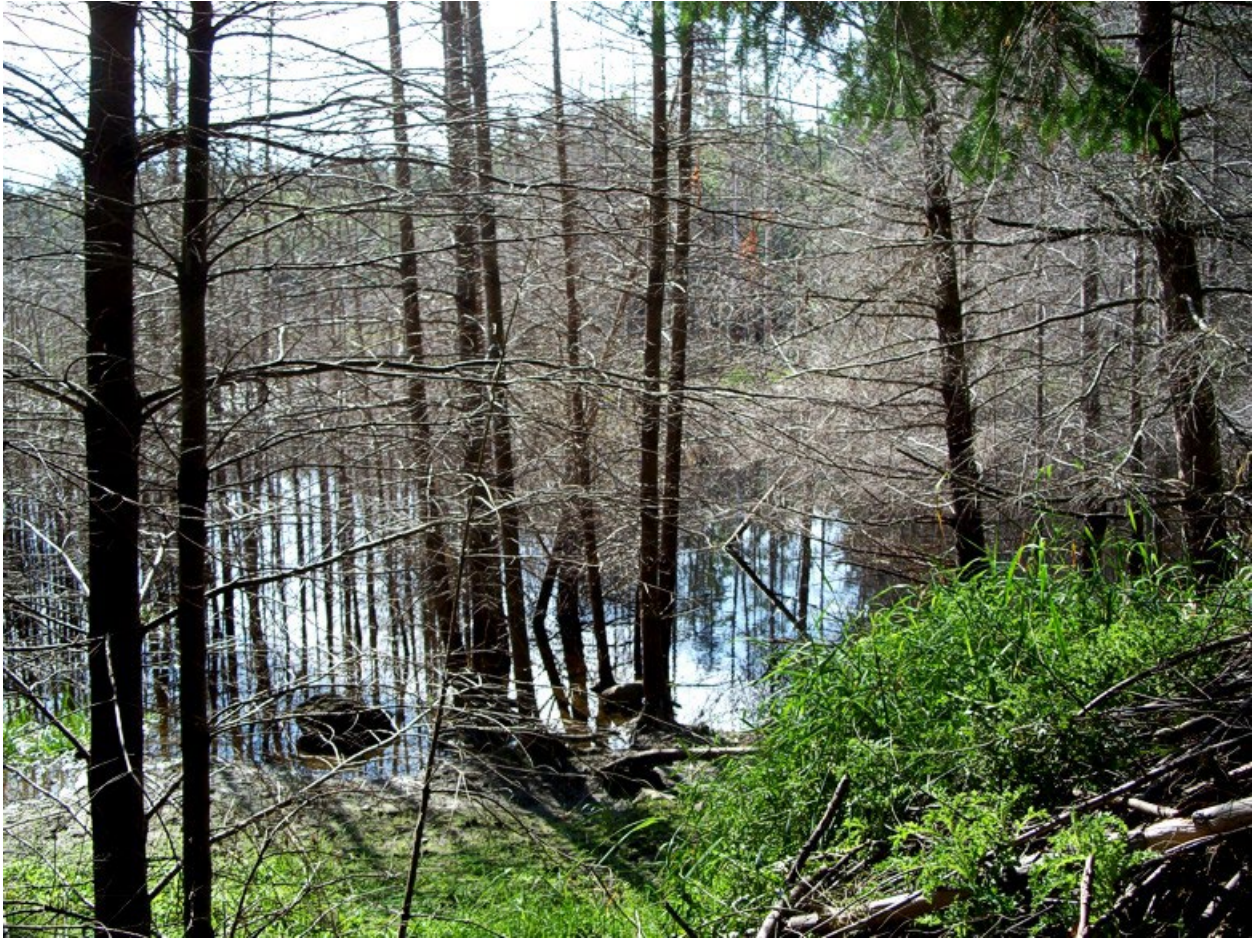
Snags at the margin of the lake killed when the site was re-flooded. Picture taken September 2009 near the weir. The then newly-constructed beaver lodge is just visible in the bottom right-hand corner of the picture.

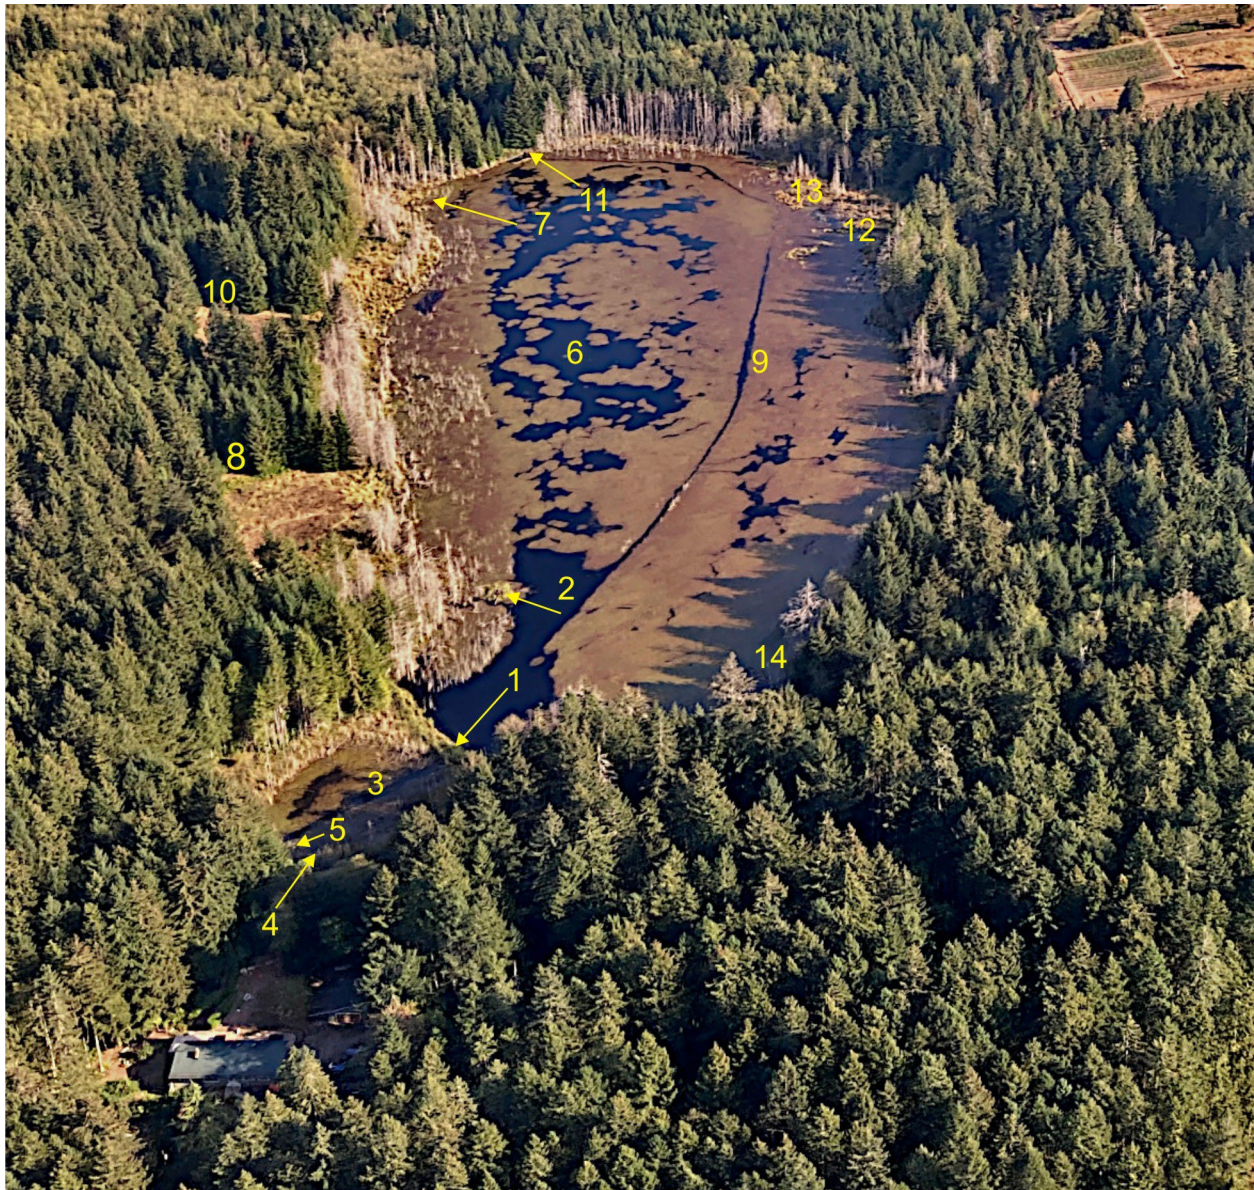
The picture was taken from a helicopter above the west end of the marsh (Lot 5) on October 13, 2022. The view is close to being due east, with the northern shore on the left. The key to the points identified are as follows:

1. the beaver dam dividing the wetland into two sections. The dam is mature and given the lake-like setting, very stable.
2. the beaver lodge. The beaver sometimes goes absent for a few weeks at a time, presumably down to Hoggan Lake, but he always comes back. He was seen at the lake on September 28, 2022.
3. the embayment at the western end of the wetland created by the beaver dam (1). Now known as the weirpool, although in the past it has also been written weir pool and weir-pool, and named weir bay, west-end bay, or just the west end. The residents (Lot 5, visible at the bottom of the picture) refer to it, or used to refer to it, as the “inner marsh”.

4. the berm built to protect the private property from flooding from the weirpool (3).
5. site of the Clemson leveller and concrete weir. Headwater of Coats Marsh Creek.

6. the shallow-water wetland, often called informally and technically incorrectly as the lake. Includes the weirpool (3). The green-beige surface is watershield (*Brasenia schreberi*), the dominant aquatic surface plant in summer. The residents at the western park boundary refer to, or used to refer to the wetland beyond the beaver dam (1) as the “outer marsh” as distinct from the “inner marsh” (3).

7. the inlet from the channels draining the NE Arm wetland. There is a hydrological map in File [668](#). Watercourses from the NE Arm wetland down to the lake are mostly irregularly strewn. The beaver regularly spends time here, perhaps attracted by the red alder trees.

8. the western burn-pile clearing. Quote from the Management Plan: “For approximately 20 years prior to park designation [in 1989], woody debris [mainly stumps], was stockpiled on the northern margins of the wetland in the Coats Marsh RP property and burned annually in the autumn under permit from the BC Ministry of Environment. There are no known incidents of wildfire on the property.” See footnote 1.

9. track of the ditch dug by Bill Coats in a time when the wetland was completely drained. It is now too deep to support watershield (6), which is rooted in the lake bed.

10. the eastern burn-pile clearing. See 8.
11. the concrete cistern built for watering cattle at the east end used now as a lake-level datum.
12. the Stanley Place entrance. The lake is far too small for footpaths, observation posts, boardwalks and the like to be built around it without destroying its seclusion and without seriously disturbing wildlife, particularly in the waterfowl breeding season.

13. the inlet from the East Path Creek (and two associated springs) that flows through the SE Arm wetland in the wet season. There is a hydrological map in File [668](#).

14. Beaver Bay. So called because of intensive beaver activity there. It has become a favourite secluded resting area for waterbirds, and it remains relatively ice-free in winter.

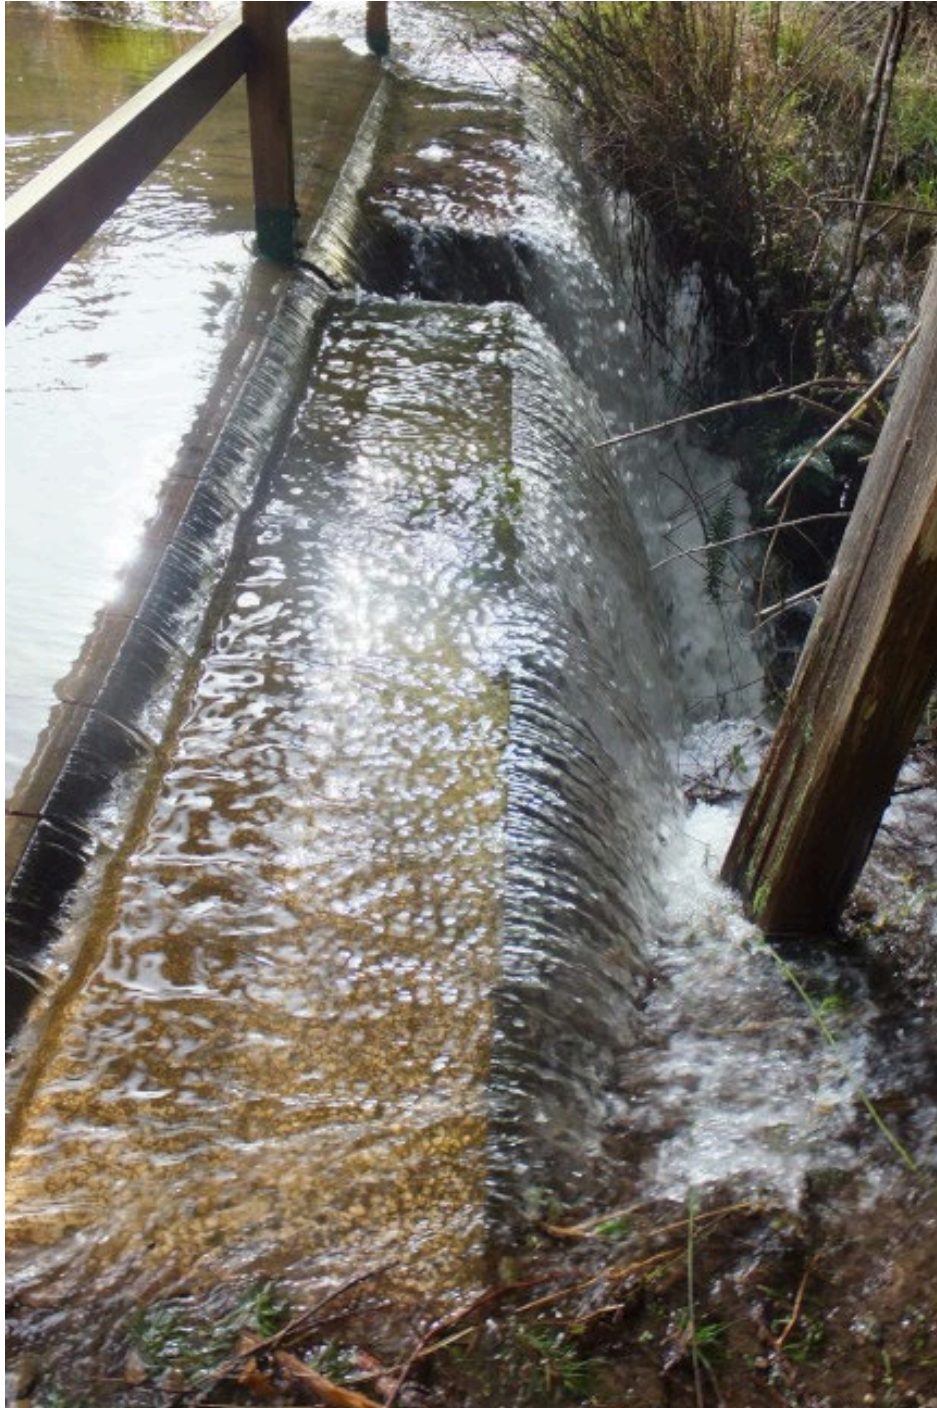
View from the NW corner.

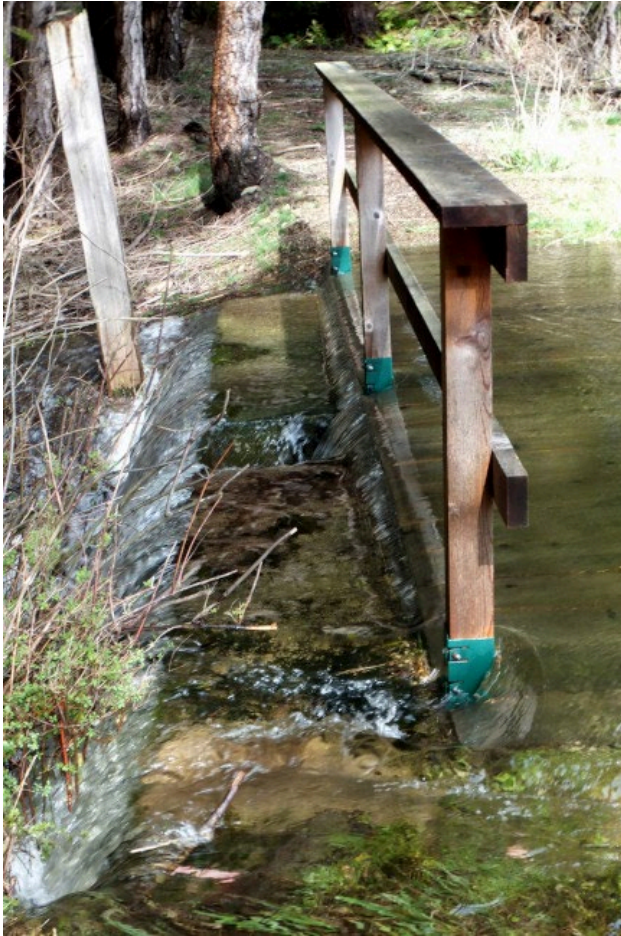
*Left:* View from the SW corner.

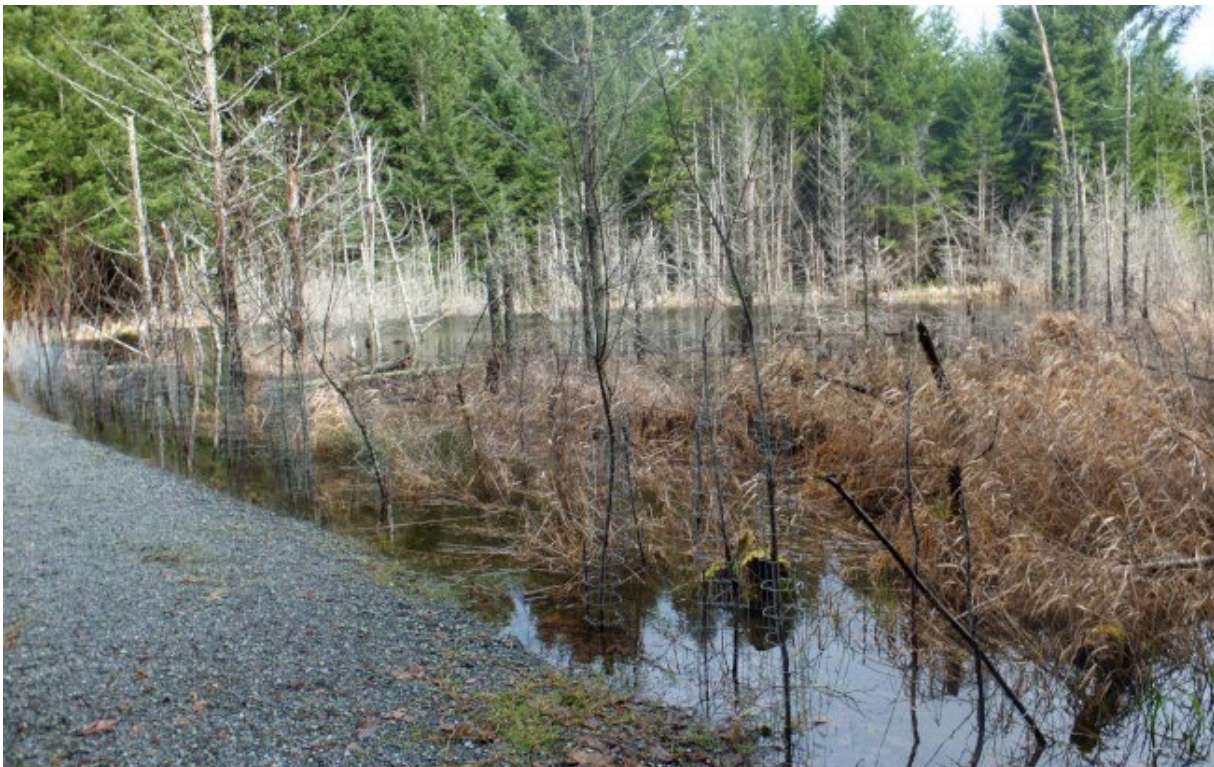
*Below:* The berm is all above the water level.

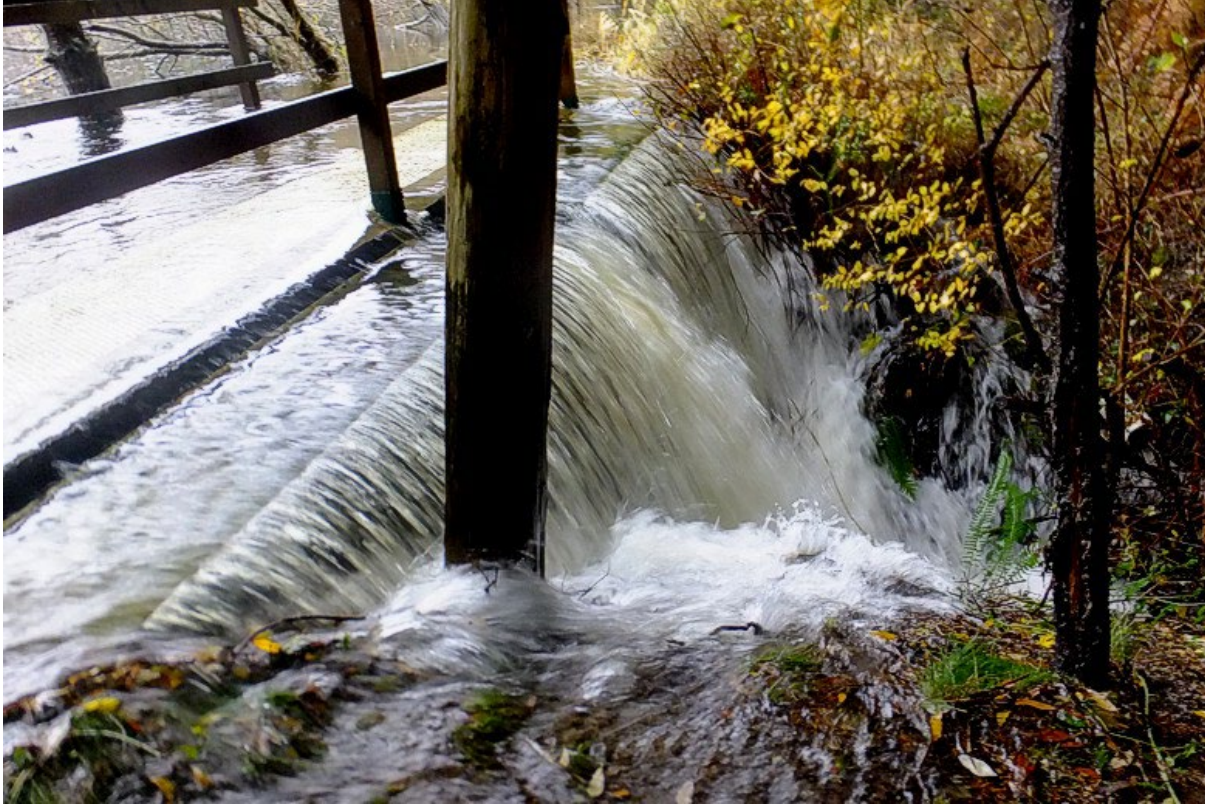
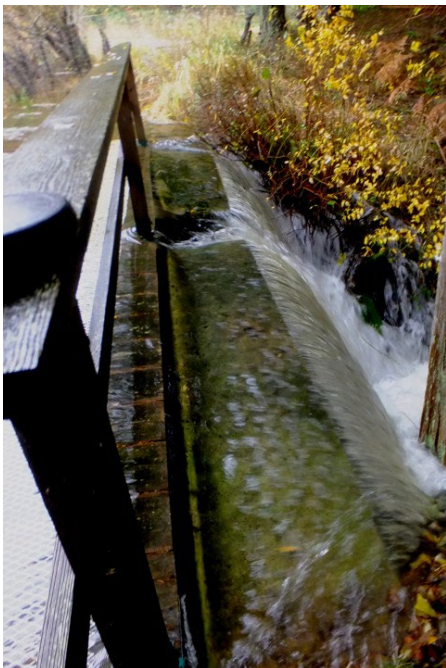
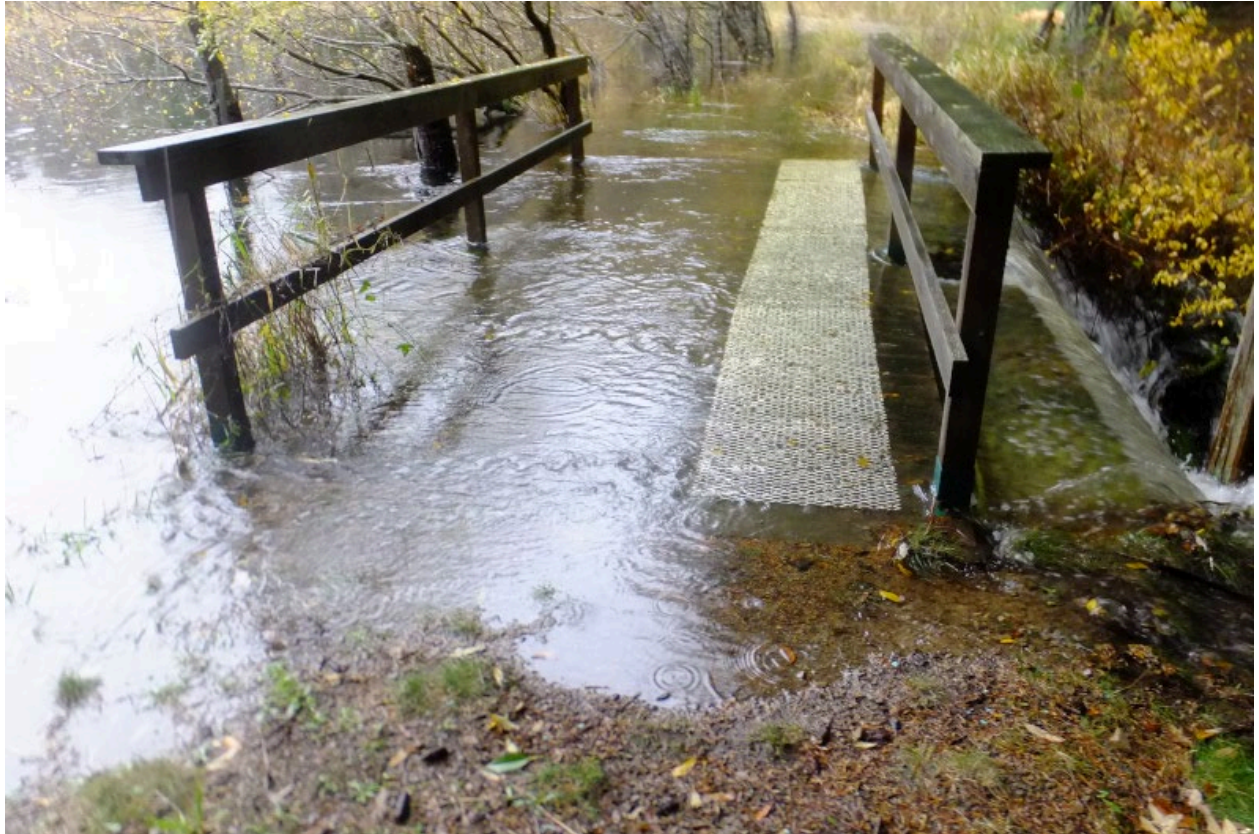
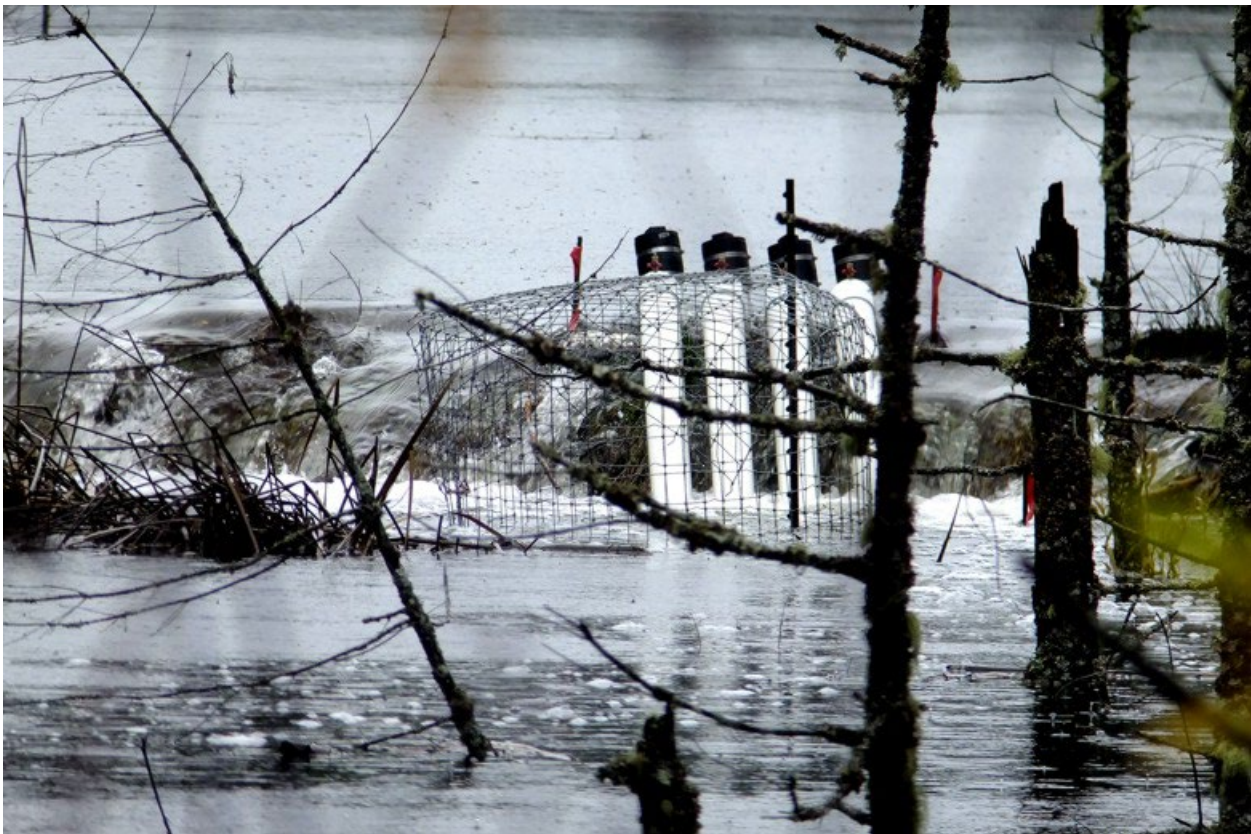
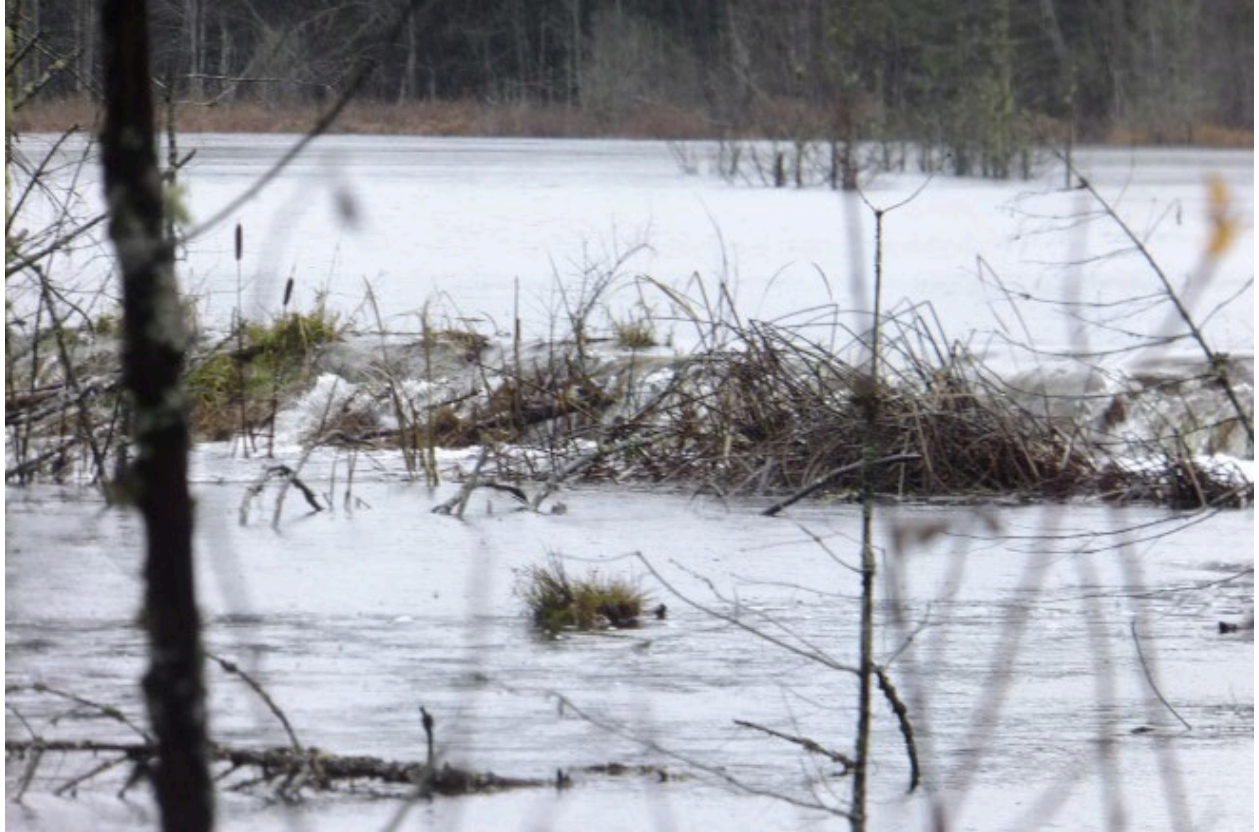
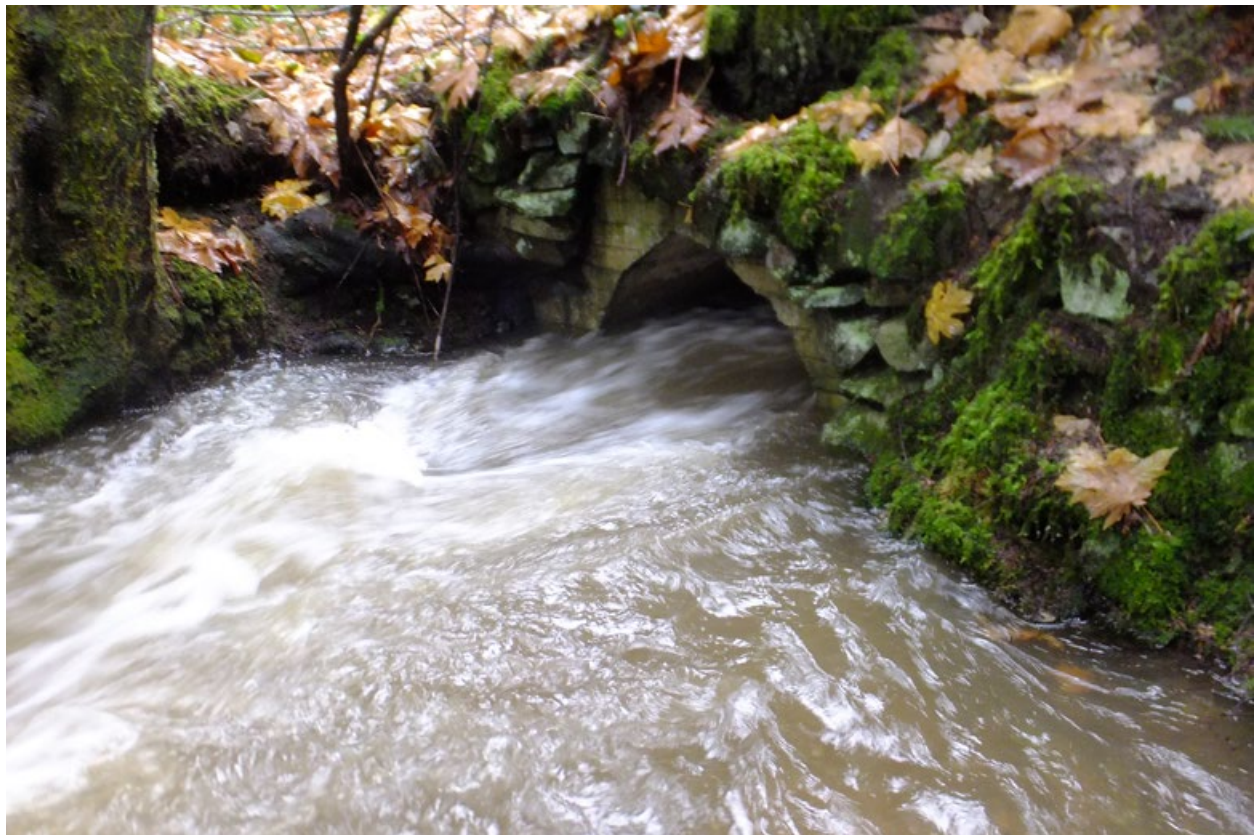
## The flood of November 15, 2021 (day +2312)

No measurement was made of the flow in Coats Marsh creek. The berm was not breached except where water circles harmlessly around the ends of the weir and adds to the flow into the creek. There was a higher flood on March 14, 2014 but it too failed to breach the berm.
