Honeycombing of a gravestone at Tilton on the Hill, Leicestershire, UK

Honeycombing of a gravestone at Tilton on the Hill, Leicestershire, UK
 —notes by [Nick Doe](#).

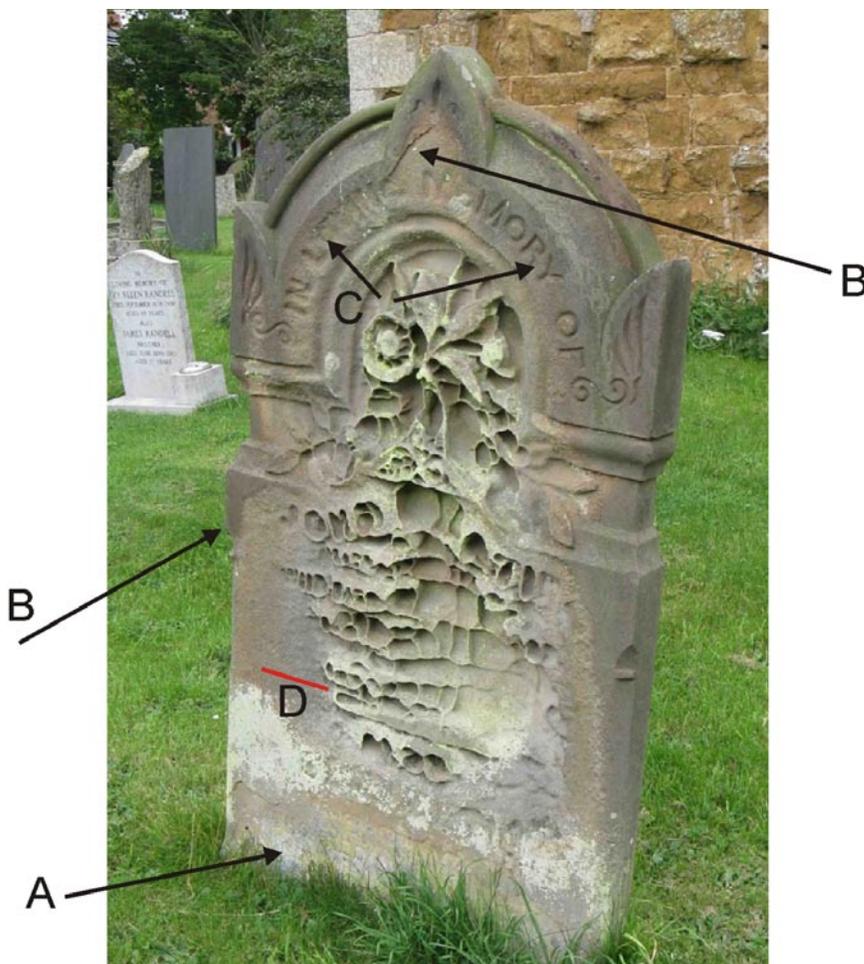
A: efflorescence? white with faint tinges of pink, if it is an evaporite mineral it's probably *calcite* with minor *magnesite* with colour added by traces of *hematite*. Also very possible is that it is just desiccated algae, not a mineral salt;

B: spalling, case-hardening. Case-hardening develops compressive stress at the junction of the weathered surface and underlying unweathered stone and this makes the surface layer prone to spalling;

C: asymmetrical weathering possibly related to orientation;

D: possible bedding plane orientation giving rise to the linear arrays of honeycomb holes.

Judging by what appears to be efflorescence [A] at the ground level, the sandstone is quite porous. The presence of efflorescence would indicate a fairly high probability of there being subflorescence present also, and, if so, this could be weakening the cementation of the sandstone.

There are traces of spalling¹ [B] so the sandstone does retain some mafic mineralization [*biotite*, *amphibole*?]. The weathering, judging

from the reddish hue, is to *hematite* and by the dark colouration to *goethite*. Brown weathering near the surface may contain manganese.

Weathering of mafic minerals produces an iron oxide/hydroxide *limonite*-cement that [case-hardens](#) the surface of the sandstone making it stronger and less permeable, possibly less porous too. It increases the

stone's resistance to salt-weathering. Often however, this increased resistance accelerates the weathering of near-by patches of the surface where case-hardening has not occurred or has been breached, which appears to be the case here. This acceleration is due to raised evaporation rates and salt deposition on the unprotected surfaces. Salt-weathering

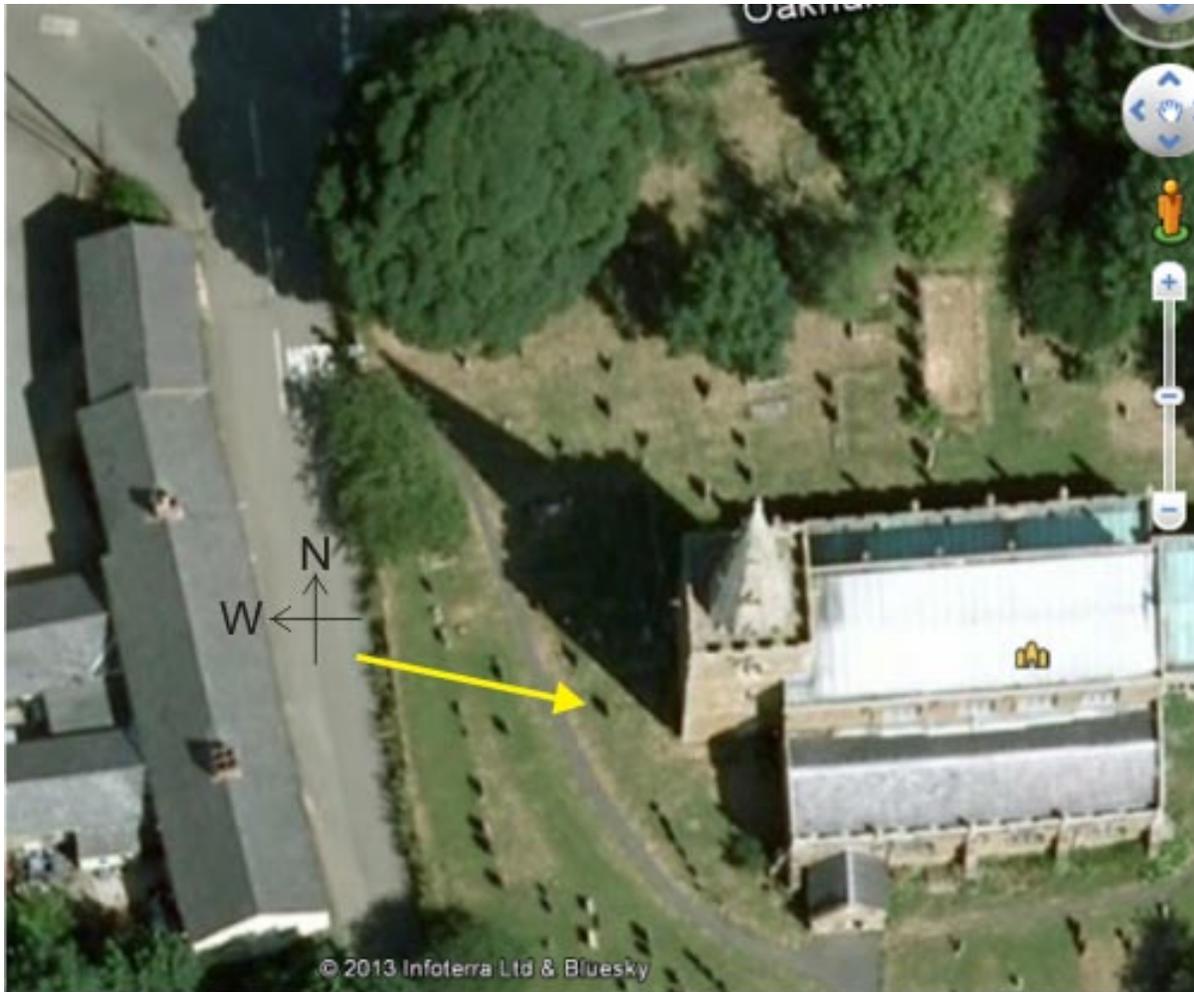
The location and N-S orientation of the stone means neither side faces the sun at noon; however, the front face facing west receives uninterrupted illumination during the afternoon and evening; while the back face is in the shadow of the church throughout the morning. Sun absorbed on the front face during the day keeps the stone warm in the evening and increases evaporation from the holes as the outer air cools. This does not happen on the back side of the stone so evaporation remains low there.

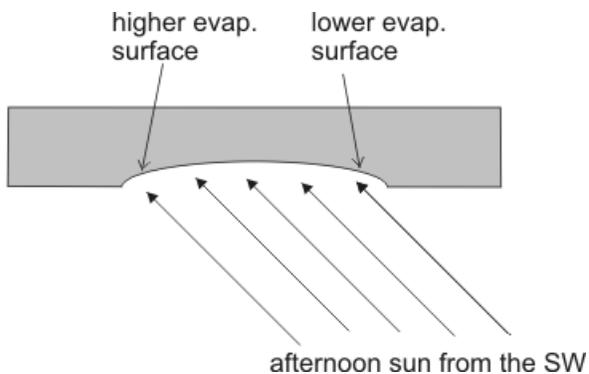
Very speculative explanation for the asymmetrical weathering pattern C on the front face.

The stone faces west, with the church behind it, which makes it a good "salt-pump" position. The sun at noon is edge on, illuminating both faces only obliquely, but the front face seen here (the high-evaporation side) faces the sun in the afternoon and is not shaded by trees or buildings, and is exposed to any wind; while the back face (the low-evaporation side) will be shaded by the tall church in the morning and will be on the backside in the afternoon, making it cooler. There is presumably no honeycombing on the back face as a consequence. [true?]

If the contrast in evaporation rates between the front and back faces is strong enough, and the geometry of the porosity is right, and the stone is not too thick, water will slowly migrate through the stone to the high-evaporation side where it deposits the salt that causes honeycombing. Once a cavity has formed, salt deposition will be higher on its back wall.

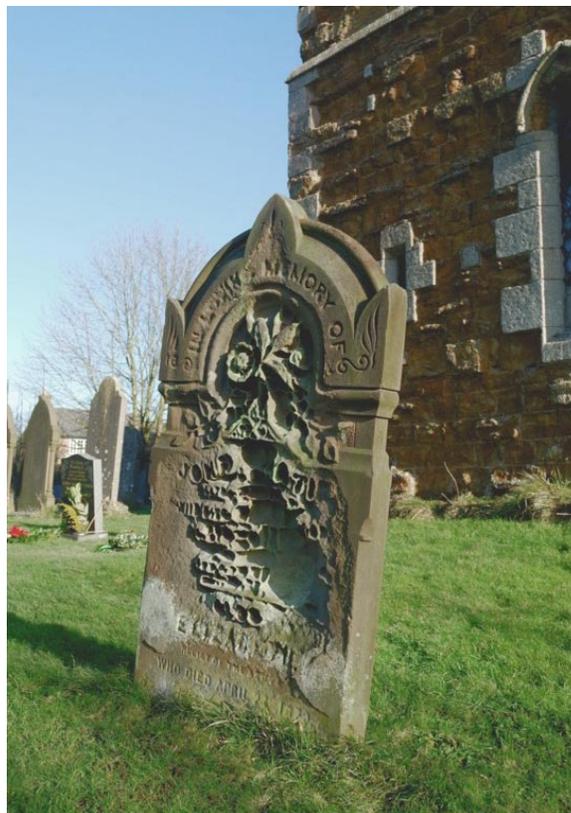
Half of a 3D photograph of the stone showing that the honeycombed portion once stood proud of the face. According to the camera taken in January 2011.

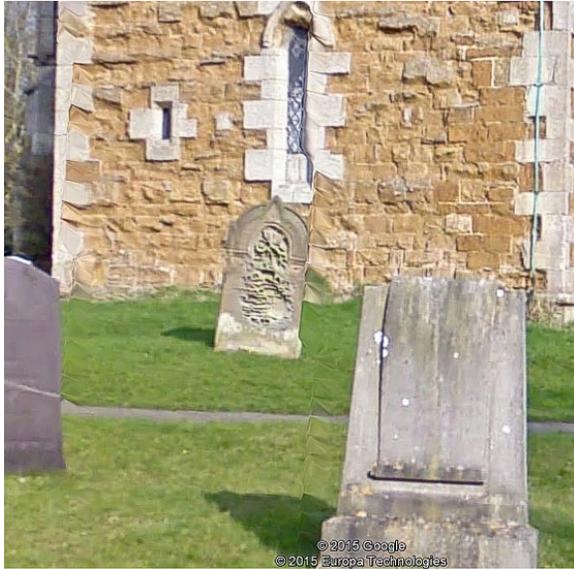
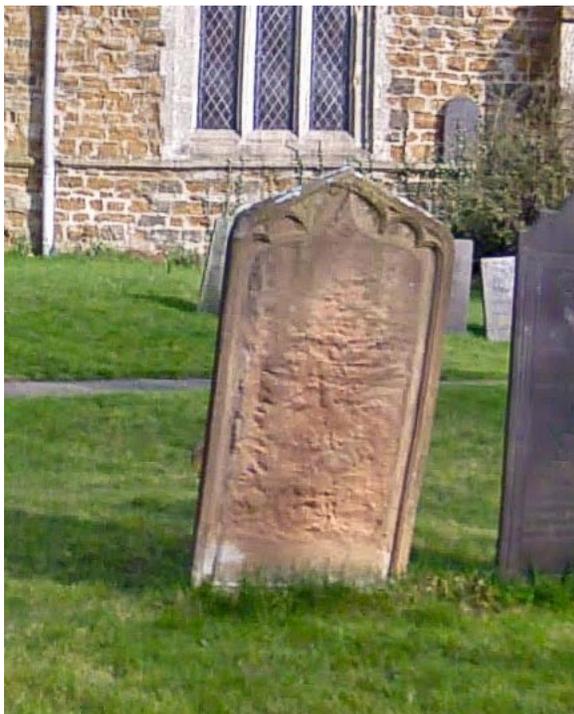
Top left: the subject headstone seen from the road

Bottom left: another headstone a little to the SW but seen from the same vantage point appears to be similar to the subject stone. It also shows efflorescence? near the ground, and there are traces of what I take to be marble (*calcite* and *dolomite*) on the top edge though it might be lichen, and there is algae, but only at the top of the stone.
