Gabriola Streamkeepers—Water levels and quality

## **Observations at Coats Marsh, Gabriola Island**

## **Field observations—2025 (Jan.—Mar. )**

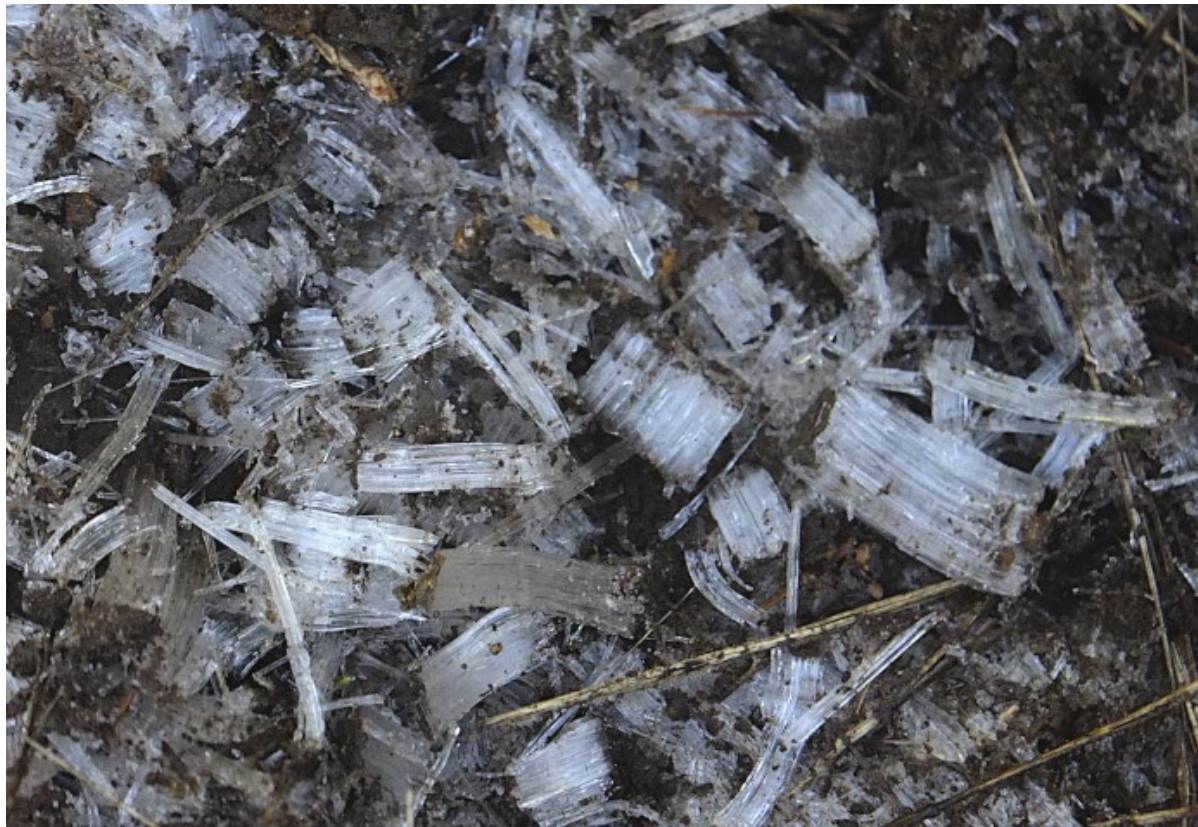
Another form of ice, pipkrakes (needle ice) East Path Jan.25,2025.  
Formed when the soil temperature is  $>0^{\circ}\text{C}$  and the air's  $<0^{\circ}\text{C}$ .

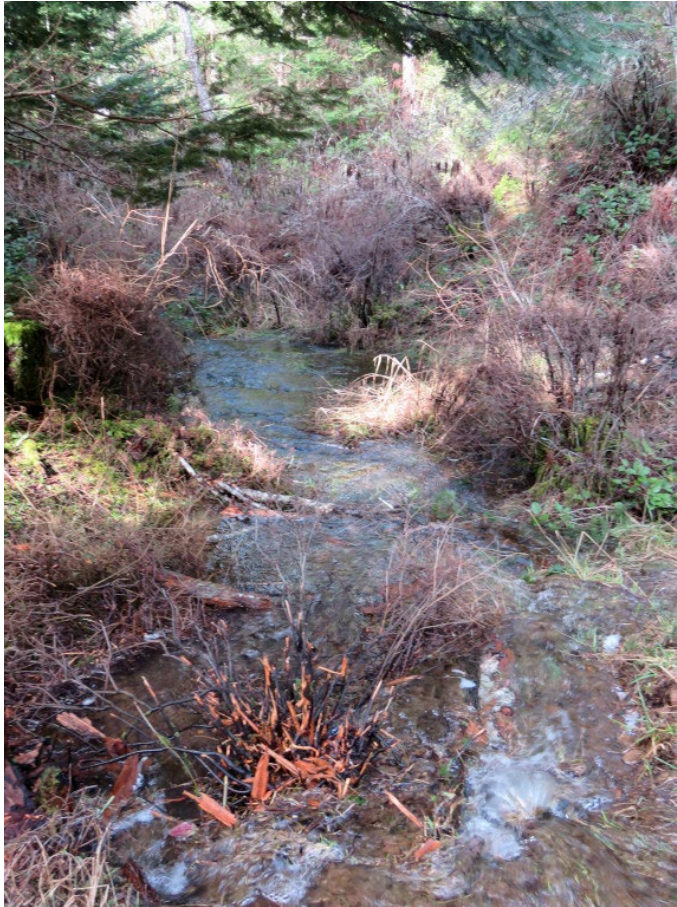
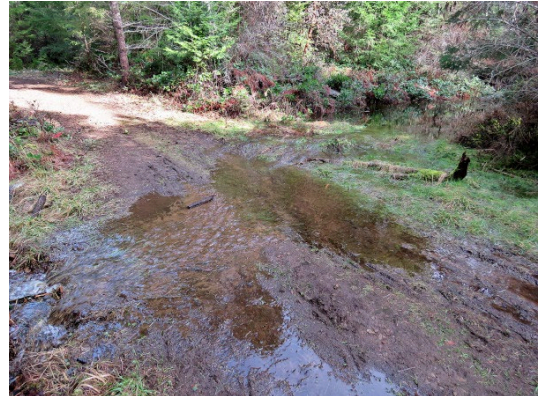
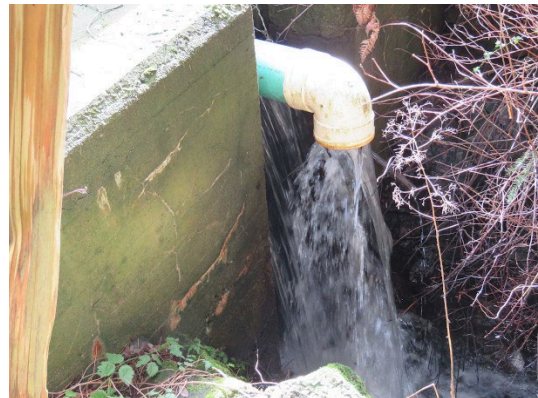
Snow gone. Lake clear of ice. Meltwater busy refilling the lake after the (unnecessary) RDN draw down. East Path Creek flowing at almost the full capacity of the culvert and the NE Arm spillway flowing strongly (illustrated) as it becomes NE Arm Creek.<sup>7</sup>

The concrete weir showing no sign of wanting to go anywhere.

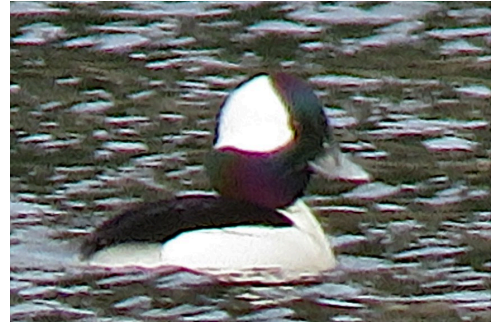
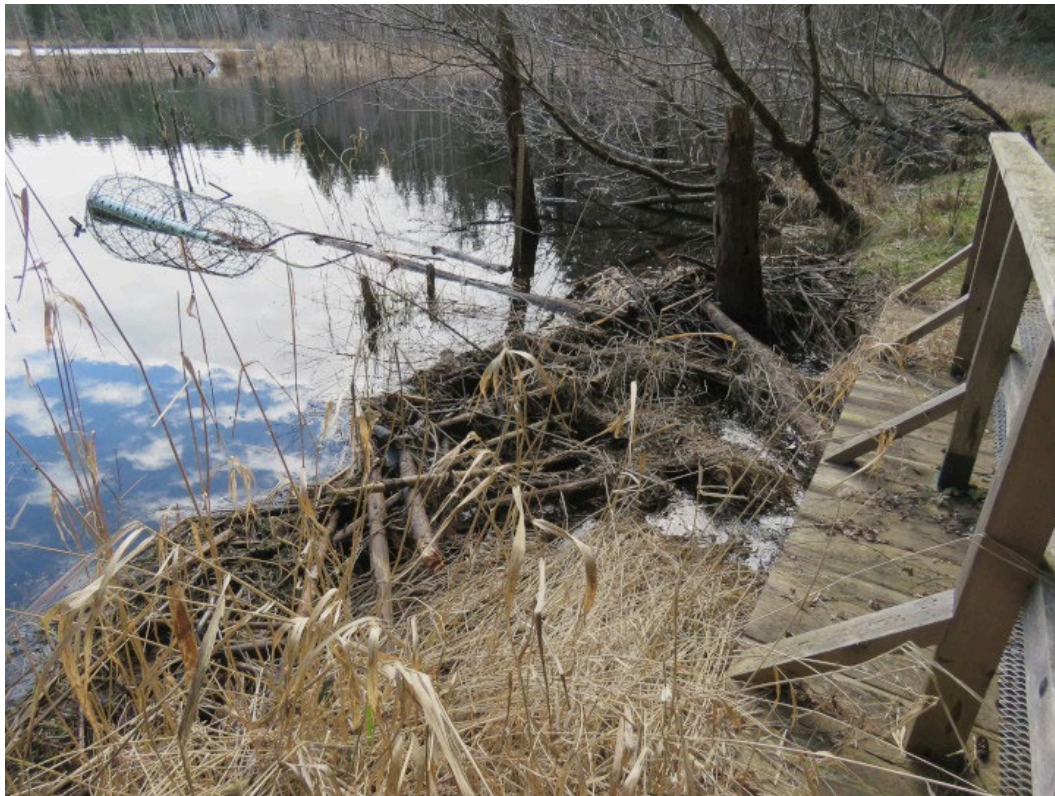
Beaver dam at the weir. Neither of the two beaver dams are perfect “dams” in that they allow some flow-through, especially when water levels are high. Some would-be flood water flows over spillways in the dams, and some flows around the ends of the dams. At all times there are also leaks through the dams.<sup>†</sup> At the moment, inflow from creeks is fairly strong, as is outflow into Coats Marsh Creek over the weir’s sill and through the pond leveller. Matching inflow and outflow stabilises water levels.

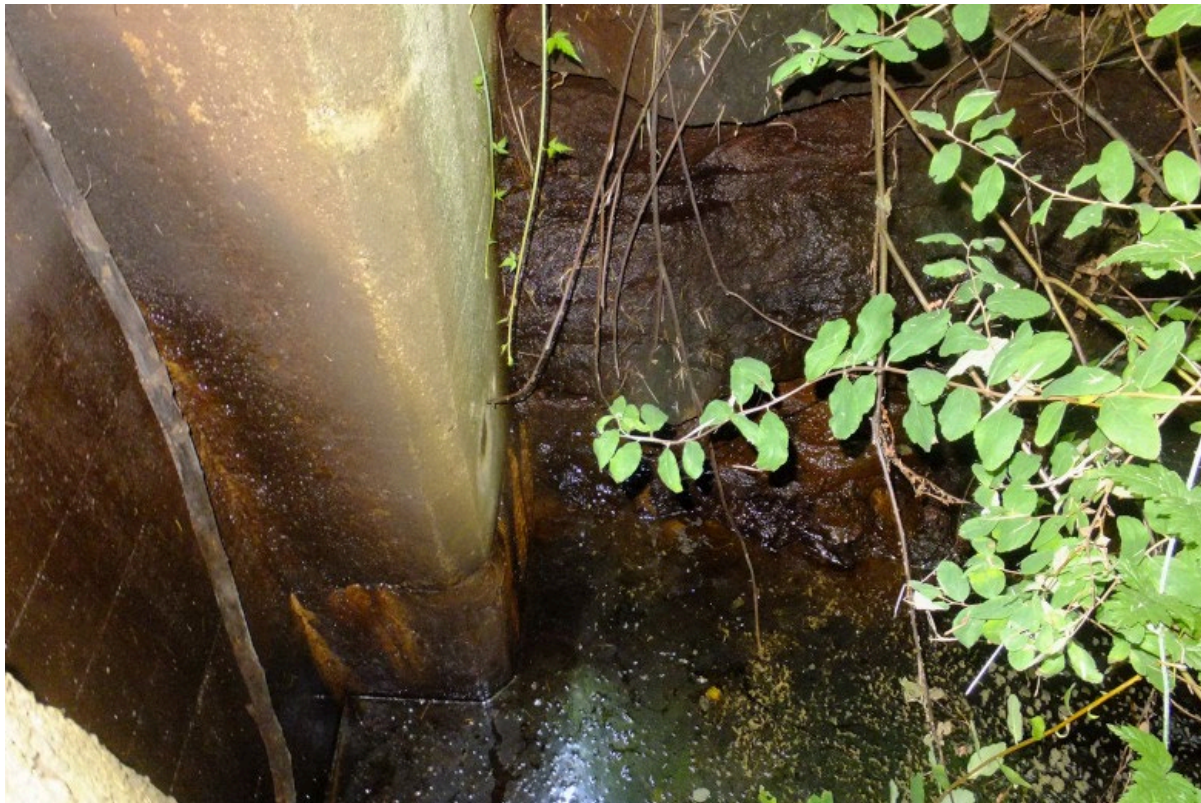
On the topic of leakage through “dams” (previous page), not even the concrete weir at Coats Marsh is free of all leakage, with implications as to its stability even though such leakage itself is trivial.<sup>†</sup>

From left to right: the wooden baffle; the concrete weir; the blasted-out rock wall of Coats Marsh Creek; with a stagnant pool of water at the bottom.

Meanwhile, the RDN plan to remove and not repair the weir continues, something I regard as tantamount to bureaucratic vandalism.

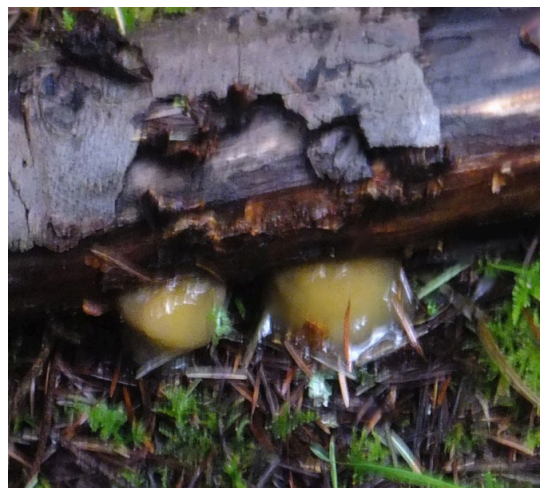
March 19, 2025 (day 3532, 3288+244):ViGRG cum. 872.7 mm (norm. 914 mm). Weir 288 mm SCB. [cal. datum: weir -0.359 m]. The weirpool as it is today. Off and on a pool has probably existed here since it was formed from meltwater at the end of the last ice age, more than ten thousand years ago. But it has apparently become too inconvenient for humans and has to go.

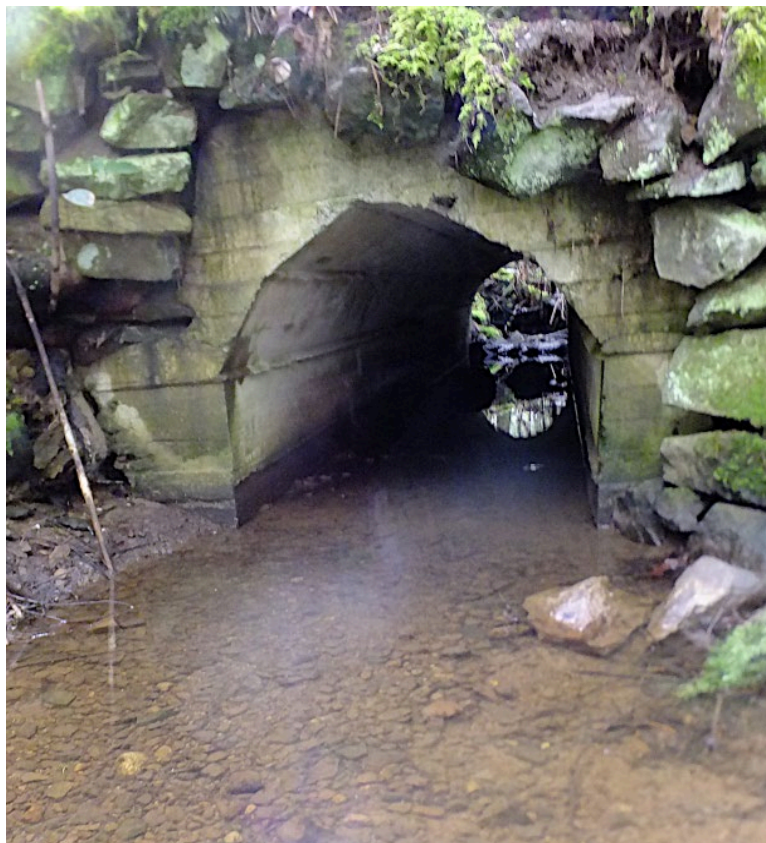
I don't know when the concrete culvert for Coats Marsh Creek under the Marsh Trail was built but it looks like it could be in the same era as the weir. If so, it looks in very good shape for its age having withstood several large flood events including draining the whole wetland.
