Gabriola Streamkeepers—Water levels and quality

Observations at Coats Marsh, Gabriola Island

Field observations—2021 (July—Sept.)

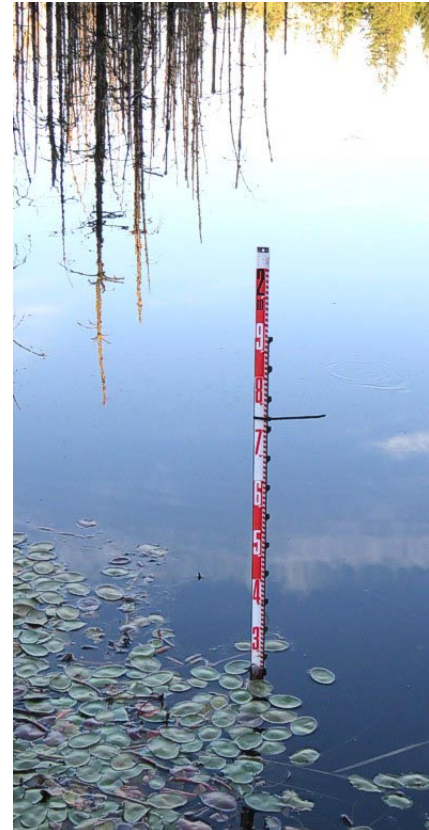
The new metric gauge reading was 1265 mm, which for the time-being I take to be equivalent to my +0.315 m [calibrated] at the cistern at the east end of the lake, a difference of 0.950 m, to be subtracted from the RDN gauge to get the calibrated CWB level.

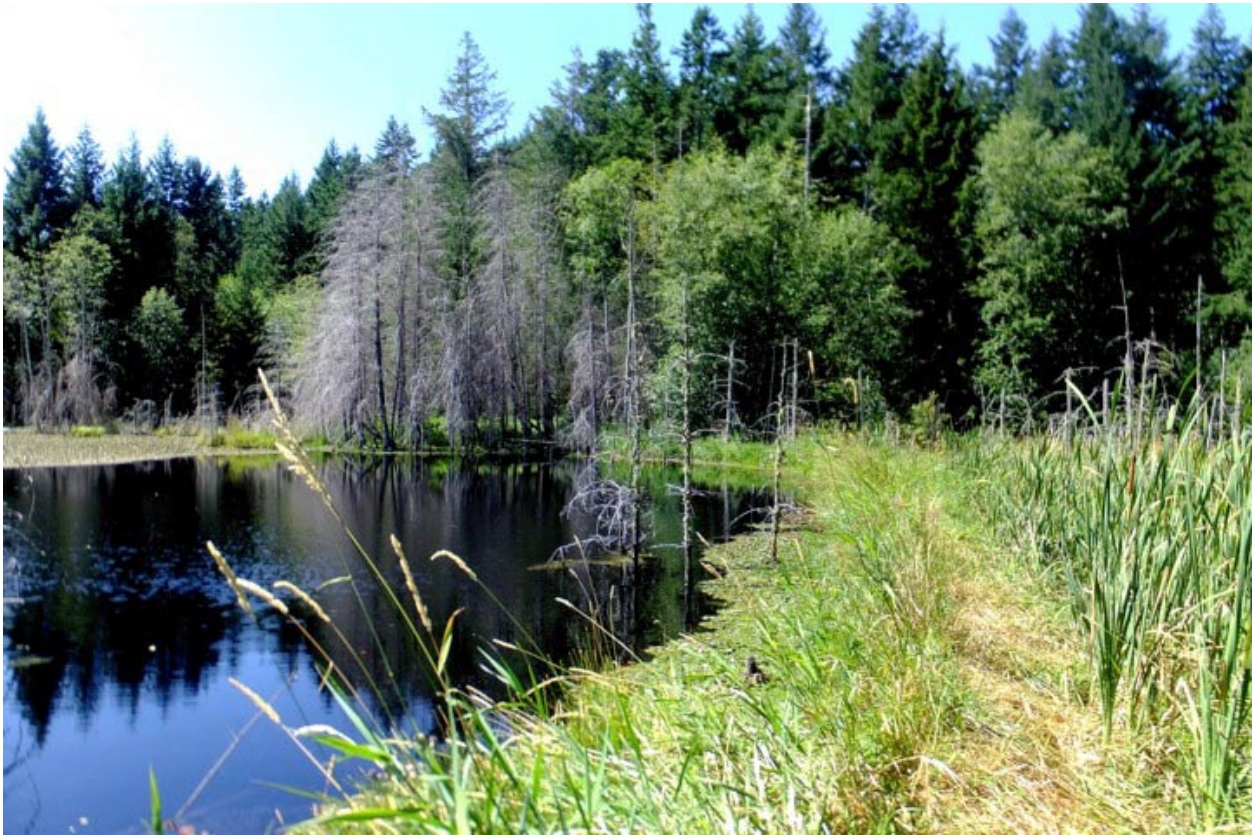
Path *right* is the top of the dam, which is stabilized by vegetation. The gradients of creeks running into the shallow-water wetland (East Path and NE Arm) are low, making for a low-energy environment overall.

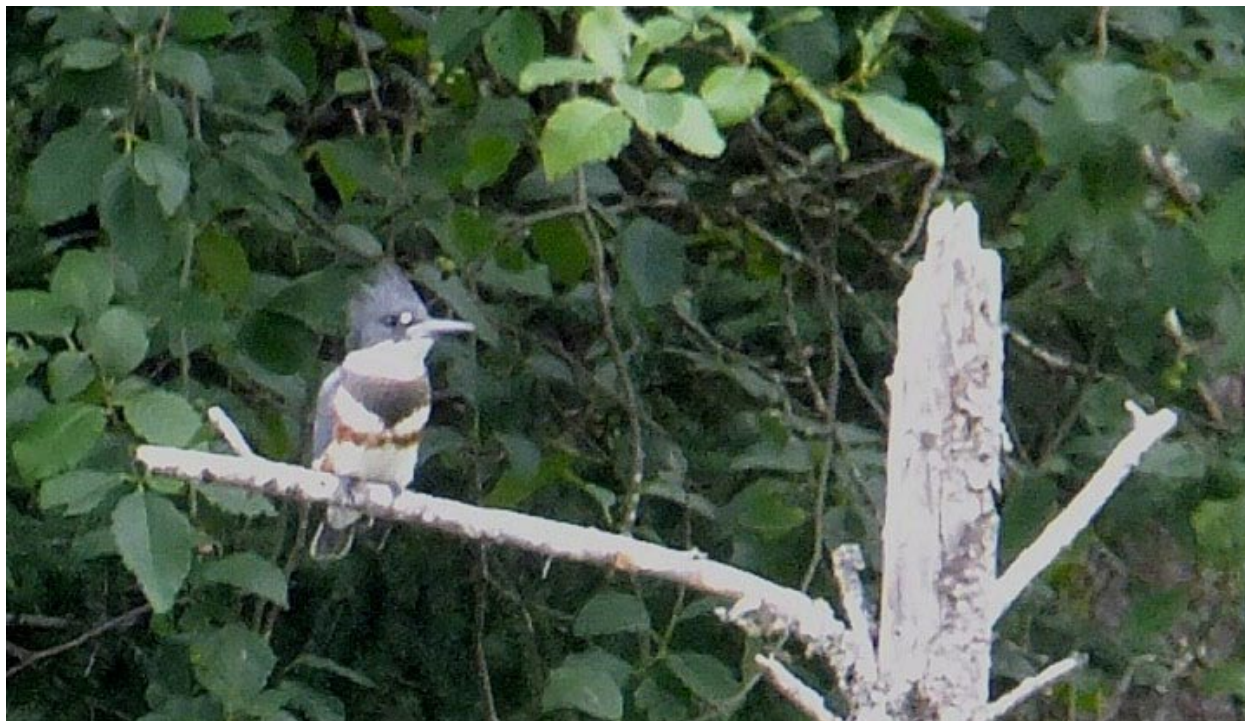
Estimate that drawing the lake level down 400 mm will cause the shoreline to retreat toward the centre of the lake by 10 metres. [File 668](#), appendix. What impact this will have on tree-cavity nesters, we'll just have to wait and see, I guess.

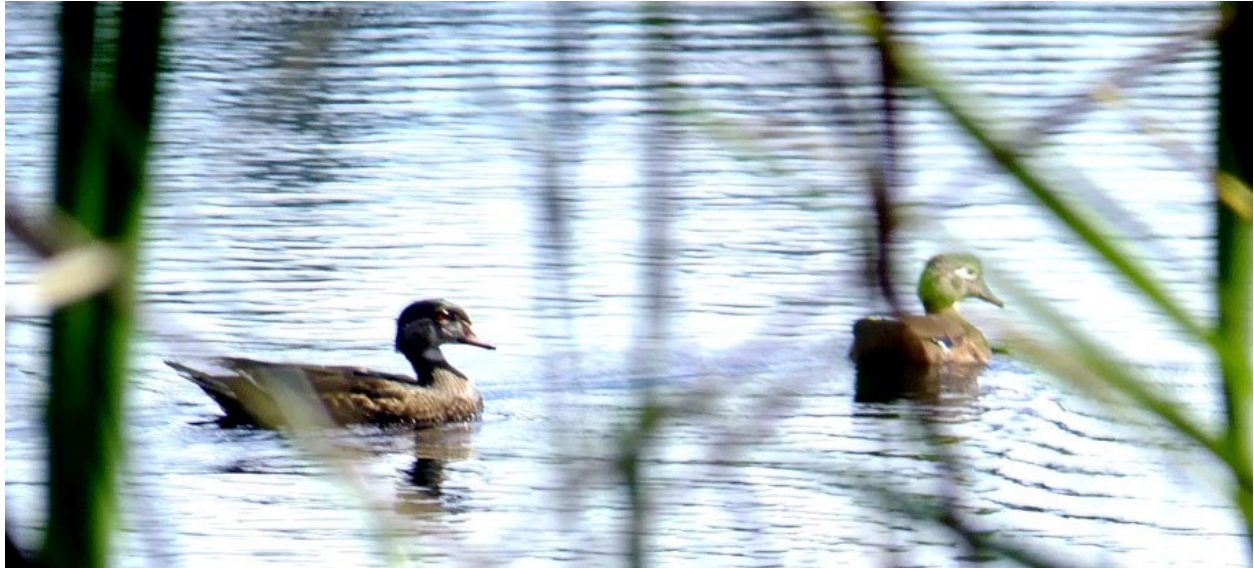
Wood ducks in their post-breeding plumage again in the weir bay inhibiting access to the RDN paraphernalia out on the dam.

As usual, when the weir-pond level is at its lowest, water has retreated from the base of the beaver dam on the downstream side.

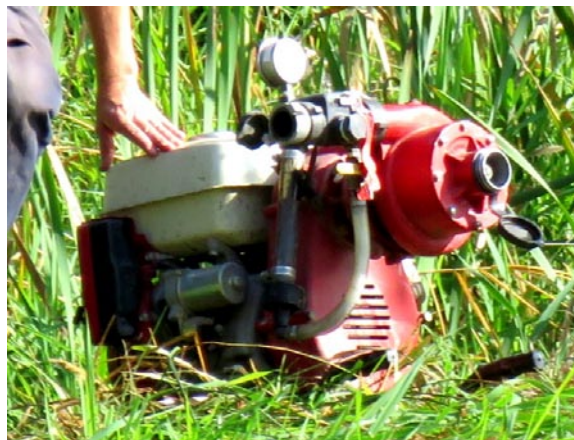
running again at the culvert but there is no flow over the sill or through the leveller. Two of the four syphons running.

The beaver has not been seen for some time and the local resident believes it may have abandoned the site. No tail-slapping in the evenings heard now and the weir has sprung a small leak at the edge of the concrete deep down on the north side, which should have attracted his attention.

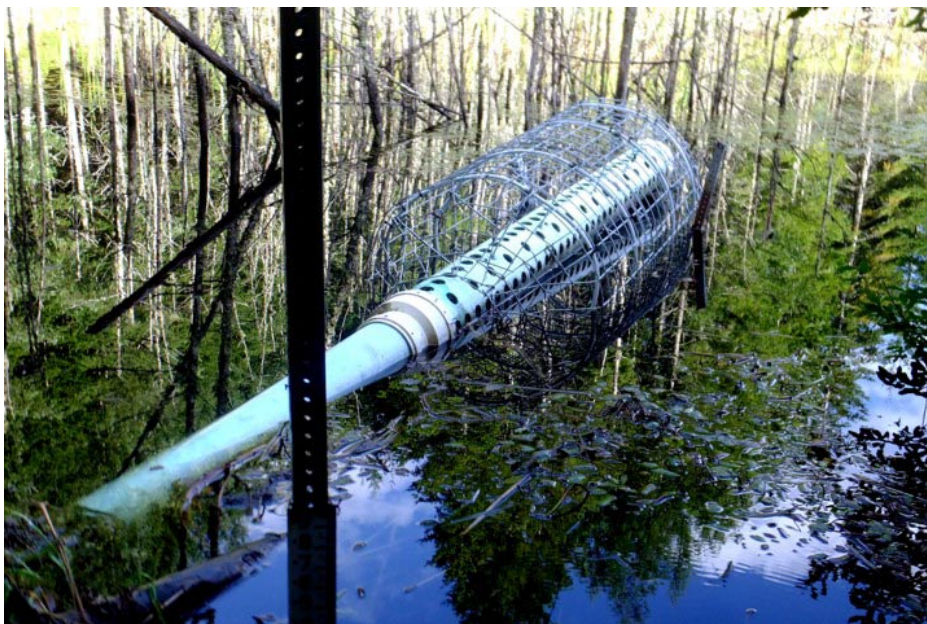
Coats Marsh Creek flowing at around 40-50 L/s, flow over the sill (depth 40 mm), pond leveller flowing but now pointing skyward ominously like a gun, the knuckles of all four syphons retro-fitted with bleed valves and their gate valves now all open.
