Gabriola Streamkeepers—Water levels and quality

Observations at Coats Marsh, Gabriola Island

Field observations—2023 (May—August)

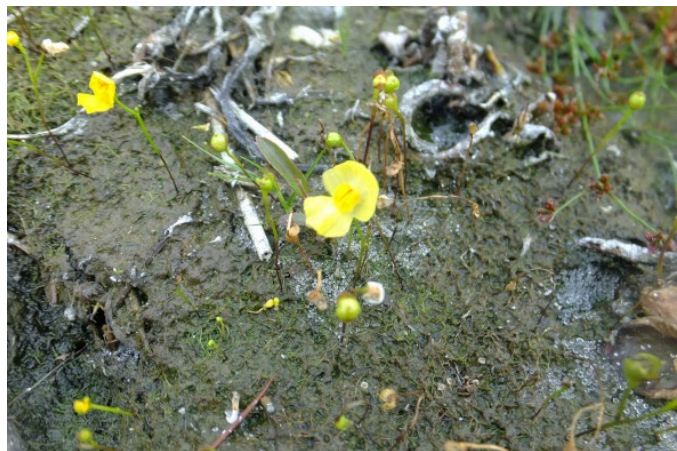
Substantial swathes of the perimeter of the "lake" have now become a thick, soft muddy morass. It's a simple enough message; you need to store water in winter in order to maintain an adequate water level in summer; and this hasn't been done. At the entrance to the RP at Stanley Place, visitors are now confronted with, not water, but mire, any water being far off toward the centre of the marsh.

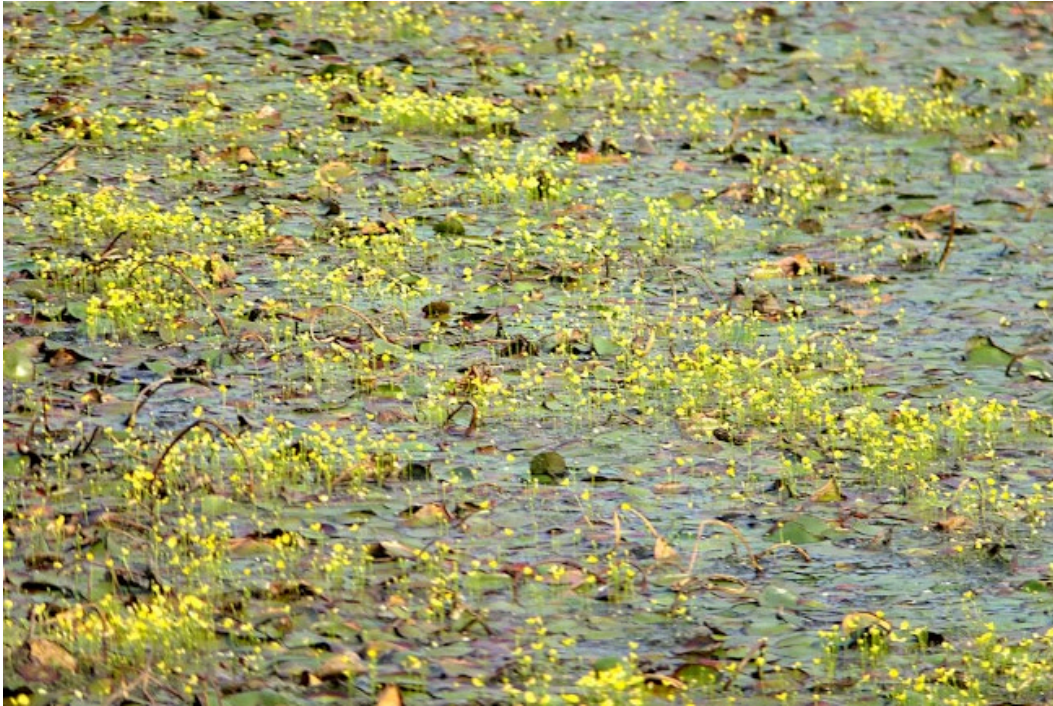
The yellow patches are mats of bladderworts, *Utricularia macrorhiza* .

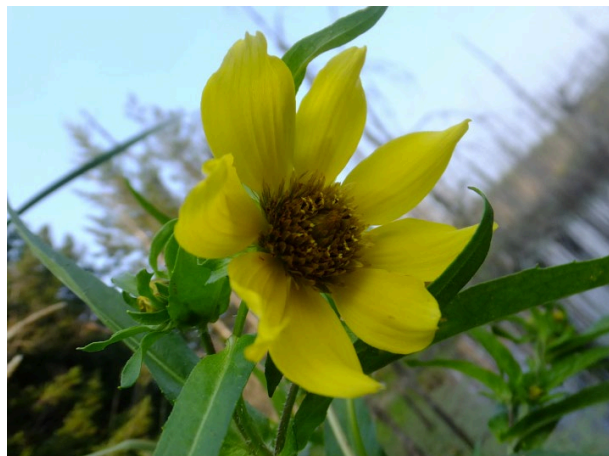
of low DO concentrations are high diurnal temperatures, and unusually high oxygen consumption by aerobic decomposers of dead aquatic plants. Nodding beggarticks (*Bidens cernua*) out on the beaver dam, the perfect habitat for this species.
