Coats Marsh Weir Assessment

Regional District of Nanaimo
1490 Springhill Road
Parksville, BC V9P 2T2
Liaison: Chris van Ossenbruggen,
Parks Operations Coordinator
Reference Number: NA

Scot Merriam, P.Eng.
Principal Engineer, SRM Projects

Date: June 1, 2020

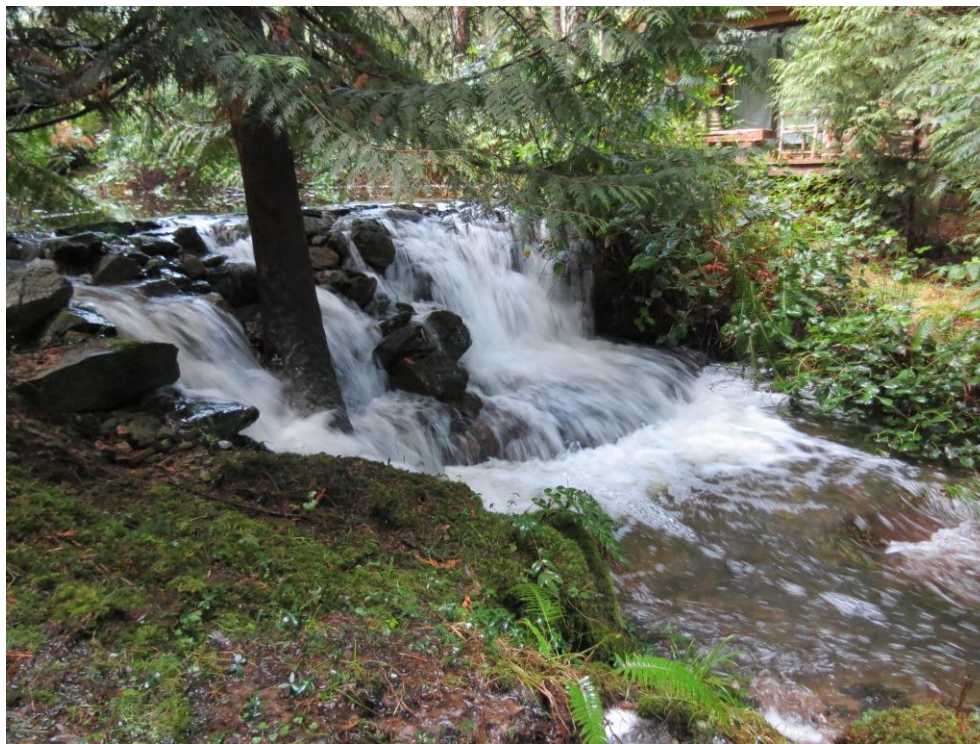
Figure 2-2: Flow over ornamental rock dam at 1040 Coats Drive March 6, 2014
(uninhabited recreational cabin in background)

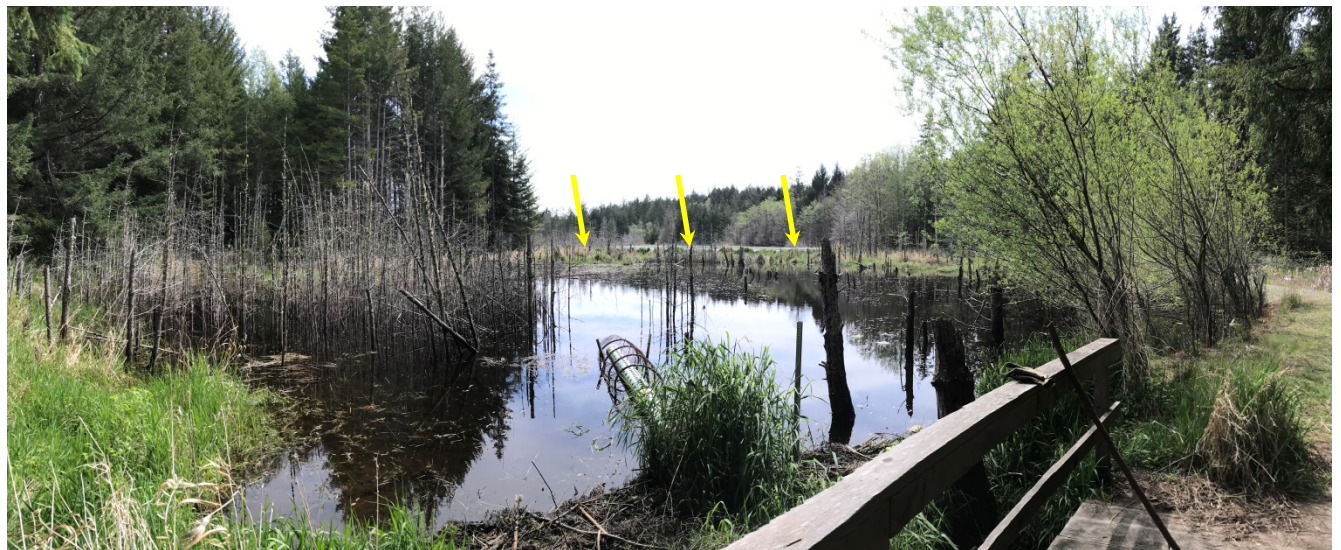
4. View from RDN footbridge at weir, looking SE towards beaver dam (yellow arrows). Residential property protection dyke at right

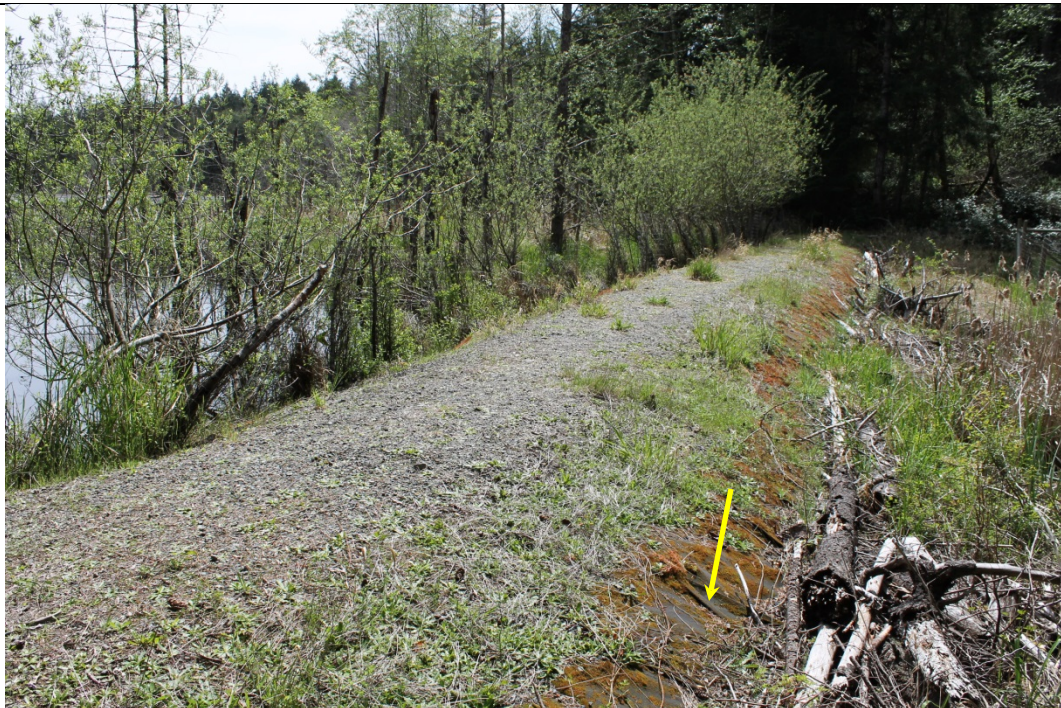
6. Residential property protection dyke – willows planted on U/S side, visible geotextile covers entire berm (yellow arrow)

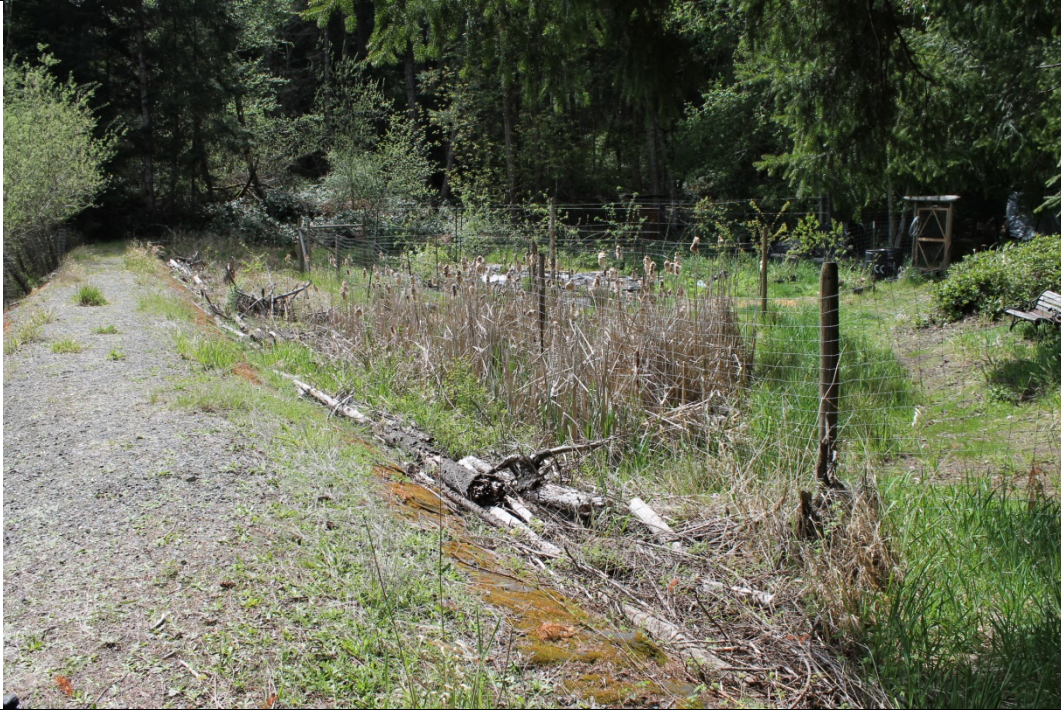
7. Residential property adjacent to dyke at 1040 Coats Drive – dyke D/S toe area is drained see photos 29/30

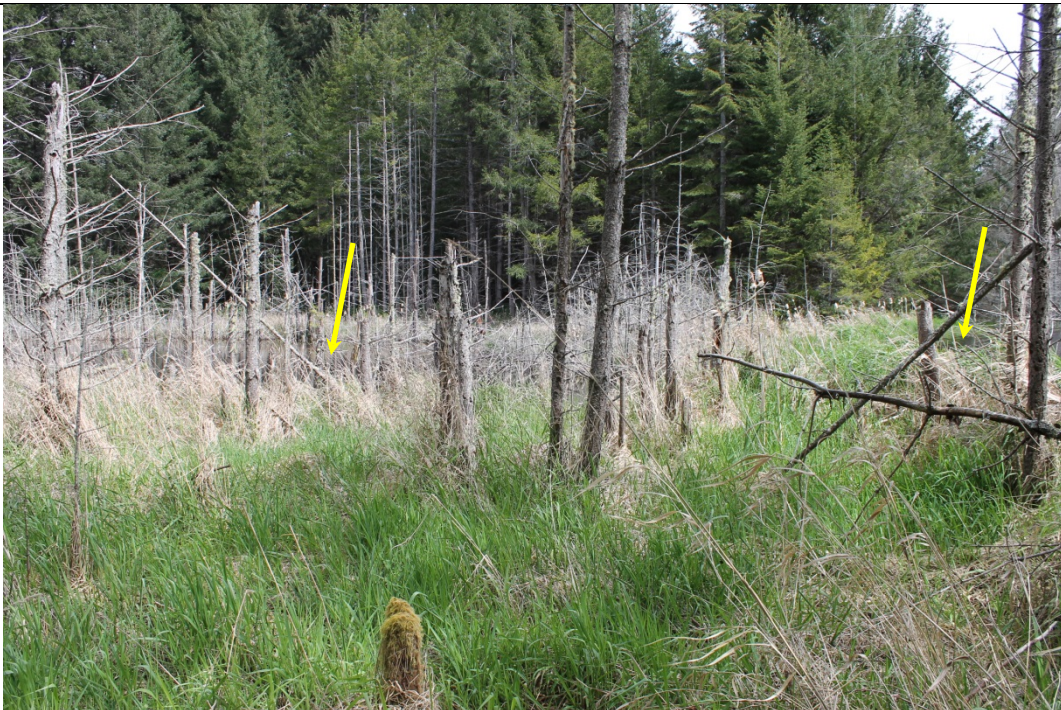
Based on the observed approximate 1 meter difference in elevation between the greater pond (beaver dammed section) and the weir pond spill elevation, we estimate an additional 54,000 cubic meters of water are impounded by the beaver dam, bringing the total pond storage to approximately 76,000 cubic meters at time of the site visit.

8. Looking roughly NE over beaver dam – note significant (~1 m) difference in water level upstream and downstream of dam

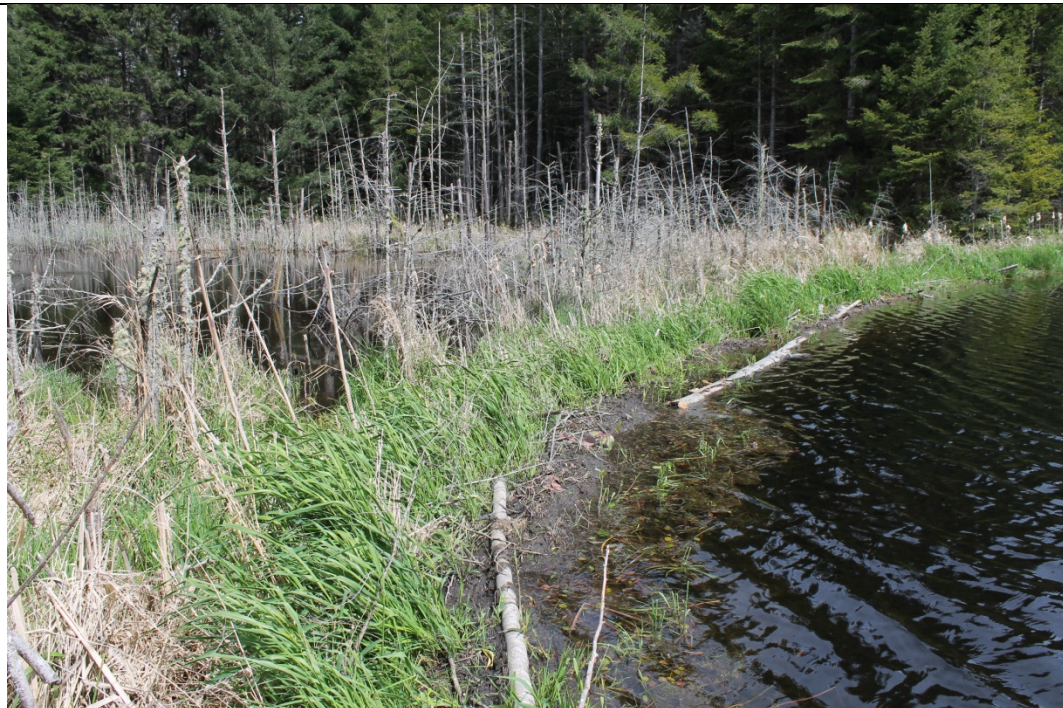
10. View from top of beaver dam looking toward weir pond at left – note significant (~1 m) difference in water level.

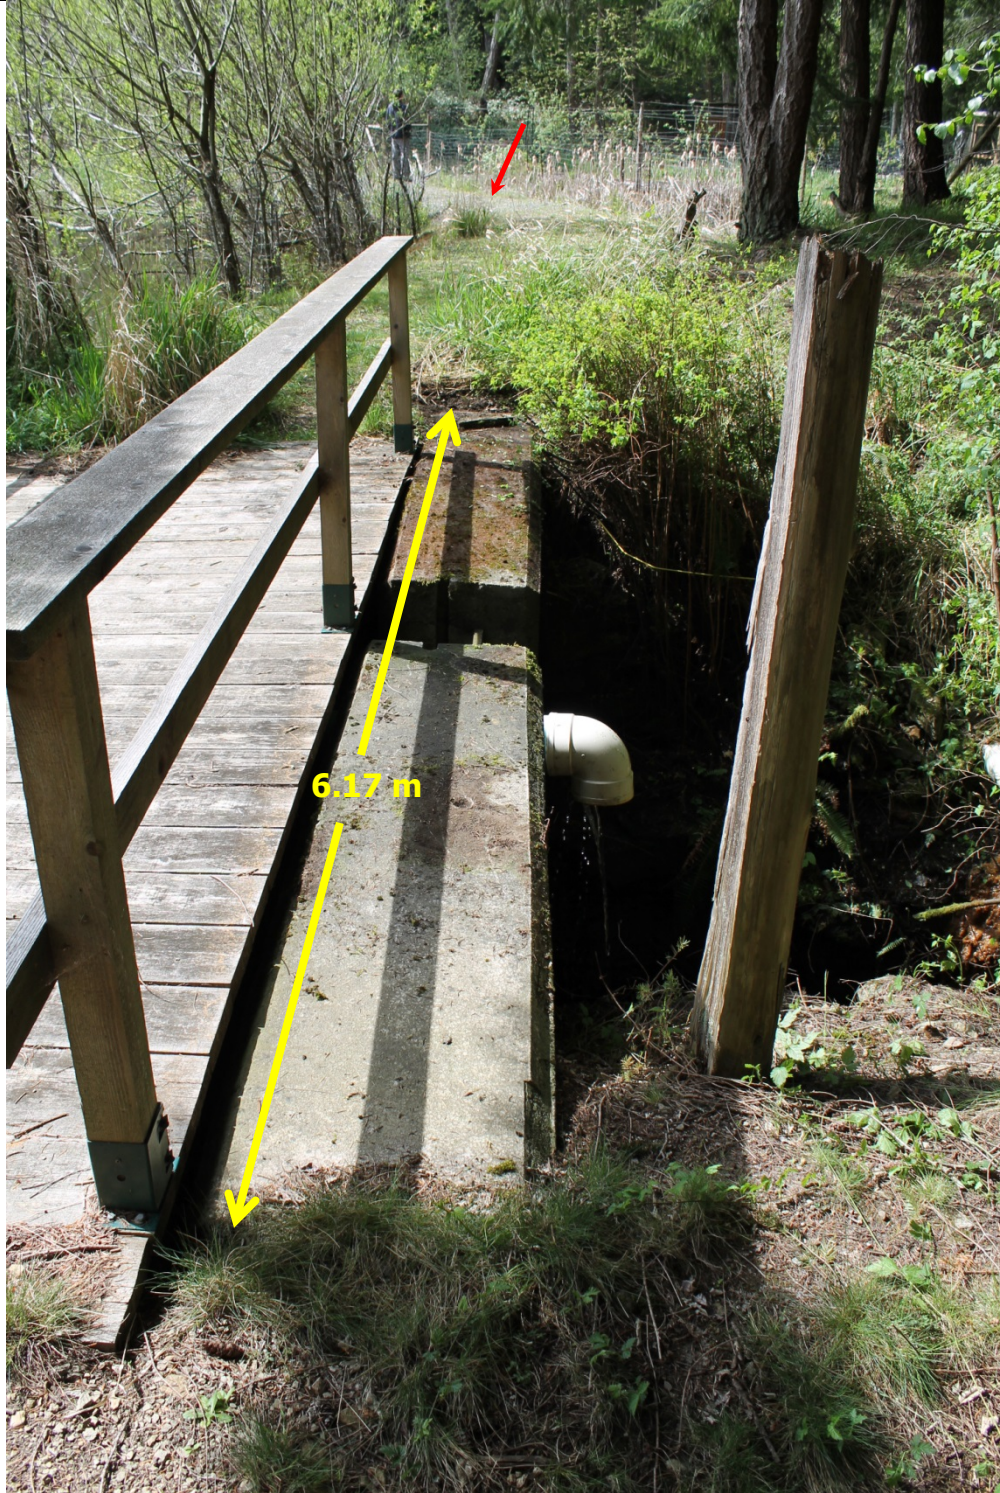
19. Concrete weir crest viewed from right abutment; residential property protection dyke in background (red arrow)

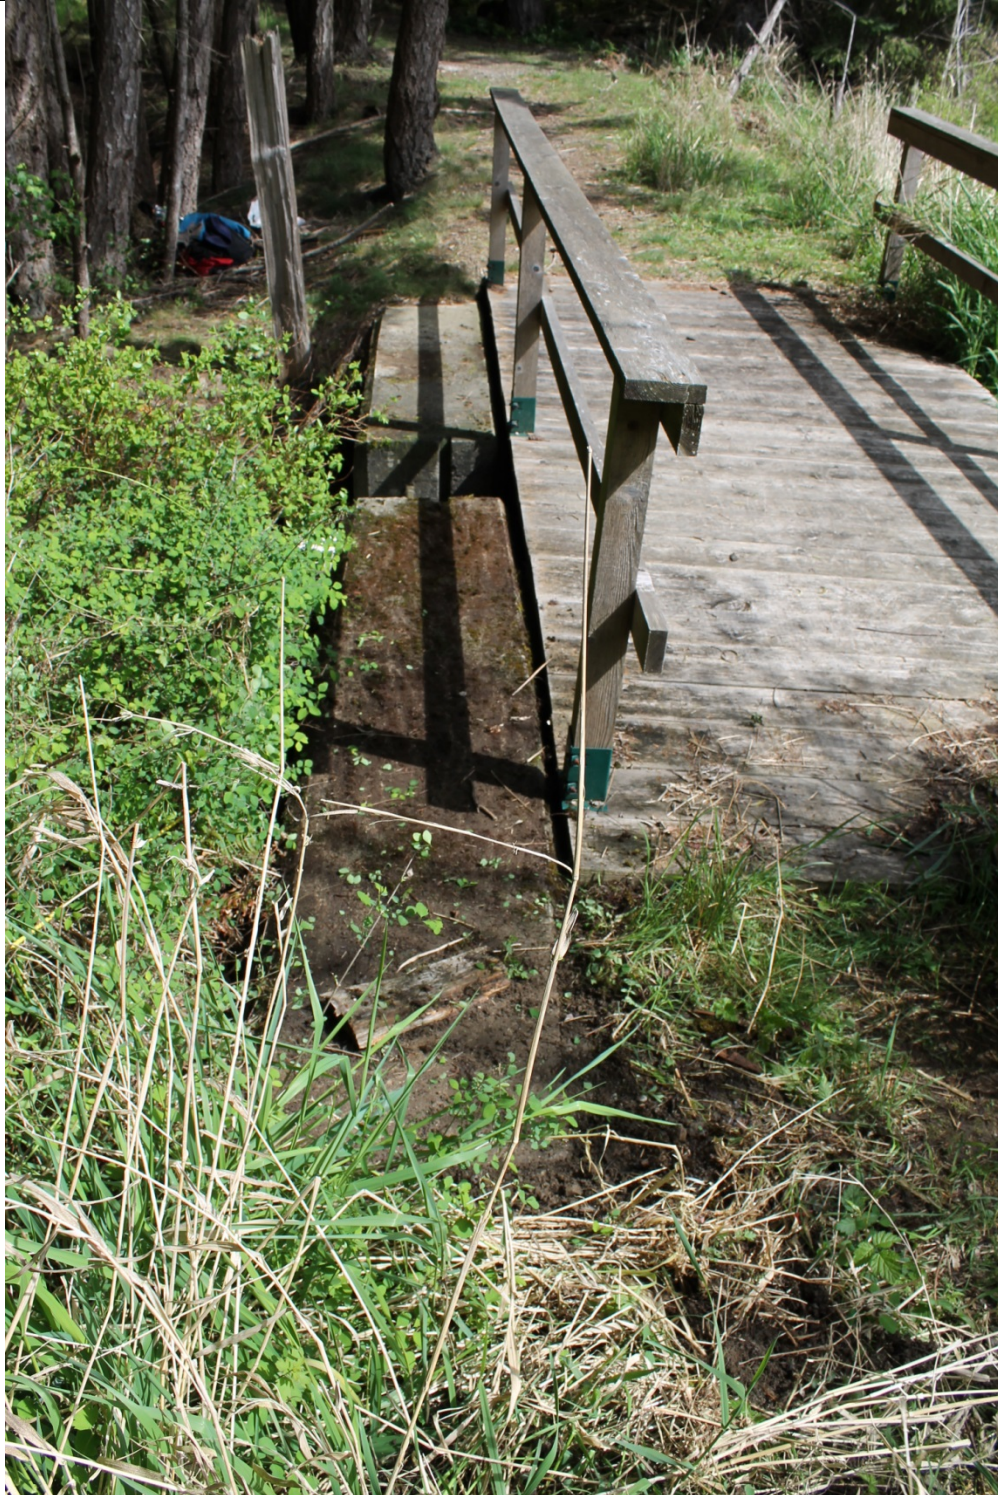
20. Concrete weir crest viewed from left abutment (crest measured to be level)

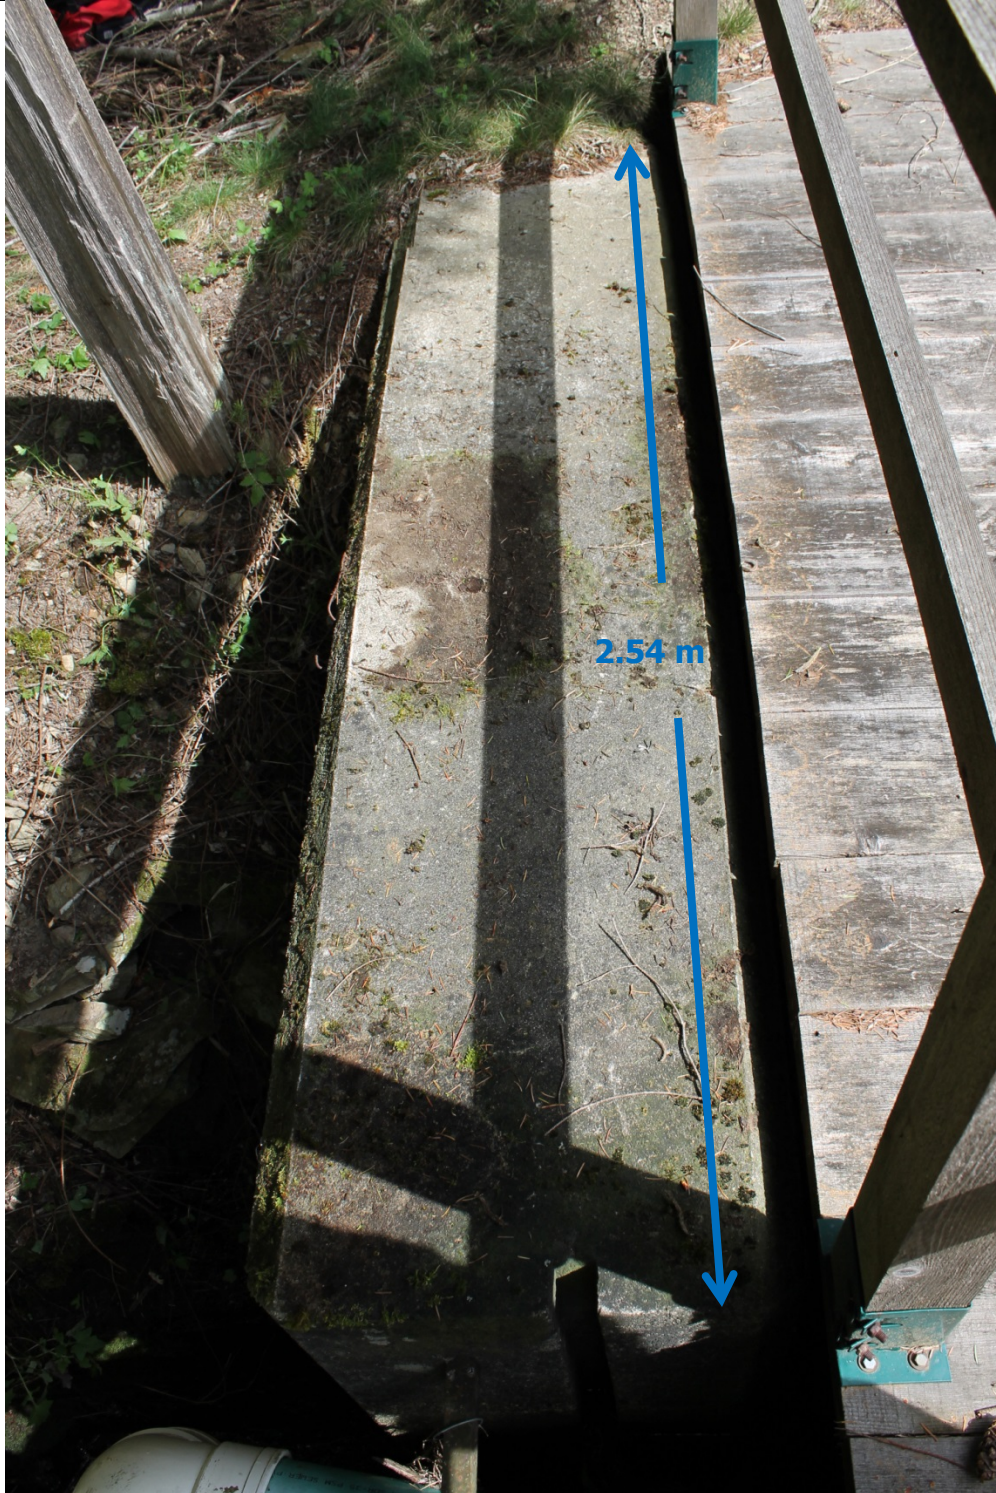
The crest concrete was visually and hammer test inspected. Cracking and two significant areas of spalling were identified. Please refer to the dam inspection report and photos for detail.

21. Close-up of right concrete weir crest viewed from spillway

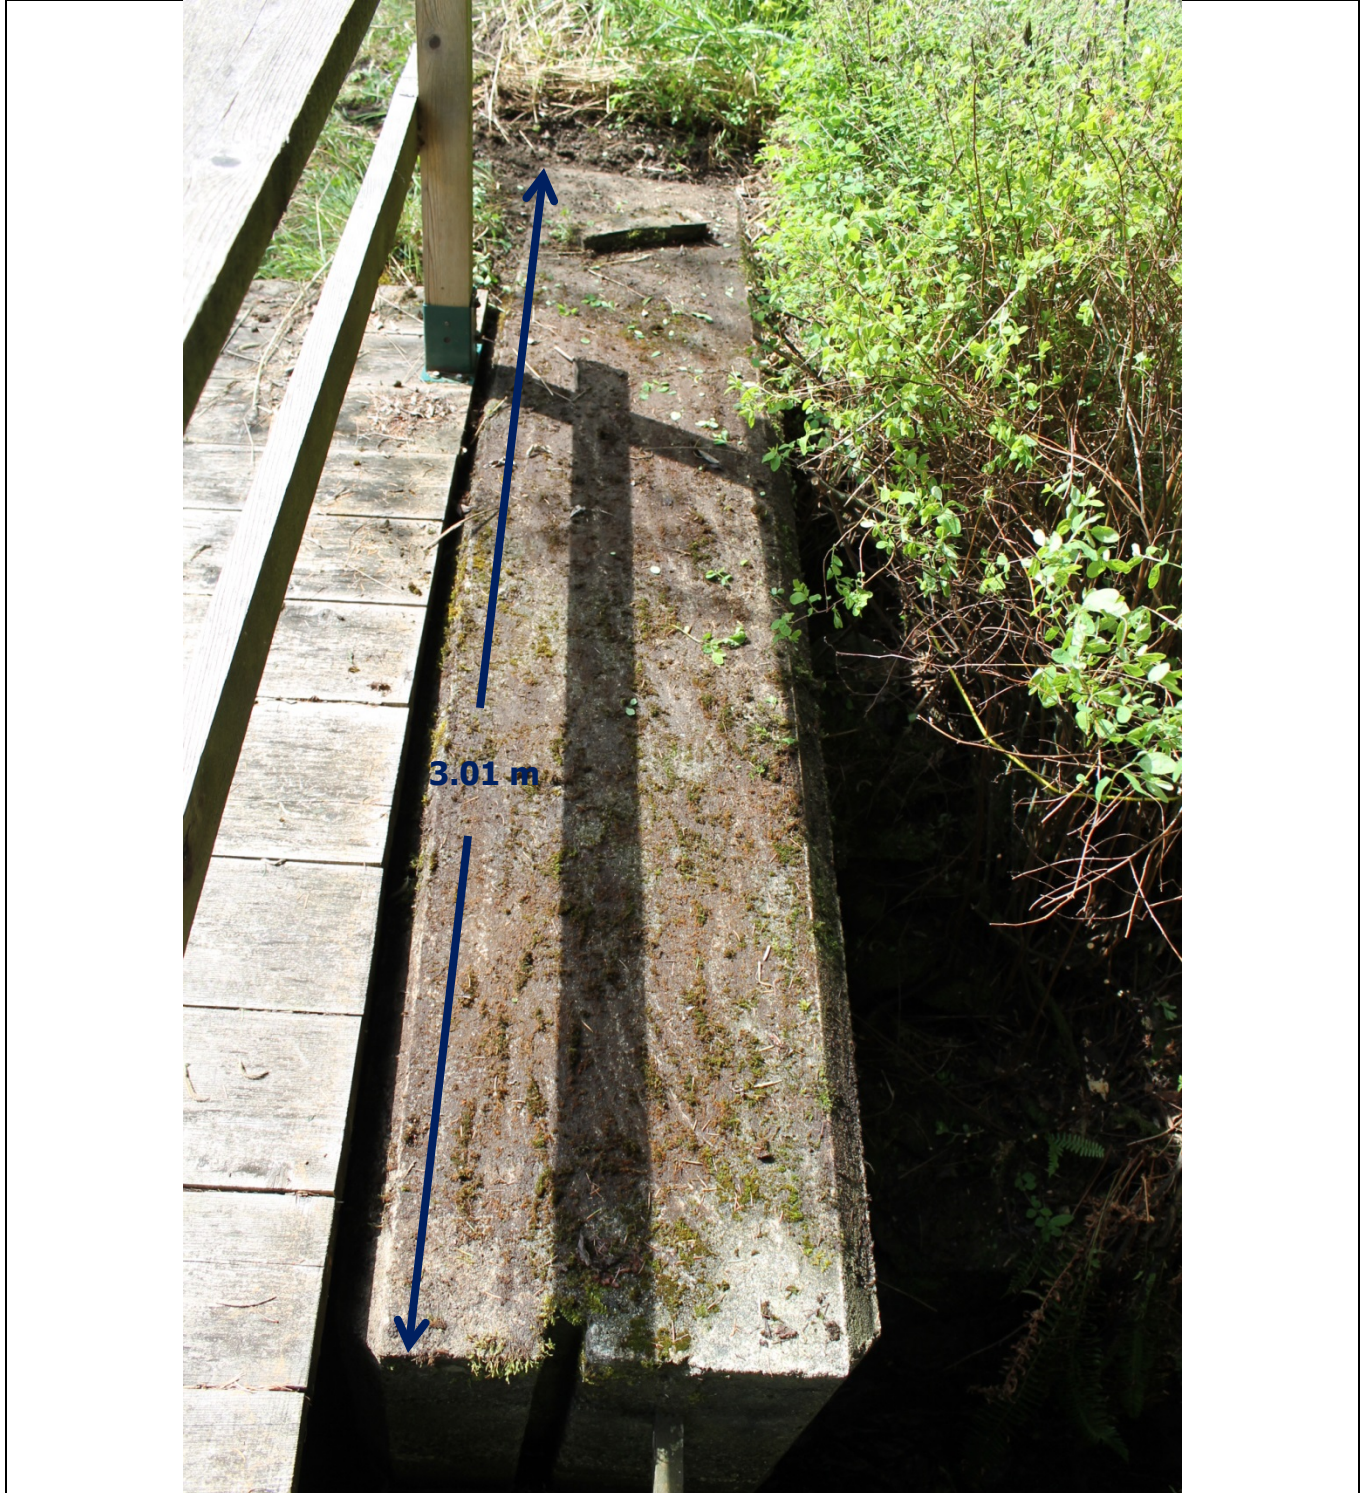
24. Close-up of left concrete weir crest viewed from spillway

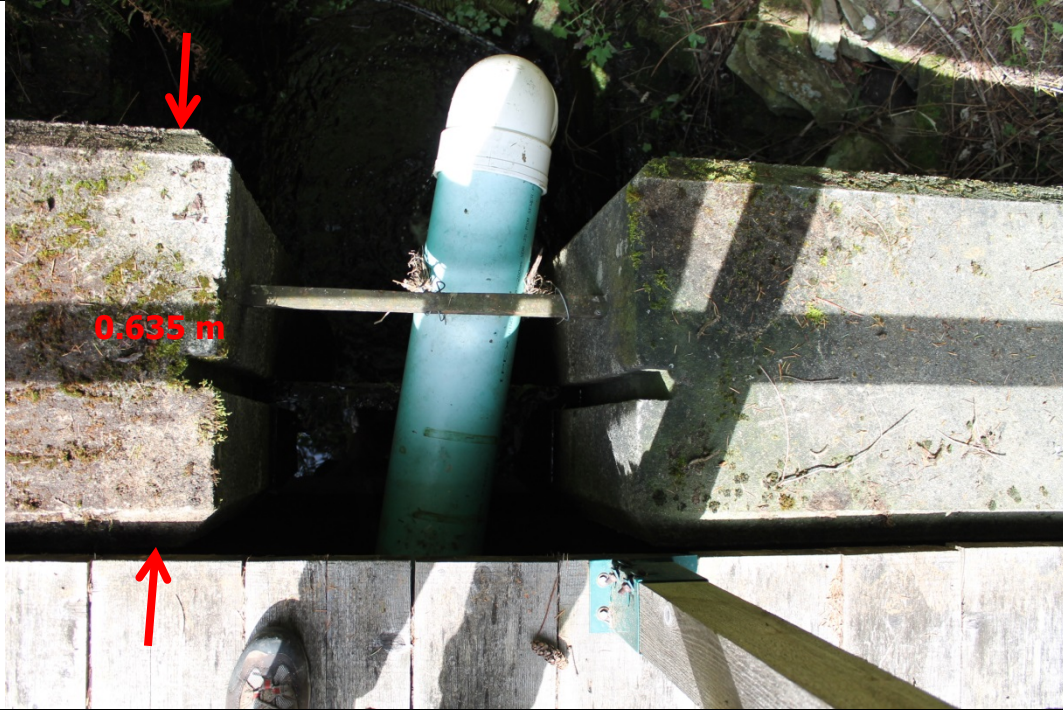
27. View looking down on weir crest and stop-log controlled spillway; 200mm pond leveler pipe visible

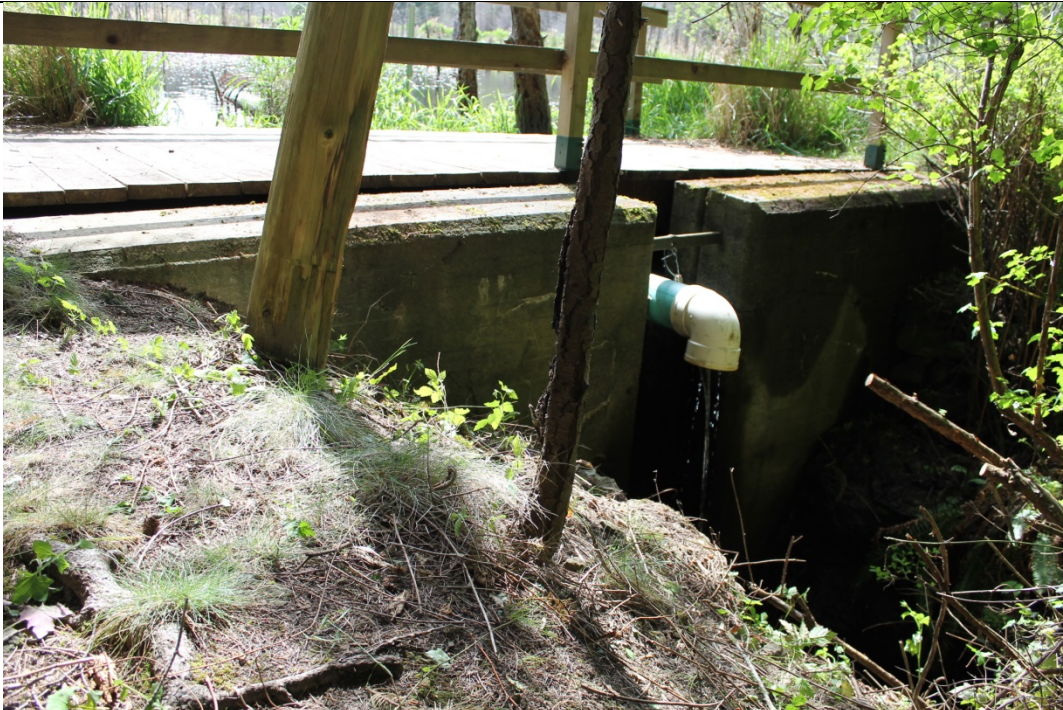
The weir structure is founded in a channel in sandstone bedrock. Based on the history of the structure, and the claim of neighbour Guy Mireau (1040 Coats Drive) that blasting holes have been observed in the surrounding bedrock, it is likely that the channel was excavated by blasting.

28. D/S view of concrete weir from right abutment – weir is located in a channel blasted into the sandstone bedrock

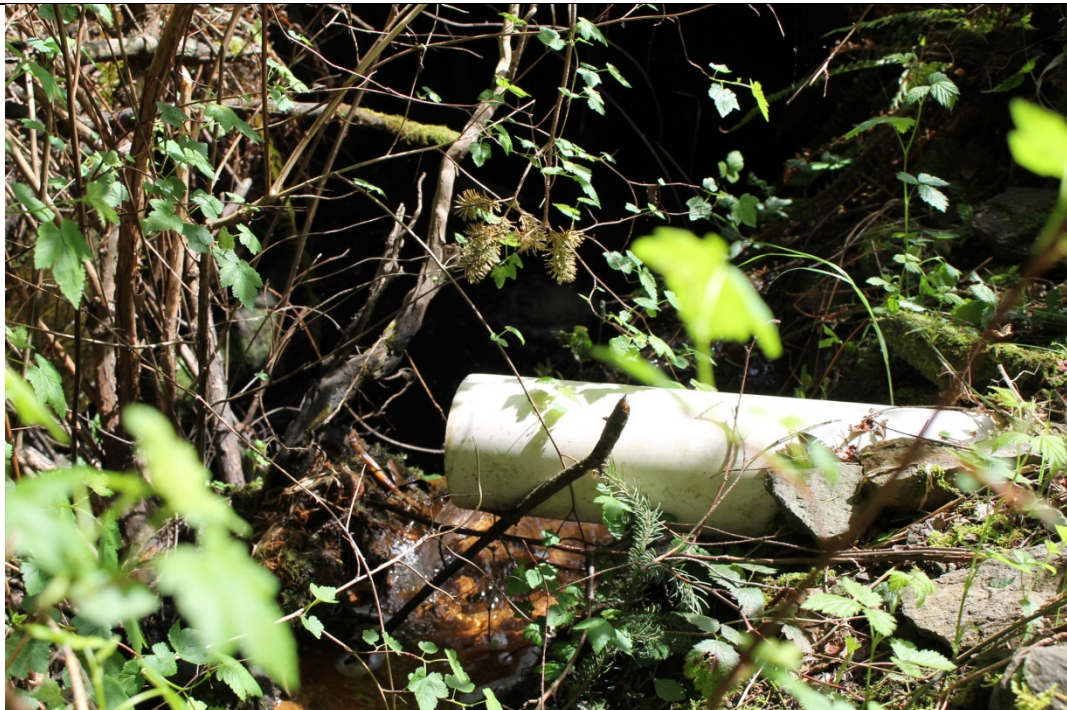
30. Close-up of white dyke downstream drain pipe showing clear water flow

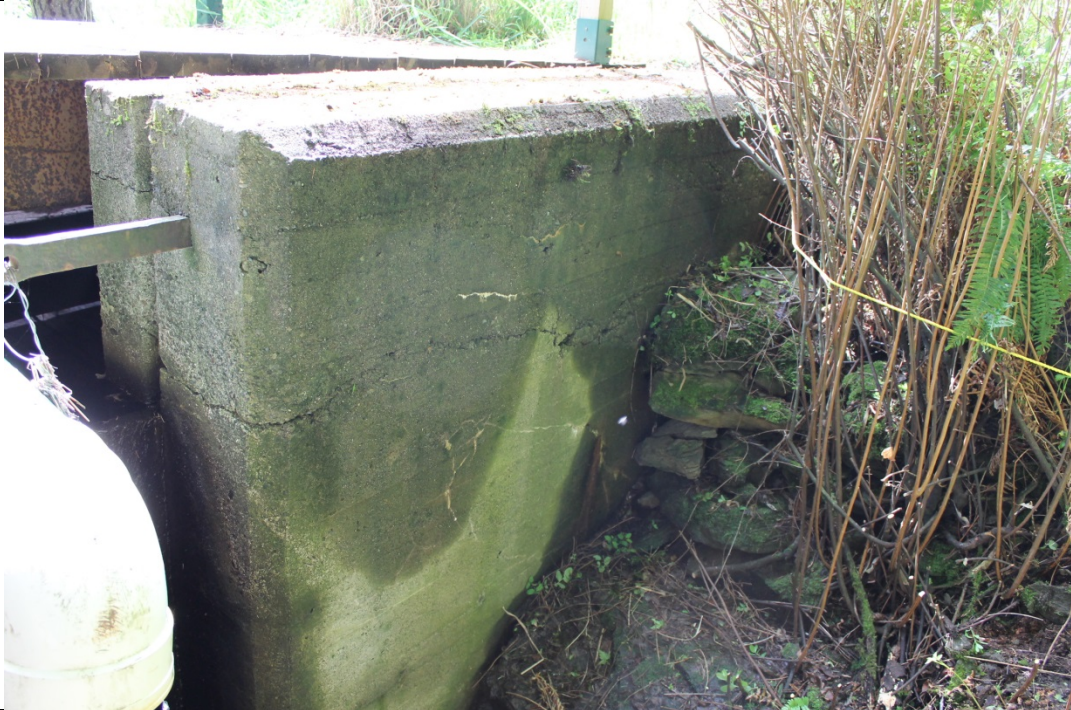
sudden release of water occur, a person could be engulfed and washed down the rocky channel). Many cracks and some spalled areas were observed. One "crack" in the left weir wall looks very much like a cold joint in the concrete and has a honeycomb appearance at one place. This fissure appears to go all the way through the weir wall to the upstream face. Some of the other fissures below the water line may also go all the way through the weir wall based on observed fissure width/prominence. Obvious water seepage was only observed at one location near the right abutment. Please refer to the dam inspection report and photos for detail.

35. D/S face of concrete weir looking toward left abutment

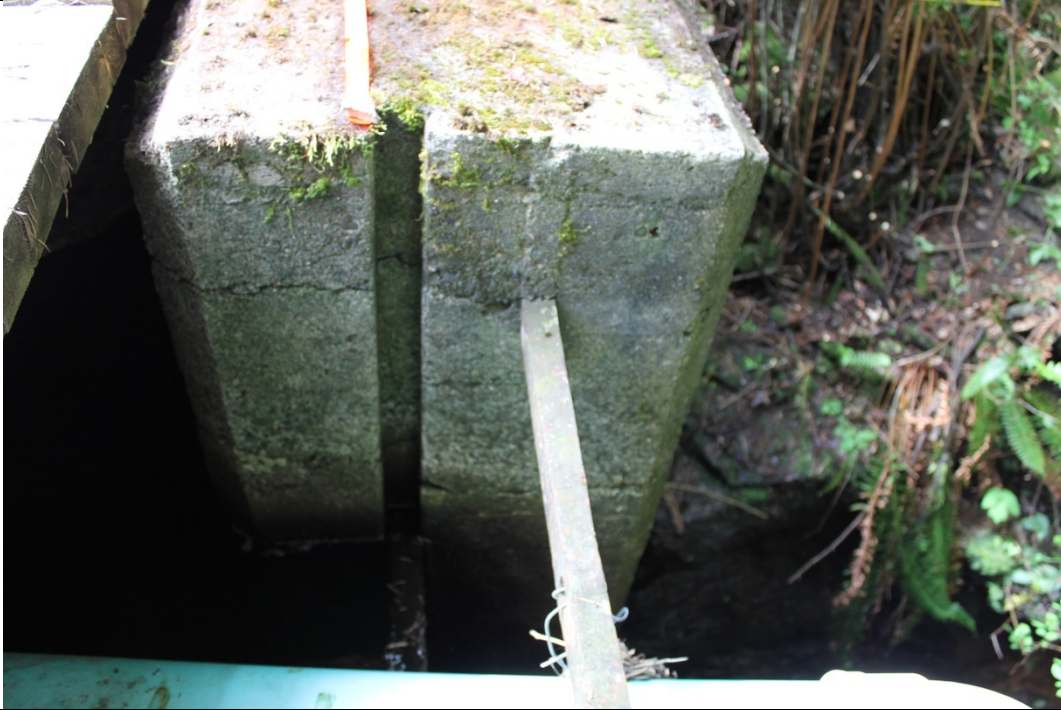
37. View of spillway in center of concrete weir, looking toward left abutment – stop-log gap in concrete

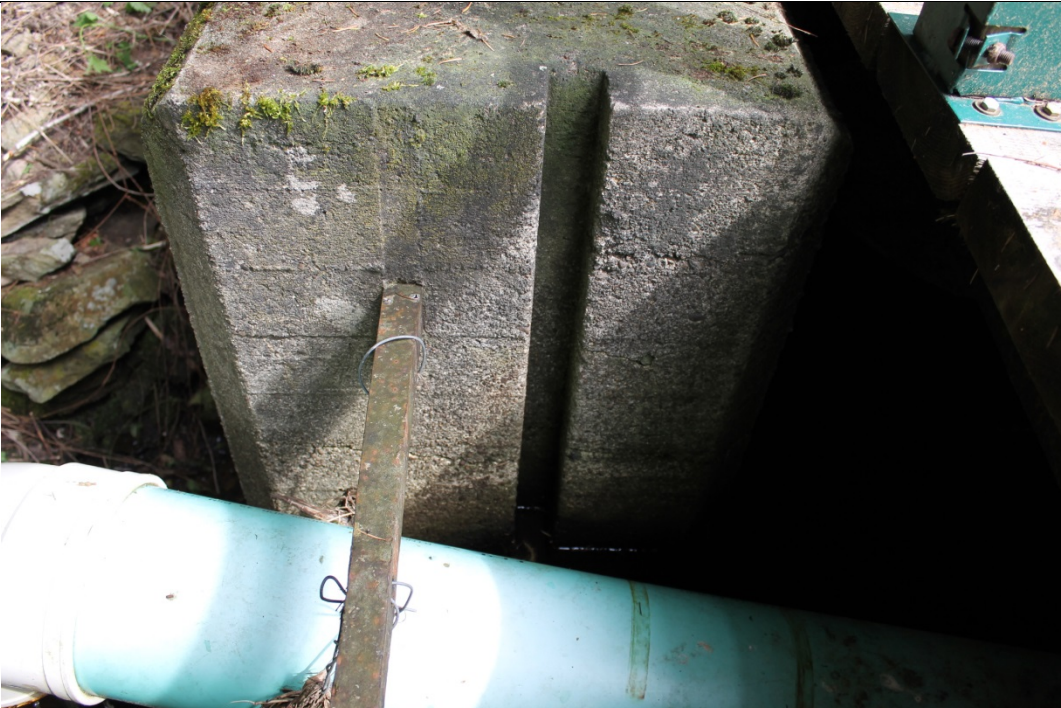
38. View of spillway, looking toward right abutment – stop-log gap in concrete and 200mm pond leveler pipe visible

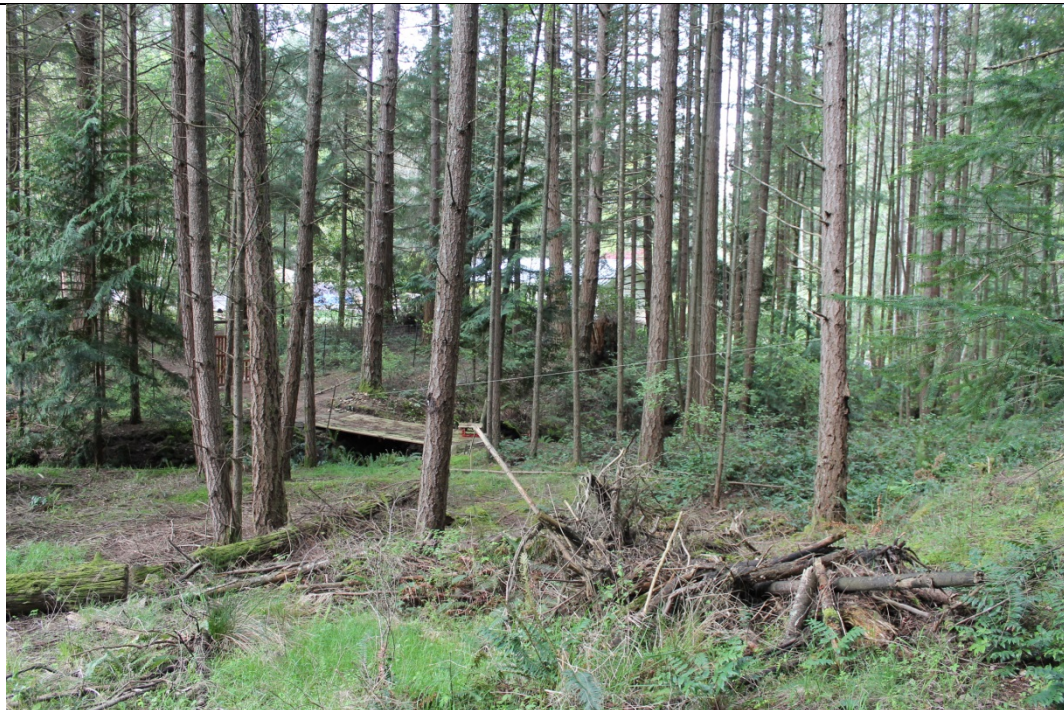
41. Spill path above blasted channel is broad and gently slopes D/S. Trees and bushes will impede overflow.

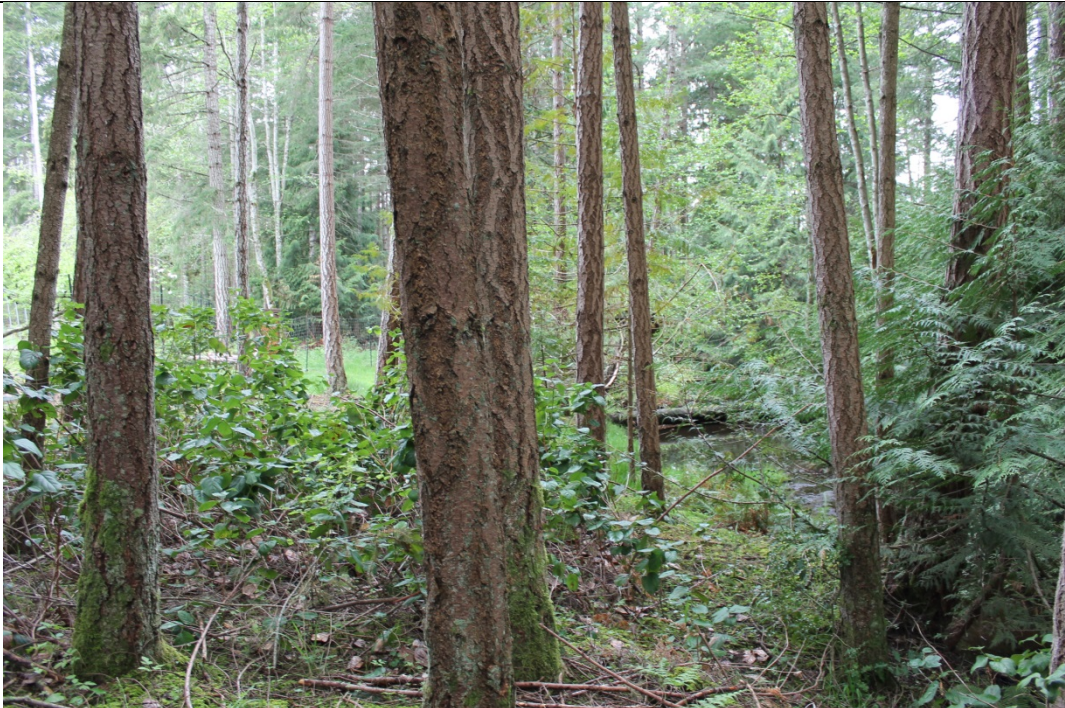
48. Spill channel looking D/S towards in/near stream residential property pond features

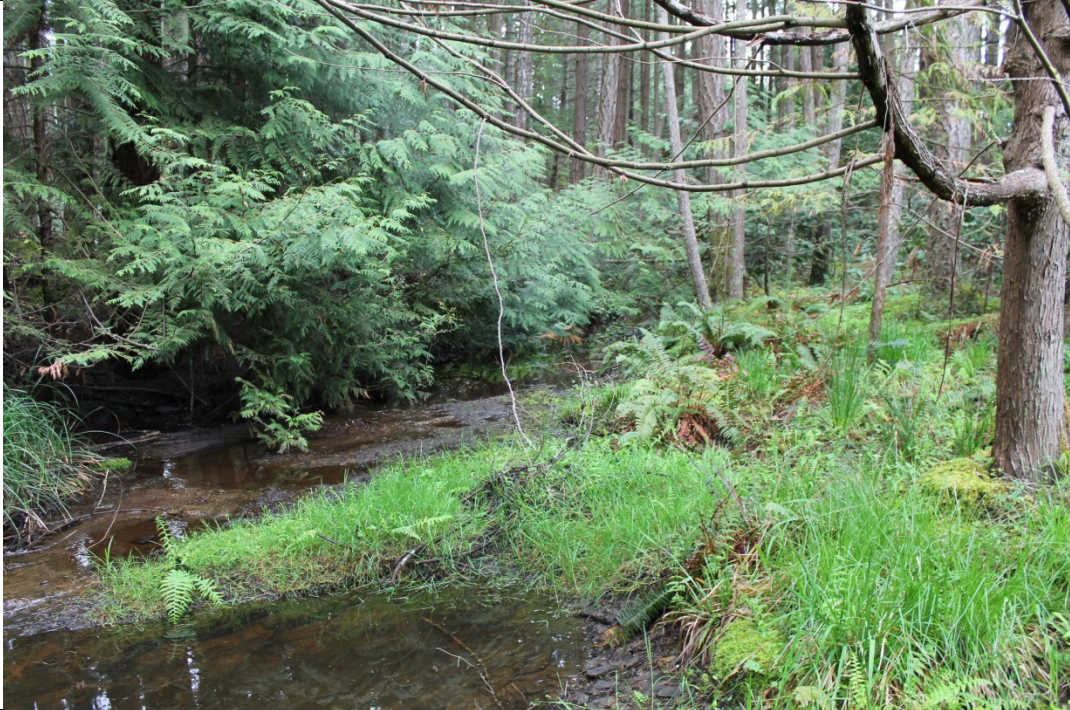
49. Looking U/S from beginning of area of residential property pond features of 1040 Coats Drive – very flat terrain

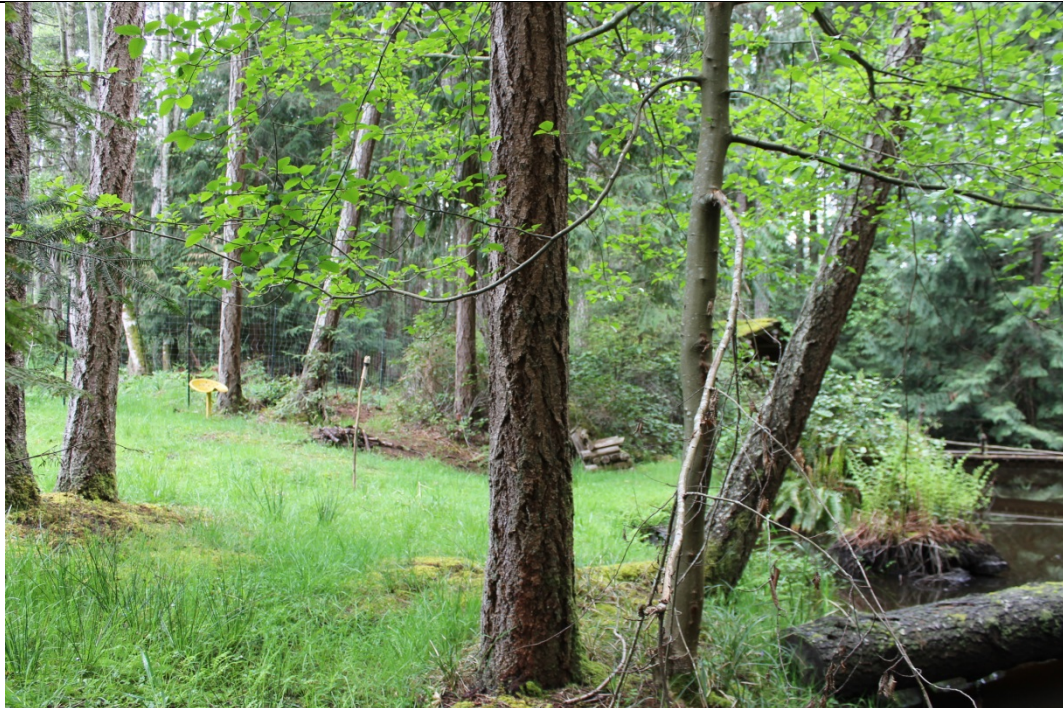
50. Looking D/S at residential property pond features of 1040 Coats Drive

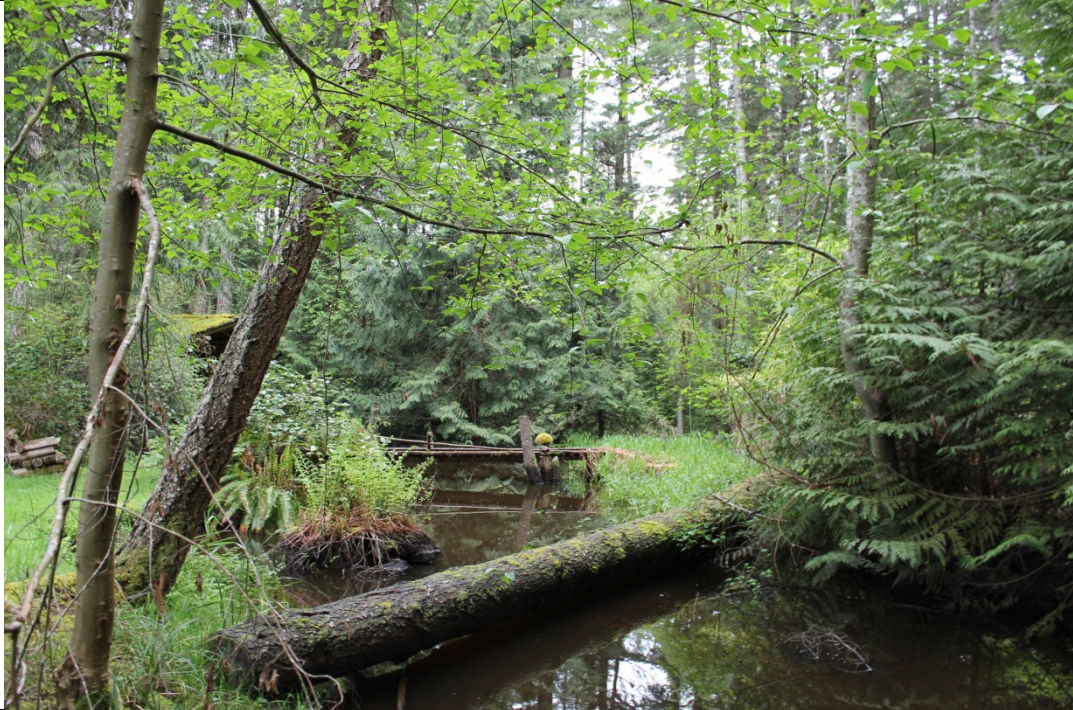
51. Looking downstream at fallen log and residential pond features – foot bridge 2 and cabin in left background

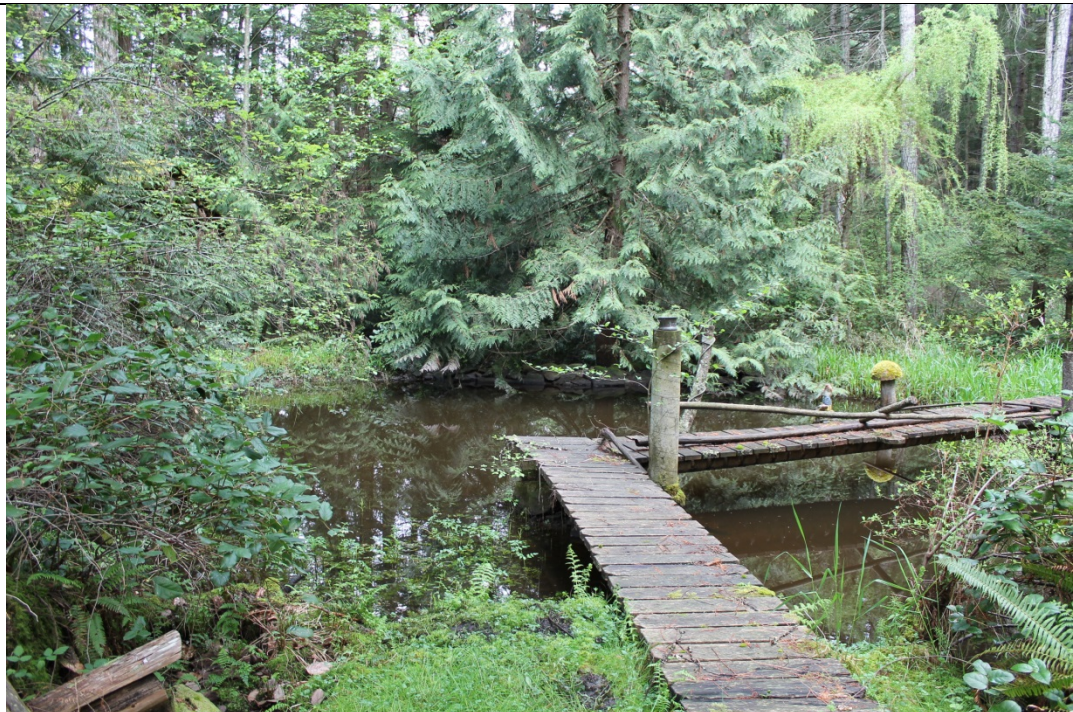
52. View of foot bridge 2 looking from left bank to right bank of spill channel – very flat terrain

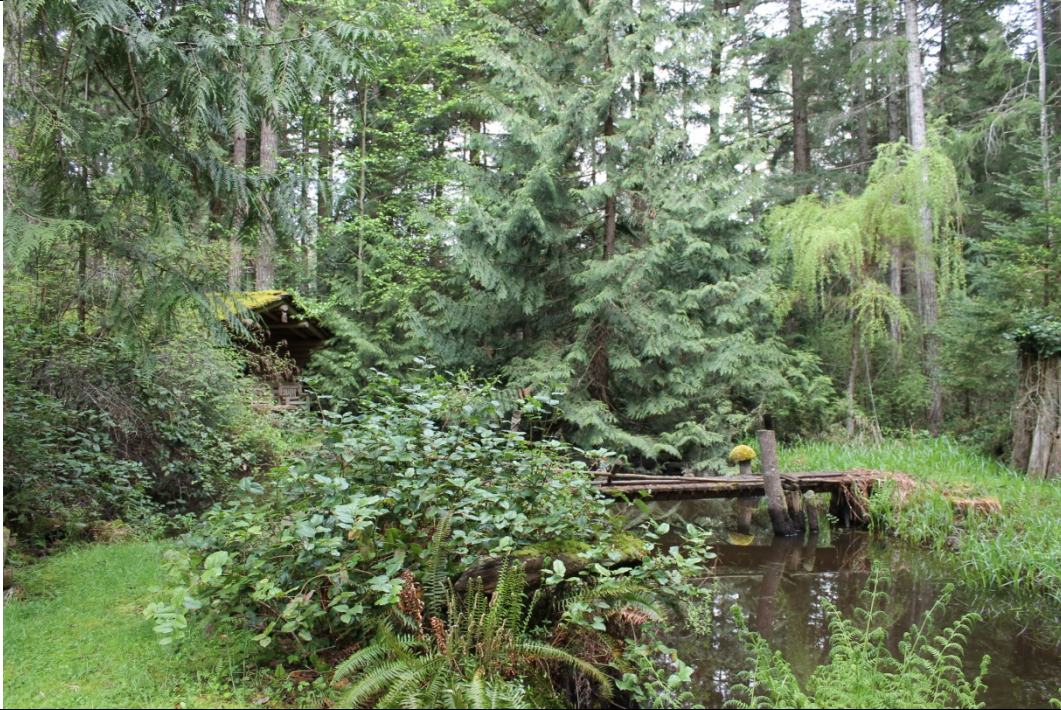
53. Looking D/S at foot bridge 2 and cabin. Pond in foreground was created by hand placed rock dam near cabin

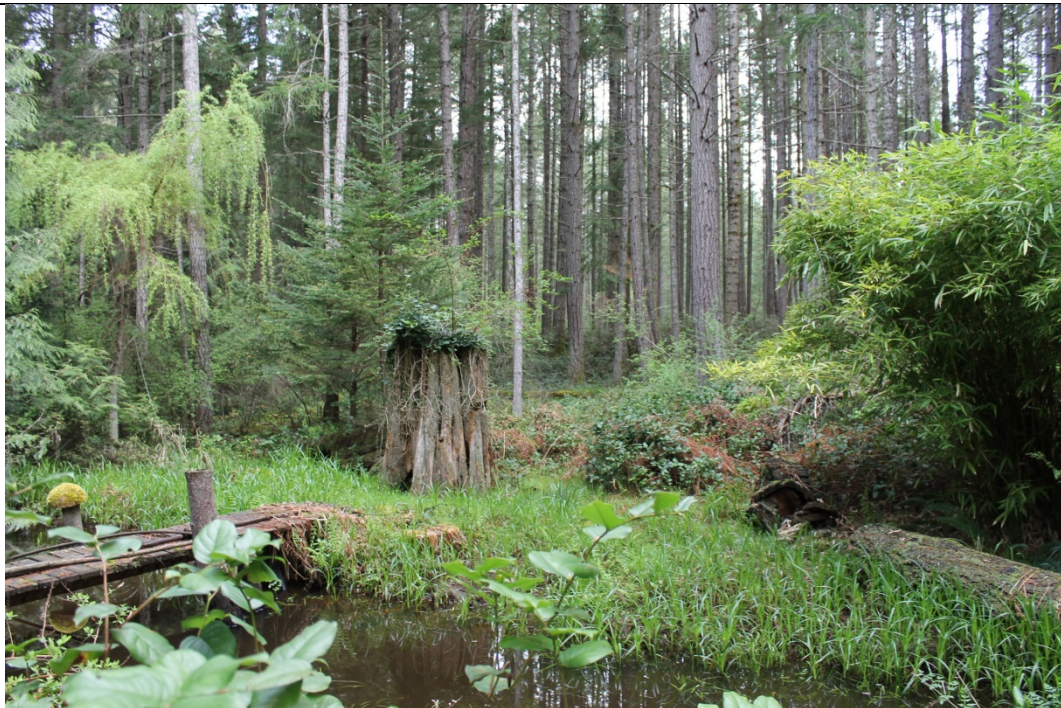
54. View across spill channel from left bank to right bank – drainage area is very broad and flat with many trees and bushes
