Coats Marsh Weir Assessment

Regional District of Nanaimo
1490 Springhill Road
Parksville, BC V9P 2T2
Liaison: Chris van Ossenbruggen,
Parks Operations Coordinator
Reference Number: NA

Scot Merriam, P.Eng.
Principal Engineer, SRM Projects

Date: June 1, 2020

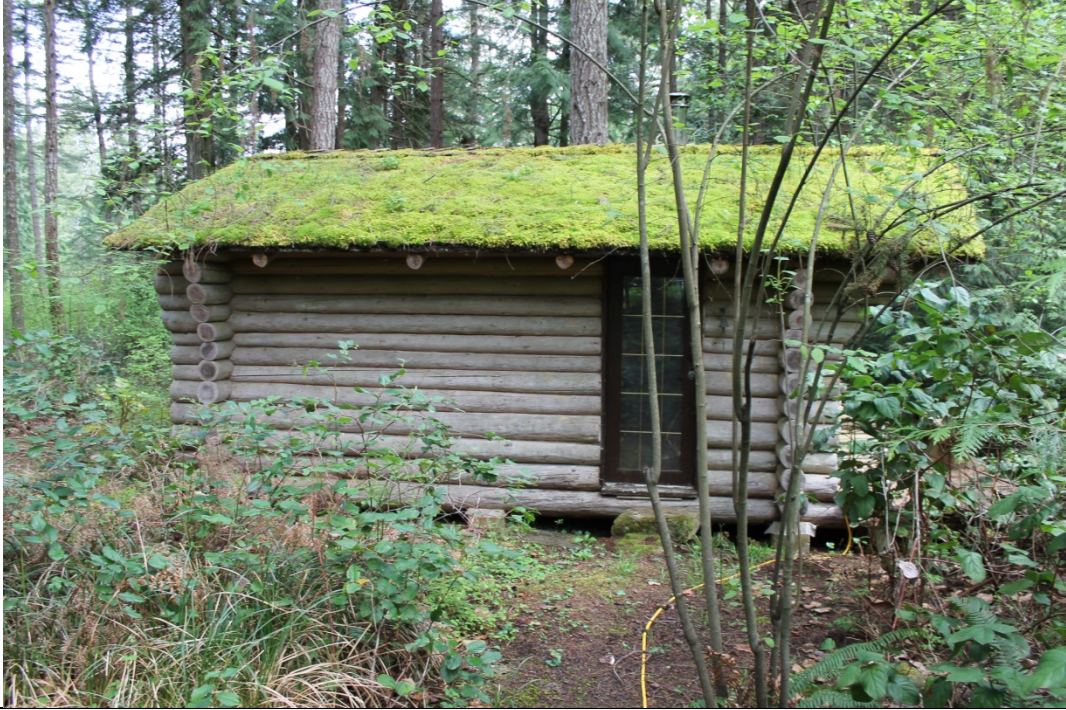
55. Side view of uninhabited recreational cabin – part of property at 1040 Coats Drive

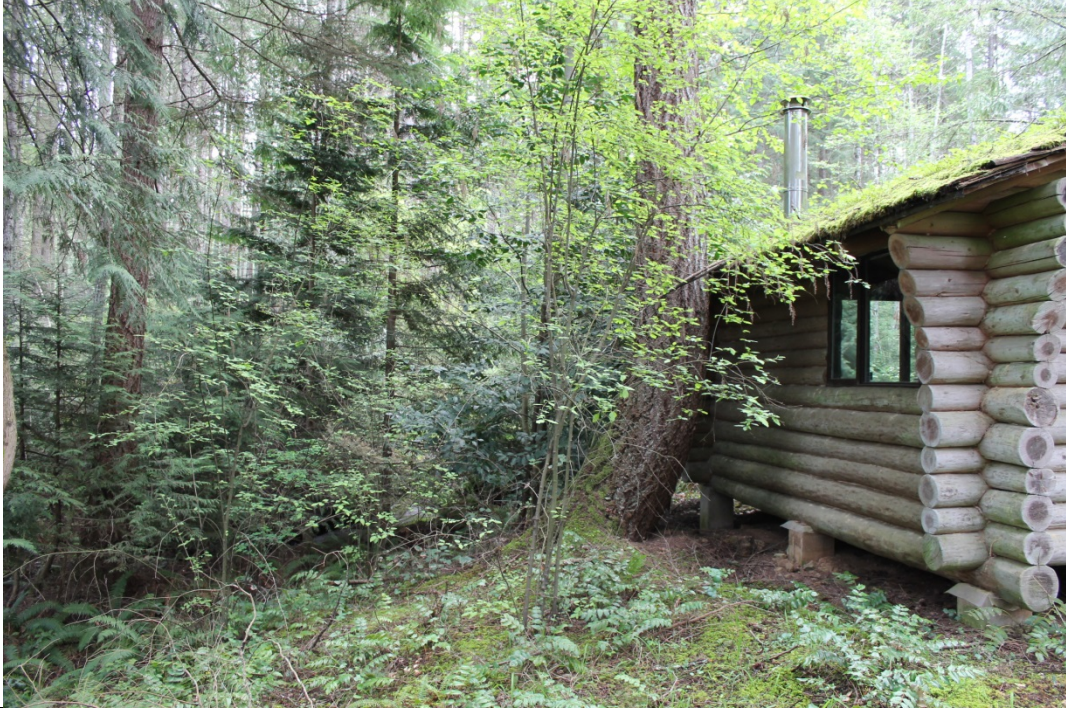
57. Spill channel side view of recreational cabin – channel at left

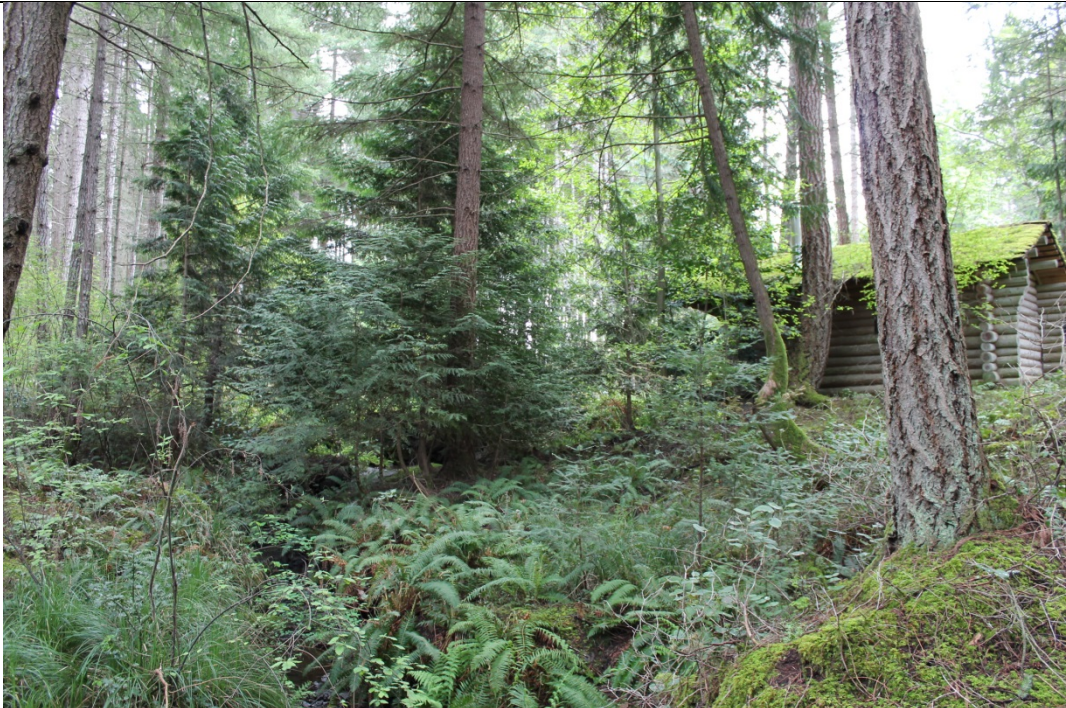
58. Spill channel looking U/S toward recreational cabin – noticeable elevation change

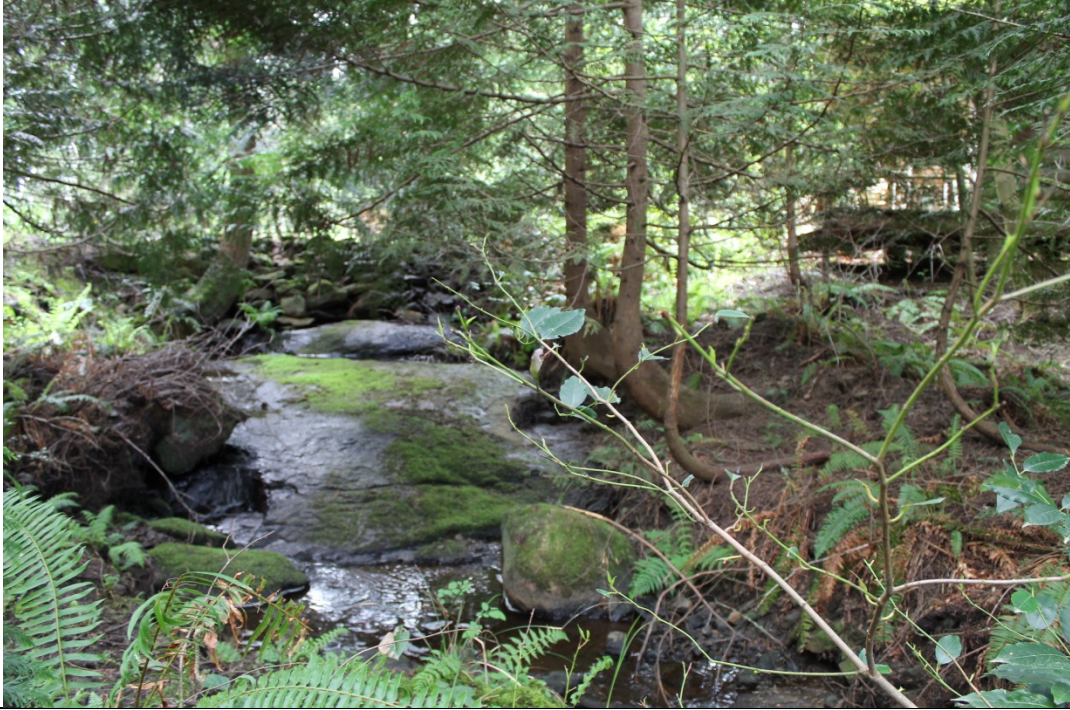
59. Looking U/S at hand placed rock dam near recreational cabin

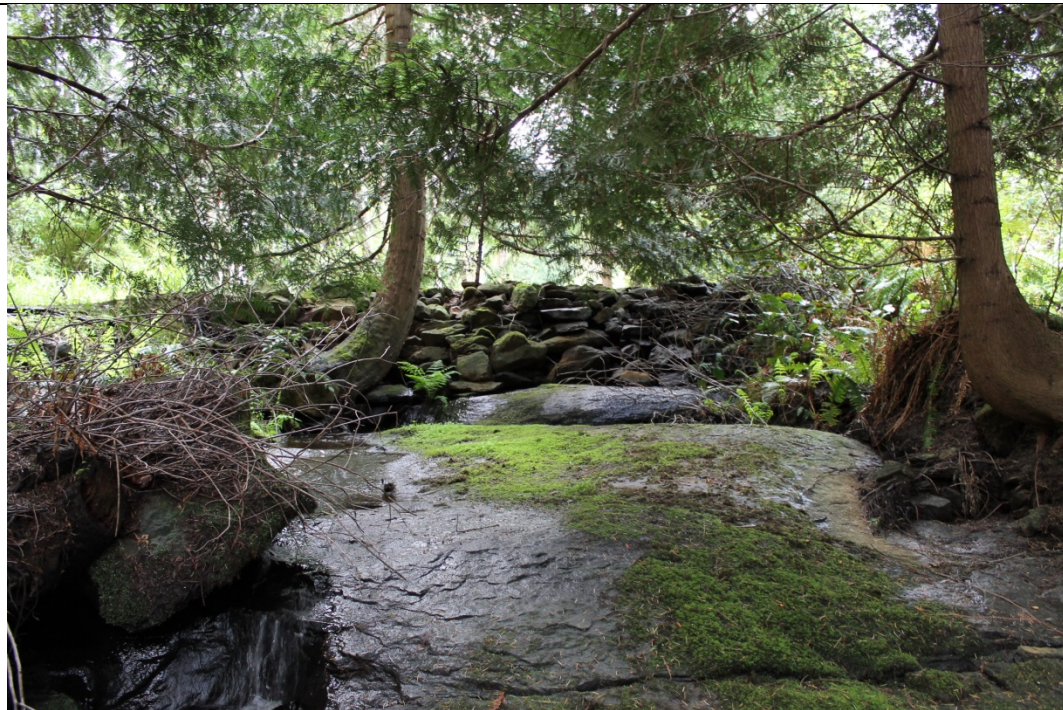
60. Close-up of rock dam in photo 59

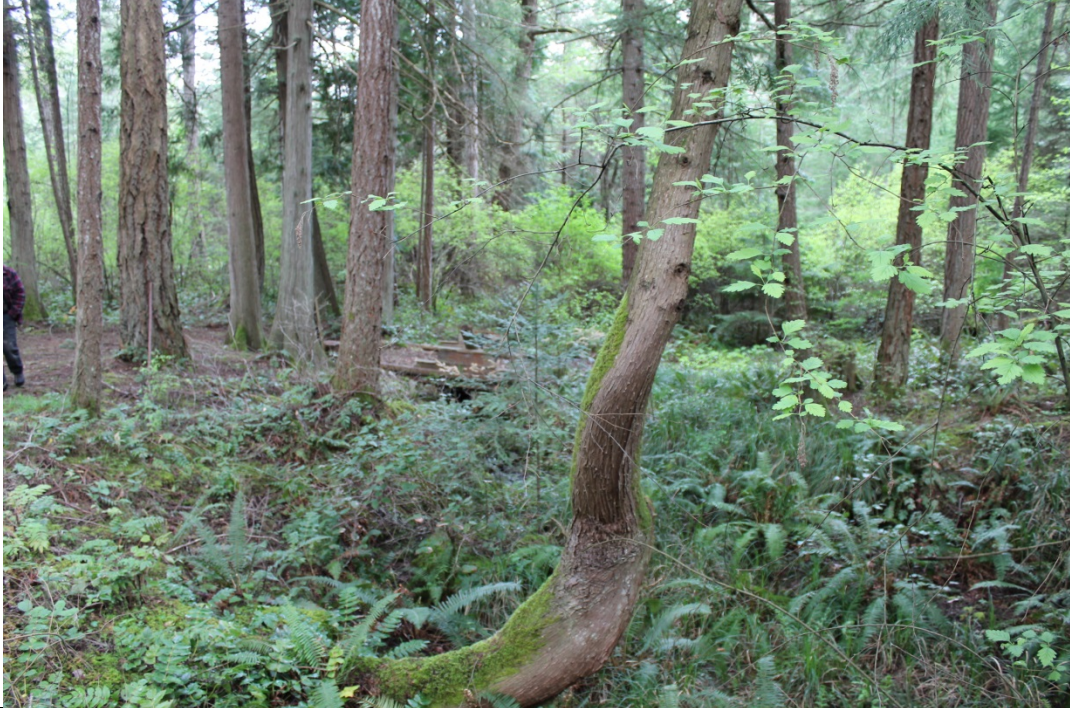
61. Spill channel looking D/S toward 1040 Coats Drive residential property bridge 3 – noticeable elevation change

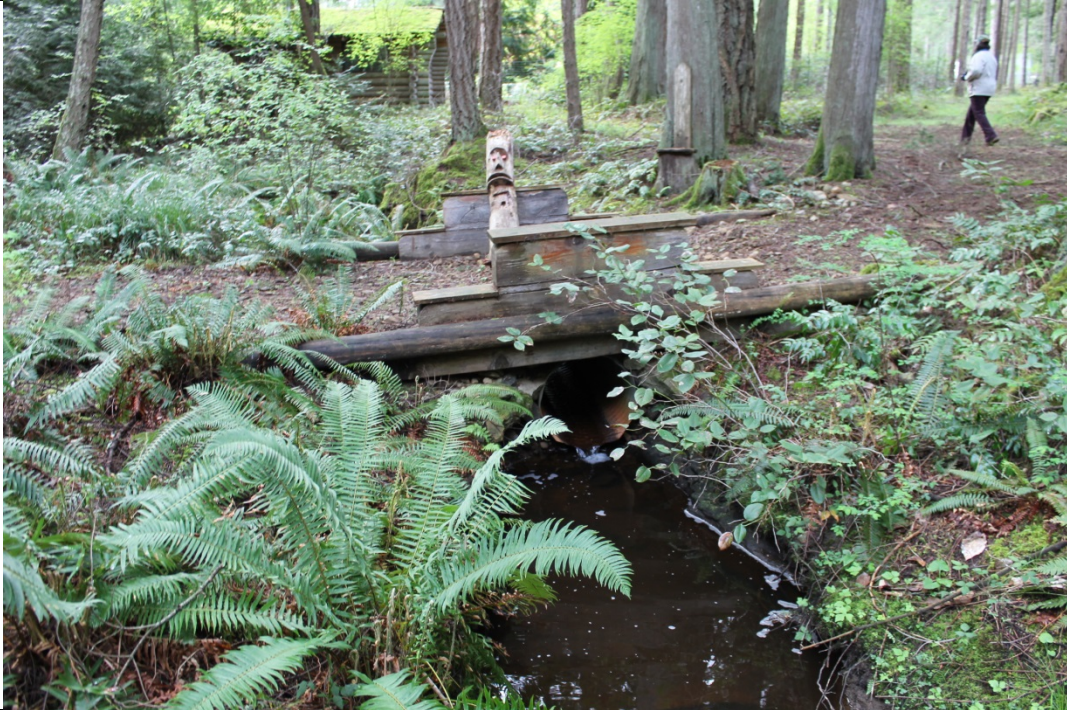
63. Looking U/S over bridge 3

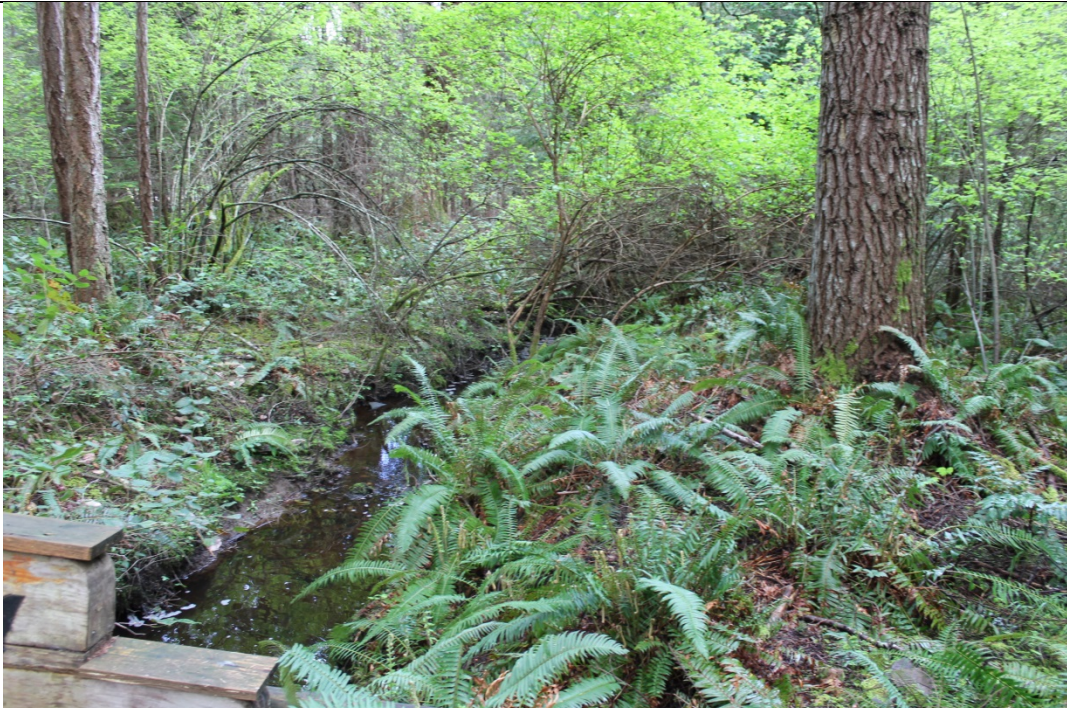
64. Looking D/S past bridge 3 – very flat terrain either side of channel

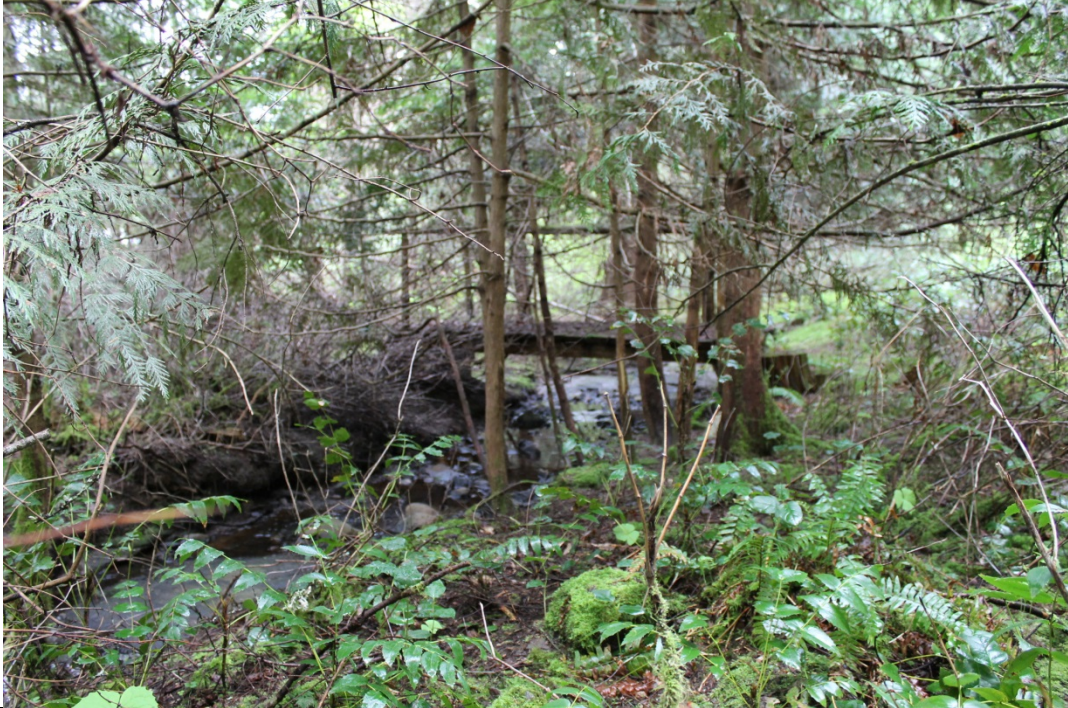
65. Looking D/S at 1040 Coats Drive residential property foot bridge 4

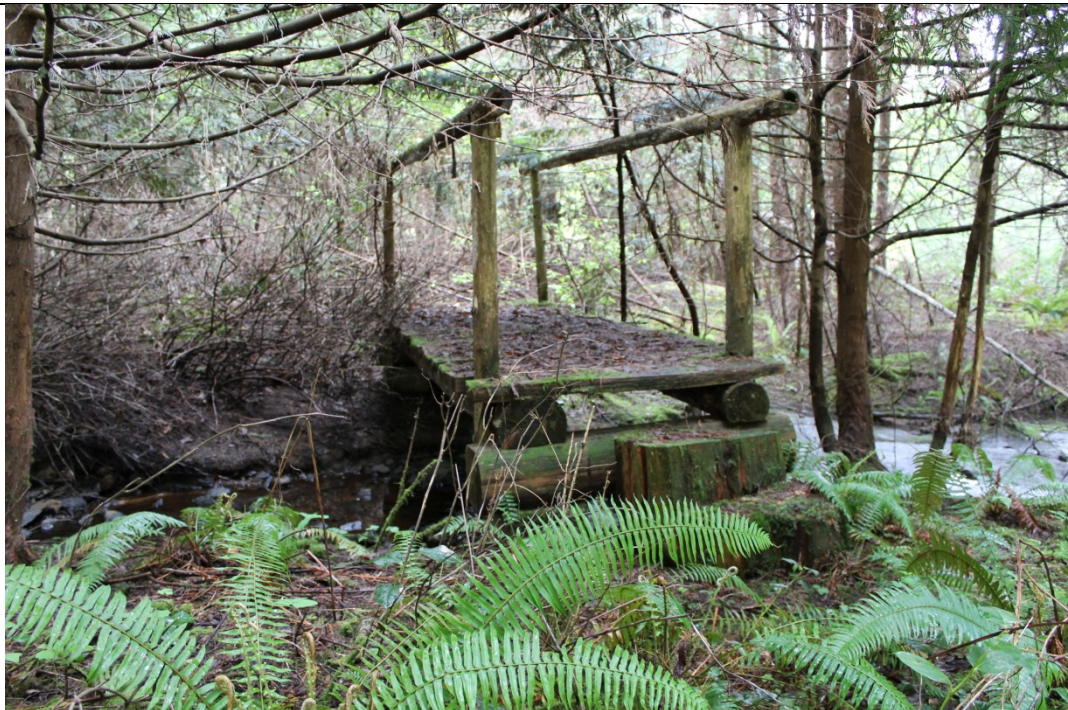
66. Looking from right bank to left bank over foot bridge 4

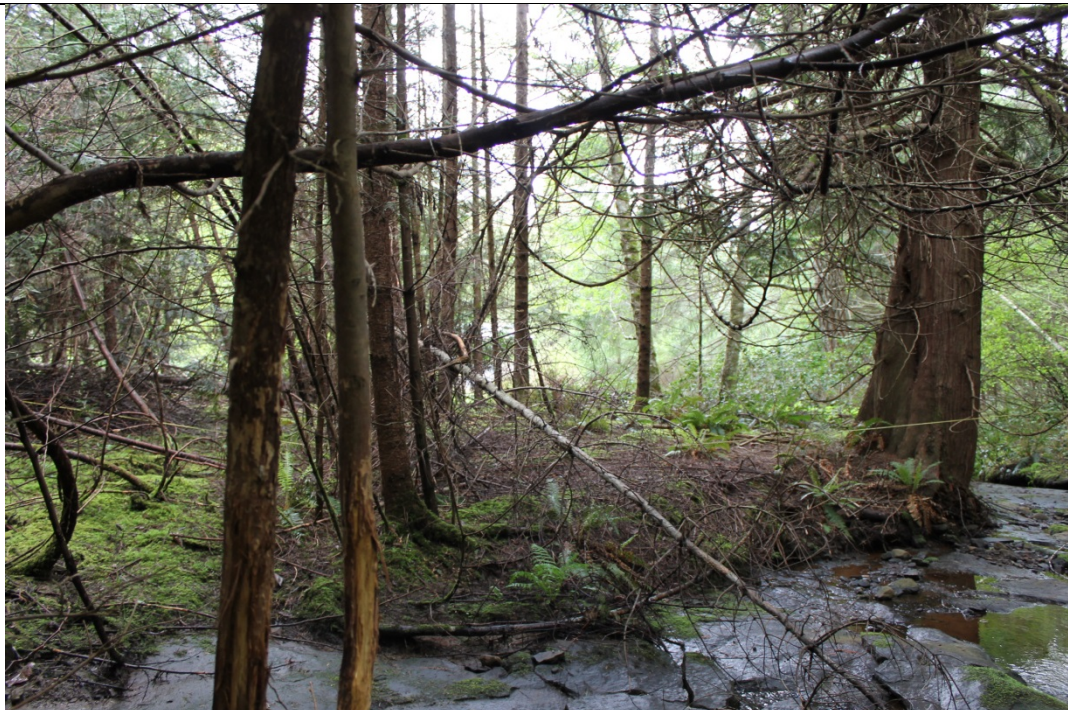
68. Clearing past trees on left bank is the start of residential property at 1034 Coats Drive

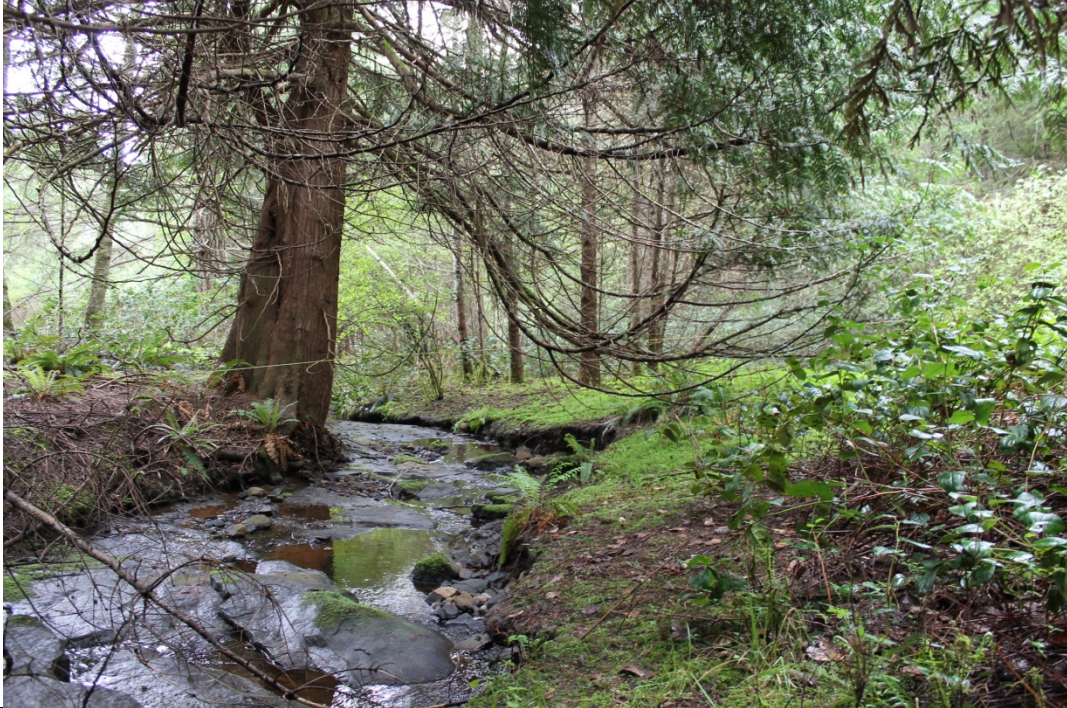
69. Looking D/S toward residential property at 1034 Coats Drive – terrain is broad and flat on both sides of channel

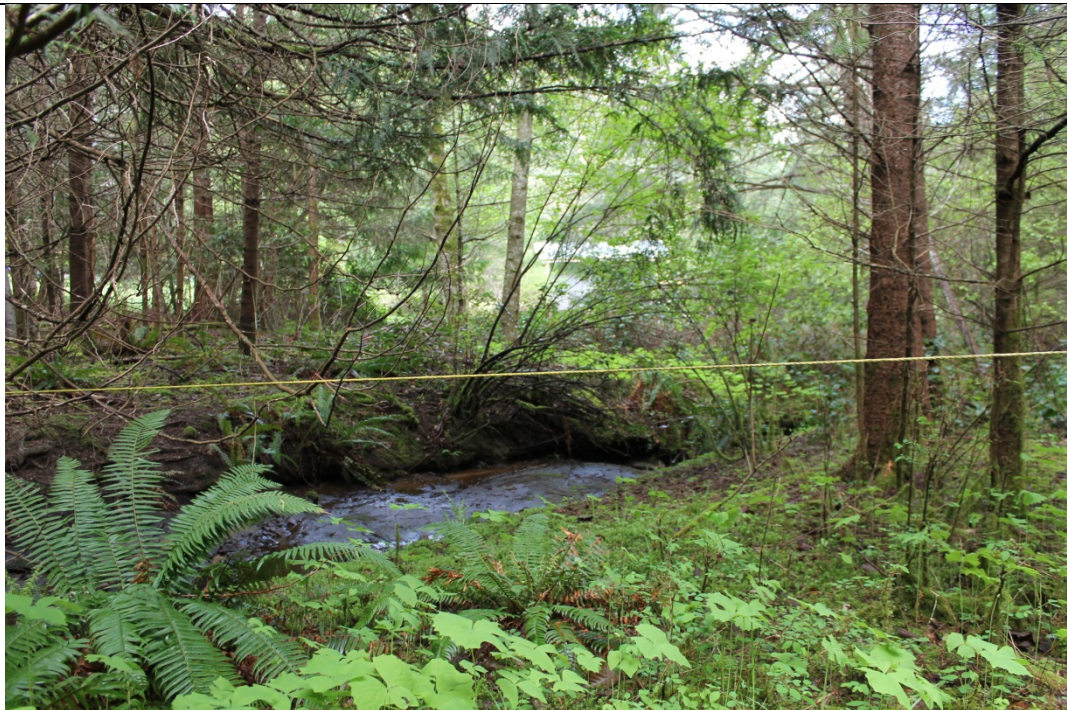
70. Yellow rope is approximate location of property line between residential properties at 1040 and 1034 Coats Drive

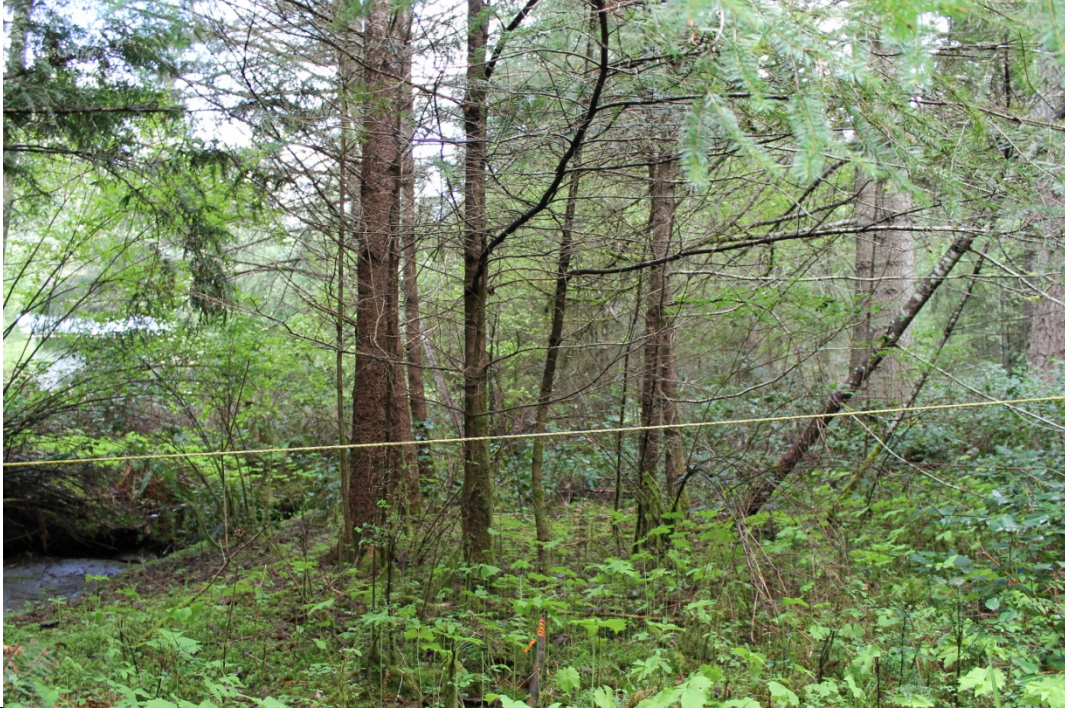
71. Looking D/S at right bank – terrain is very flat with many trees and bushes

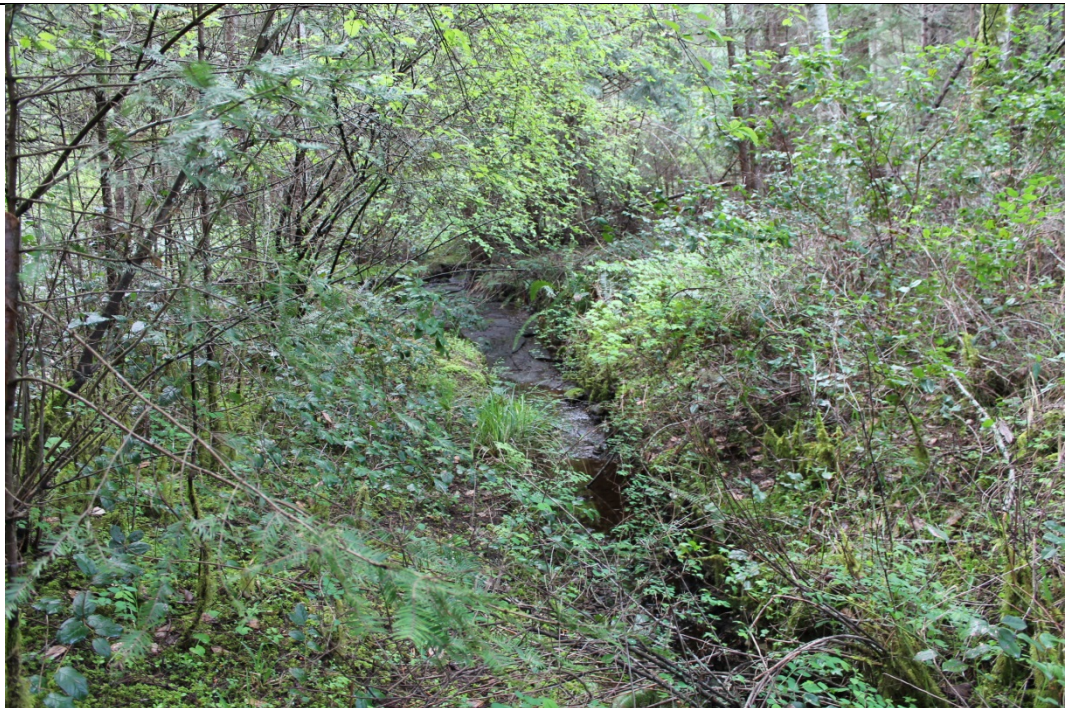
72. Spillway channel at foot of 1040 Coats Drive residential property looking D/S

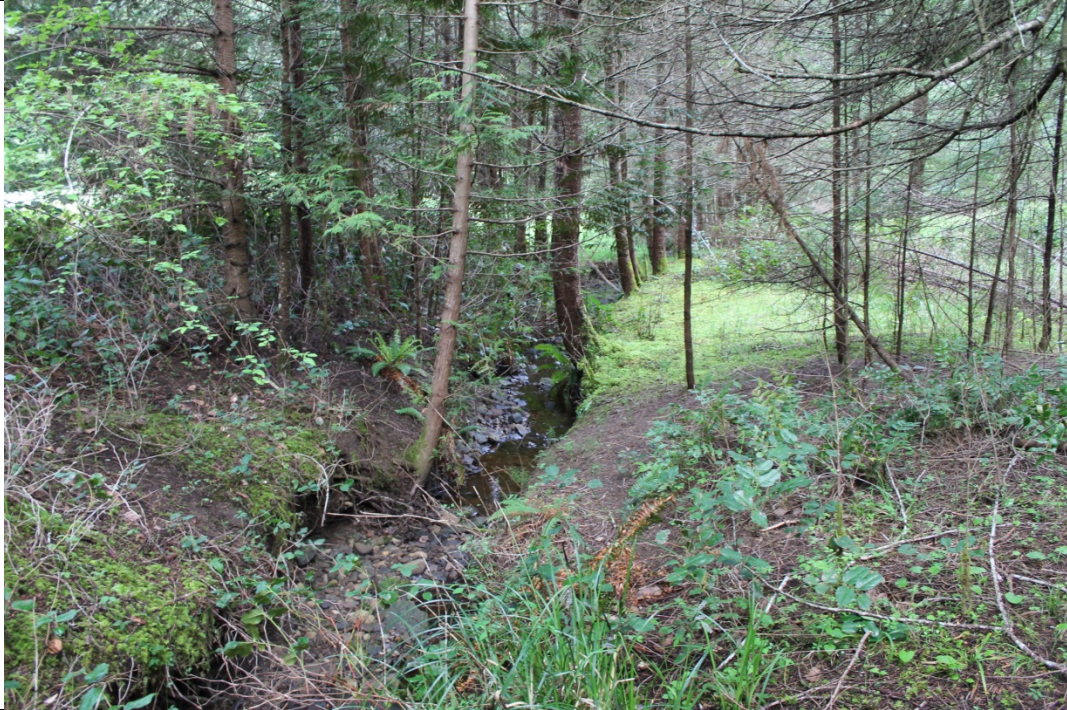
73. Spillway channel looking D/S at foot of 1040 Coats Drive cont'd

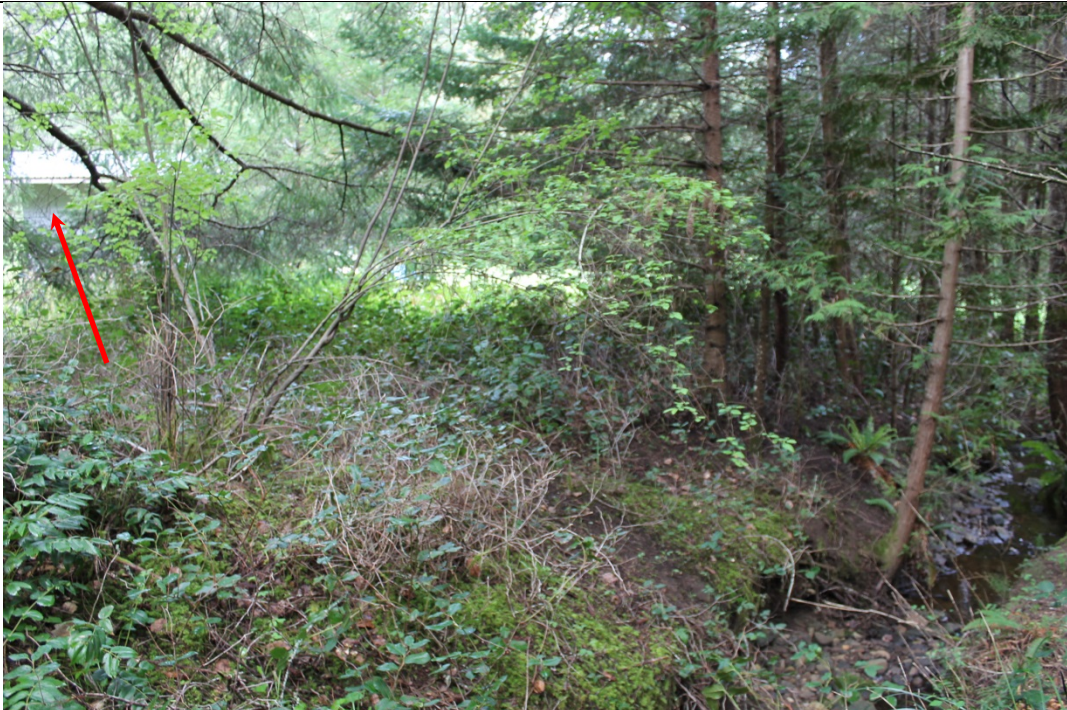
74. Left bank view from photo 73 location showing residential property shed through trees (red arrow)

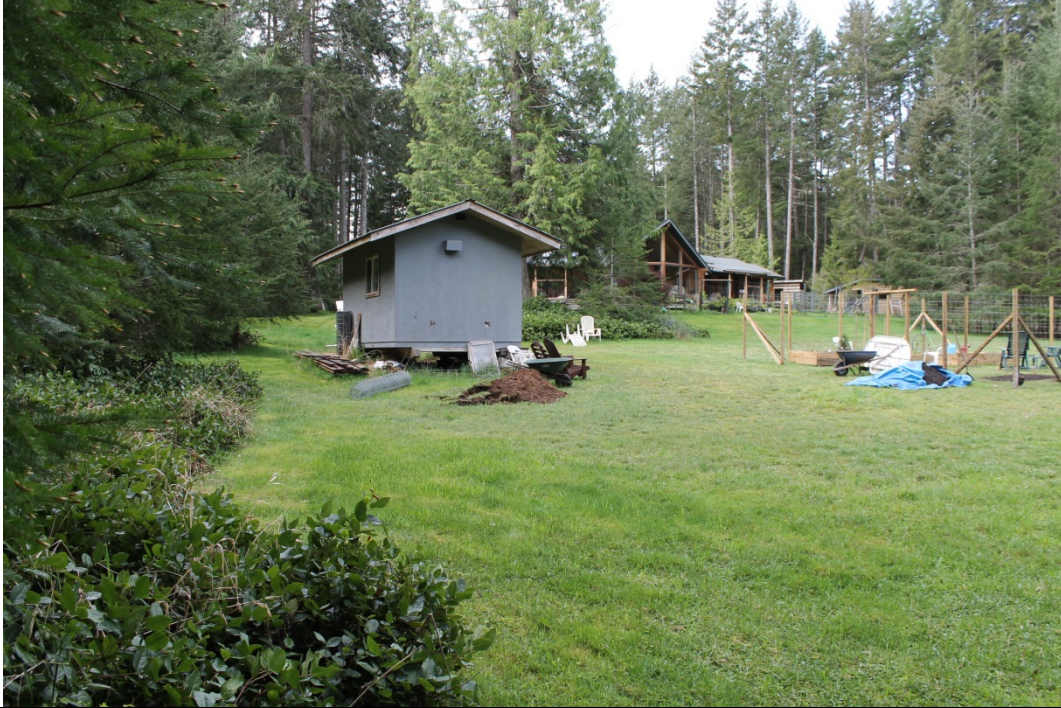
75. View from left bank of spill channel looking at 1034 Coats Drive grey shed and residence in background

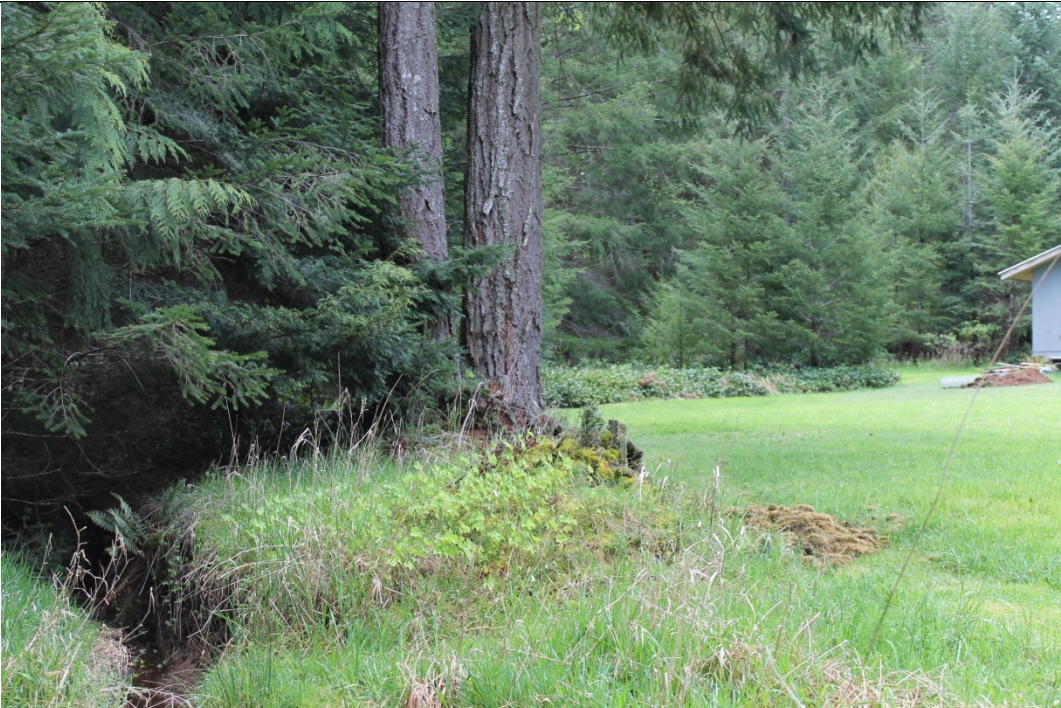
76. View showing spill channel at left and grassy left bank – terrain gently slopes up to right

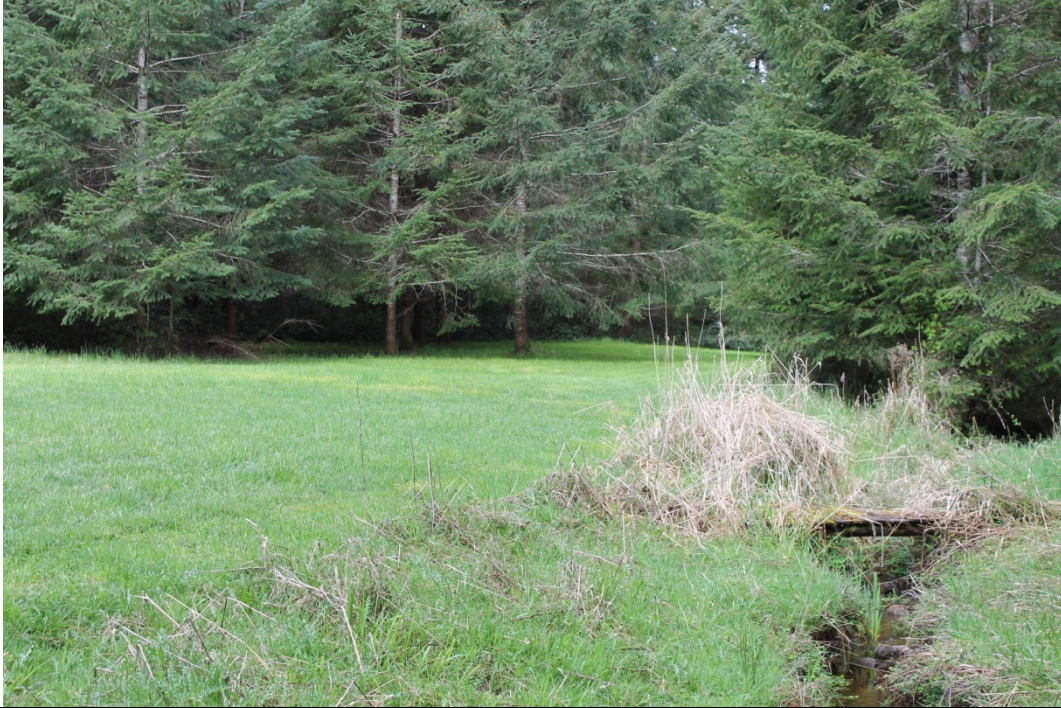
77. Spill channel looing D/S toward 1034 Coats Drive residential property foot bridge 5

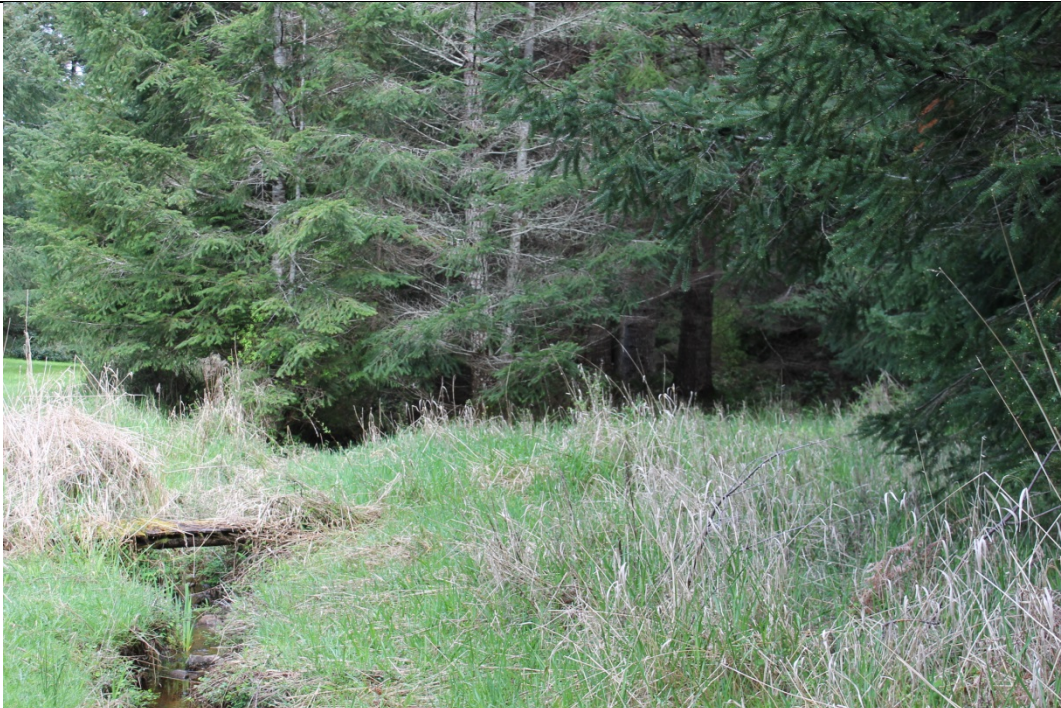
78. Right bank of spill channel near foot bridge 5 – terrain is broad and flat with many trees and bushes

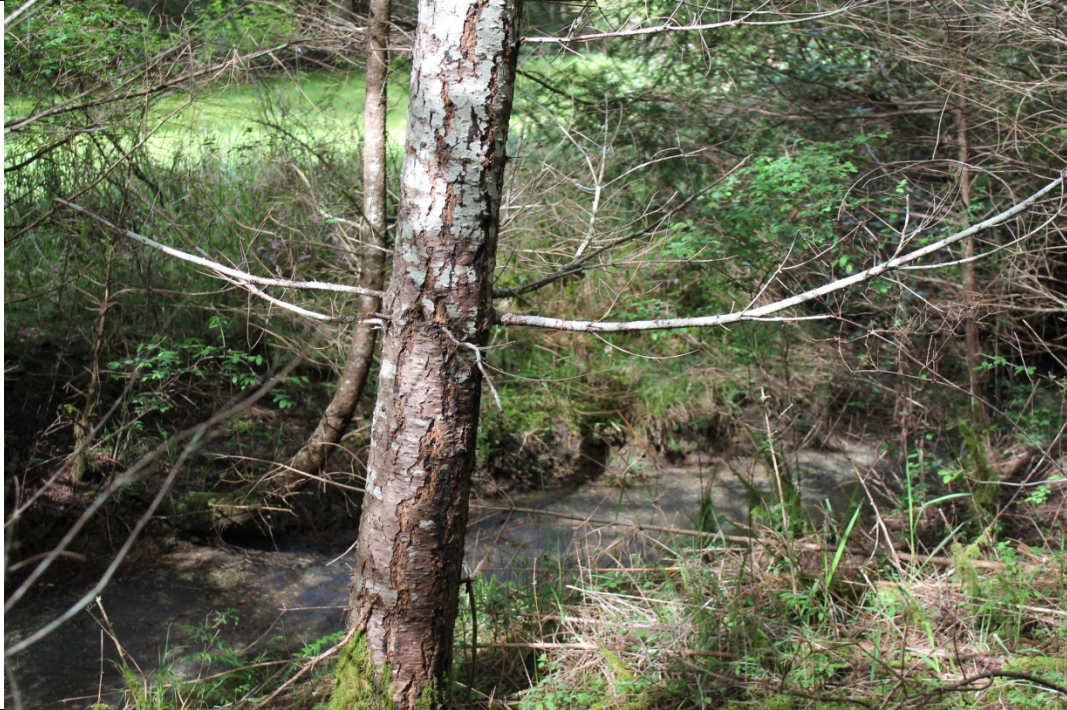
79. Spill channel looking D/S at foot of 1034 Coats Drive residential property

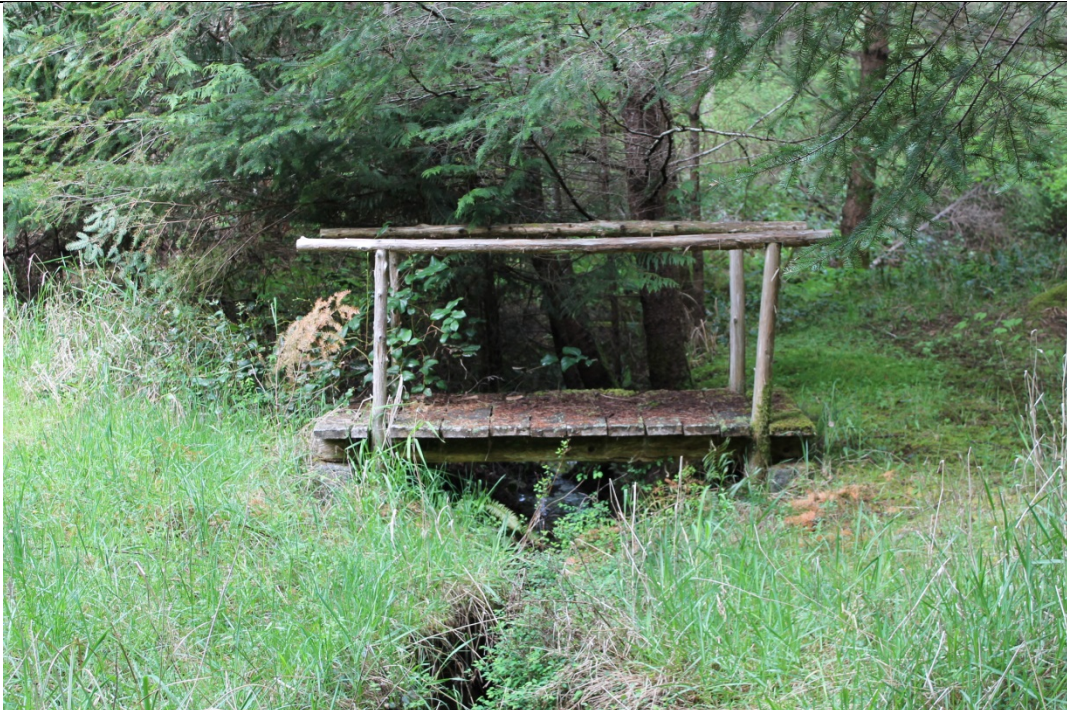
80. Spill channel looking D/S toward 1034 Coats Drive residential property foot bridge 6

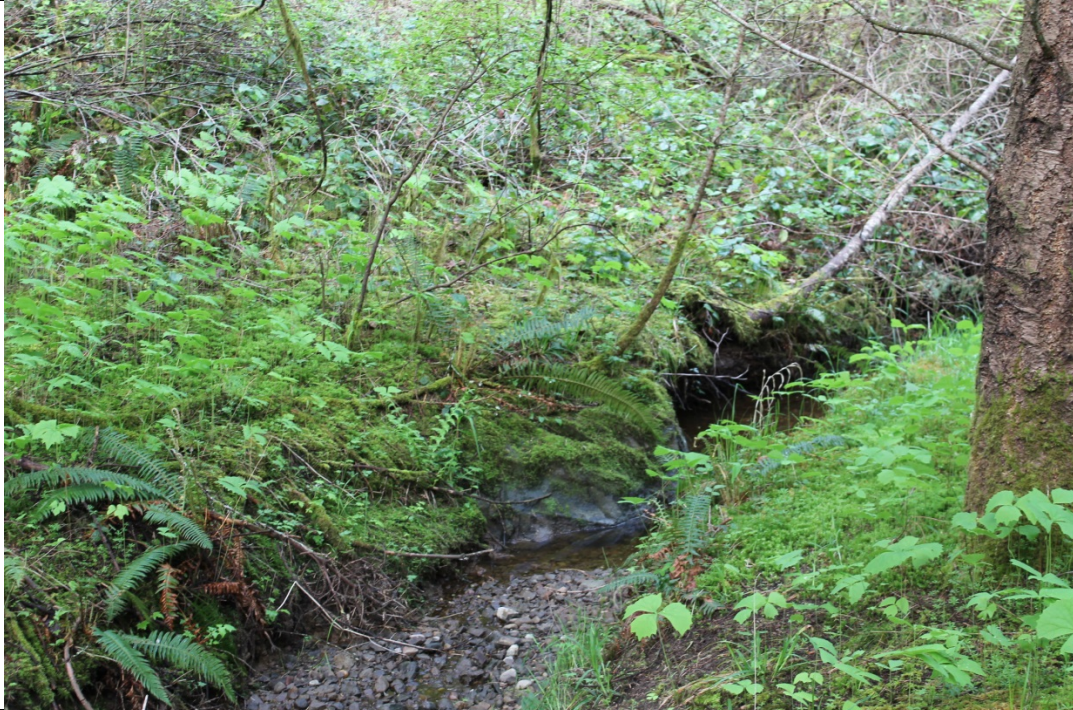
81. Spill channel looking downstream past end of residential property at 1034 Coats Drive

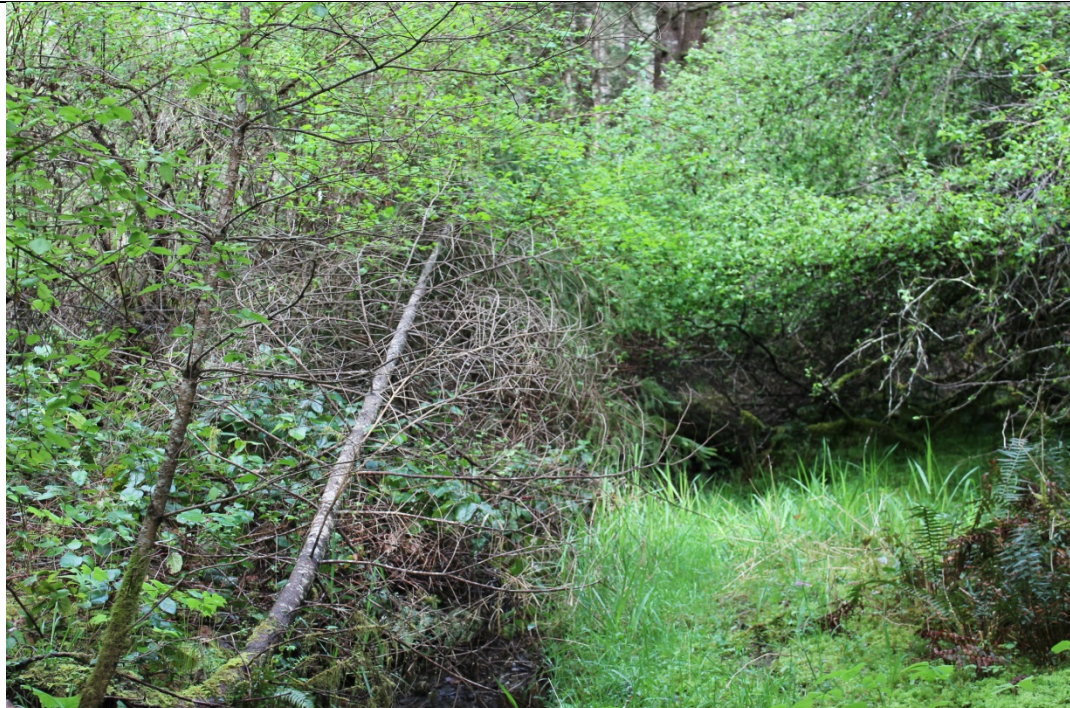
82. Spill channel disappears into flat area of trees and dense undergrowth before dropping down again toward Hoggan Lake

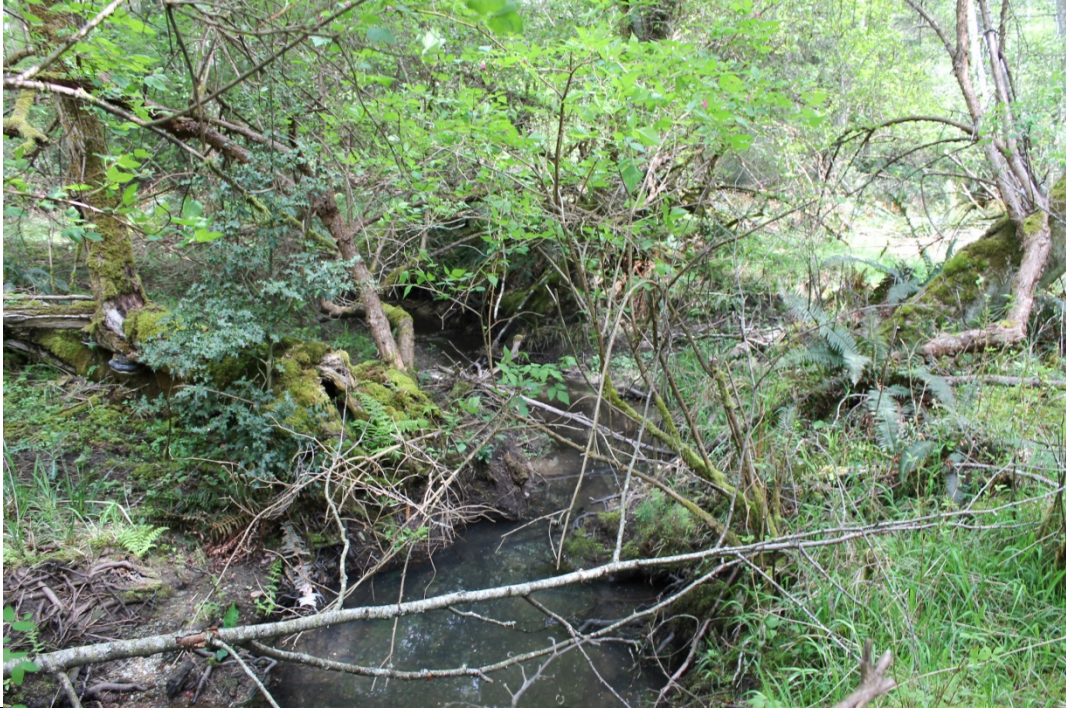
83. Looking U/S at spill channel (aka Coats Marsh Creek) near South Road crossing

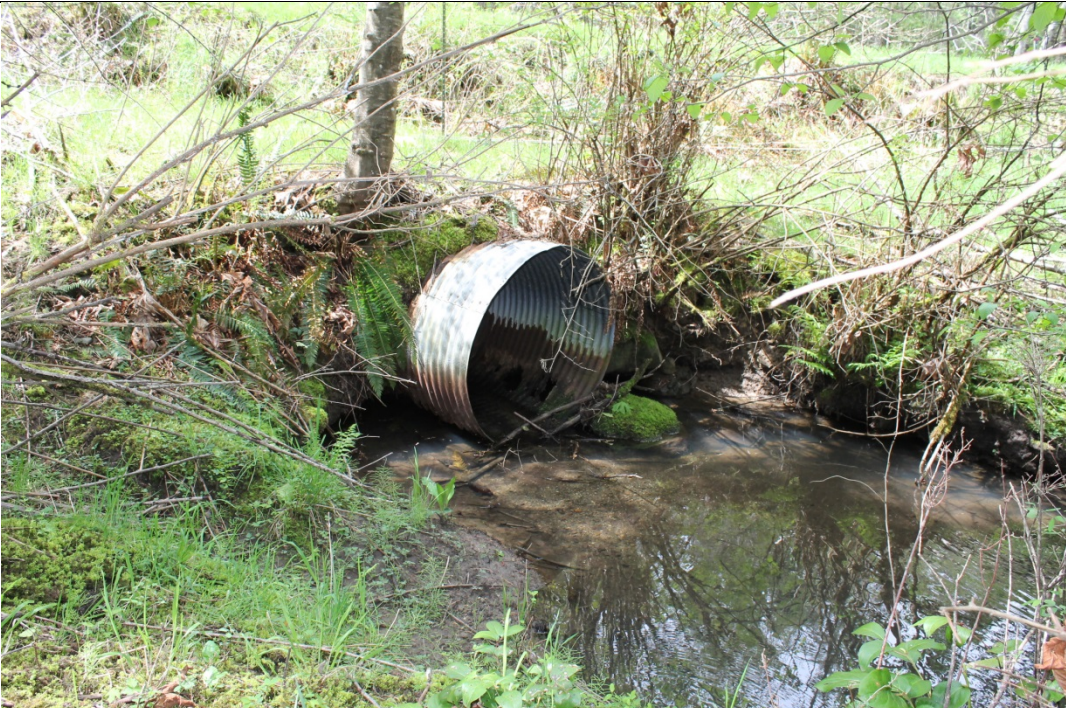
84. 1.22 m dia. Coats Marsh Creek culvert crossing under South Road

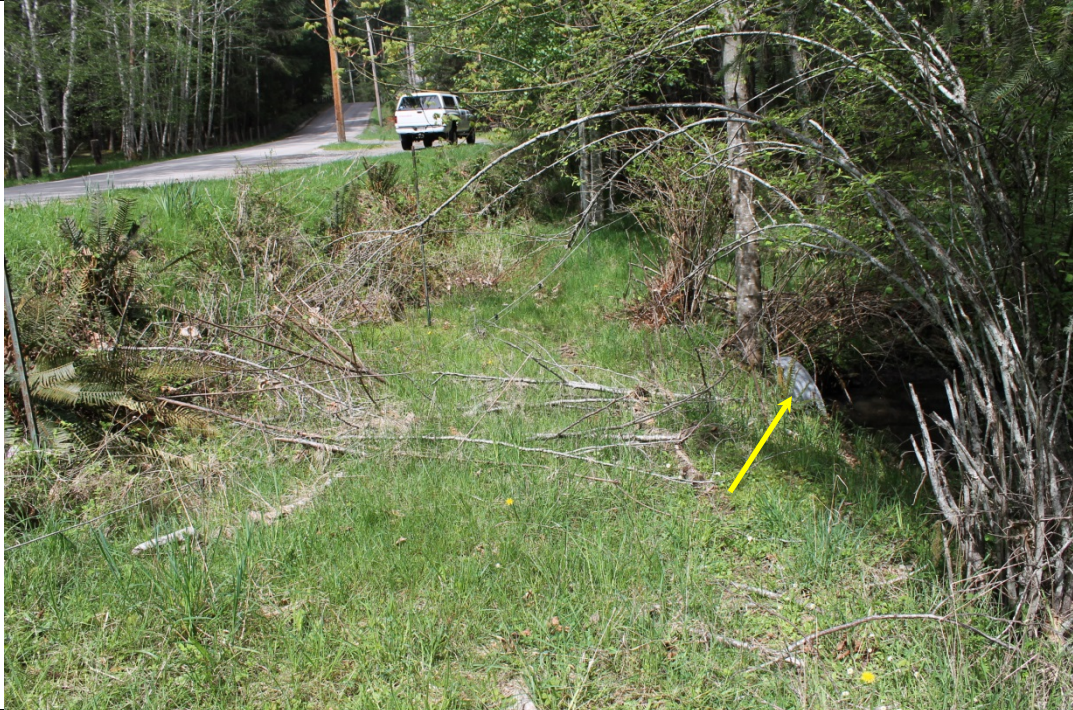
85. View of culvert in photo 84 (yellow arrow) showing South Road crossing

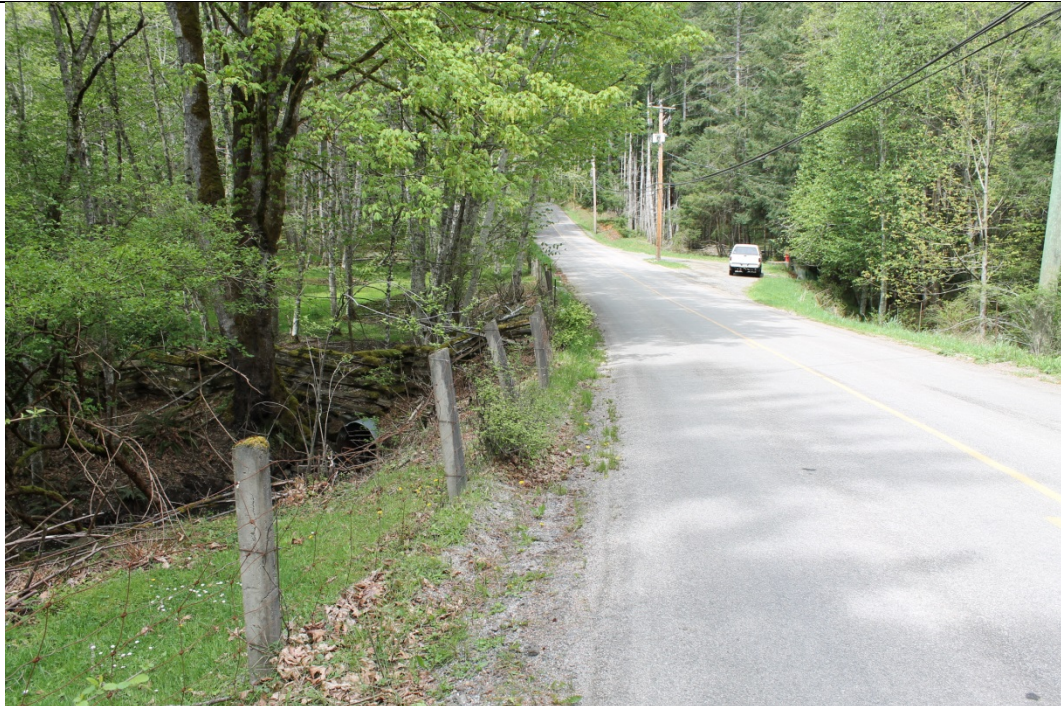
86. D/S end of South Road crossing culvert – culvert crosses at dip in road
