Coats Marsh Weir Assessment

Regional District of Nanaimo
1490 Springhill Road
Parksville, BC V9P 2T2
Liaison: Chris van Ossenbruggen,
Parks Operations Coordinator
Reference Number: NA

Scot Merriam, P.Eng.
Principal Engineer, SRM Projects

Date: June 1, 2020

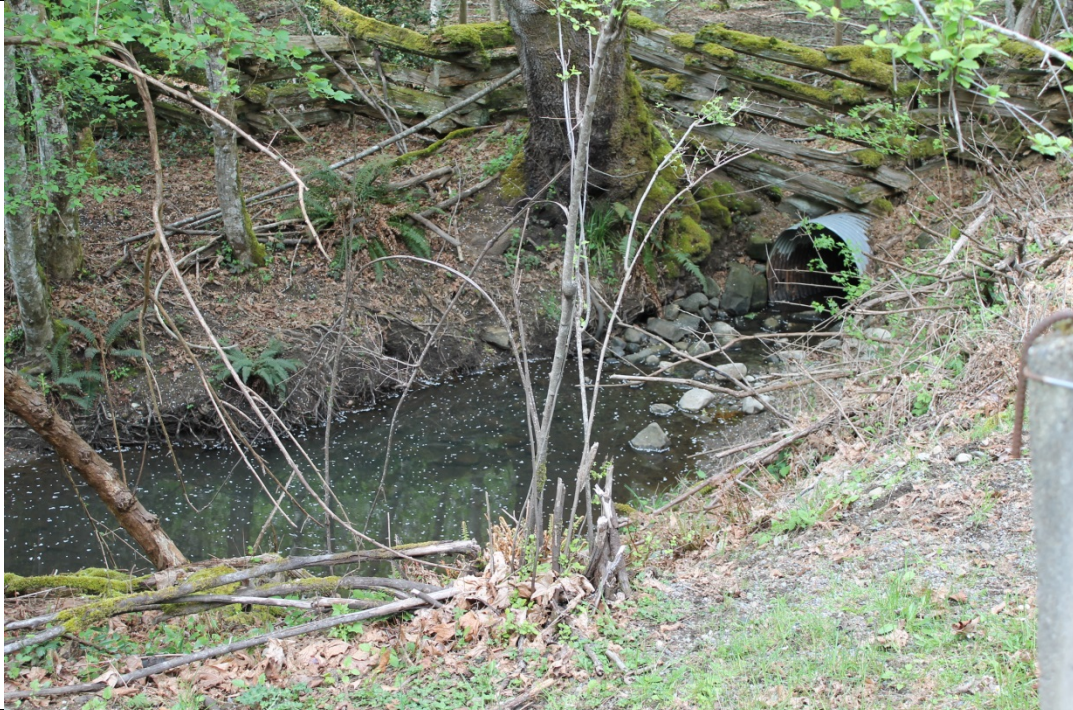
87. Close-up of D/S end of South Road crossing culvert

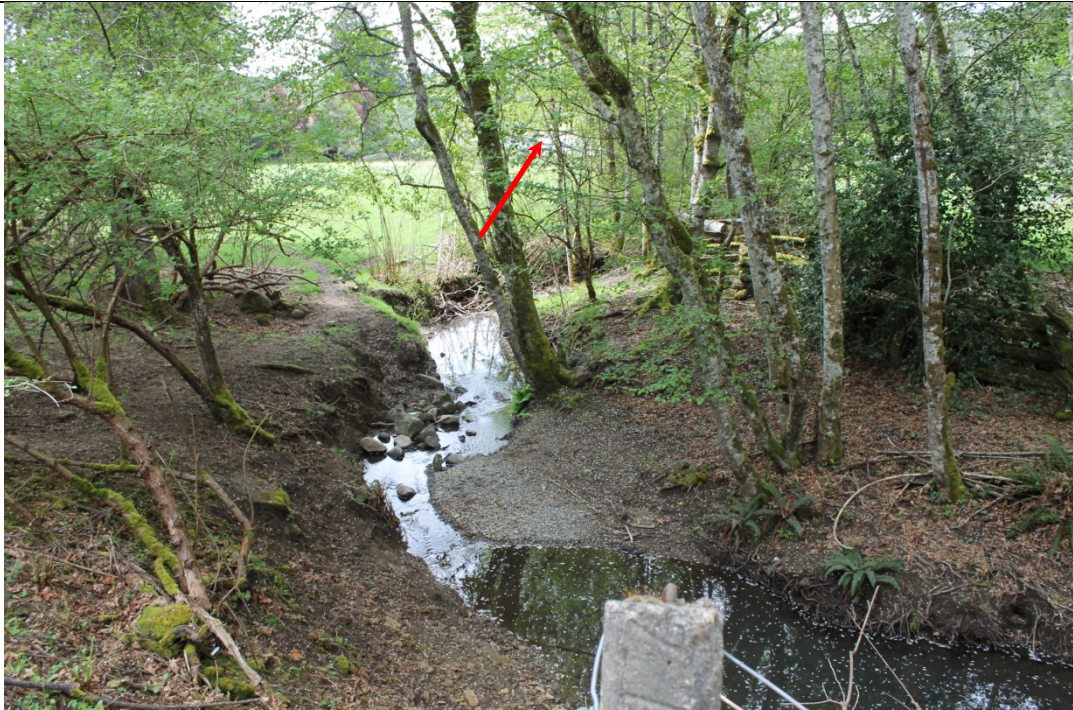
88. Coats Marsh Creek looking D/S toward Hoggan Lake (lake past grassy area at red arrow)
