## Addendum to report on Texada “goop” used on Gabriola

### Magnesium/calcium silicate scaling

### The “corrosion” problem—real or imagined?

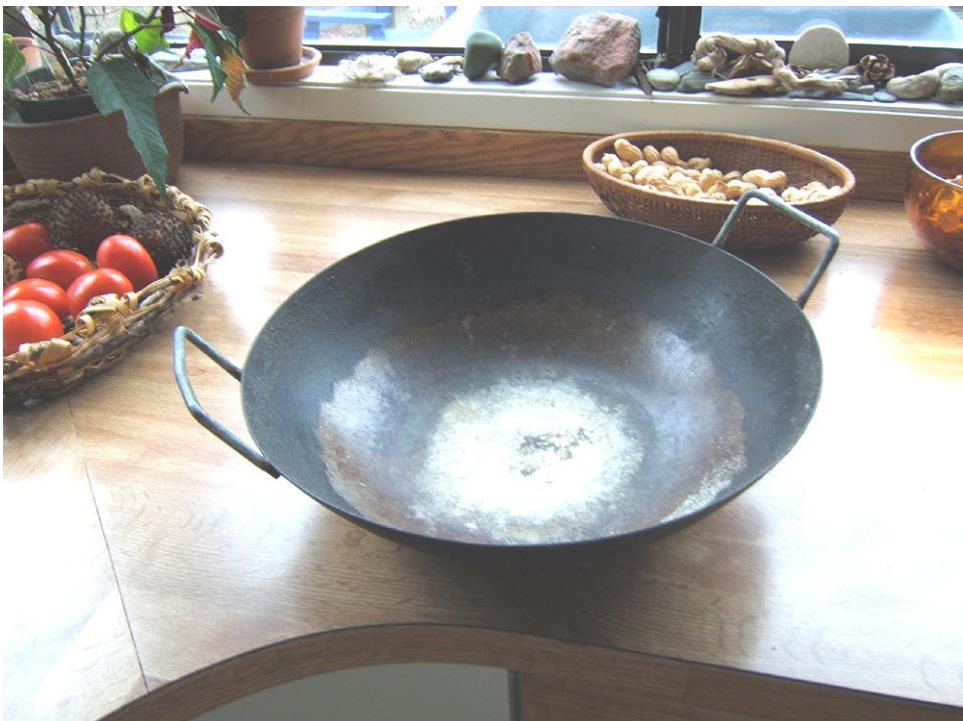
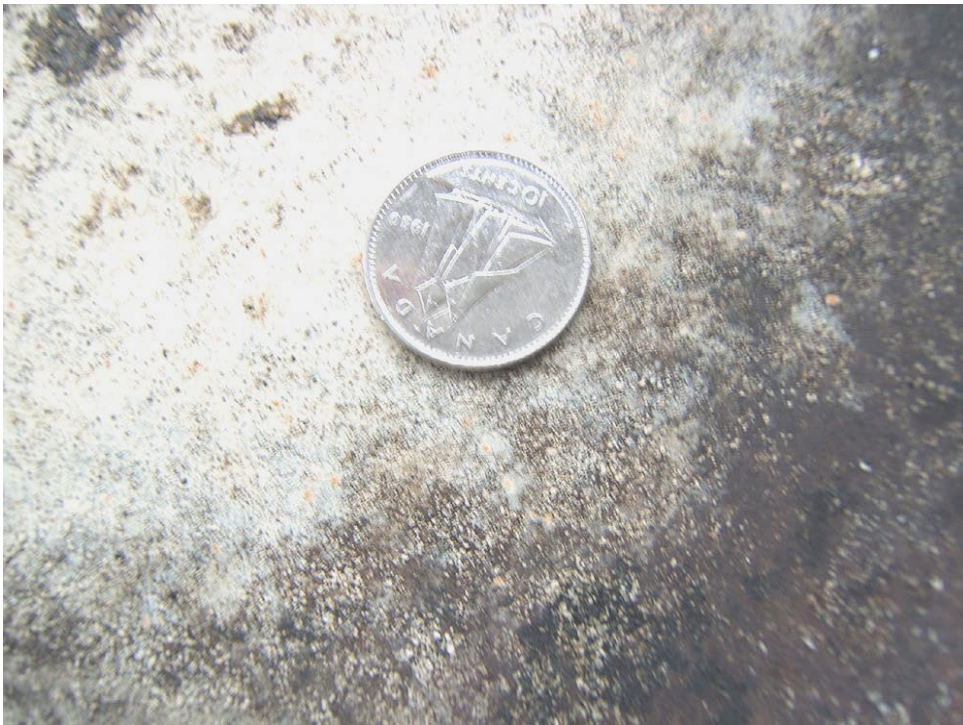
To confirm that I was not going off on a technological tangent, I did the simple experiment of slowly removing the water from a goop sample in a warm wok on the kitchen stove. After the water had gone, I discarded all the powdery material, and was left with a wok with a thin white film on the bottom adhering to the metal surface. This could not be removed by vigorous washing or rubbing with fingers, but it could be using a regular plastic dish scrubber.

I showed my wok to the owner of the Gabriola Automotive Company (Tim Nicklom), who services many “gooped” vehicles on the Island. He assured me that the stuff in my wok had all the physical qualities and appearance of the material he was seeing on the inside of brake drums. It is therefore a reasonable supposition, I think, that part of the “corrosion” problem is silica scaling. Jeremy Baker has observed the formation of a silica gel in goop-laden water, likely initiated by a drop in pH. Smectite clays are, as are all clays, rich in silica.
