Gabriola Streamkeepers—Water levels and quality

Observations at Coats Marsh, Gabriola Island

Field observations—2024 (Jan.—May)

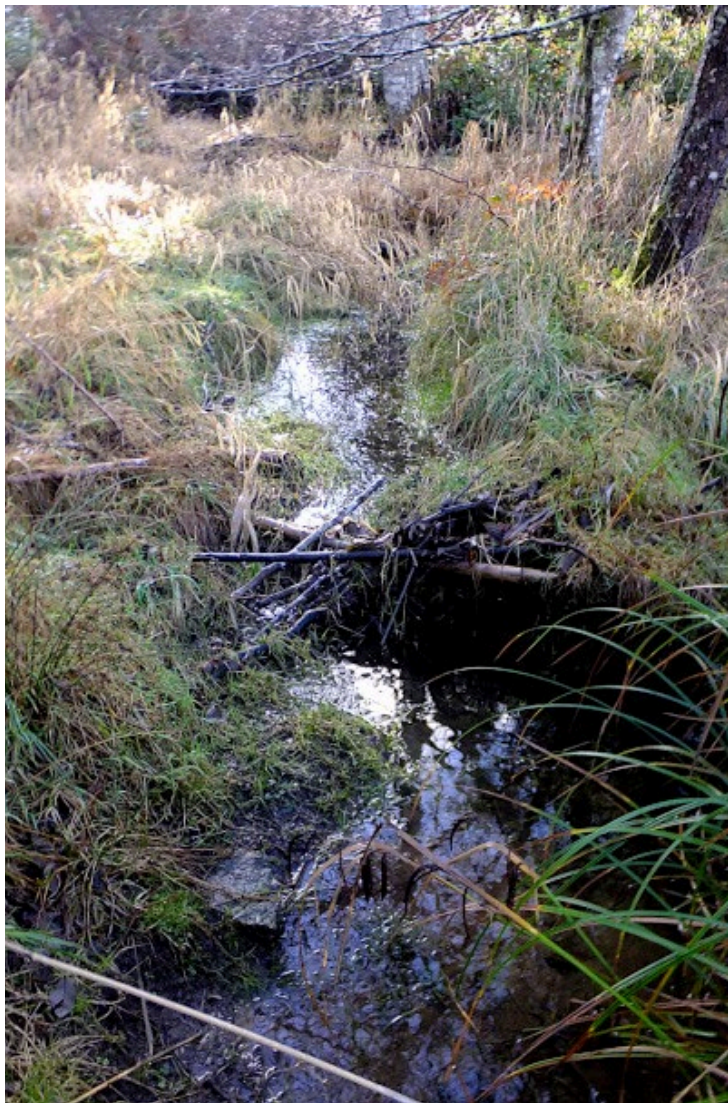
One interesting discovery was what appeared to be a drainage channel noted last summer when the lake water level was extraordinarily low (File: [673zc](#), p.ZC 544). On investigation today (there were no ducks

around), I found that this channel extends into the bush where it is obviously natural. The channel was ponded but no flow could be observed, even though EPC was flowing gently at the culvert; however, there was little doubt that at times this is a significant ephemeral watercourse. It and other smaller ones nearby appear to have attracted the beaver's passing interest.

This ties in nicely with my observations of years ago that the glaciofluvial smectite clay underlying the lake suggests the lake was more extensive at the time of its deposit at the end of the Pleistocene (File: [668](#)). My guess is that the lake was blocked by massive amounts of ice at its western end, and its immediate catchment area was thereby extended beyond the wetted perimeter of the lake today. This extension of the lake's perimeter acts to funnel runoff into the modern lake evidently often as subsurface or poorly-defined flows, with almost none infiltrating through the gleysol into the

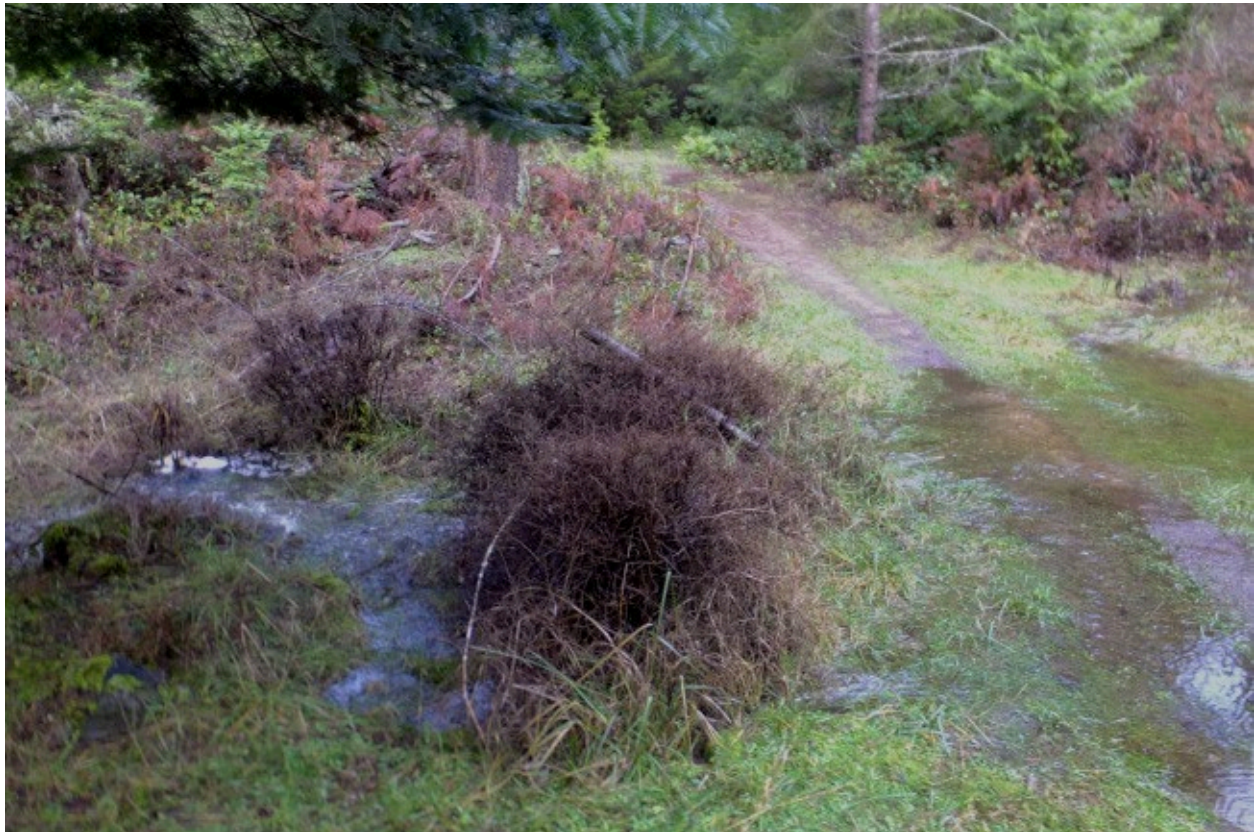
Heavy rain with passage of a cold-front overnight. EPC culvert full. NE Arm spillway (shown below) flooded with a flow over and under East Path comparable with that observed at the EPC culvert.

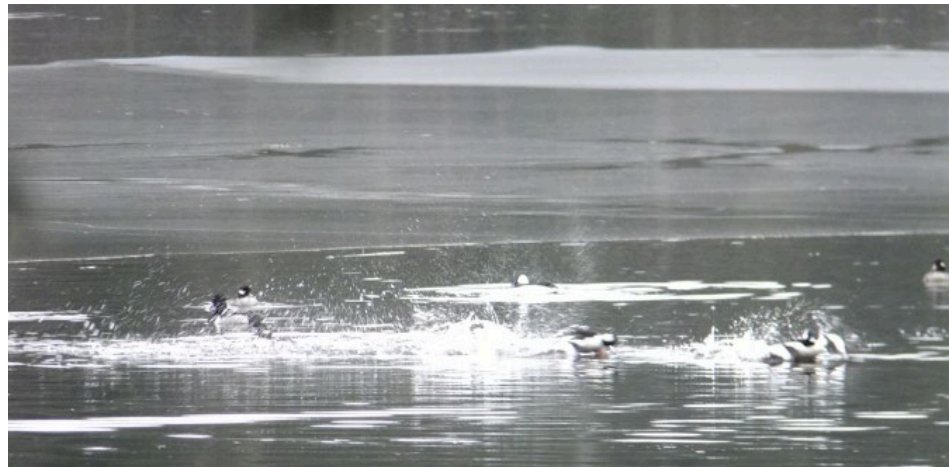
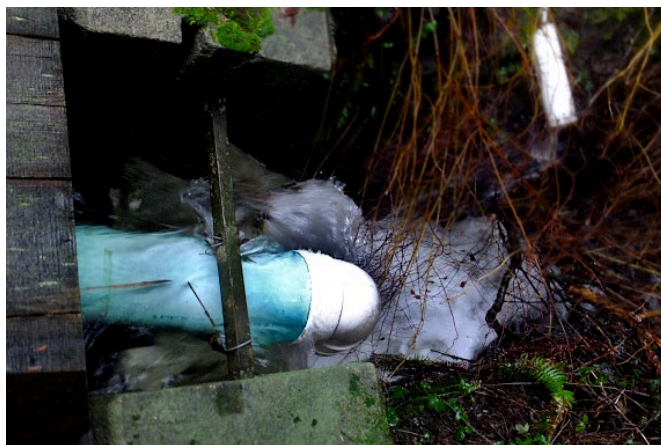
Discharge into Coats Marsh Creek. Rather more than the submerged pond leveller can handle (hard to see in the photo, but the level of water over the sill is higher than the top of the leveller).

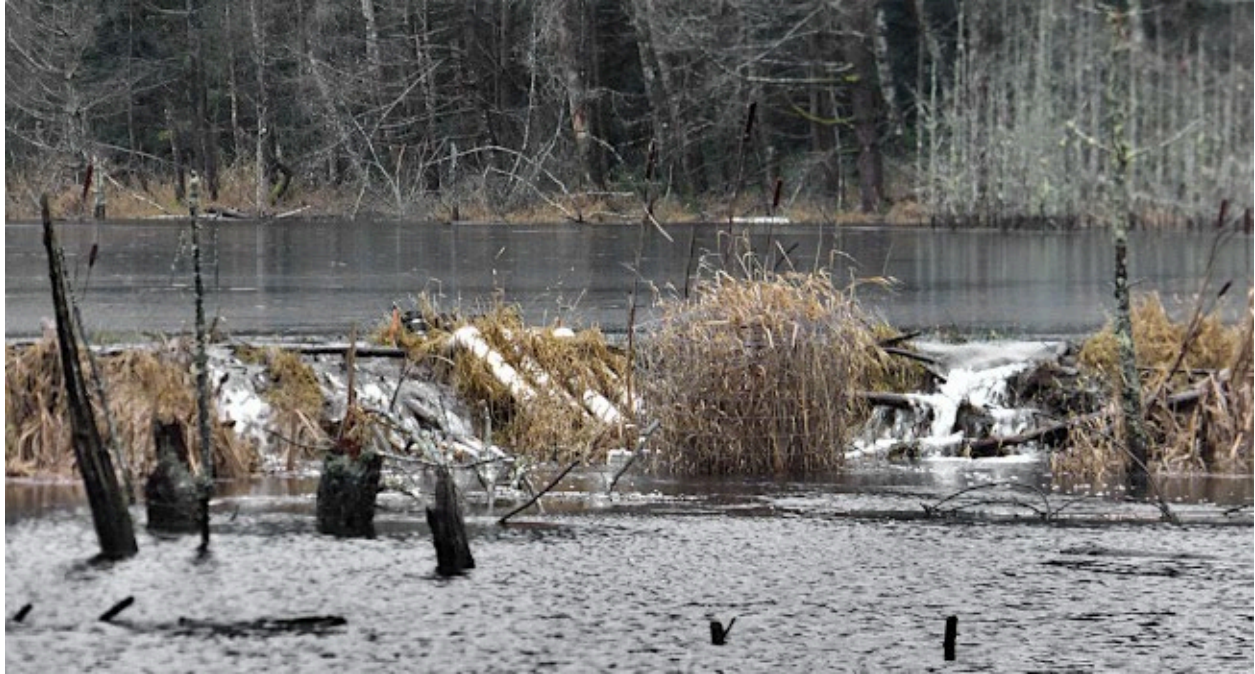
The beaver doesn't need the siphons to release potential floodwater. It also looks a bit dangerous to go out there to attend to the siphons. *Below:* The second beaver dam by the weir is raising the weirpool level.

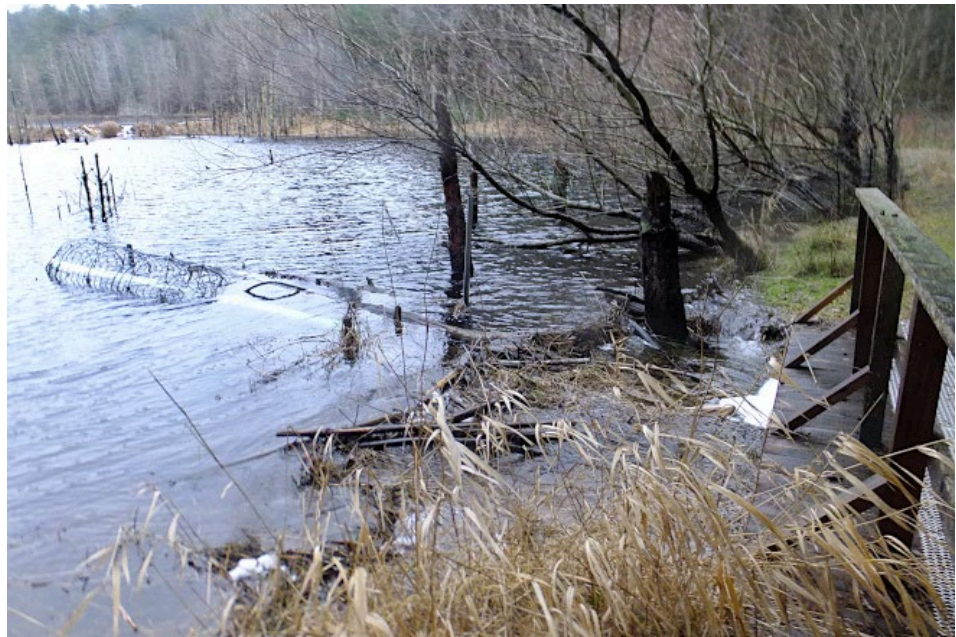
In one month (Oct. 4 to Nov. 6, 2023), rainfall raised the lake level from -37 cm below the crest of the concrete weir to +52 cm above the crest of the concrete weir. At the same time, the level in the weirpool rose from 54 cm below the level of the sill (a severe drawdown) to 49 cm above it (partially blocked by the beaver).

Drawing water levels down in late-summer, regardless of the degradation of the ecology that might cause, in the expectation that levels will not return to pre-siphon levels is fraught. As was demonstrated in October last year, with the present design, a single pineapple express can negate any late-summer drawdown no matter how extreme the drawdown.

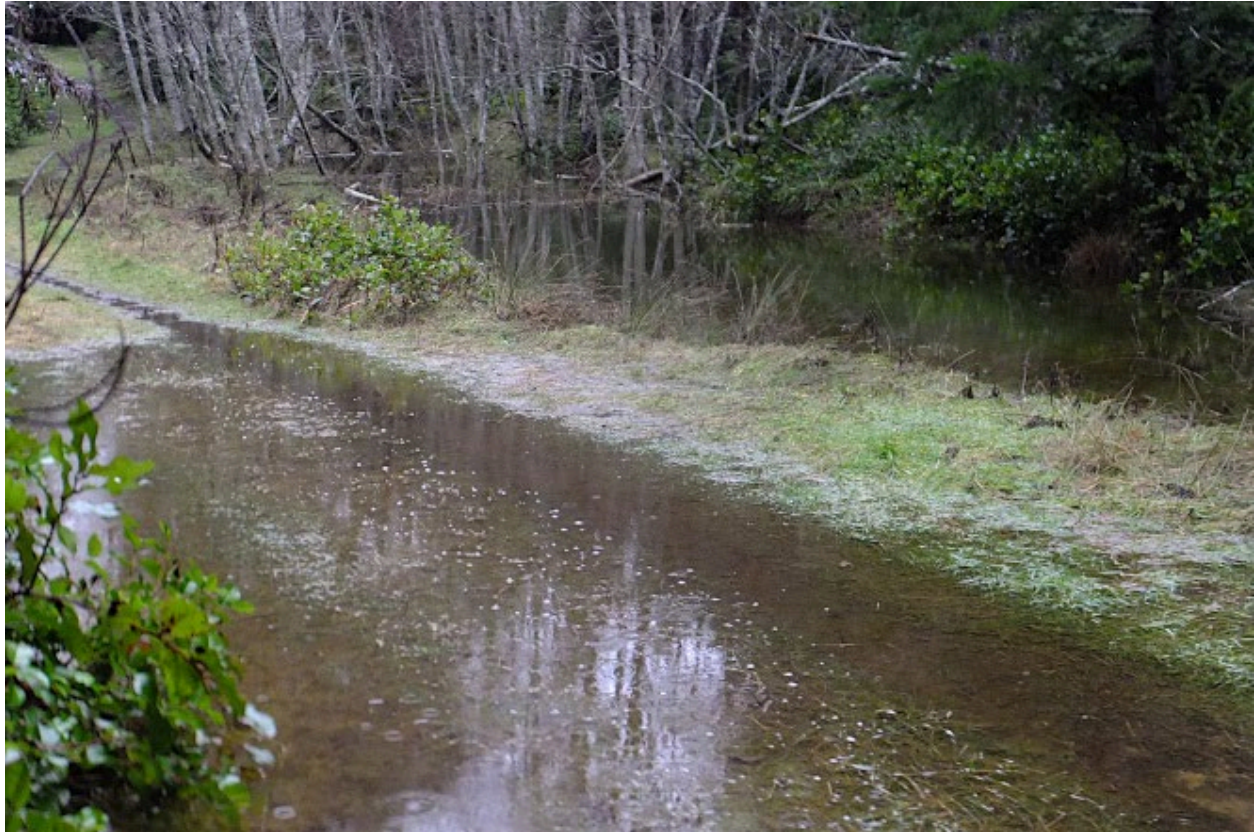
NNE Arm spillway. Not nearly as substantial as the NE Arm Creek, which it joins, more ephemeral, but contributes to “flash” flooding. Flows in watertracks rather than recognizable channels.

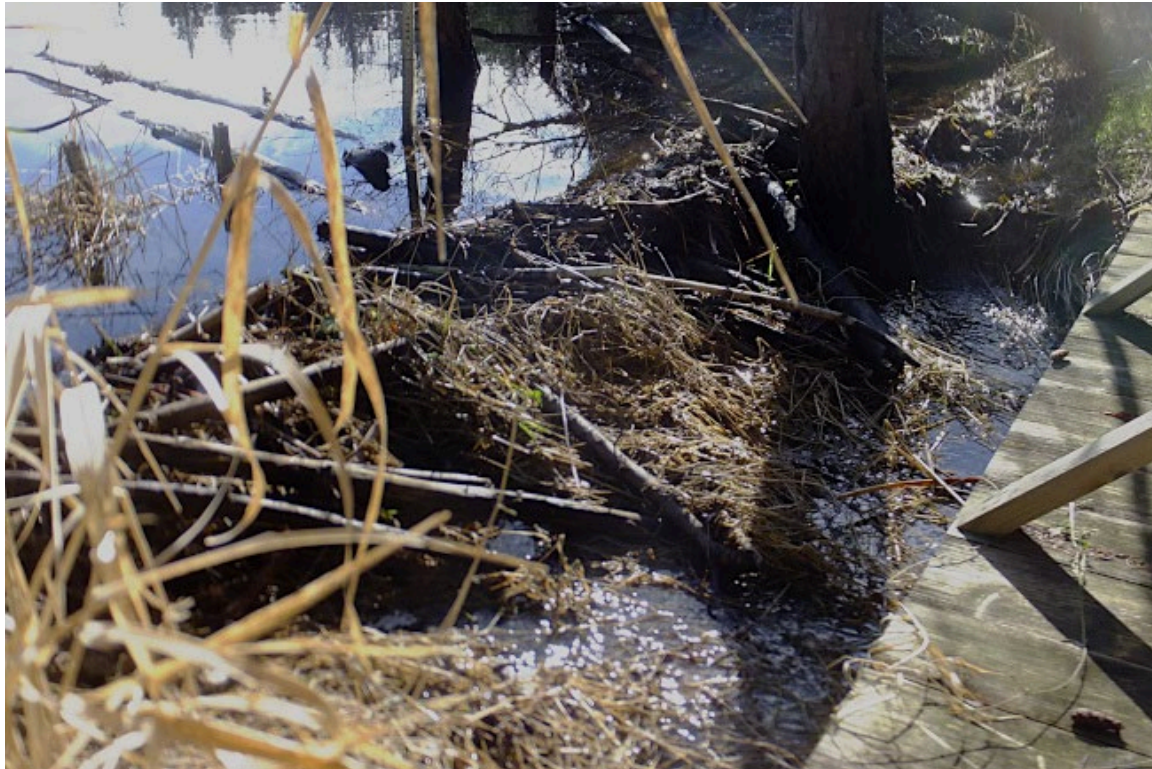
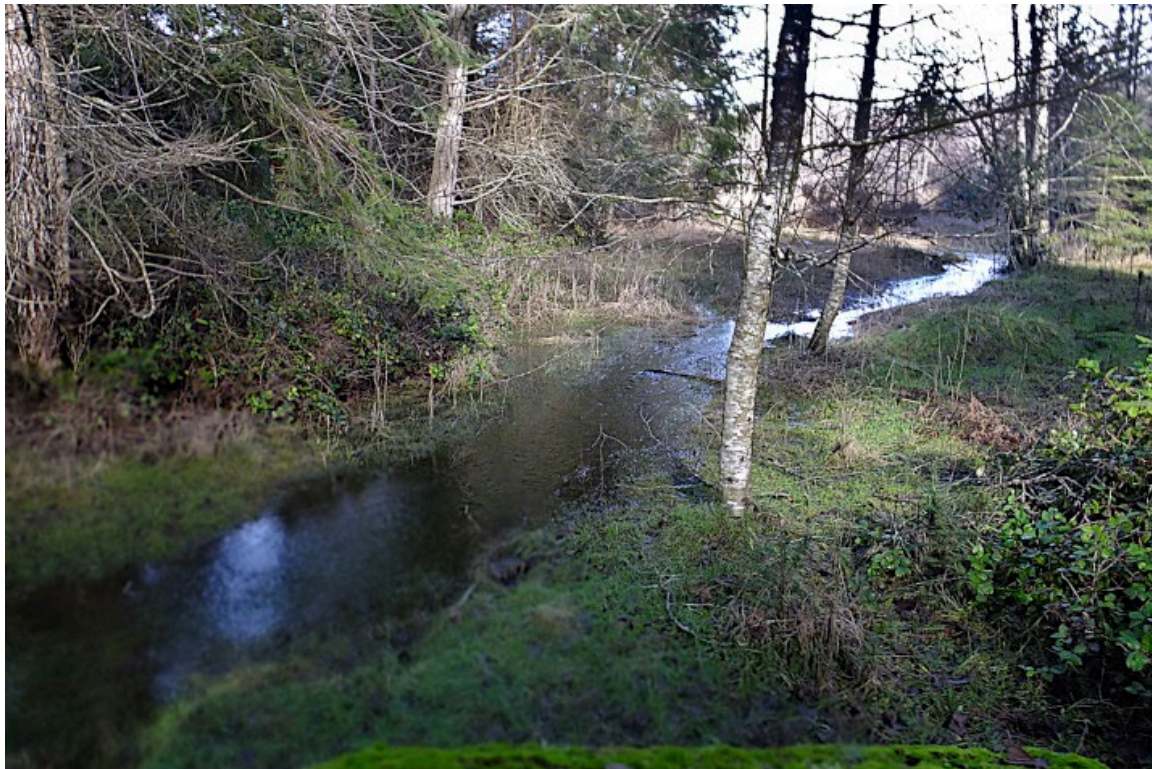
Stump Farm Number 1 Stream as it leaves Canary Grass Meadow (looking upstream, NE).

Established by a tortuous bushwhack around deadfalls and through sometimes thorny thickets, following trickling water, puddles, waterlogged grassy patches and other hydrophytic vegetation, that Stump Farm No.2 Stream² is readily traceable upstream from the Stump Farm Trail culvert³ eastward to a culvert on the Marsh Trail,⁴ which, measured along the trail, is about 60 metres west of the entrance to the western burn-pile clearing. It's often ponded on the NE side of the Marsh Trail at the culvert location.

The elevation of the Marsh Trail culvert relative to the Stump Farm Trail culvert is small, hard to measure but six to eight metres in a distance of about 150 metres (hand-held GPS).
