Coats Marsh Weir Replacement Elevation Study Final Report

April 12, 2023 Final Report, Rev. 0

NHC Reference 3007584

Regional District of Nanaimo 6300 Hammond Bay Road Nanaimo BC V9T 6N2

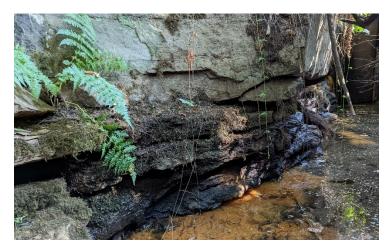
Photo 2.6 Typical condition of fractured bedrock downstream of the weir.

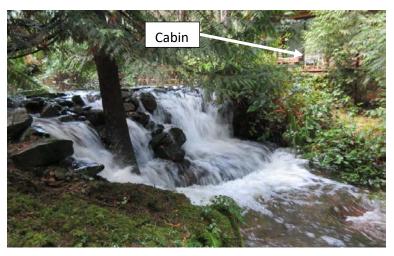
- There is a small cabin located on private property at 1040 Coats Drive, approximately 60 m downstream of the weir (Photo 4.1 and Photo 4.2.) The cabin is raised on concrete piers and is sited immediately adjacent to the stream channel near an ornamental rock weir. RDN contacted the property owner to obtain additional information on the structure; he indicated that the cabin is uninhabited, but occasionally used as a guest house for visitors. Photos from previous studies indicate that the cabin has a wood burning stove and an electrical line from the main house on the lot. The property owner also indicated that water runs under the cabin during periods of intense rainfall and high-water flow. Based on provincial guidelines (BC FLNRORD, 2017), the cabin likely meets the definition of a "seasonal cottage" and populations at risk are considered permanent rather than temporary. This interpretation is also relevant if the cabin becomes more regularly inhabited in the future. If there is low potential for loss of life in a dam breach, the consequence classification is Significant. If loss of life is possible, the consequence classification is High. Other downstream populations at risk are temporary only, such as park users and the travelling public along South Road; these populations at risk fall under the Significant classification.

Photo 4.1 Flow over ornamental rock weir at 1040 Coats Drive, March 6, 2014 (SRM Projects, 2020).

- The replacement spillway could include extensive rockfill on its downstream side to reduce the potential for a sudden, catastrophic failure of the dam, thereby reducing peak outflows and flood hazards during a breach.

- If either of these alternatives is proposed for implementation, dam breach inundation modelling should be completed to confirm that the mitigation work will reduce flood hazard levels to acceptable levels for a Significant consequence dam.

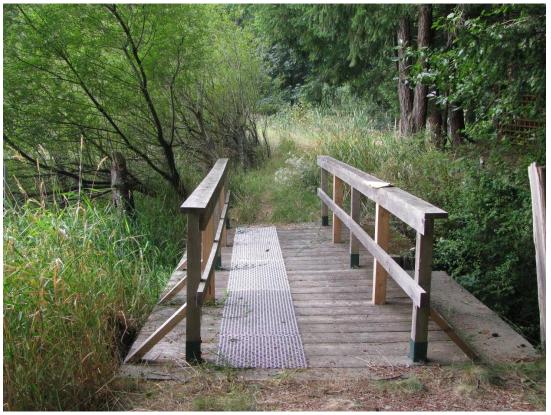
Coats Marsh weir is a concrete outlet weir that is approximately 3.3 m high (downstream side), 6 m wide and 0.6 m thick with a wooden bridge built to cross the water outlet. The weir, bridge and berm are located on Coats Marsh Creek at the west end of Coats Marsh on Gabriola Island (Photo 1-1). The design water storage of the weir is approximately 22,000 cubic meters.

Photo 1-1. Wood bridge over Coats Creek and adjacent to cement weir with berm on the other side

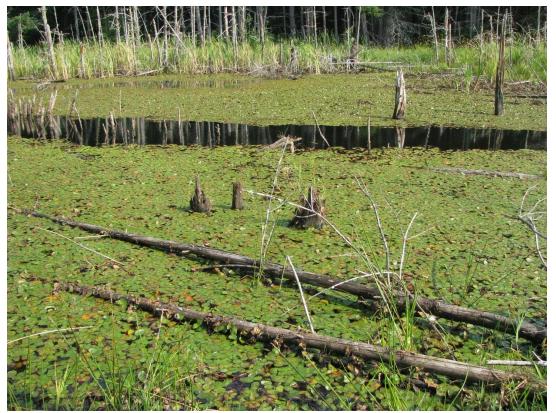
Photo 1-3. Area between cement weir and beaver dam (looking north).

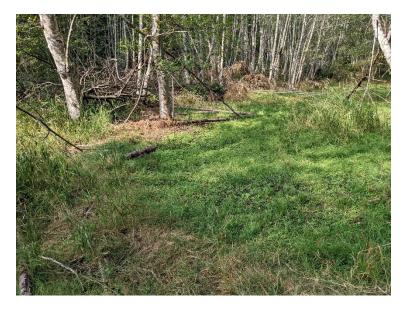
Photo B1 East Path Creek inlet at northeast of Coats Marsh, looking upstream. This is an ephemeral stream.

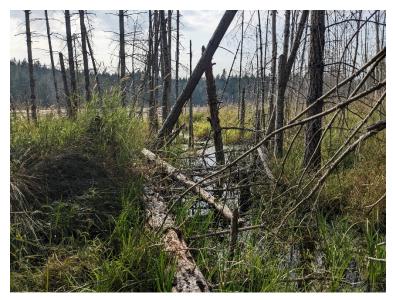
Photo B2 East Path Creek inlet at northeast of Coats Marsh, looking downstream.

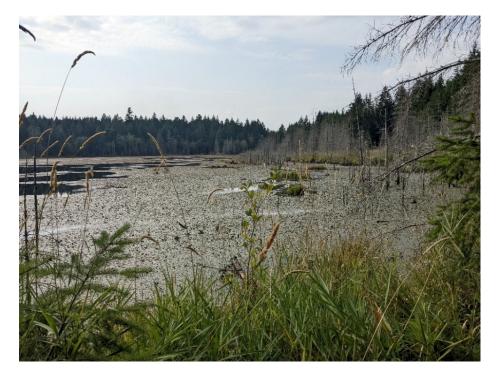
Photo B3 View of Coats Marsh from inlet of East Path Creek.

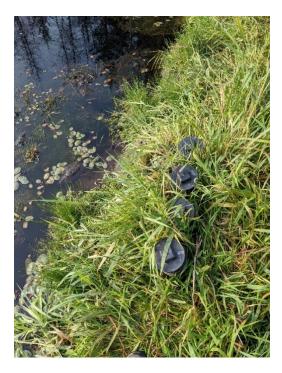
Photo B7 Part of RDN installed siphon system in beaver dam, almost completely obscured by vegetation.

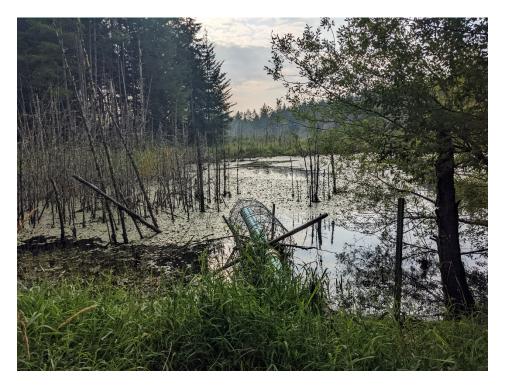
Photo B8 View from weir toward beaver dam, with caged inlet pipe.

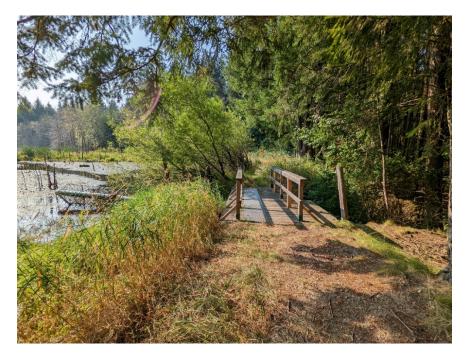
Photo B9 Pedestrian footbridge and weir, looking toward berm.

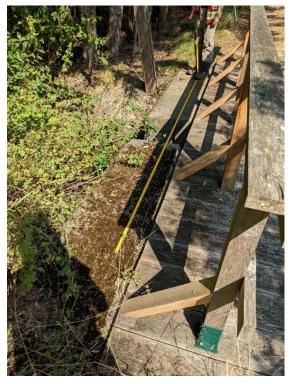
Photo B10 Top view of weir.

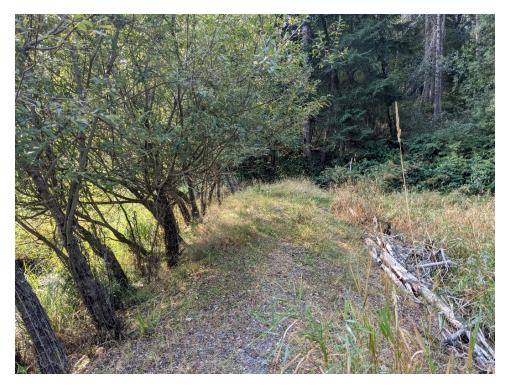
Photo B15 Berm, willows are caged near their bases to prevent beavers from cutting.

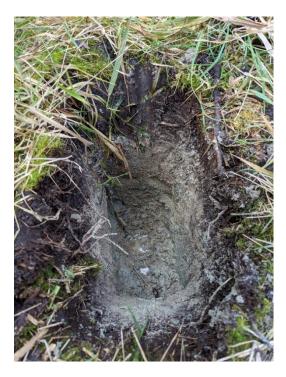
Photo B17 View of test pit excavated by hand shovel immediately west of berm.

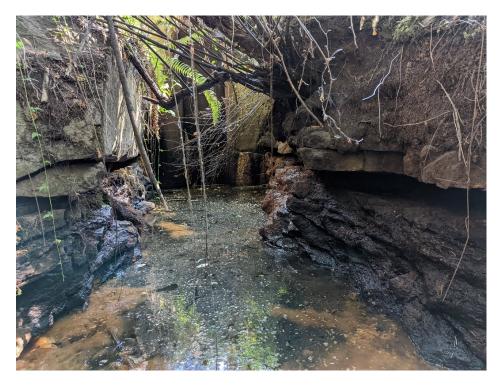
Photo B19 View in the narrow channel immediately downstream of the weir.

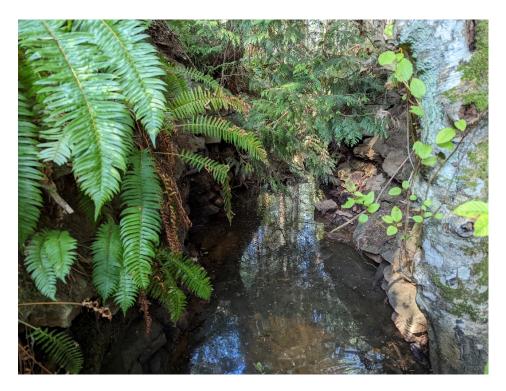
Photo B20 View of Coats Marsh Creek looking downstream, narrow channel with bedrock walls.

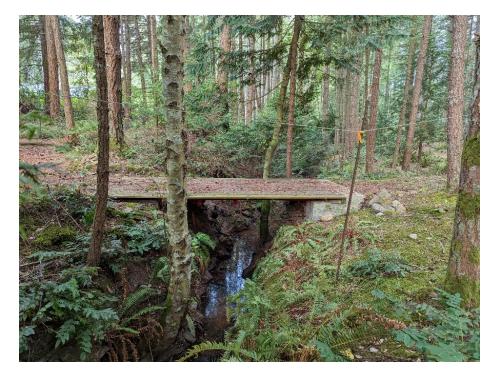
Photo B21 View toward private property where Coats Marsh Creek enters 1040 Coats Drive. Private wooden footbridge. Marker indicates property line.

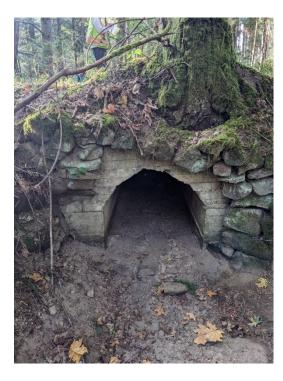
Photo B22 Culvert crossing below easement accessing Coats Marsh Regional Park from the west.

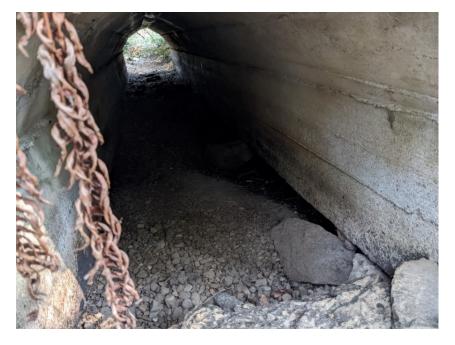
Photo B23 Culvert for Coats Marsh Creek below easement access.

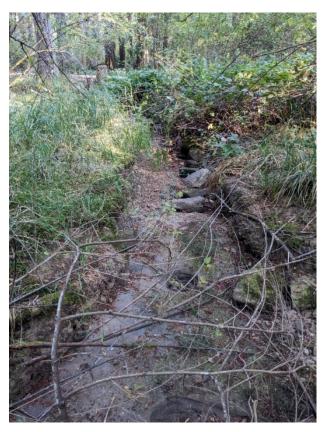
Photo B24 Typical conditions of Coats Marsh Creek in western Regional Park area, uneven with exposed bedrock.

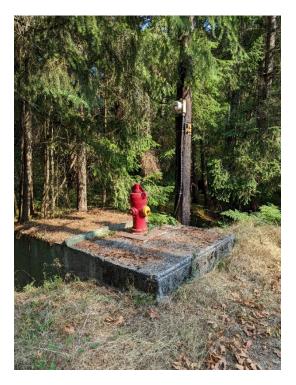
Photo B25 Fire hydrant and pump house located at South Road near Coats Marsh Creek.

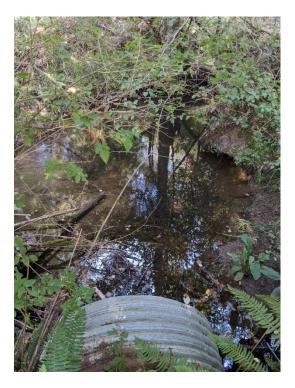
Photo B26 Inlet of Coats Marsh Creek to culvert crossing below South Road.
