Coats Marsh Weir Assessment

Regional District of Nanaimo
1490 Springhill Road
Parksville, BC V9P 2T2
Liaison: Chris van Ossenbruggen,
Parks Operations Coordinator
Reference Number: NA

Scot Merriam, P.Eng.
Principal Engineer, SRM Projects

Date: June 1, 2020

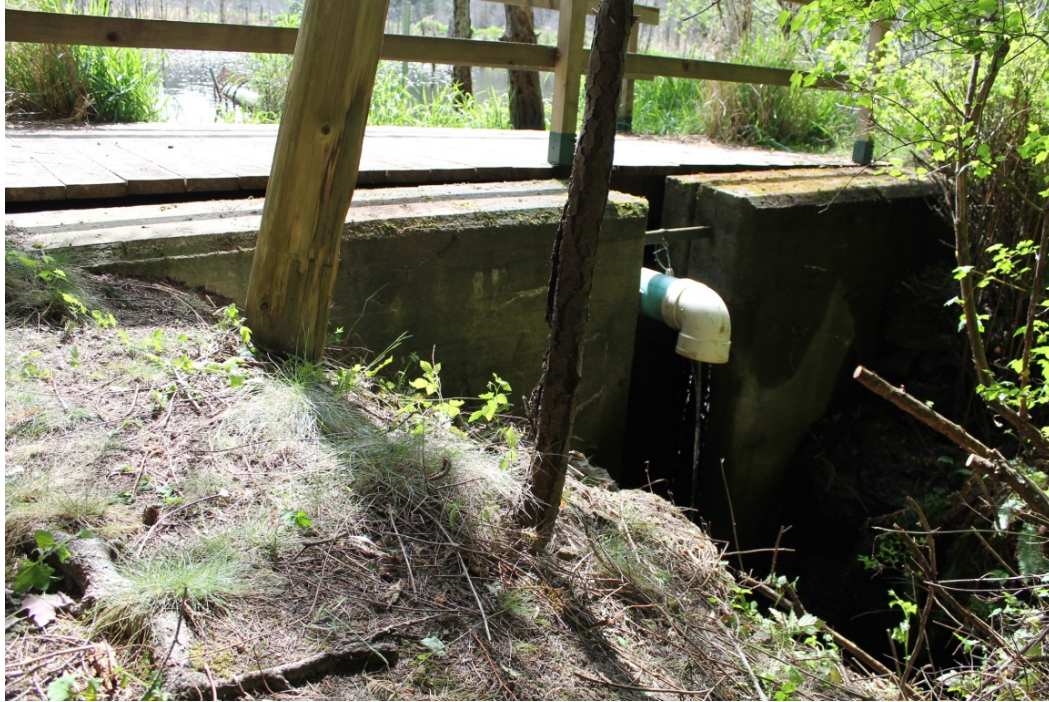
Figure 1-2: Coats Marsh weir downstream side view

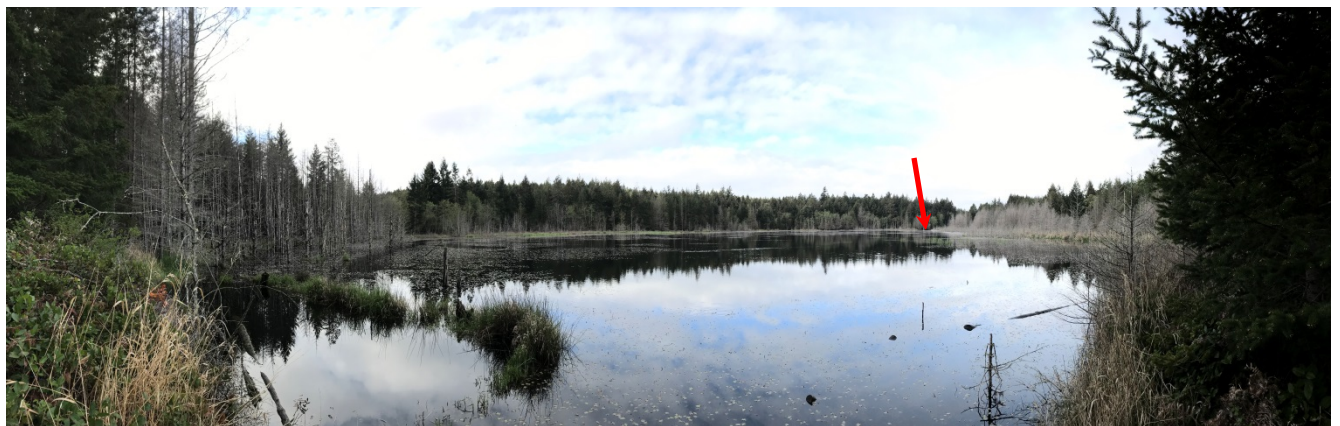
2. View from SE end of Coats Marsh looking roughly west. Approximate beaver dam location shown by red arrow

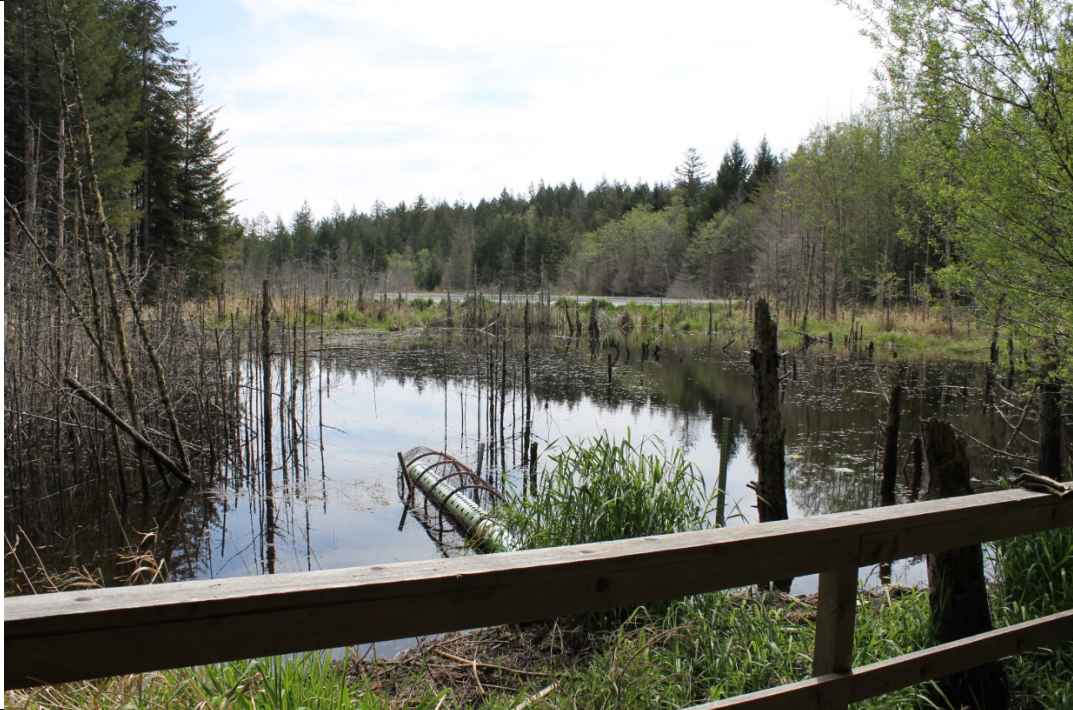
5. View of beaver dam from footbridge at weir; looking approximately SE

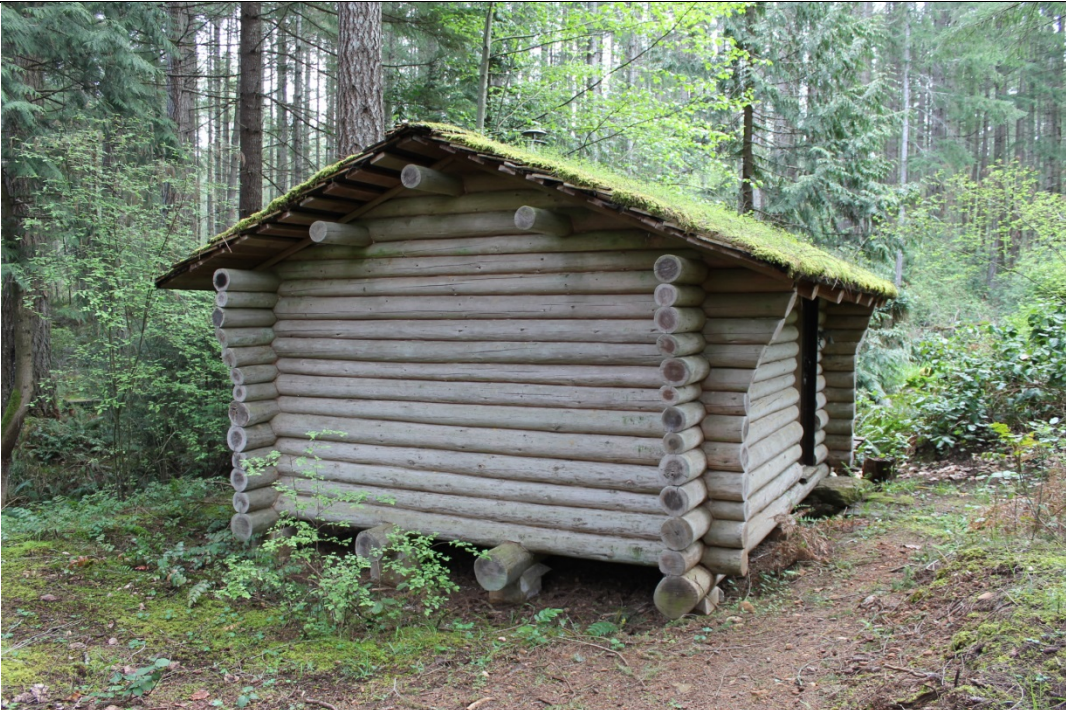
56. Recreational cabin end view

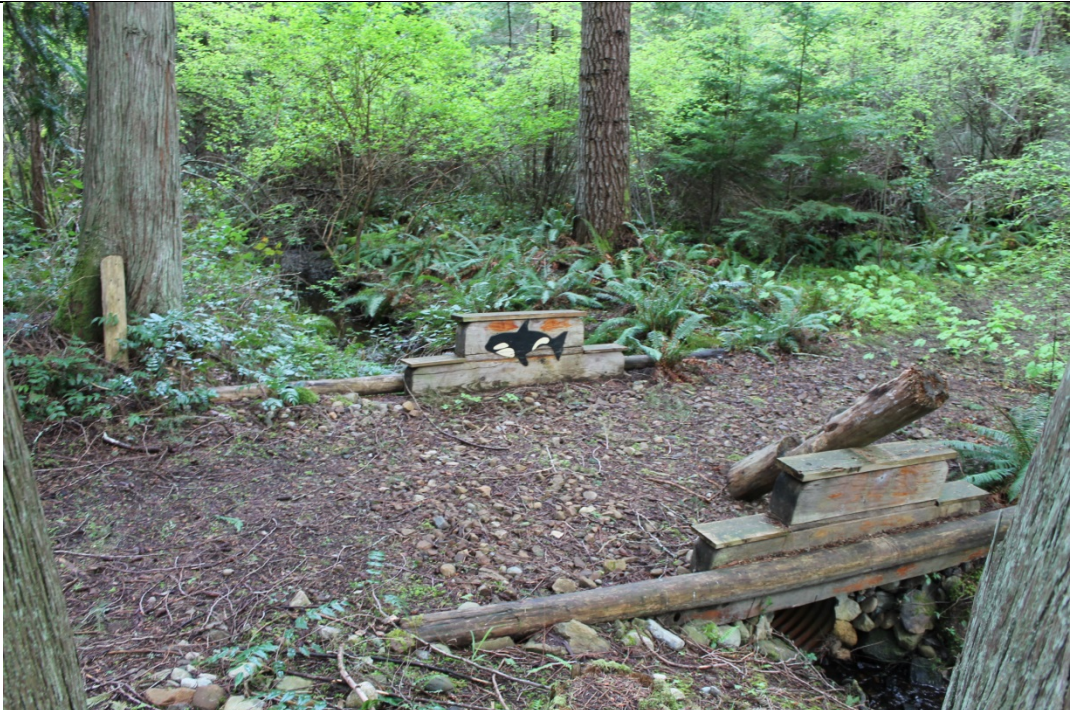
62. Looking D/S over bridge 3 – terrain is broad and very flat

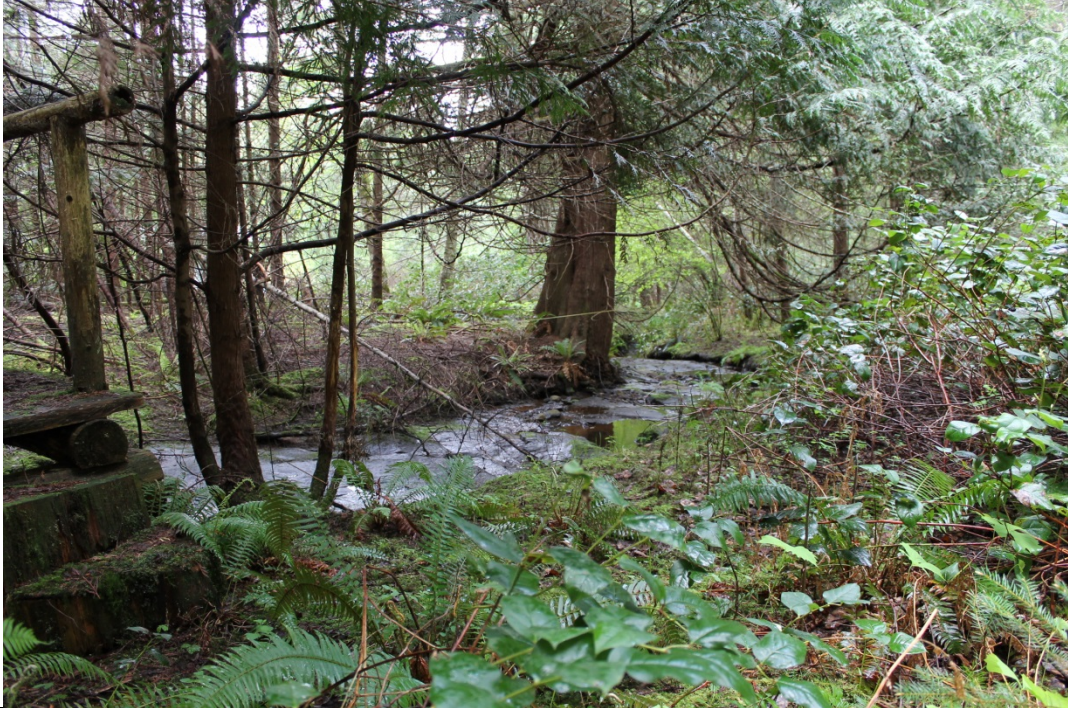
67. Looking D/S past foot bridge 4
